Final Report

Road Inventory and Condition Assessment of Paved Routes Thomas Edison National Historical Park

**Federal Lands Highway
Road Inventory Program**

Report Date: September 2021

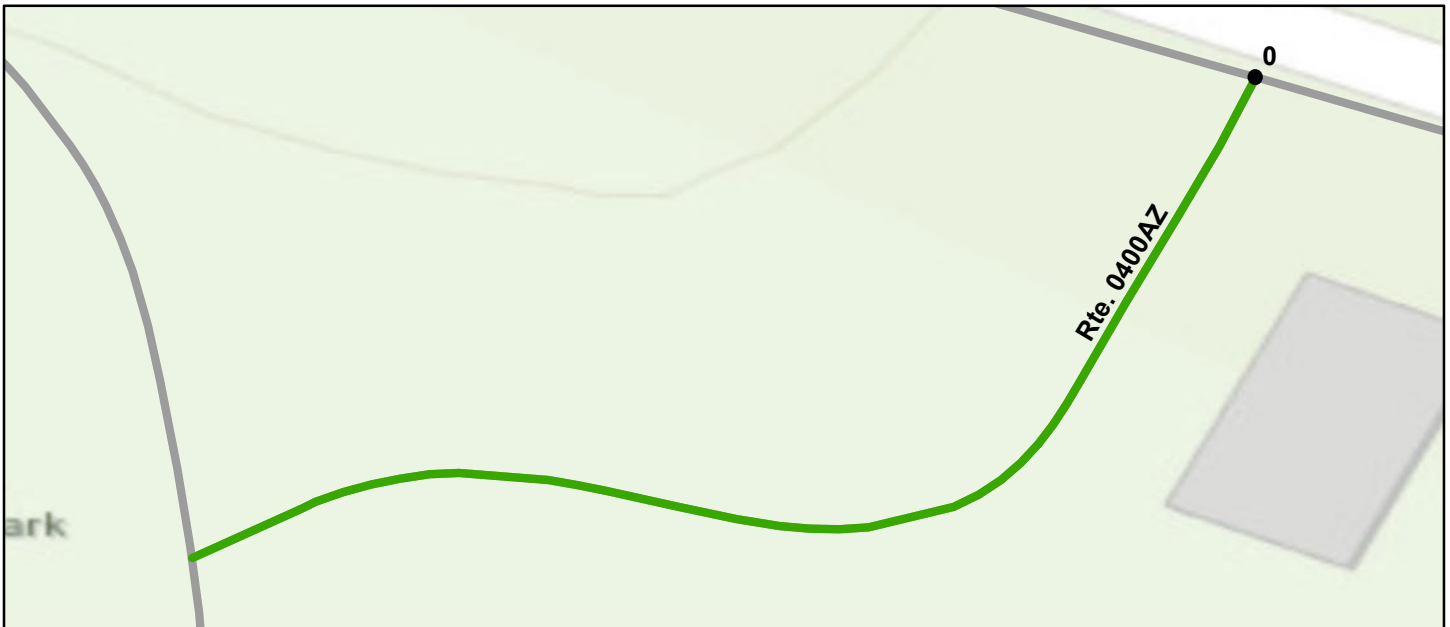
ROUTE 0400AZ: EDISON HOMESITE N SERVICE ROAD

Route Condition Legend – Pavement Condition Rating (PCR)						
Poor (0 - 60)	Fair (61- 84)	Good (85 - 94)	Excellent (95 - 100)	Not Rated		
Colors on map represent condition scores at 0.10-mile intervals. See Appendix for definitions and formulas.						
Inspection Date: 11/14/2020	Beginning Section MP	0				
Paved Length (Miles): 0.04	Section Length (MI)	0.04				
Surface Type: ASPHALT	Route Summary					
Roadway Condition Information						
Pavement Condition Rating (PCR)	90	90				
Surface Condition Rating (SCR)	N/A	N/A				
Roughness Condition Index (RCI)	N/A	N/A				
Distress Index Values						
Structural Crack Index	N/A	N/A				
Alligator Crack Index	N/A	N/A				
Longitudinal Crack Index	N/A	N/A				
Transverse Cracking Index	N/A	N/A				
Patching Index	N/A	N/A				
Rutting Index	N/A	N/A				
International Roughness Index (IRI)	N/A	N/A				
Lane & Width Information						
Number of Lanes	1	1				
Paved Width (ft)	15	15

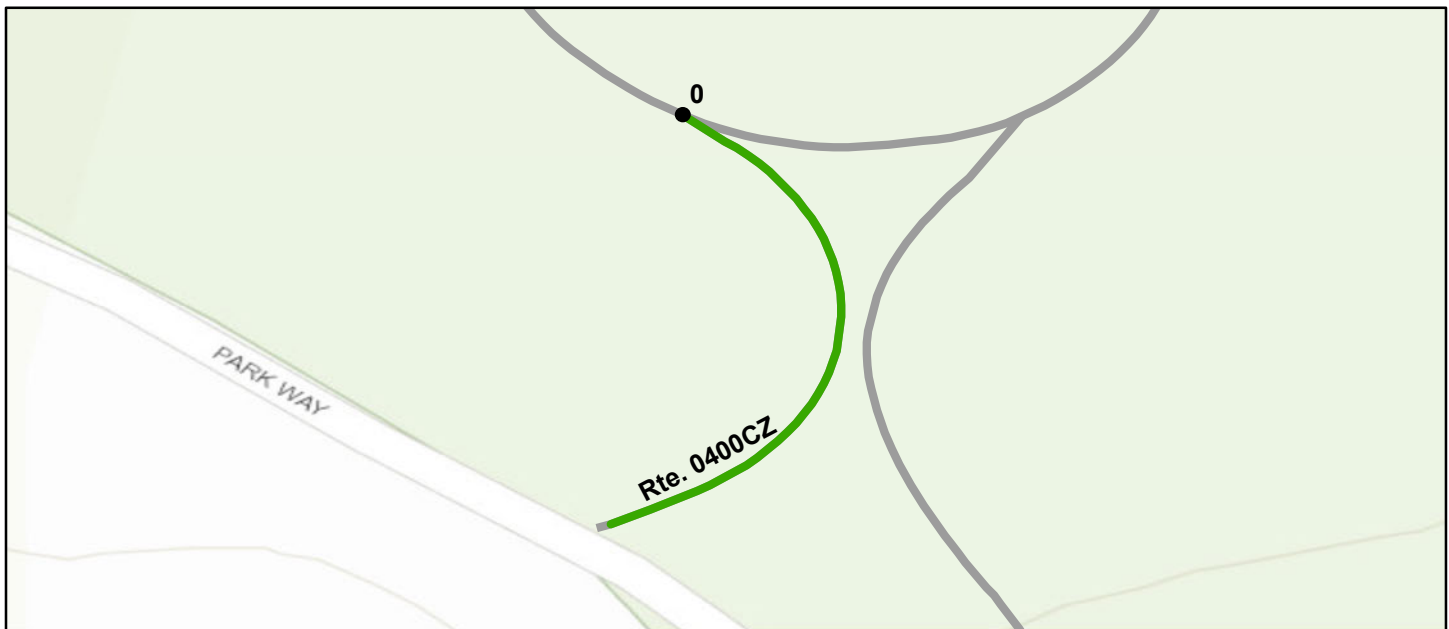
ROUTE 0400CZ: EDISON HOMESITE S SERVICE ROAD WEST EXIT

Route Condition Legend – Pavement Condition Rating (PCR)						
Poor (0 - 60)	Fair (61- 84)	Good (85 - 94)	Excellent (95 - 100)	Not Rated		
Colors on map represent condition scores at 0.10-mile intervals. See Appendix for definitions and formulas.						
Inspection Date: 11/14/2020	Beginning Section MP	0				
Paved Length (Miles): 0.04	Section Length (MI)	0.04				
Surface Type: ASPHALT	Route Summary					
Roadway Condition Information						
Pavement Condition Rating (PCR)	92	92				
Surface Condition Rating (SCR)	92	92				
Roughness Condition Index (RCI)	N/A	N/A				
Distress Index Values						
Structural Crack Index	100	100				
Alligator Crack Index	100	100				
Longitudinal Crack Index	100	100				
Transverse Cracking Index	100	100				
Patching Index	100	100				
Rutting Index	92	92				
International Roughness Index (IRI)	N/A	N/A				
Lane & Width Information						
Number of Lanes	1	1				
Paved Width (ft)	14.8	14.8

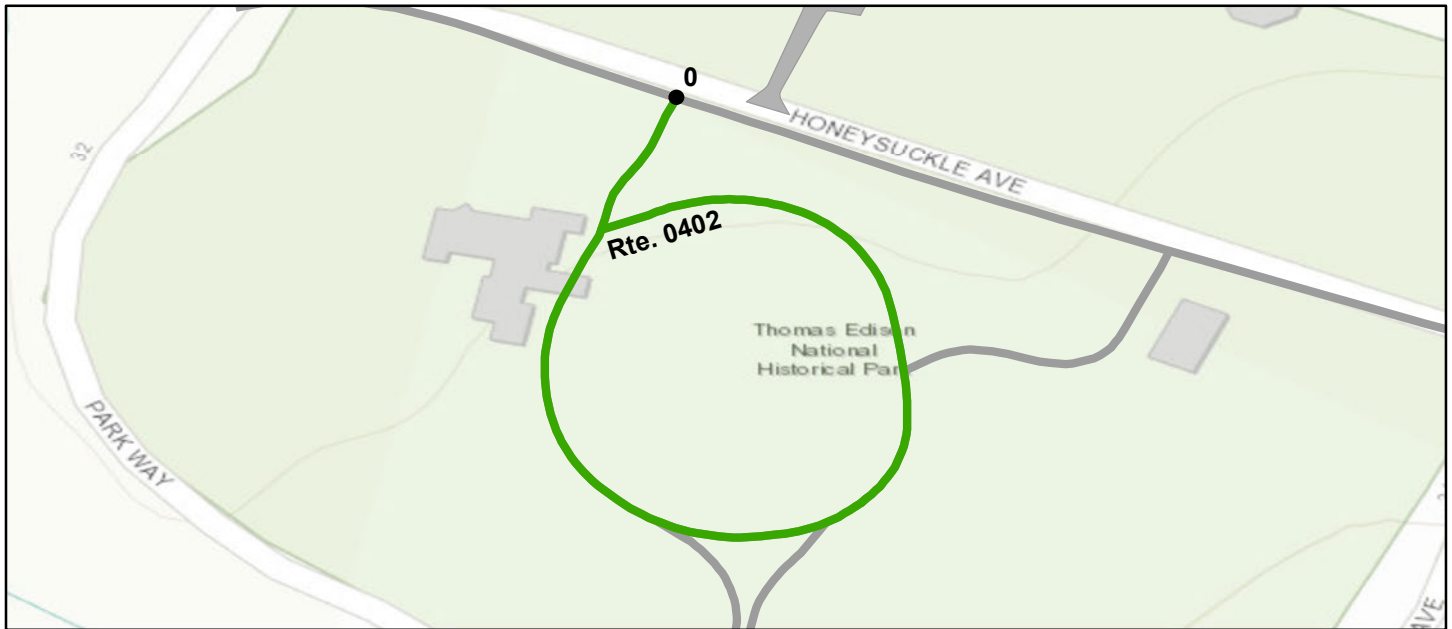
ROUTE 0402: CIRCULAR DRIVEWAY

Inspection Date:	11/14/2020	Beginning Section MP	0				
Paved Length (Miles):	0.18	Section Length (MI)	0.18				
Surface Type:	ASPHALT	Route Summary					
Roadway Condition Information							
Pavement Condition Rating (PCR)	90	90					
Surface Condition Rating (SCR)	90	90					
Roughness Condition Index (RCI)	N/A	N/A					
Distress Index Values							
Structural Crack Index	100	100					
Alligator Crack Index	100	100					
Longitudinal Crack Index	100	100					
Transverse Cracking Index	100	100					
Patching Index	100	100					
Rutting Index	90	90					
International Roughness Index (IRI)	N/A	N/A					
Lane & Width Information							
Number of Lanes	1	1					
Paved Width (ft)	14	14					
Lane Width (ft)	14	14

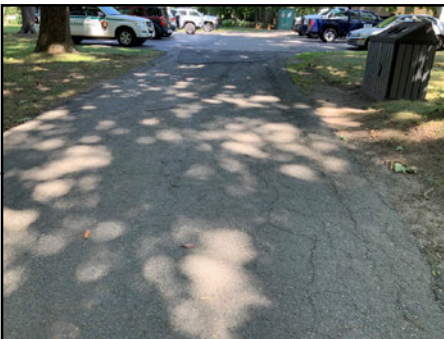
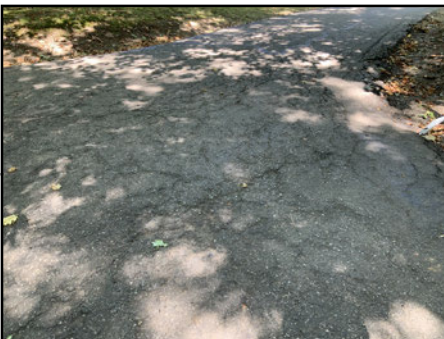
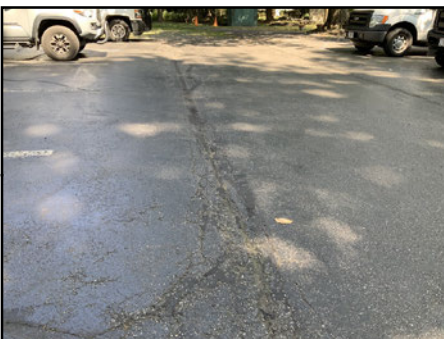
Inspection Date	FMSS Number	User Access	Surface Type
9/22/2020	59523	PUBLIC	ASPHALT
Area (Sq. Ft.)	Lane Miles (11' Widths)	Curb Reveal (Inches)	Curb Recommendation
5,176	0.089	NOT APPLICABLE	NOT APPLICABLE
Curb Type		Curb & Gutter Type	
NO CURB		NO CURB AND GUTTER	
Pavement Recommendation		Condition Rating / PCR	
HEAVY 3R TREATMENTS		POOR / 53

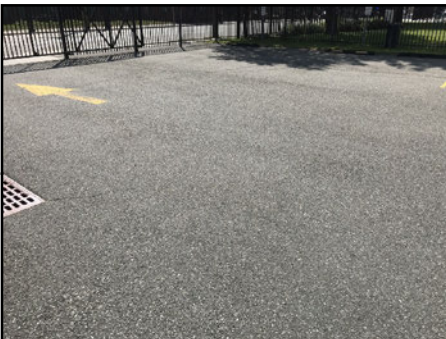
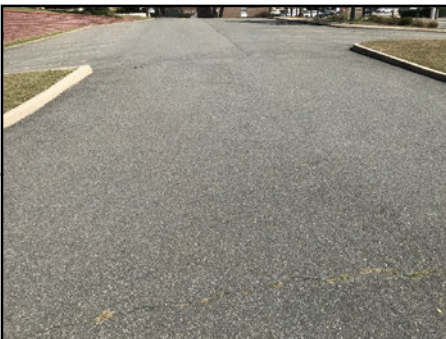
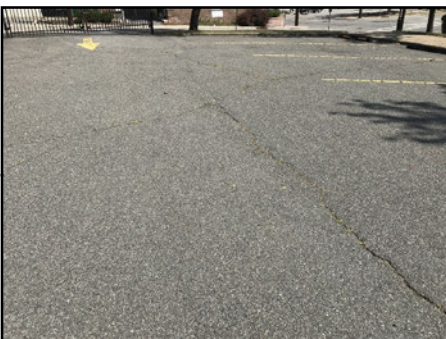
ROUTE 0901: EDISON LAB VISITOR PARKING

Inspection Date	FMSS Number	User Access	Surface Type
9/22/2020	59555	PUBLIC	ASPHALT
Area (Sq. Ft.)	Lane Miles (11' Widths)	Curb Reveal (Inches)	Curb Recommendation
15,992	0.275	6	LIGHT REPAIR
Curb Type		Curb & Gutter Type	
CONCRETE		NO CURB AND GUTTER	
Pavement Recommendation		Condition Rating / PCR	
HEAVY 3R TREATMENTS		POOR / 53

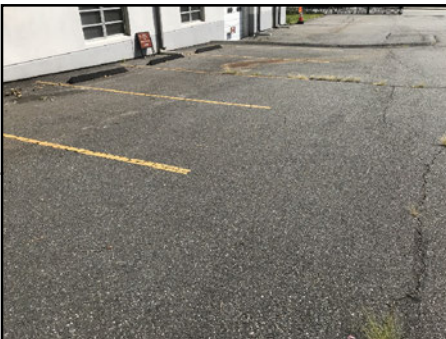
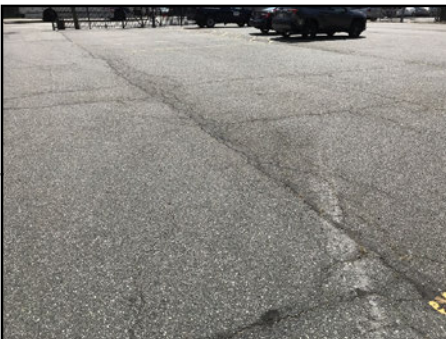
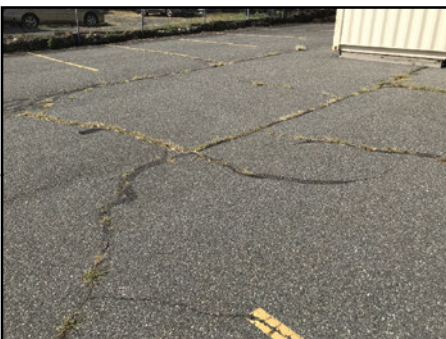
ROUTE 0902: MAINTENANCE/ VISITOR CENTER PARKING

Inspection Date	FMSS Number	User Access	Surface Type
9/22/2020	103343	NONPUBLIC	ASPHALT
Area (Sq. Ft.)	Lane Miles (11' Widths)	Curb Reveal (Inches)	Curb Recommendation
19,803	0.341	NOT APPLICABLE	NOT APPLICABLE
Curb Type		Curb & Gutter Type	
NO CURB		NO CURB AND GUTTER	
Pavement Recommendation		Condition Rating / PCR	
HEAVY 3R TREATMENTS		POOR / 53

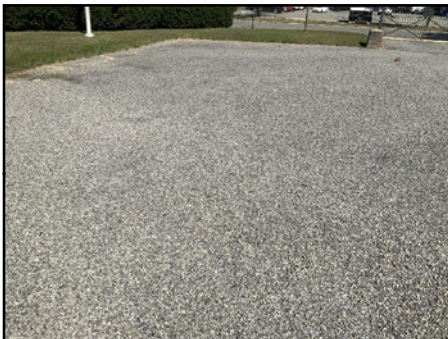
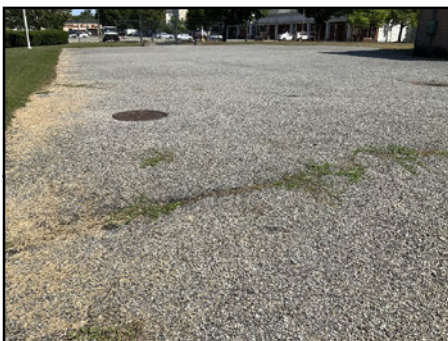
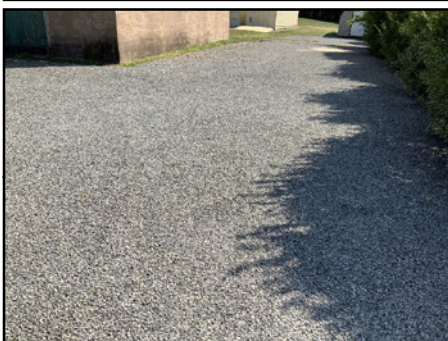
ROUTE 0905: ALDEN STREET ACCESS PARKING

Inspection Date	FMSS Number	User Access	Surface Type
9/22/2020	N/A	NONPUBLIC	ASPHALT
Area (Sq. Ft.)	Lane Miles (11' Widths)	Curb Reveal (Inches)	Curb Recommendation
8,983	0.155	NOT APPLICABLE	NOT APPLICABLE
Curb Type		Curb & Gutter Type	
NO CURB		NO CURB AND GUTTER	
Pavement Recommendation		Condition Rating / PCR	
NOT APPLICABLE		NOT RATED

NOTE: NOT RATED DUE TO TAR AND CHIP SURFACE OVER ASPHALT

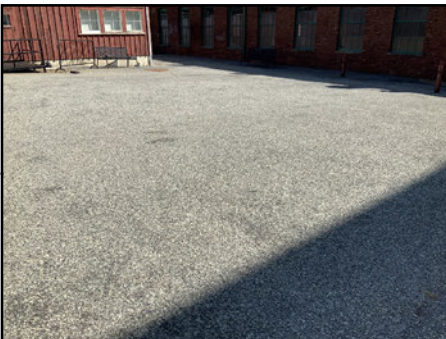
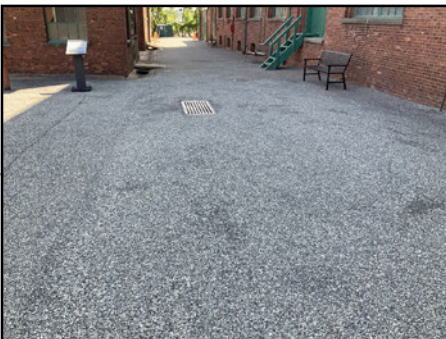
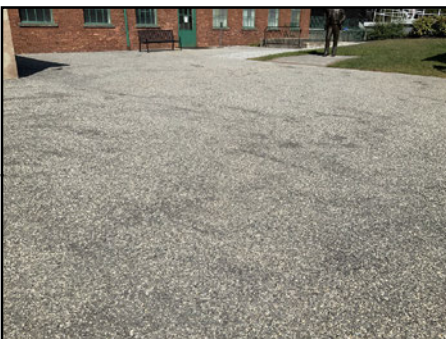
ROUTE 0906: LABORATORY COURTYARD PARKING

Inspection Date	FMSS Number	User Access	Surface Type
9/22/2020	103336	NONPUBLIC	ASPHALT
Area (Sq. Ft.)	Lane Miles (11' Widths)	Curb Reveal (Inches)	Curb Recommendation
14,979	0.258	NOT APPLICABLE	NOT APPLICABLE
Curb Type		Curb & Gutter Type	
NO CURB		NO CURB AND GUTTER	
Pavement Recommendation		Condition Rating / PCR	
LIGHT 3R TREATMENTS		FAIR / 73
