#### Road Inventory and Condition Assessment of Paved Routes Eisenhower National Historic Site

Federal Highway Administration Eastern Federal Lands Highway Division Road Inventory Program (RIP)

**Report Date: August 2021**

#### Eisenhower National Historic Site in Pennsylvania

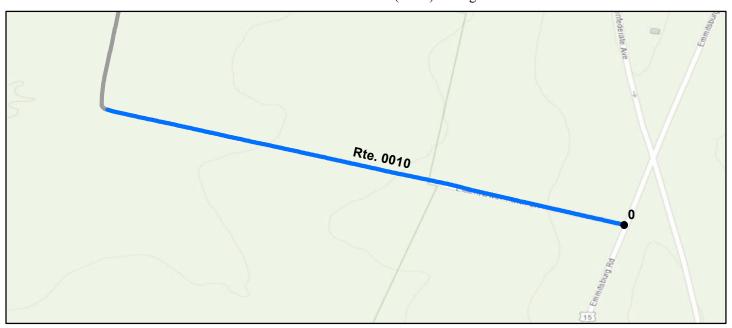
**ROUTE 0010: EISENHOWER FARM LANE**

Route (	Condition Legend – Pav	ement Condi	ition Rating (	PCR)		
Poor (0 - 60	_		(85 - 94)	Excellent (		Not Ra	ted
Colors	on map represent cond	dition scores at 0.10-mile	intervals. Se	e Appendix fo	or definitions	and formulas.	
Inspection Date:	11/20/2020	<b>Beginning Section MP</b>	0				
Paved Length (Mile	es): 0.38	Section Length (MI)	0.38				
Surface Type:	ASPHALT	Route Summary		•		•	
Roadway Condition	1 Information						
Pavement Conditio	n Rating (PCR)	100	100				
Surface Condition R	ating (SCR)	100	100				
Roughness Condition	n Index (RCI)	N/A	N/A				
Distress Index Value	es						
Structural Crack In-	dex	100	100				
Alligator Crack Ind	lex	100	100				
Longitudinal Crack	Index	100	100				
Transverse Crackin	g Index	100	100				
Patching Index		100	100				
Rutting Index		100	100				
International Rough	hness Index (IRI)	N/A	N/A				
Lane & Width Info	rmation						
Number of Lanes		2	2				
Paved Width (ft)		18	18

Lane Width (ft)		9	9

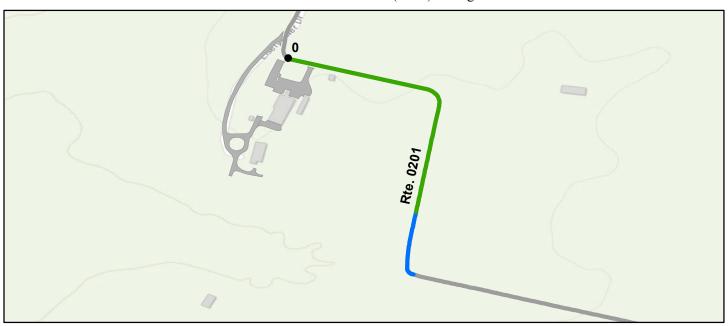
ROUTE 0201: EISENHOWER FARM NEVINS LANE

Route	Condition Legend – Pav	ement Condi	ition Rating (	PCR)		
		(85 - 94)	Excellent (9		Not Ra	ted
Colors on map represent co	ndition scores at 0.10-mile	intervals. Se	e Appendix fo	r definitions	and formulas.	
Inspection Date: 11/20/2020	<b>Beginning Section MP</b>	0				
Paved Length (Miles): 0.25	Section Length (MI)	0.25				
Surface Type: ASPHALT	Route Summary				•	
Roadway Condition Information						
Pavement Condition Rating (PCR)	94	94				
Surface Condition Rating (SCR)	94	94				
Roughness Condition Index (RCI)	N/A	N/A				
Distress Index Values						
Structural Crack Index	100	100				
Alligator Crack Index	100	100				
Longitudinal Crack Index	100	100				
Transverse Cracking Index	94	94				
Patching Index	100	100				
Rutting Index	95	95				
International Roughness Index (IRI)	N/A	N/A				
Lane & Width Information						
Number of Lanes	1	1				
Paved Width (ft)	13.3	13.3				
Lane Width (ft)	13.3	13.3

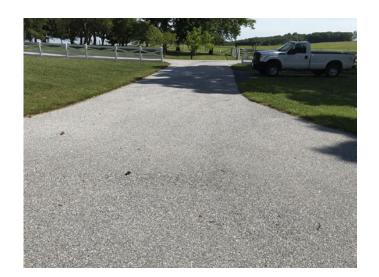
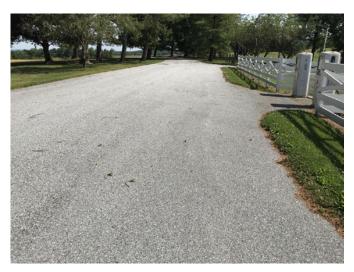
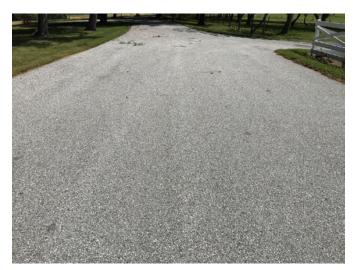
## **Eisenhower National Historic Site ROUTE 0900: EISENHOWER RECEPTION CENTER PARKING**

Inspection Date	FMSS Number	User Access	Surface Type		
6/15/2020	90721	NONPUBLIC	ASPHALT		
Area (Sq. Ft.)	Lane Miles (11' Widths)	Curb Reveal (Inches)	Curb Recommendation		
11,807	0.203	NOT APPLICABLE	NOT APPLICABLE		
Curb	Туре	Curb & Gutter Type			
NO C	CURB	NO CURB A	ND GUTTER		
Pavement Rec	commendation	Condition R	Rating / PCR		
PREVENTIVE N	MAINTENANCE	GOOD / 90

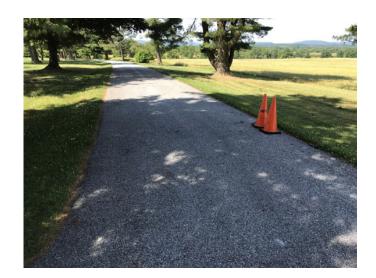
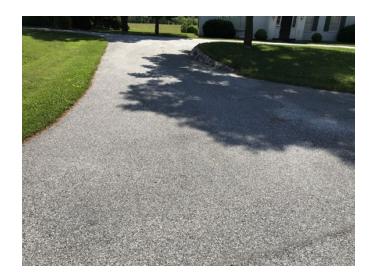
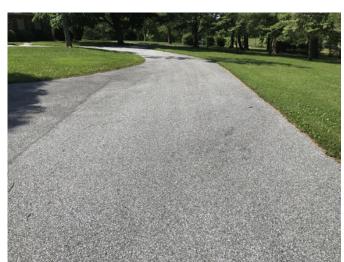
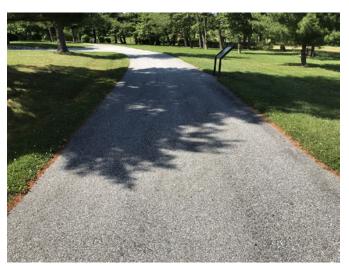
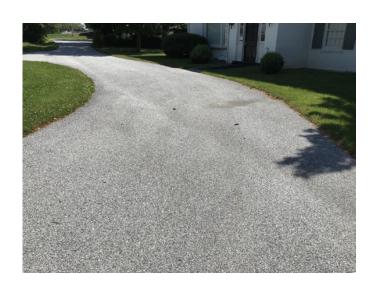
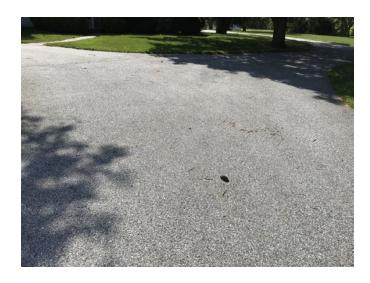
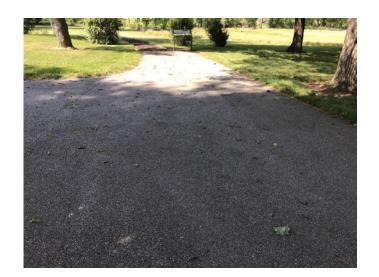
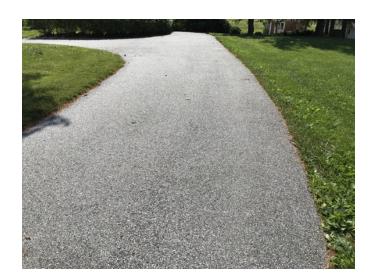
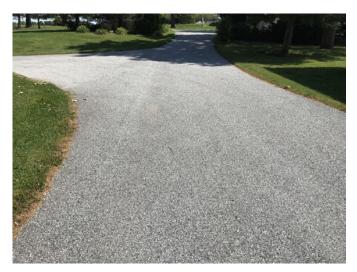
## **Eisenhower National Historic Site ROUTE 0901: EISENHOWER HOUSE DROP OFF PARKING**

Inspection Date	FMSS Number	User Access	Surface Type		
6/15/2020	90722	NONPUBLIC	ASPHALT		
Area (Sq. Ft.)	Lane Miles (11' Widths)	Curb Reveal (Inches)	Curb Recommendation		
14,953	0.257	NOT APPLICABLE	NOT APPLICABLE		
Curb	Туре	Curb & Gutter Type			
NO C	CURB	NO CURB AND GUTTER			
Pavement Rec	commendation	Condition Rating / PCR			
PREVENTIVE N	MAINTENANCE	GOOD / 90			
	Doute Condition Logand Day	oment Condition Dating (DCD)

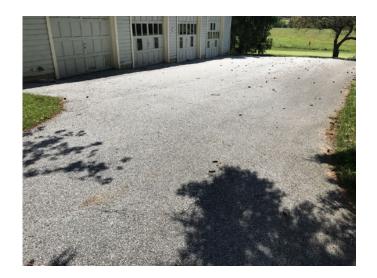
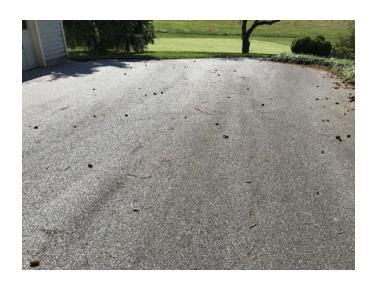
#### **Eisenhower National Historic Site** ROUTE 0902: EISENHOWER HOUSE GARAGE PARKING

<b>Inspection Date</b>	FMSS Number	User Access	Surface Type					
6/15/2020	90723	NONPUBLIC	ASPHALT					
Area (Sq. Ft.)	Lane Miles (11' Widths)	Curb Reveal (Inches)	Curb Recommendation					
1,987	0.034	NOT APPLICABLE	NOT APPLICABLE					
Curb	Туре	Curb & Gutter Type						
NO C	CURB	NO CURB A	ND GUTTER					
Pavement Rec	commendation	Condition R	Rating / PCR					
PREVENTIVE N	MAINTENANCE	GOOI	O / 90					
	Route Condition Legend – Pavement Condition Rating (PCR)							
Poor (0 - 60)	Fair (61- 84) Good (	(85 - 94) <b>Excellent</b> (95 - 10	0) Not Rated					
	See Appendix for definitions and formulas

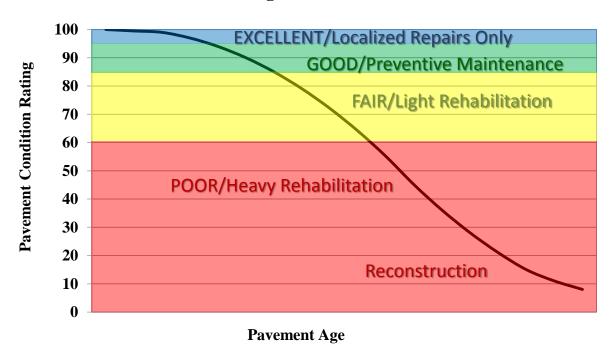
# **Condition Categories and Treatments**

- Excellent/New: PCR of 95-100. Pavements in this range will require only spot repairs
- Good: PCR of 85-94. Pavements in this range will likely be candidates for preventive maintenance. Examples include Chip and Slurry Seals, Micro Surfacing and Thin Overlays.
- Fair: PCR of 61-84. Pavements in this range will likely be candidates of Light Rehabilitation (L3R). Examples include single-lift overlays up to 2.5 inches in total thickness, milling and overlays.
- Poor: PCR of 60 or below. Pavements in this range will likely be candidates of Heavy Rehabilitation or Reconstruction (H3R or 4R). Examples include Pulverization, Multiple Lift Overlays, and Reconstruction.
