# ELMA Cycle 6

## Final Report

### Road Inventory and Condition Assessment of Paved Routes El Malpais National Monument

Report Date: May 2017

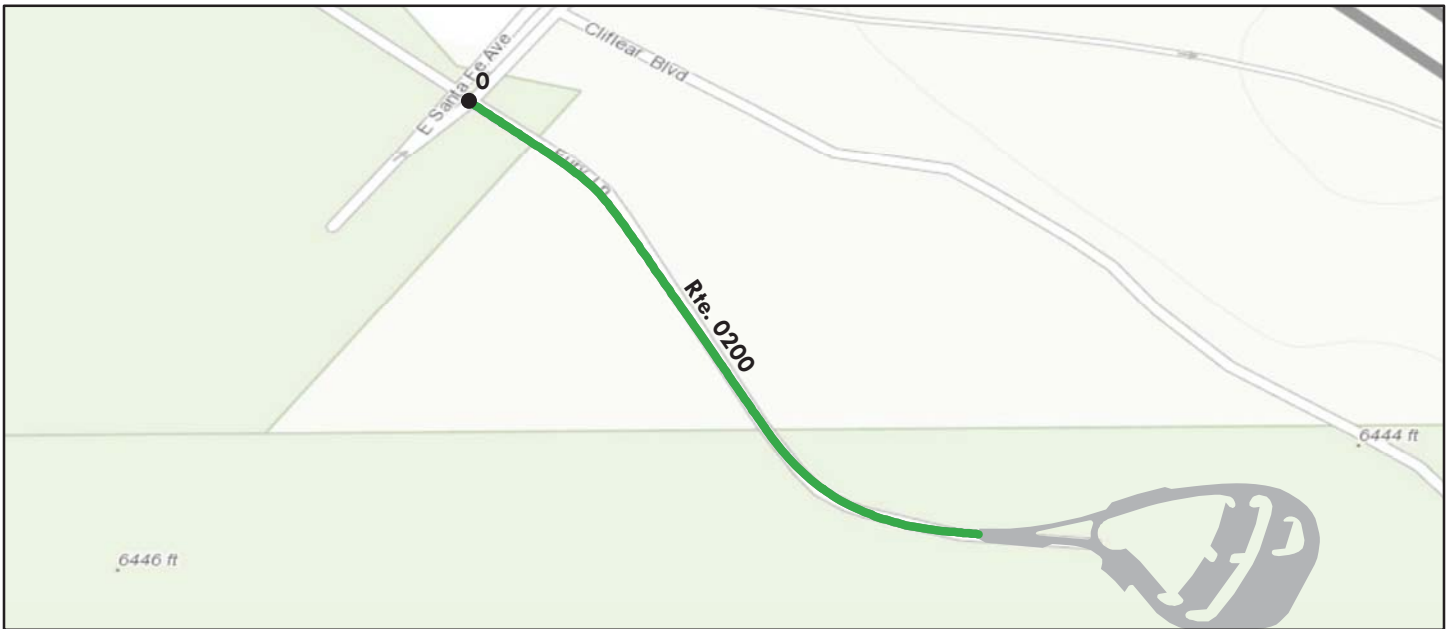
## ROUTE 0200: EURY LANE

### Data Collection Vehicle (DCV) Rating

Route Condition Legend – Pavement Condition Rating (PCR)						
Poor (0 - 60)	Fair (61- 84)	Good (85 - 94)	Excellent (95 - 100)	Not Rated		
See Appendix for definitions and formulas						
<b>Inspection Date:</b> 1/4/2017	<b>Beginning Section MP</b>	0				
<b>Paved Length (Miles):</b> 0.26	<b>Section Length (MI)</b>	0.26				
<b>Surface Type:</b> ASPHALT	<b>Route Summary</b>					
<b>Roadway Condition Information</b>						
Pavement Condition Rating (PCR)	90	90				
Surface Condition Rating (SCR)	90	90				
Roughness Condition Index (RCI)	N/A	N/A				
<b>Distress Index Values</b>						
Structural Crack Index	98	98				
Alligator Crack Index	100	100				
Longitudinal Crack Index	98	98				
Transverse Cracking Index	90	90				
Patching Index	100	100				
Rutting Index	99	99				
International Roughness Index (IRI)	N/A	N/A				
<b>Lane &amp; Width Information</b>						
Number of Lanes	2	2				
Paved Width (ft)	24.4	24.4				
Lane Width (ft)	12	12

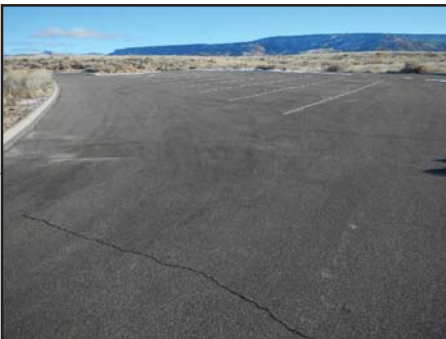
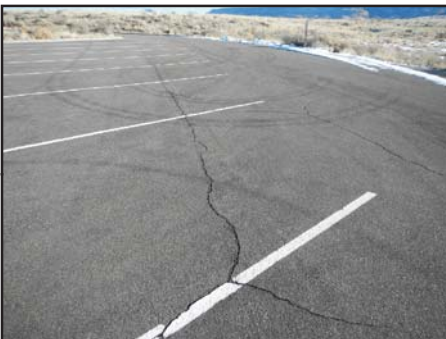
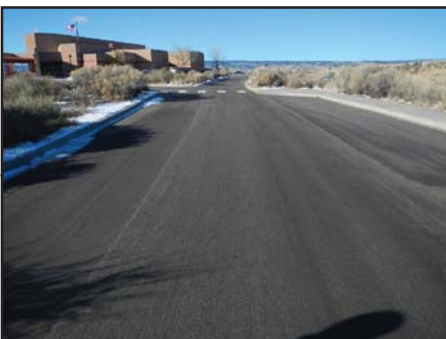
Inspection Date	FMSS Number	User Access	Surface Type
1/11/2016	45808	PUBLIC	ASPHALT
Area (Sq. Ft.)	Lane Miles (11' Widths)	Curb Reveal (Inches)	Curb Recommendation
68,723	1.183	6	DO NOTHING
Curb Type		Curb & Gutter Type	
CONCRETE		CONCRETE	
Pavement Recommendation		Condition Rating / PCR	
PREVENTIVE MAINTENANCE		GOOD / 90

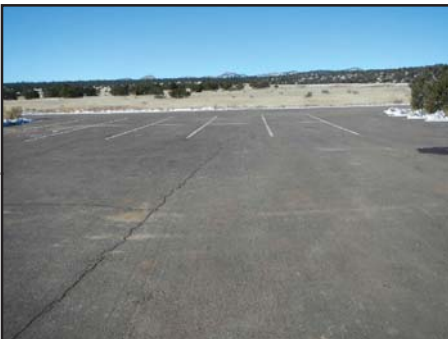
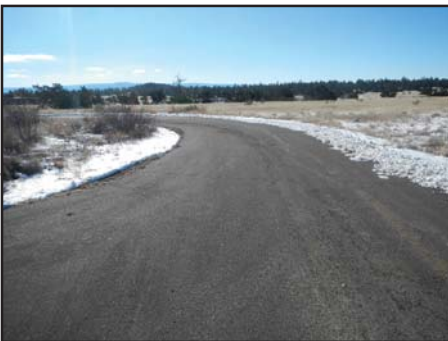
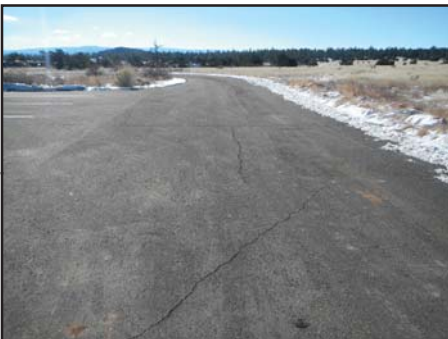
## ROUTE 0901: ZUNI-ACOMA TRAILHEAD PARKING

Inspection Date	FMSS Number	User Access	Surface Type
1/11/2016	42817	PUBLIC	ASPHALT
Area (Sq. Ft.)	Lane Miles (11' Widths)	Curb Reveal (Inches)	Curb Recommendation
23,664	0.407	NOT APPLICABLE	NOT APPLICABLE
Curb Type		Curb & Gutter Type	
NO CURB		NO CURB AND GUTTER	
Pavement Recommendation		Condition Rating / PCR	
PREVENTIVE MAINTENANCE		GOOD / 90

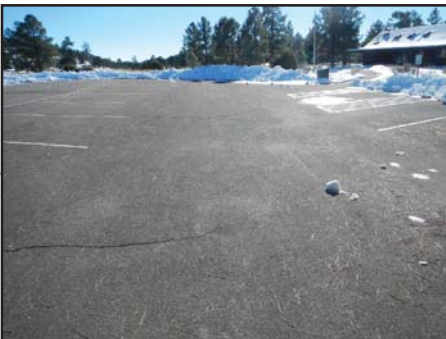
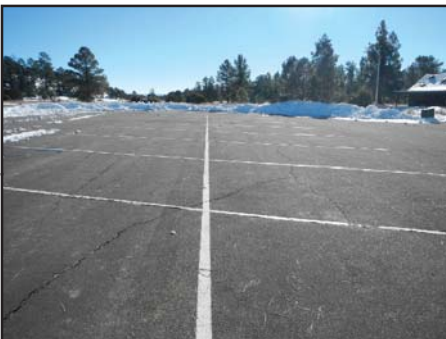
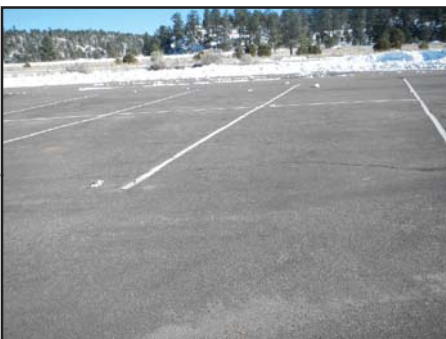
## ROUTE 0902: INFORMATION CENTER PARKING

Inspection Date	FMSS Number	User Access	Surface Type
1/11/2016	1090	PUBLIC	ASPHALT
Area (Sq. Ft.)	Lane Miles (11' Widths)	Curb Reveal (Inches)	Curb Recommendation
30,143	0.519	NOT APPLICABLE	NOT APPLICABLE
Curb Type		Curb & Gutter Type	
NO CURB		NO CURB AND GUTTER	
Pavement Recommendation		Condition Rating / PCR	
PREVENTIVE MAINTENANCE		GOOD / 90
