ELMO Cycle 6

Road Inventory and Condition Assessment of Paved Routes El Morro National Monument

**Federal Highway Administration
Eastern Federal Lands Highway Division
Road Inventory Program (RIP)**

Report Date: May 2017

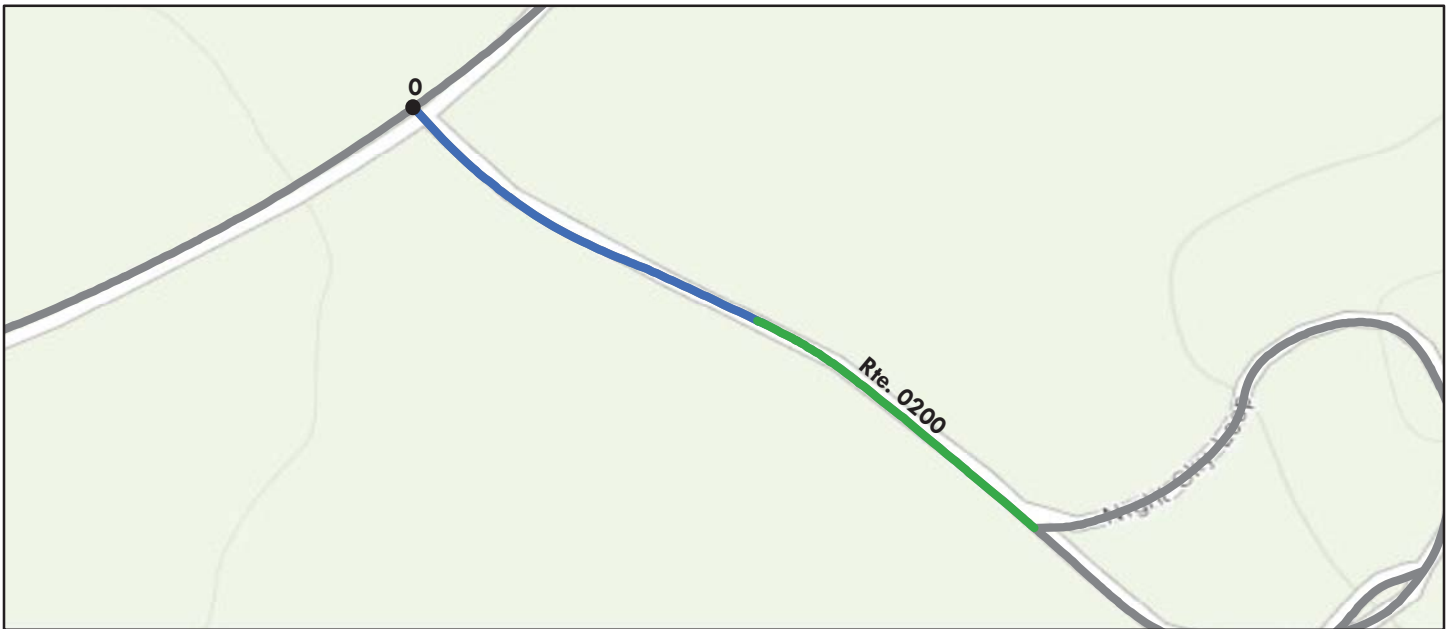
ROUTE 0200: CAMPGROUND LOOP ACCESS

Route Condition Legend – Pavement Condition Rating (PCR)							
Poor (0 - 60)		Fair (61- 84)		Good (85 - 94)		Excellent (95 - 100)	Not Rated
See Appendix for definitions and formulas							
Inspection Date:	1/12/2017	Beginning Section MP	0				
Paved Length (Miles):	0.19	Section Length (MI)	0.19				
Surface Type:	ASPHALT	Route Summary					
Roadway Condition Information							
Pavement Condition Rating (PCR)		94	94				
Surface Condition Rating (SCR)		94	94				
Roughness Condition Index (RCI)		N/A	N/A				
Distress Index Values							
Structural Crack Index		97	97				
Alligator Crack Index		100	100				
Longitudinal Crack Index		97	97				
Transverse Cracking Index		99	99				
Patching Index		100	100				
Rutting Index		94	94				
International Roughness Index (IRI)		N/A	N/A				
Lane & Width Information							
Number of Lanes		2	2				
Paved Width (ft)		14.7	14.7				
Lane Width (ft)		7.3	7.3

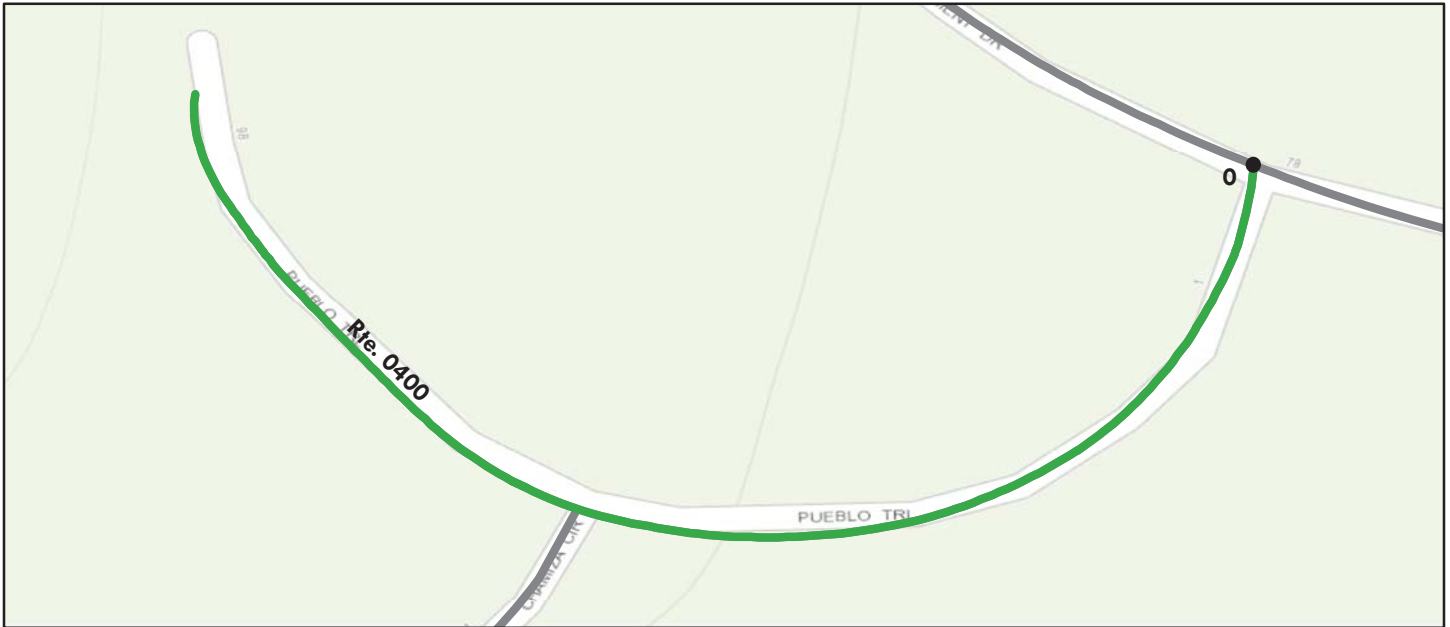
ROUTE 0400: RESIDENCE ROAD

Route Condition Legend – Pavement Condition Rating (PCR)						
Poor (0 - 60)	Fair (61- 84)	Good (85 - 94)	Excellent (95 - 100)	Not Rated		
See Appendix for definitions and formulas						
Inspection Date:	1/12/2017	Beginning Section MP	0			
Paved Length (Miles):	0.16	Section Length (MI)	0.16			
Surface Type:	ASPHALT	Route Summary				
Roadway Condition Information						
Pavement Condition Rating (PCR)	90	90				
Surface Condition Rating (SCR)	90	90				
Roughness Condition Index (RCI)	N/A	N/A				
Distress Index Values						
Structural Crack Index	100	100				
Alligator Crack Index	100	100				
Longitudinal Crack Index	100	100				
Transverse Cracking Index	90	90				
Patching Index	99	99				
Rutting Index	97	97				
International Roughness Index (IRI)	N/A	N/A				
Lane & Width Information						
Number of Lanes	2	2				
Paved Width (ft)	16.7	16.7				
Lane Width (ft)	8.4	8.4

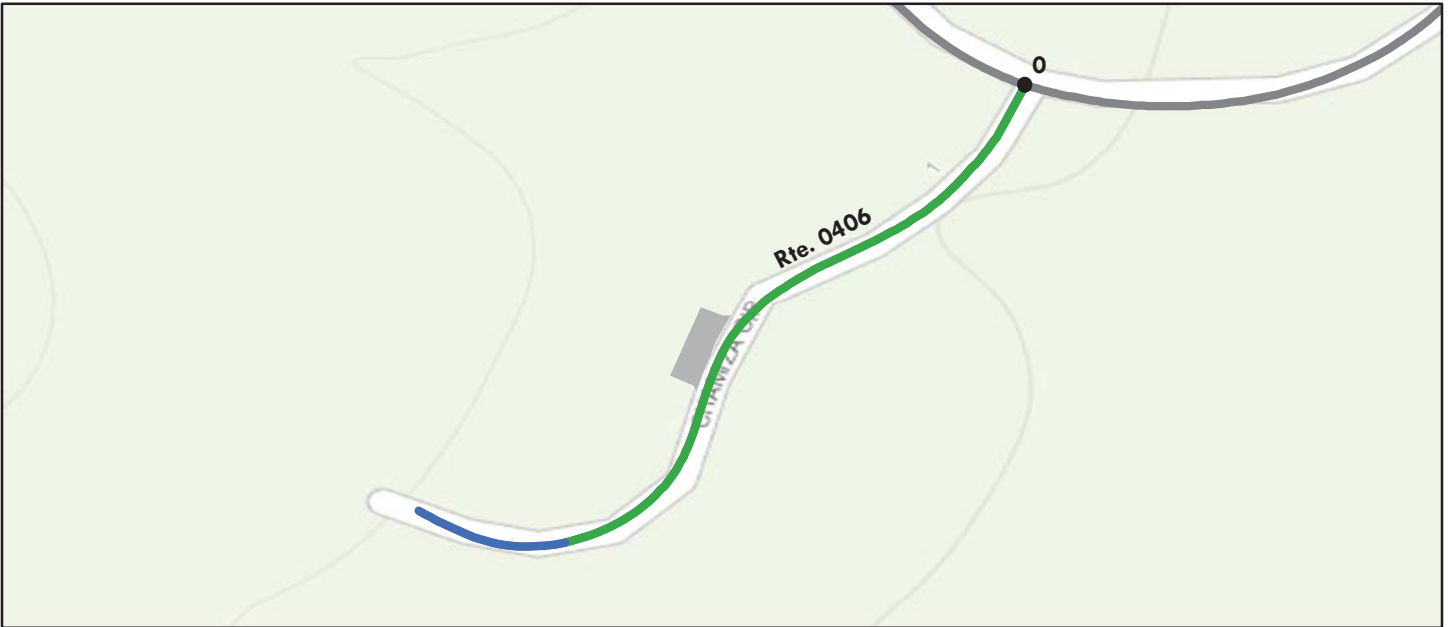
ROUTE 0406: RESIDENCE ROAD A

Route Condition Legend – Pavement Condition Rating (PCR)						
Poor (0 - 60)	Fair (61- 84)	Good (85 - 94)	Excellent (95 - 100)	Not Rated		
See Appendix for definitions and formulas						
Inspection Date: 1/12/2017	Beginning Section MP	0				
Paved Length (Miles): 0.12	Section Length (MI)	0.12				
Surface Type: ASPHALT	Route Summary					
Roadway Condition Information						
Pavement Condition Rating (PCR)	87	87				
Surface Condition Rating (SCR)	87	87				
Roughness Condition Index (RCI)	N/A	N/A				
Distress Index Values						
Structural Crack Index	99	99				
Alligator Crack Index	100	100				
Longitudinal Crack Index	99	99				
Transverse Cracking Index	87	87				
Patching Index	100	100				
Rutting Index	95	95				
International Roughness Index (IRI)	N/A	N/A				
Lane & Width Information						
Number of Lanes	2	2				
Paved Width (ft)	18.4	18.4				
Lane Width (ft)	9.2	9.2

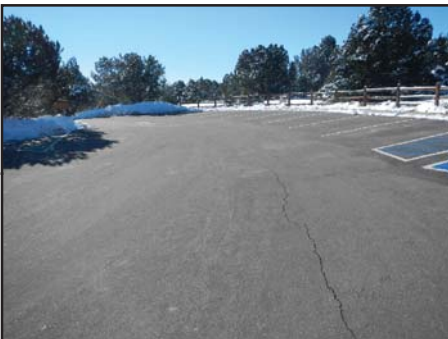
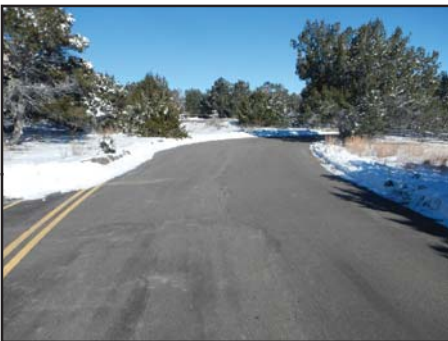
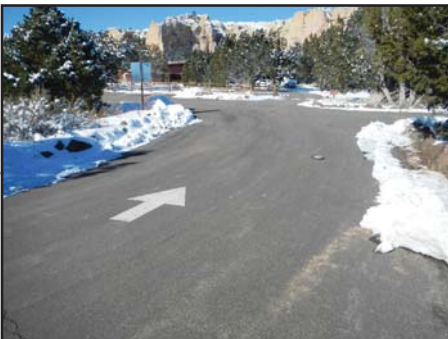
Inspection Date	FMSS Number	User Access	Surface Type
1/11/2016	67333	PUBLIC	ASPHALT
Area (Sq. Ft.)	Lane Miles (11' Widths)	Curb Reveal (Inches)	Curb Recommendation
20,866	0.359	2	DO NOTHING
Curb Type		Curb & Gutter Type	
STONE		NO CURB AND GUTTER	
Pavement Recommendation		Condition Rating / PCR	
PREVENTIVE MAINTENANCE		GOOD / 90

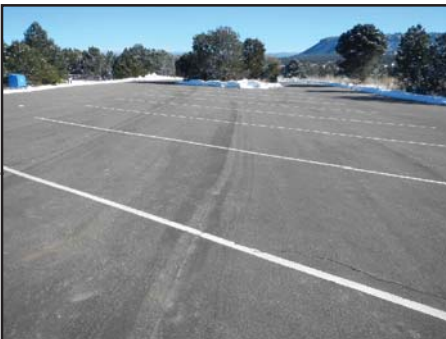
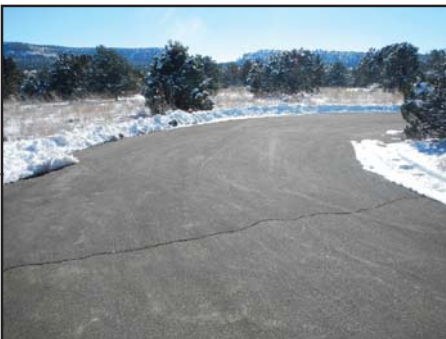
ROUTE 0903: RV PARKING

Inspection Date	FMSS Number	User Access	Surface Type
1/11/2016	97565	PUBLIC	ASPHALT
Area (Sq. Ft.)	Lane Miles (11' Widths)	Curb Reveal (Inches)	Curb Recommendation
20,165	0.347	NOT APPLICABLE	NOT APPLICABLE
Curb Type		Curb & Gutter Type	
NO CURB		NO CURB AND GUTTER	
Pavement Recommendation		Condition Rating / PCR	
PREVENTIVE MAINTENANCE		GOOD / 90

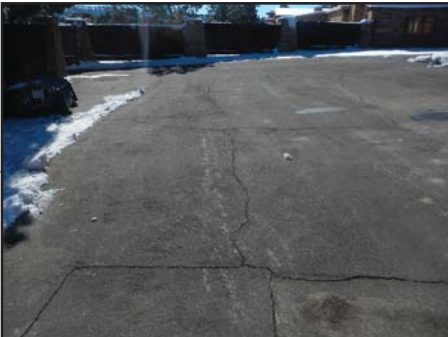
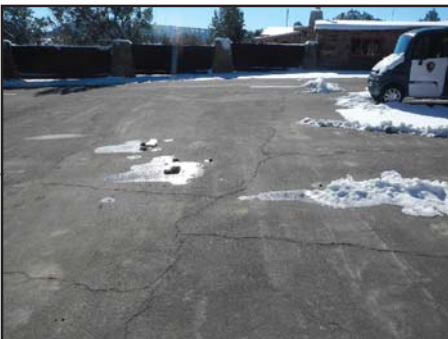
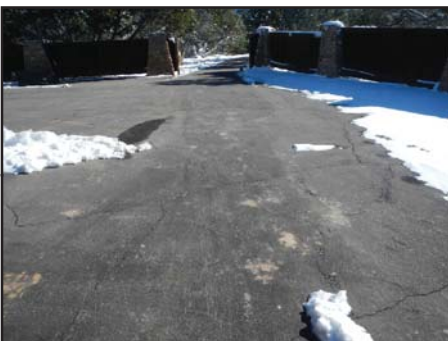
ROUTE 0904: MAINTENANCE COMPOUND

Inspection Date	FMSS Number	User Access	Surface Type
1/11/2016	91761	NONPUBLIC	ASPHALT
Area (Sq. Ft.)	Lane Miles (11' Widths)	Curb Reveal (Inches)	Curb Recommendation
6,671	0.115	NOT APPLICABLE	NOT APPLICABLE
Curb Type		Curb & Gutter Type	
NO CURB		NO CURB AND GUTTER	
Pavement Recommendation		Condition Rating / PCR	
HEAVY 3R TREATMENTS		POOR / 53

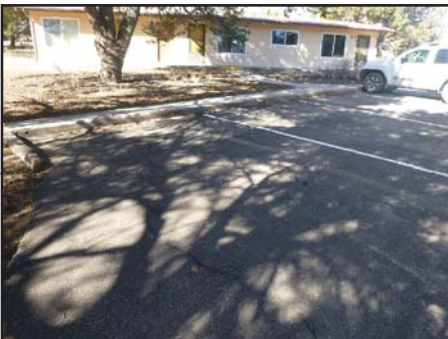
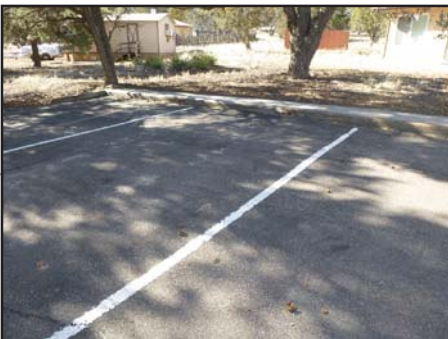
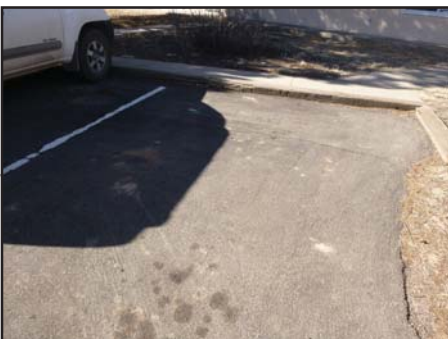
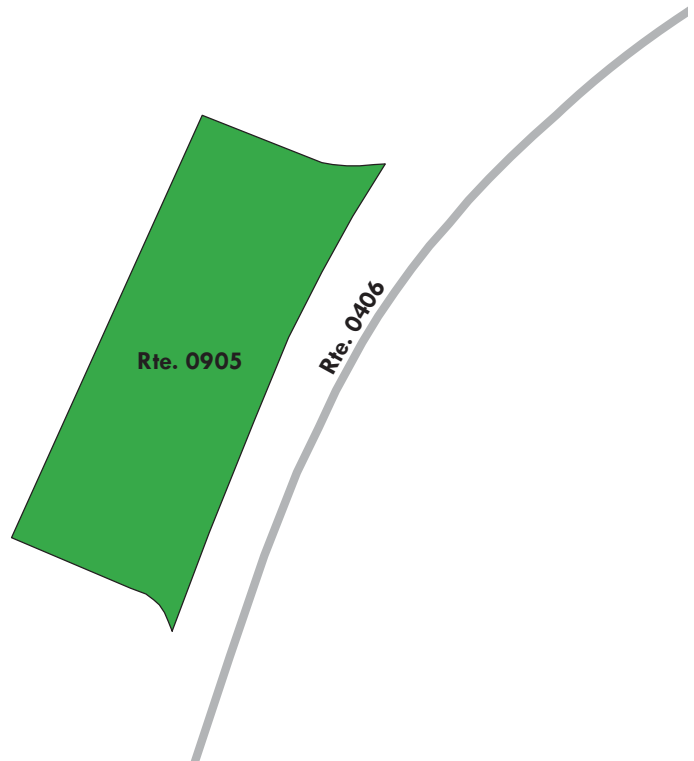
ROUTE 0905: HOUSING PARKING

Inspection Date	FMSS Number	User Access	Surface Type
1/12/2017	98863	NONPUBLIC	ASPHALT
Area (Sq. Ft.)	Lane Miles (11' Widths)	Curb Reveal (Inches)	Curb Recommendation
1,339	0.023	5	LIGHT REPAIR
Curb Type		Curb & Gutter Type	
WOOD		NO CURB AND GUTTER	
Pavement Recommendation		Condition Rating / PCR	
PREVENTIVE MAINTENANCE		GOOD / 90
