# EUON Cycle 6

# **Final Report**

# Road Inventory and Condition Assessment of Paved Routes Eugene O'Neill National Historic Site

**Report Date: August 2015**

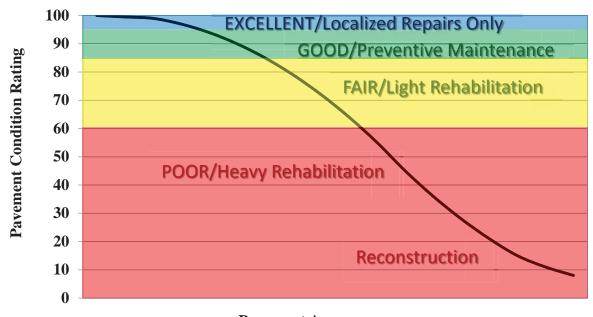
## **Condition Categories and Treatments**

- Excellent/New: PCR of 95-100. Pavements in this range will require only spot repairs
- Good: PCR of 85-94. Pavements in this range will likely be candidates for preventive maintenance. Examples include Chip and Slurry Seals, Micro Surfacing and Thin Overlays.
- Fair: PCR of 61-84. Pavements in this range will likely be candidates of Light Rehabilitation (L3R). Examples include single-lift overlays up to 2.5 inches in total thickness, milling and overlays.
- Poor: PCR of 60 or below. Pavements in this range will likely be candidates of Heavy Rehabilitation or Reconstruction (H3R or 4R). Examples include Pulverization, Multiple Lift Overlays, and Reconstruction.
