Final Report

Road Inventory and Condition Assessment of Paved Routes Fire Island National Seashore

Federal Highway Administration Eastern Federal Lands Highway Division Road Inventory Program (RIP)

Report Date: January 2022

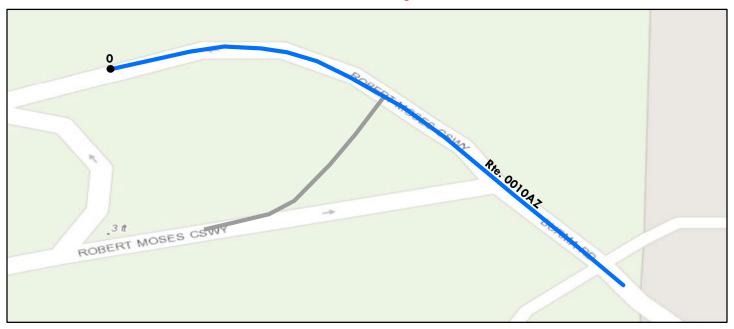
Subcomponent of Route FIIS-0010ZZ

Route	Condition Legend – Pav	ement Condi	ition Rating (PCR)			
Poor (0 - 6		3 ,						
		See Appendix for det	finitions and f	formulas				
Inspection Date:	3/2/2021	Beginning Section MP	0.00					
Paved Length (Mile	es): 0.08	Section Length (MI)	0.08					
Surface Type:	ASPHALT	Route Summary		!		!		
Roadway Condition	n Information							
Pavement Condition	on Rating (PCR)	95	95					
Surface Condition F	Rating (SCR)	95	95					
Roughness Condition	on Index (RCI)	N/A	N/A					
Distress Index Values								
Structural Crack In	ndex	99	99					
Alligator Crack Inc	dex	100	100					
Longitudinal Cracl	k Index	99	99					
Transverse Crackin	ng Index	95	95					
Patching Index		97	97					
Rutting Index		100	100					
International Roughness Index (IRI)		N/A	N/A					
Lane & Width Info	ormation							
Number of Lanes		2	2					
Paved Width (ft)		21	21					
Lane Width (ft)		10.5	10.5

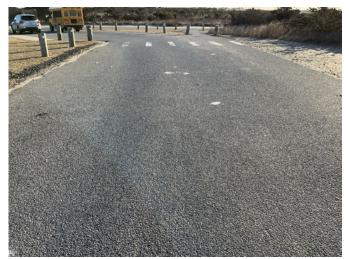
FIIS_0010BZ_1.jpg

Route (Condition Legend – Pav	ement Condi	ition Rating (PCR)		
Poor (0 - 6			(85 - 94)	Excellent (Not Ra	ted
		See Appendix for def	initions and f	ormulas			_
Inspection Date:	3/2/2021	Beginning Section MP	0.00				
Paved Length (Mile	es): 0.03	Section Length (MI)	0.03				
Surface Type:	ASPHALT	Route Summary		!			
Roadway Conditio	n Information						
Pavement Condition	on Rating (PCR)	97	97				
Surface Condition I	Rating (SCR)	97	97				
Roughness Condition	on Index (RCI)	N/A	N/A				
Distress Index Values							
Structural Crack Ir	ndex	97	97				
Alligator Crack In-	dex	100	100				
Longitudinal Cracl	k Index	97	97				
Transverse Crackin	ng Index	100	100				
Patching Index		100	100				
Rutting Index		100	100				
International Roughness Index (IRI)		N/A	N/A				
Lane & Width Info	ormation						
Number of Lanes		2	2				
Paved Width (ft)		24	24				
Lane Width (ft)		12	12
