FOBU Cycle 6

Road Inventory and Condition Assessment of Paved Routes Fossil Butte National Monument

Federal Highway Administration
Eastern Federal Lands Highway Division
Road Inventory Program (RIP)

Report Date: March 2018

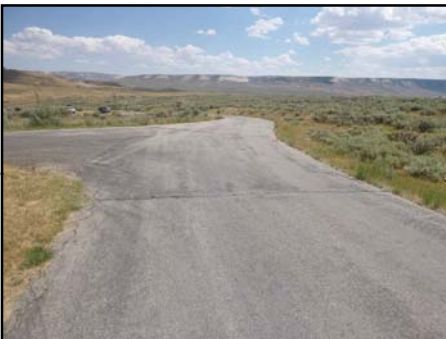
Inspection Date	FMSS Number	User Access	Surface Type
8/16/2017	74184	PUBLIC	ASPHALT
Area (Sq. Ft.)	Lane Miles (11' Widths)	Curb Reveal (Inches)	Curb Recommendation
39,518	0.68	NOT APPLICABLE	LIGHT REPAIR
Curb Type		Curb & Gutter Type	
NO CURB		CONCRETE	
Pavement Recommendation		Condition Rating / PCR	
LIGHT 3R TREATMENTS		FAIR / 73

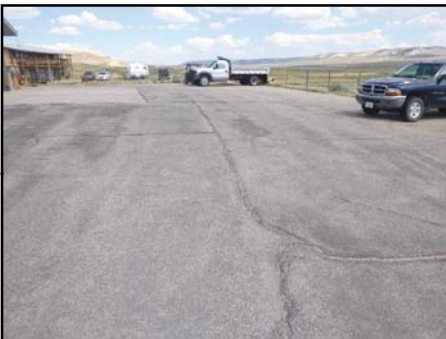
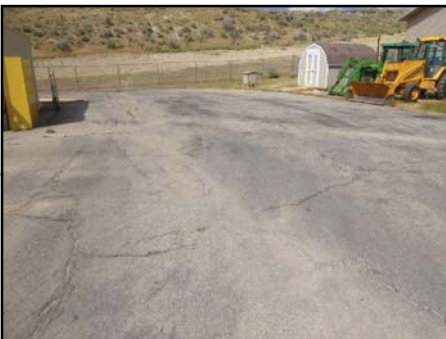
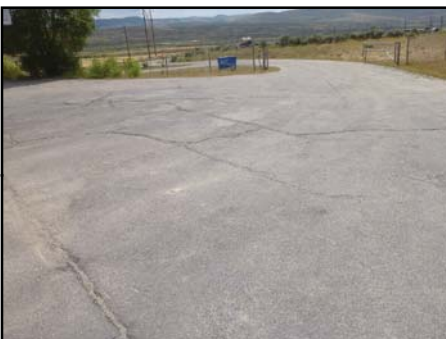
ROUTE 0901: MAINTENANCE COMPLEX

Inspection Date	FMSS Number	User Access	Surface Type
8/16/2017	73900	NONPUBLIC	ASPHALT
Area (Sq. Ft.)	Lane Miles (11' Widths)	Curb Reveal (Inches)	Curb Recommendation
22,710	0.391	NOT APPLICABLE	DO NOTHING
Curb Type		Curb & Gutter Type	
NO CURB		CONCRETE	
Pavement Recommendation		Condition Rating / PCR	
HEAVY 3R TREATMENTS		POOR / 53

Note: Parking area consists of multiple surface types: 1 part Asphalt at 21,634 square feet; 1 part Concrete at 1,076 square feet.

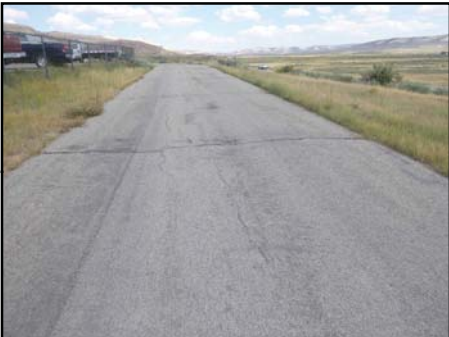
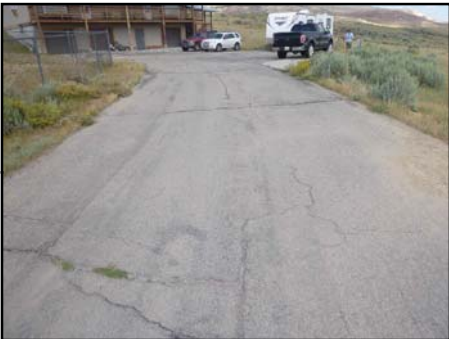
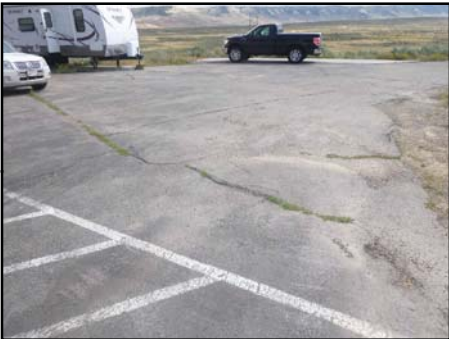
ROUTE 0902: RESIDENCE PARKING

Inspection Date	FMSS Number	User Access	Surface Type
8/16/2017	73910	NONPUBLIC	ASPHALT
Area (Sq. Ft.)	Lane Miles (11' Widths)	Curb Reveal (Inches)	Curb Recommendation
9,254	0.159	NOT APPLICABLE	NOT APPLICABLE
Curb Type		Curb & Gutter Type	
NO CURB		NO CURB AND GUTTER	
Pavement Recommendation		Condition Rating / PCR	
HEAVY 3R TREATMENTS		POOR / 53

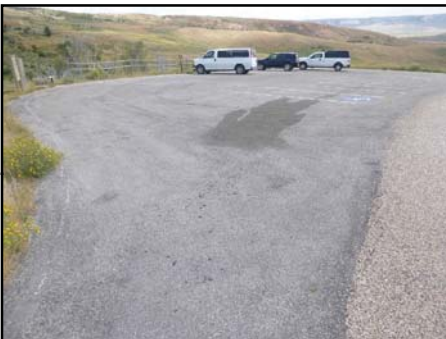
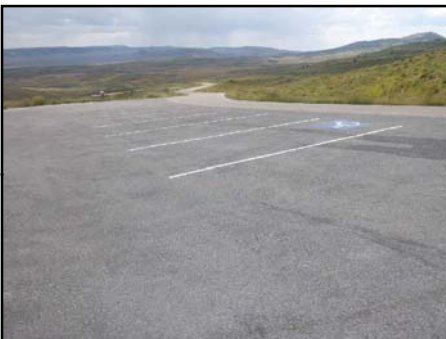
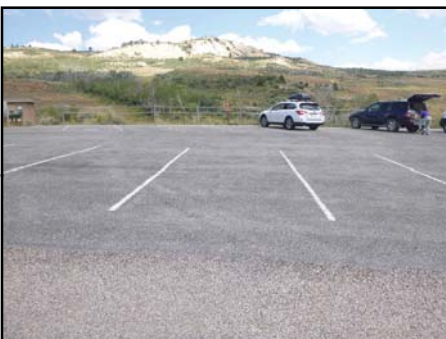
ROUTE 0903: CHICKEN CREEK PICNIC AREA PARKING

Inspection Date	FMSS Number	User Access	Surface Type
8/16/2017	72037	PUBLIC	ASPHALT
Area (Sq. Ft.)	Lane Miles (11' Widths)	Curb Reveal (Inches)	Curb Recommendation
9,010	0.155	NOT APPLICABLE	NOT APPLICABLE
Curb Type		Curb & Gutter Type	
NO CURB		NO CURB AND GUTTER	
Pavement Recommendation		Condition Rating / PCR	
LIGHT 3R TREATMENTS		FAIR / 73

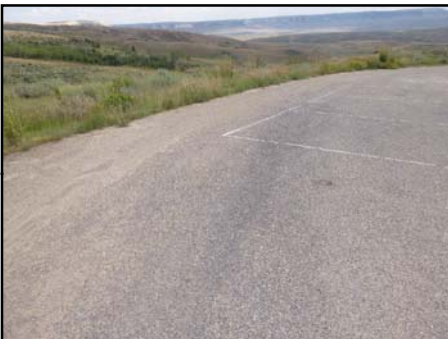
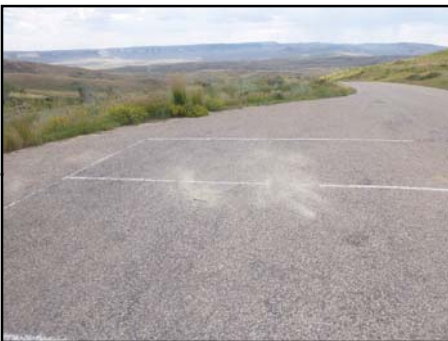
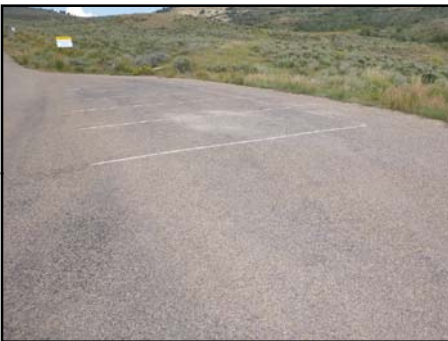
ROUTE 0904: CHICKEN CREEK NATURE TRAIL PARKING AREA

Inspection Date	FMSS Number	User Access	Surface Type
8/16/2017	73867	PUBLIC	ASPHALT
Area (Sq. Ft.)	Lane Miles (11' Widths)	Curb Reveal (Inches)	Curb Recommendation
3,104	0.053	NOT APPLICABLE	NOT APPLICABLE
Curb Type		Curb & Gutter Type	
NO CURB		NO CURB AND GUTTER	
Pavement Recommendation		Condition Rating / PCR	
PREVENTIVE MAINTENANCE		GOOD / 90

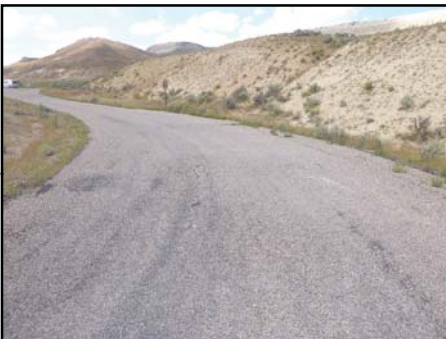
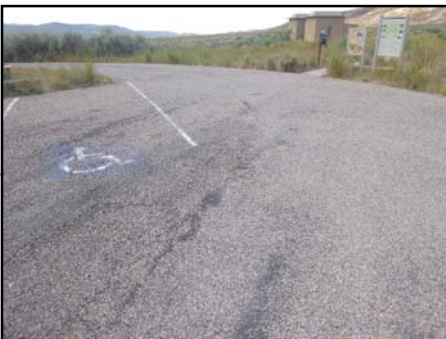
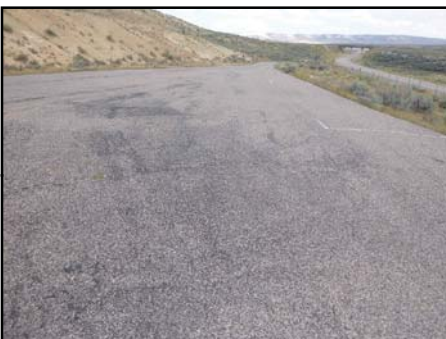
ROUTE 0905: HISTORIC QUARRY TRAIL PARKING

Inspection Date	FMSS Number	User Access	Surface Type
8/16/2017	74228	PUBLIC	ASPHALT
Area (Sq. Ft.)	Lane Miles (11' Widths)	Curb Reveal (Inches)	Curb Recommendation
22,713	0.391	NOT APPLICABLE	NOT APPLICABLE
Curb Type		Curb & Gutter Type	
NO CURB		NO CURB AND GUTTER	
Pavement Recommendation		Condition Rating / PCR	
LIGHT 3R TREATMENTS		FAIR / 73
