FOLA Cycle 6

Final Report

Road Inventory and Condition Assessment of Paved Routes Fort Laramie National Historic Site

Report Date: December 2017

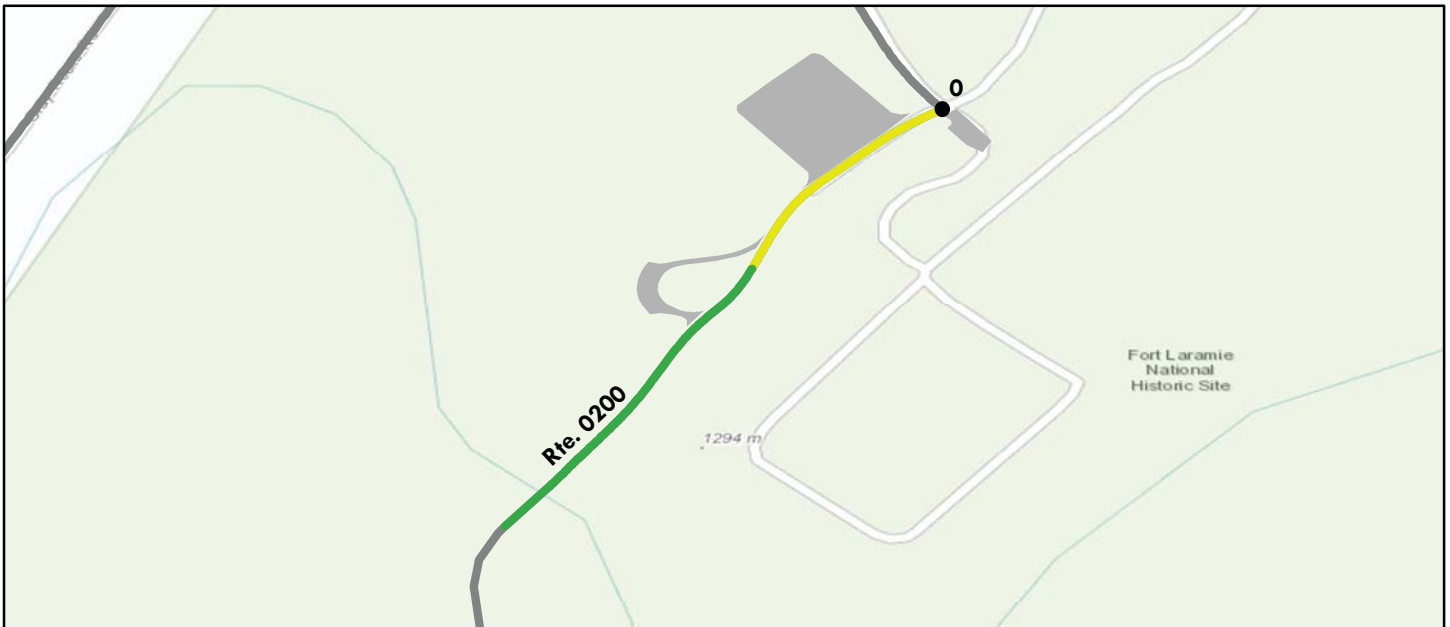
ROUTE 0200: LOOP ROAD

Route Condition Legend – Pavement Condition Rating (PCR)						
Poor (0 - 60)	Fair (61- 84)	Good (85 - 94)	Excellent (95 - 100)	Not Rated		
See Appendix for definitions and formulas						
Inspection Date: 7/17/2017	Beginning Section MP	0				
Paved Length (Miles): 0.24	Section Length (MI)	0.24				
Surface Type: ASPHALT	Route Summary					
Roadway Condition Information						
Pavement Condition Rating (PCR)	88	88				
Surface Condition Rating (SCR)	88	88				
Roughness Condition Index (RCI)	N/A	N/A				
Distress Index Values						
Structural Crack Index	88	88				
Alligator Crack Index	100	100				
Longitudinal Crack Index	88	88				
Transverse Cracking Index	89	89				
Patching Index	100	100				
Rutting Index	99	99				
International Roughness Index (IRI)	N/A	N/A				
Lane & Width Information						
Number of Lanes	2	2				
Paved Width (ft)	17.3	17.3				
Lane Width (ft)	11.1	11.1

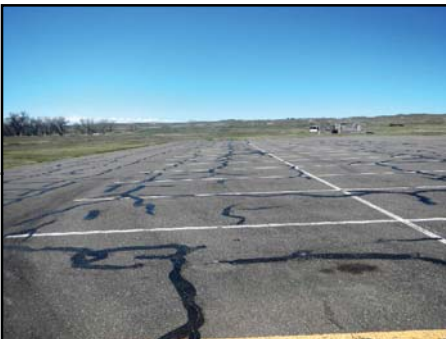
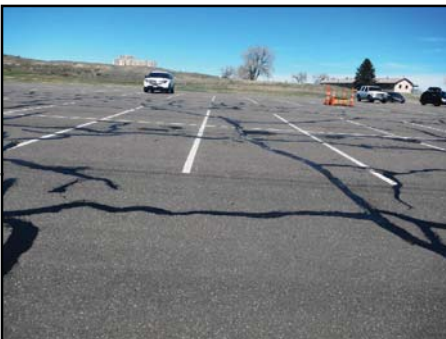
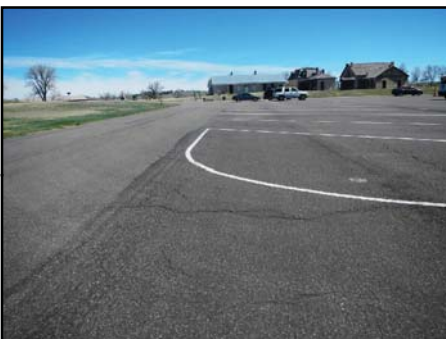
Inspection Date	FMSS Number	User Access	Surface Type
4/30/2017	41335	PUBLIC	ASPHALT
Area (Sq. Ft.)	Lane Miles (11' Widths)	Curb Reveal (Inches)	Curb Recommendation
46,211	0.796	NOT APPLICABLE	NOT APPLICABLE
Curb Type		Curb & Gutter Type	
NO CURB		NO CURB AND GUTTER	
Pavement Recommendation		Condition Rating / PCR	
HEAVY 3R TREATMENTS		POOR / 53

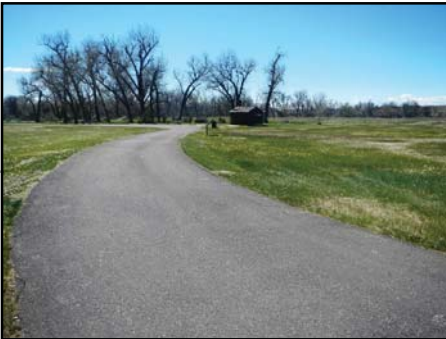
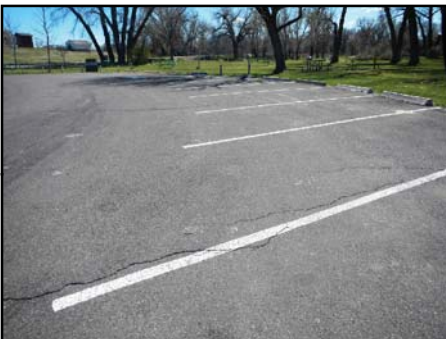
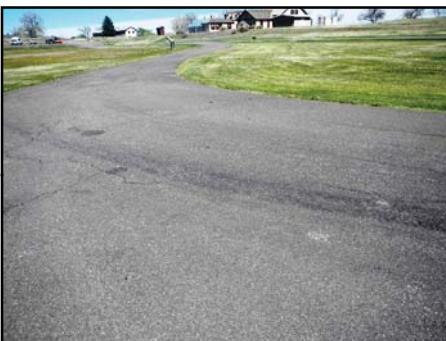
ROUTE 0901: PICNIC AREA PARKING

Inspection Date	FMSS Number	User Access	Surface Type
4/30/2017	66784	PUBLIC	ASPHALT
Area (Sq. Ft.)	Lane Miles (11' Widths)	Curb Reveal (Inches)	Curb Recommendation
7,879	0.136	NOT APPLICABLE	NOT APPLICABLE
Curb Type		Curb & Gutter Type	
NO CURB		NO CURB AND GUTTER	
Pavement Recommendation		Condition Rating / PCR	
PREVENTIVE MAINTENANCE		GOOD / 90

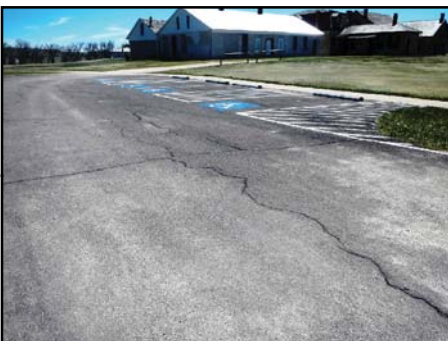
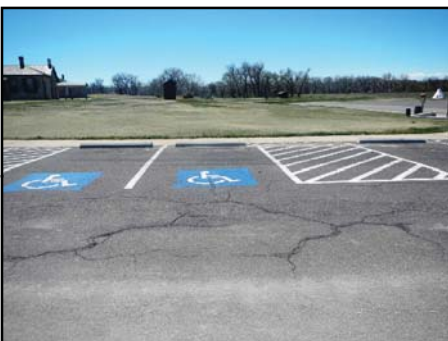
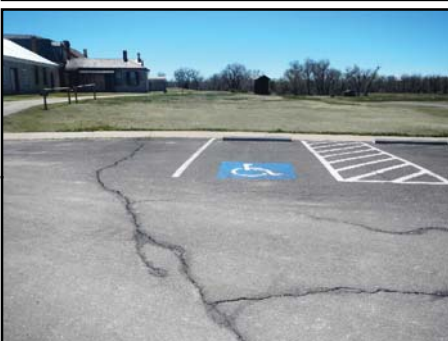
ROUTE 0904: HANDICAP PARKING

Inspection Date	FMSS Number	User Access	Surface Type
4/30/2017	84600	PUBLIC	ASPHALT
Area (Sq. Ft.)	Lane Miles (11' Widths)	Curb Reveal (Inches)	Curb Recommendation
3,831	0.066	NOT APPLICABLE	NOT APPLICABLE
Curb Type		Curb & Gutter Type	
NO CURB		NO CURB AND GUTTER	
Pavement Recommendation		Condition Rating / PCR	
HEAVY 3R TREATMENTS		POOR / 53
