# FOMC Cycle 6

## Final Report

### Road Inventory and Condition Assessment of Paved Routes Fort McHenry National Monument and Historic Shrine

**Report Date: January 2022**

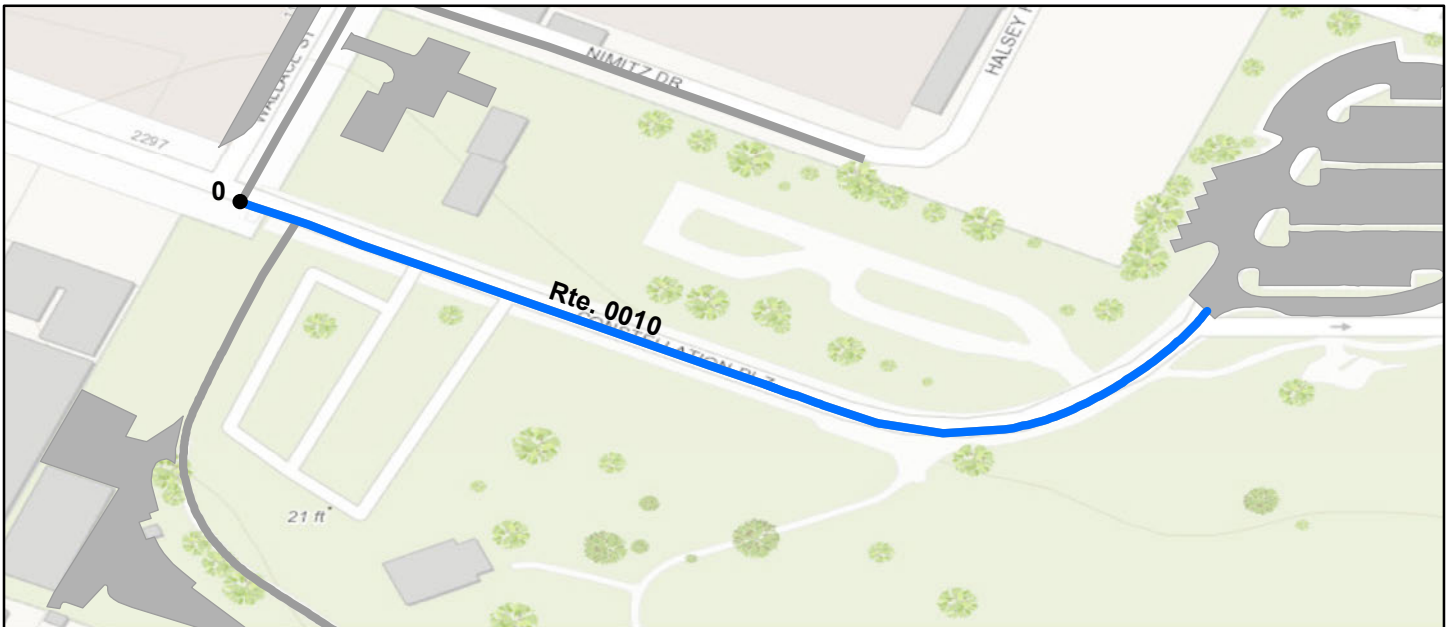
## ROUTE 0010: FORT AVENUE

Colors on map represent condition scores at 0.10-mile intervals. See Appendix for definitions and formulas.

<b>Inspection Date:</b>	4/20/2021	<b>Beginning Section MP</b>	0				
<b>Paved Length (Miles):</b>	0.18	<b>Section Length (MI)</b>	0.18				
<b>Surface Type:</b>	ASPHALT	<b>Route Summary</b>					
<b>Roadway Condition Information</b>							
Pavement Condition Rating (PCR)	98	98					
Surface Condition Rating (SCR)	98	98					
Roughness Condition Index (RCI)	N/A	N/A					
<b>Distress Index Values</b>							
Structural Crack Index	99	99					
Alligator Crack Index	100	100					
Longitudinal Crack Index	99	99					
Transverse Cracking Index	98	98					
Patching Index	99	99					
Rutting Index	98	98					
International Roughness Index (IRI)	N/A	N/A					
<b>Lane &amp; Width Information</b>							
Number of Lanes	2	2					
Paved Width (ft)	32.3	32.3					
Lane Width (ft)	18.5	18.5

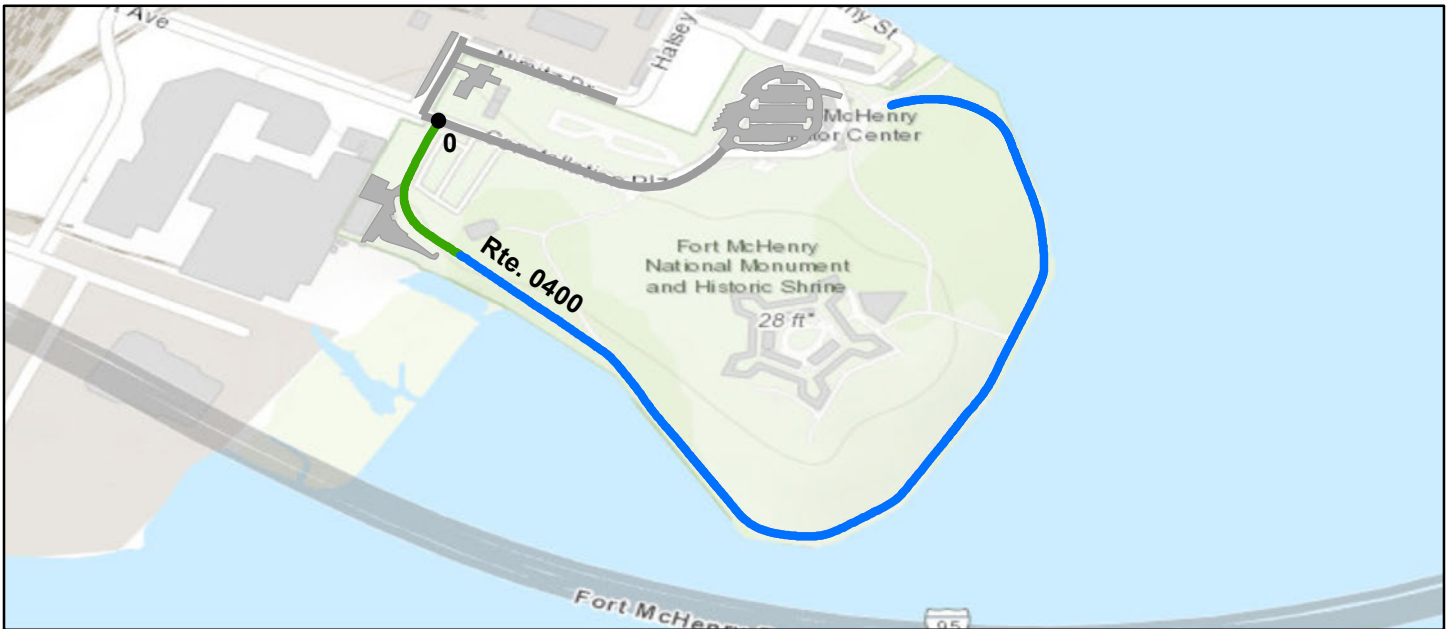
## ROUTE 0400: SEAWALL ROAD

Colors on map represent condition scores at 0.10-mile intervals. See Appendix for definitions and formulas.

<b>Inspection Date:</b>	4/20/2021	<b>Beginning Section MP</b>	0				
<b>Paved Length (Miles):</b>	0.74	<b>Section Length (MI)</b>	0.74				
<b>Surface Type:</b>	ASPHALT	<b>Route Summary</b>					
<b>Roadway Condition Information</b>							
Pavement Condition Rating (PCR)		97	97				
Surface Condition Rating (SCR)		97	97				
Roughness Condition Index (RCI)		N/A	N/A				
<b>Distress Index Values</b>							
Structural Crack Index		100	100				
Alligator Crack Index		100	100				
Longitudinal Crack Index		100	100				
Transverse Cracking Index		97	97				
Patching Index		100	100				
Rutting Index		97	97				
International Roughness Index (IRI)		N/A	N/A				
<b>Lane &amp; Width Information</b>							
Number of Lanes		1	1				
Paved Width (ft)		11.2	11.2				
Lane Width (ft)		10.2	10.2

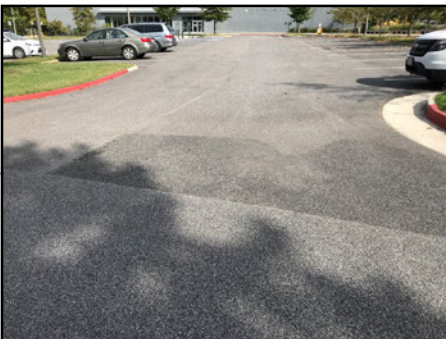
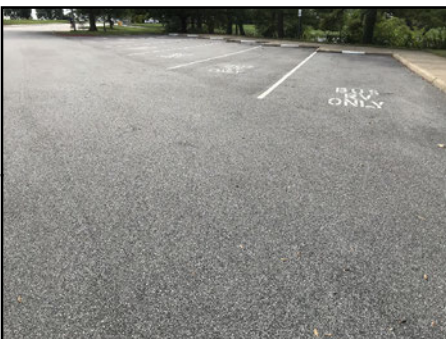
Inspection Date	FMSS Number	User Access	Surface Type
9/28/2020	55616	PUBLIC	ASPHALT
Area (Sq. Ft.)	Lane Miles (11' Widths)	Curb Reveal (Inches)	Curb Recommendation
52,705	0.907	5	LIGHT REPAIR
Curb Type		Curb & Gutter Type	
CONCRETE		CONCRETE	
Pavement Recommendation		Condition Rating / PCR	
PREVENTIVE MAINTENANCE		GOOD / 90

NOTE: MULTIPLE SURFACE TYPES: CONCRETE = 1,388 SQ FT; ASPHALT = 51,317 SQ FT.

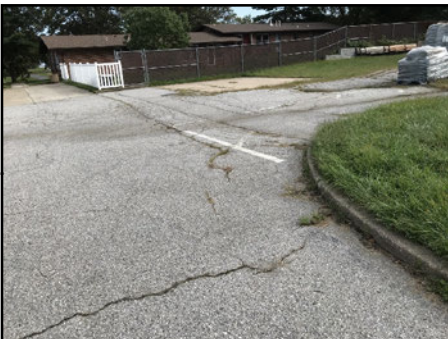
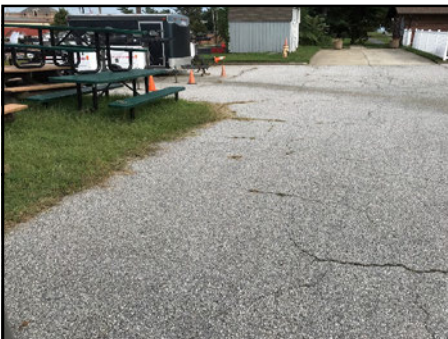
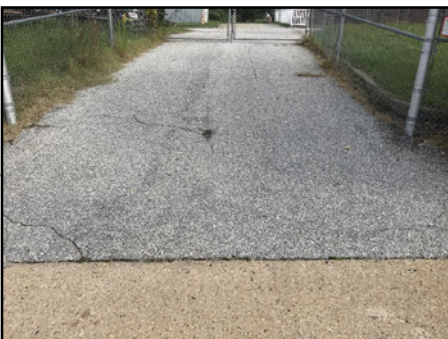
## ROUTE 0901: STORAGE SHOP PARKING

Inspection Date	FMSS Number	User Access	Surface Type
9/28/2020	55617	NONPUBLIC	ASPHALT
Area (Sq. Ft.)	Lane Miles (11' Widths)	Curb Reveal (Inches)	Curb Recommendation
7,164	0.123	4	MODERATE REPAIR
Curb Type		Curb & Gutter Type	
CONCRETE		NO CURB AND GUTTER	
Pavement Recommendation		Condition Rating / PCR	
RECONSTRUCTION		POOR / 30

NOTE: MULTIPLE SURFACE TYPES: CONCRETE = 1,602 SQ FT; ASPHALT = 5,562 SQ FT.

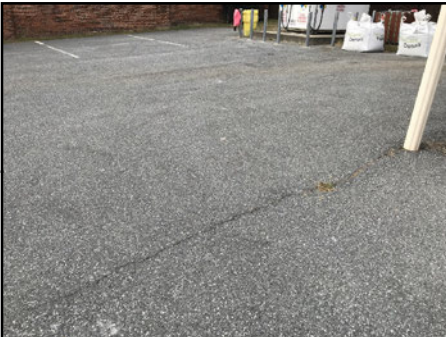
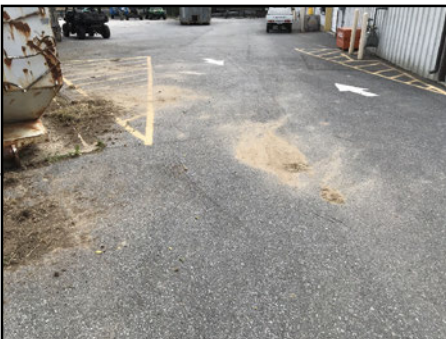
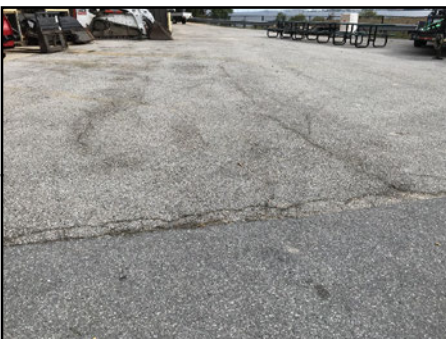
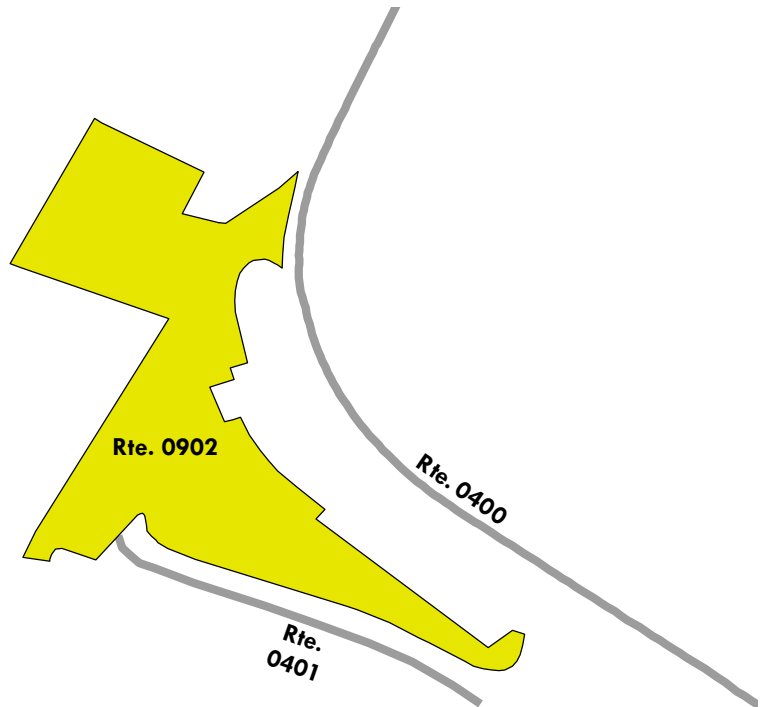
## ROUTE 0902: MAINTENANCE SHOP

Inspection Date	FMSS Number	User Access	Surface Type
9/28/2020	55618	NONPUBLIC	ASPHALT
Area (Sq. Ft.)	Lane Miles (11' Widths)	Curb Reveal (Inches)	Curb Recommendation
18,286	0.315	NOT APPLICABLE	NOT APPLICABLE
Curb Type		Curb & Gutter Type	
NO CURB		NO CURB AND GUTTER	
Pavement Recommendation		Condition Rating / PCR	
LIGHT 3R TREATMENTS		FAIR / 73

NOTE: MULTIPLE SURFACE TYPES: CONCRETE = 334 SQ FT; ASPHALT = 17,952 SQ FT.

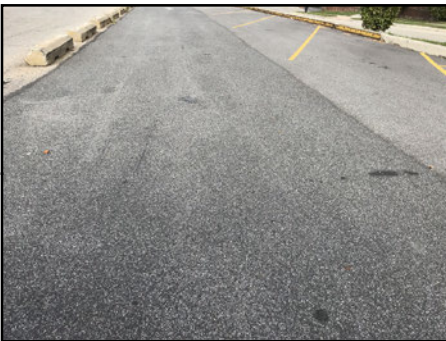
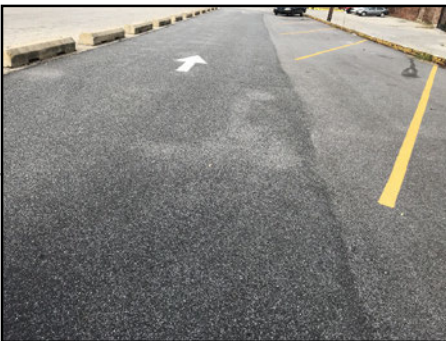
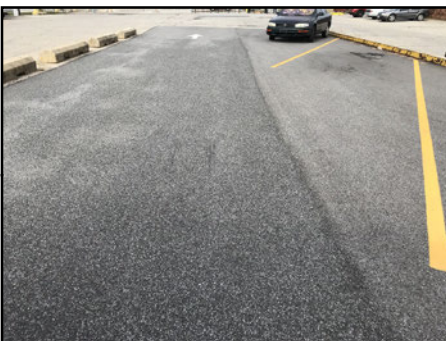
## ROUTE 0905: MAIN GATE PARKING

Inspection Date	FMSS Number	User Access	Surface Type
9/28/2020	245417	PUBLIC	ASPHALT
Area (Sq. Ft.)	Lane Miles (11' Widths)	Curb Reveal (Inches)	Curb Recommendation
4,183	0.072	6	MODERATE REPAIR
Curb Type		Curb & Gutter Type	
CONCRETE		NO CURB AND GUTTER	
Pavement Recommendation		Condition Rating / PCR	
PREVENTIVE MAINTENANCE		GOOD / 90
