FONE Cycle 6

Final Report

Road Inventory and Condition Assessment of Paved Routes Fort Necessity National Battlefield

Report Date: October 2021

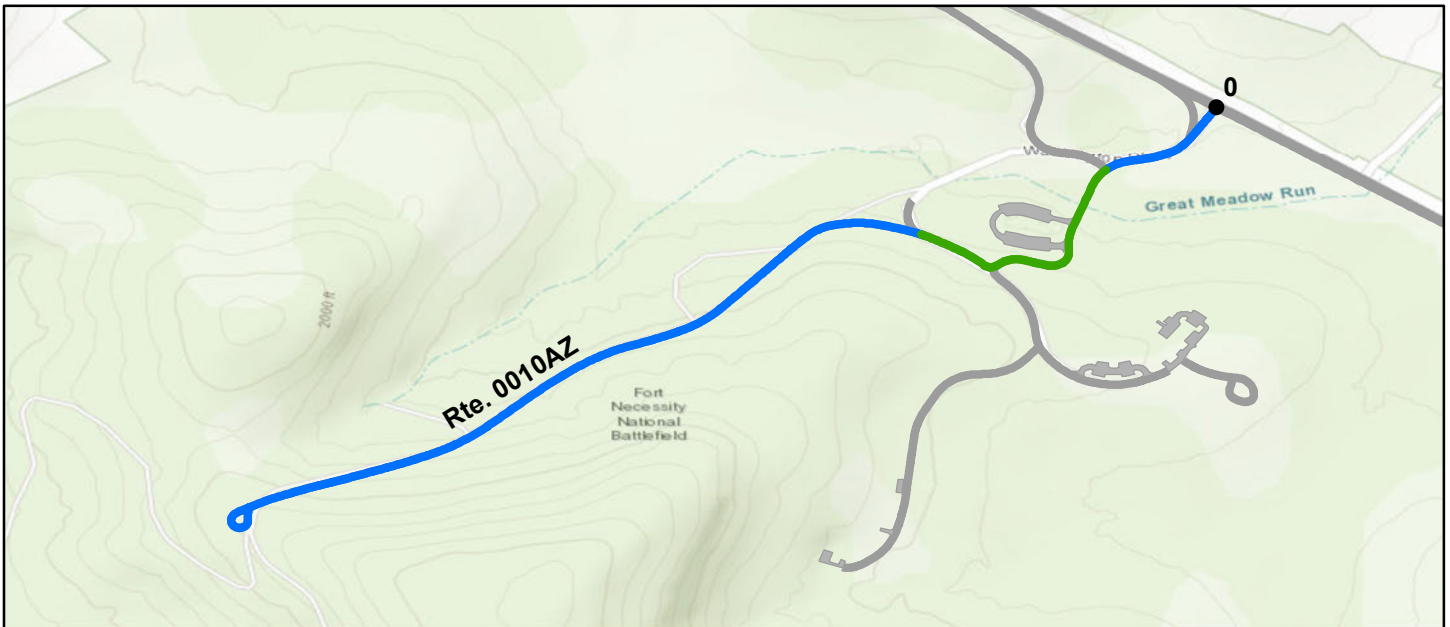
Data Collection Vehicle (DCV) Rating

Inspection Date:	11/11/2020	Beginning Section MP	0				
Paved Length (Miles):	0.9	Section Length (MI)	0.9				
Surface Type:	ASPHALT	Route Summary					
Roadway Condition Information							
Pavement Condition Rating (PCR)	97	97					
Surface Condition Rating (SCR)	97	97					
Roughness Condition Index (RCI)	N/A	N/A					
Distress Index Values							
Structural Crack Index	97	97					
Alligator Crack Index	100	100					
Longitudinal Crack Index	97	97					
Transverse Cracking Index	97	97					
Patching Index	100	100					
Rutting Index	98	98					
International Roughness Index (IRI)	N/A	N/A					
Lane & Width Information							
Number of Lanes	2	2					
Paved Width (ft)	18.9	18.9					
Lane Width (ft)	9.9	9.9

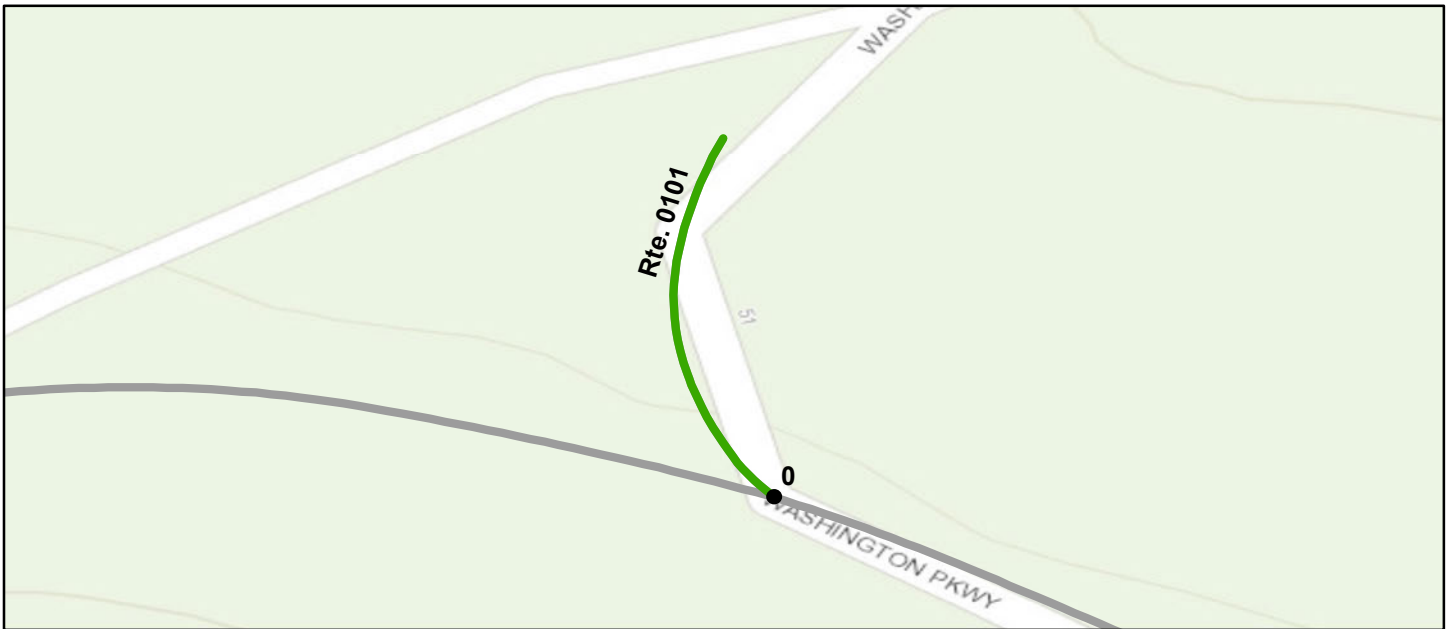
Data Collection Vehicle (DCV) Rating

Route Condition Legend – Pavement Condition Rating (PCR)						
Poor (0 - 60)	Fair (61- 84)	Good (85 - 94)	Excellent (95 - 100)	Not Rated		
Colors on map represent condition scores at 0.10-mile intervals. See Appendix for definitions and formulas.						
Inspection Date: 11/11/2020	Beginning Section MP	0				
Paved Length (Miles): 0.03	Section Length (MI)	0.03				
Surface Type: ASPHALT	Route Summary					
Roadway Condition Information						
Pavement Condition Rating (PCR)	88	88				
Surface Condition Rating (SCR)	88	88				
Roughness Condition Index (RCI)	N/A	N/A				
Distress Index Values						
Structural Crack Index	88	88				
Alligator Crack Index	100	100				
Longitudinal Crack Index	88	88				
Transverse Cracking Index	99	99				
Patching Index	100	100				
Rutting Index	98	98				
International Roughness Index (IRI)	N/A	N/A				
Lane & Width Information						
Number of Lanes	2	2				
Paved Width (ft)	23.3	23.3				
Lane Width (ft)	11.7	11.7

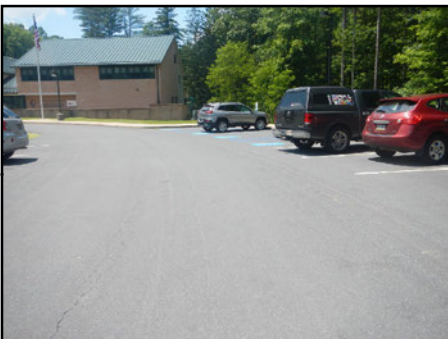
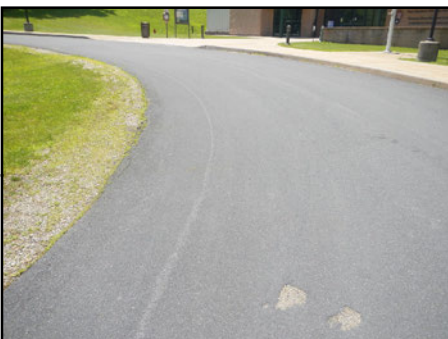
Inspection Date	FMSS Number	User Access	Surface Type
6/27/2019	238935	PUBLIC	ASPHALT
Area (Sq. Ft.)	Lane Miles (11' Widths)	Curb Reveal (Inches)	Curb Recommendation
27,696	0.477	5	DO NOTHING
Curb Type		Curb & Gutter Type	
CONCRETE		NO CURB AND GUTTER	
Pavement Recommendation		Condition Rating / PCR	
PREVENTIVE MAINTENANCE		GOOD / 90

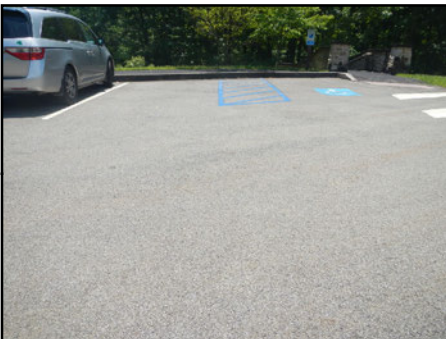
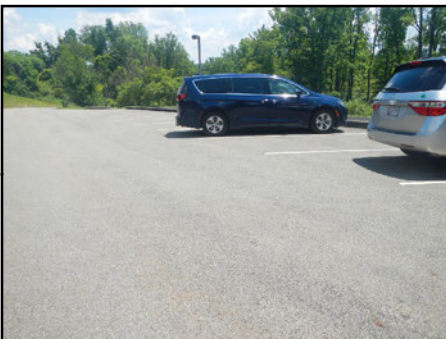
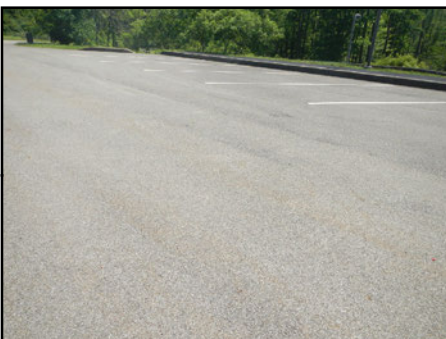
ROUTE 0901AZ: MOUNT WASHINGTON TAVERN UPPER PARKING

Inspection Date	FMSS Number	User Access	Surface Type
6/27/2019	42490	PUBLIC	ASPHALT
Area (Sq. Ft.)	Lane Miles (11' Widths)	Curb Reveal (Inches)	Curb Recommendation
2,526	0.043	NOT APPLICABLE	DO NOTHING
Curb Type		Curb & Gutter Type	
NO CURB		CONCRETE	
Pavement Recommendation		Condition Rating / PCR	
PREVENTIVE MAINTENANCE		GOOD / 90

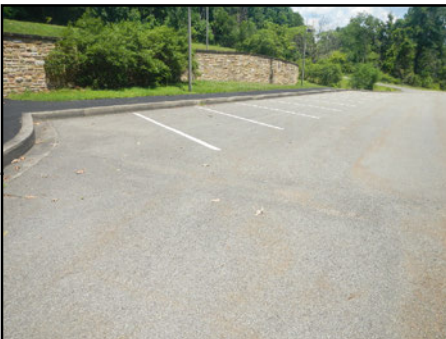
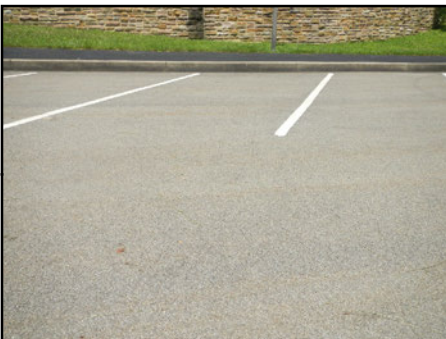
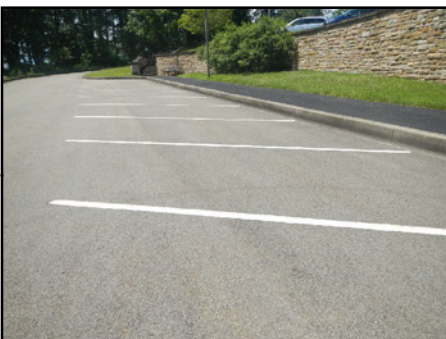
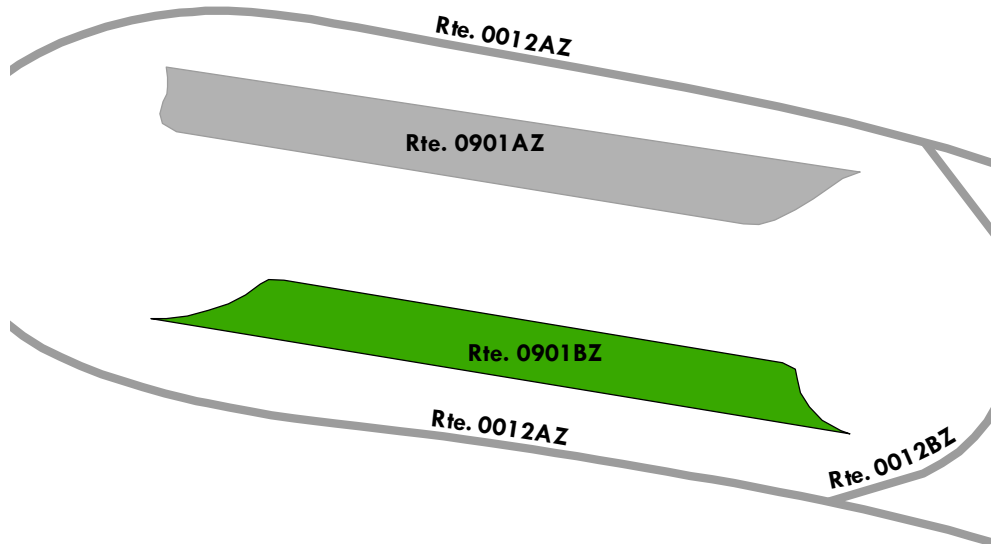
ROUTE 0901BZ: MOUNT WASHINGTON TAVERN LOWER PARKING

Inspection Date	FMSS Number	User Access	Surface Type
6/27/2019	42490	PUBLIC	ASPHALT
Area (Sq. Ft.)	Lane Miles (11' Widths)	Curb Reveal (Inches)	Curb Recommendation
2,066	0.036	NOT APPLICABLE	DO NOTHING
Curb Type		Curb & Gutter Type	
NO CURB		CONCRETE	
Pavement Recommendation		Condition Rating / PCR	
PREVENTIVE MAINTENANCE		GOOD / 90

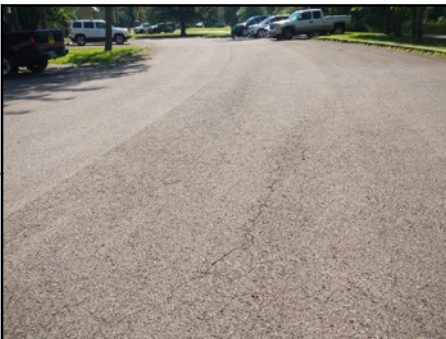
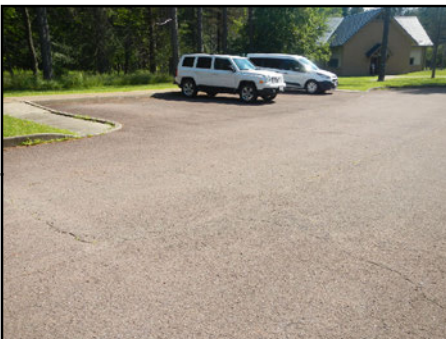
ROUTE 0902: HEADQUARTERS PARKING

Inspection Date	FMSS Number	User Access	Surface Type
6/27/2019	16508	NONPUBLIC	ASPHALT
Area (Sq. Ft.)	Lane Miles (11' Widths)	Curb Reveal (Inches)	Curb Recommendation
11,718	0.202	7	LIGHT REPAIR
Curb Type		Curb & Gutter Type	
CONCRETE		NO CURB AND GUTTER	
Pavement Recommendation		Condition Rating / PCR	
LIGHT 3R TREATMENTS		FAIR / 73

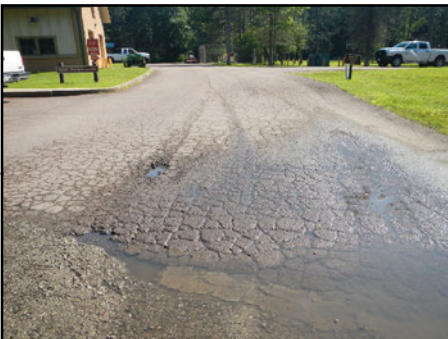
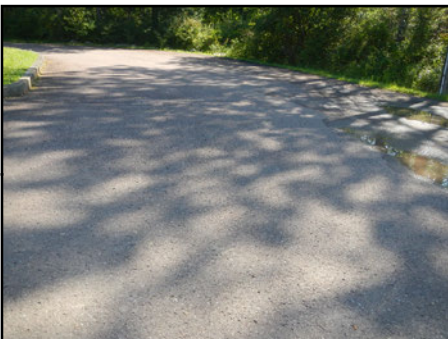
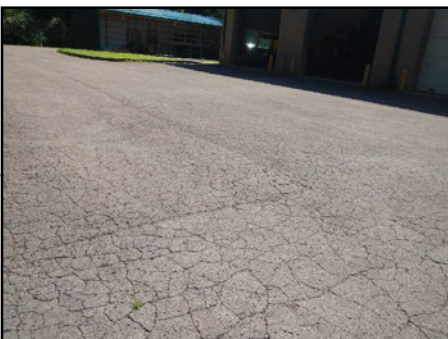
ROUTE 0903: MAINTENANCE AREA PARKING

Inspection Date	FMSS Number	User Access	Surface Type
6/27/2019	42491	NONPUBLIC	ASPHALT
Area (Sq. Ft.)	Lane Miles (11' Widths)	Curb Reveal (Inches)	Curb Recommendation
17,418	0.3	7	LIGHT REPAIR
Curb Type		Curb & Gutter Type	
CONCRETE		NO CURB AND GUTTER	
Pavement Recommendation		Condition Rating / PCR	
RECONSTRUCTION		POOR / 30

Note: Parking area consists of multiple surface types: 1 part Asphalt at 16,859 square feet; 1 part Concrete at 559 square feet.

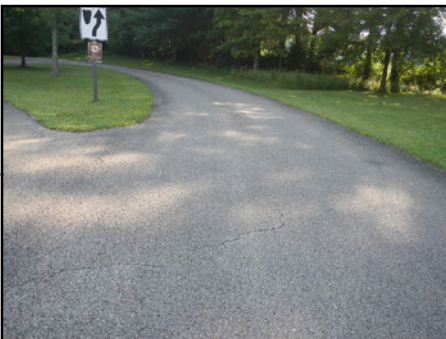
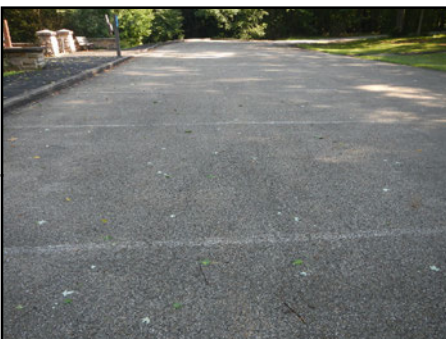
ROUTE 0905: BRADDOCK'S GRAVE PARKING

Inspection Date	FMSS Number	User Access	Surface Type
6/27/2019	16537	PUBLIC	ASPHALT
Area (Sq. Ft.)	Lane Miles (11' Widths)	Curb Reveal (Inches)	Curb Recommendation
18,083	0.311	6	DO NOTHING
Curb Type		Curb & Gutter Type	
CONCRETE		NO CURB AND GUTTER	
Pavement Recommendation		Condition Rating / PCR	
LIGHT 3R TREATMENTS		FAIR / 73

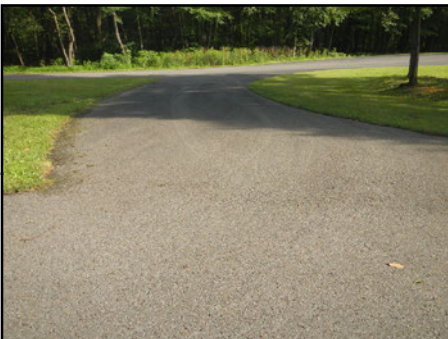
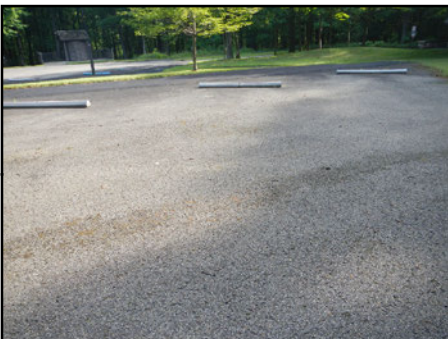
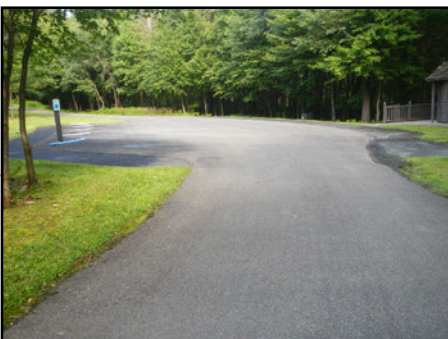
ROUTE 0906: JUMONVILLE GLEN PARKING

Inspection Date	FMSS Number	User Access	Surface Type
6/27/2019	16548	PUBLIC	ASPHALT
Area (Sq. Ft.)	Lane Miles (11' Widths)	Curb Reveal (Inches)	Curb Recommendation
17,108	0.295	NOT APPLICABLE	NOT APPLICABLE
Curb Type		Curb & Gutter Type	
NO CURB		NO CURB AND GUTTER	
Pavement Recommendation		Condition Rating / PCR	
LIGHT 3R TREATMENTS		FAIR / 73
