Final Report

Road Inventory and Condition Assessment of Paved Routes Fort Pulaski National Monument

Federal Highway Administration Eastern Federal Lands Highway Division Road Inventory Program (RIP)

Report Date: November 2021

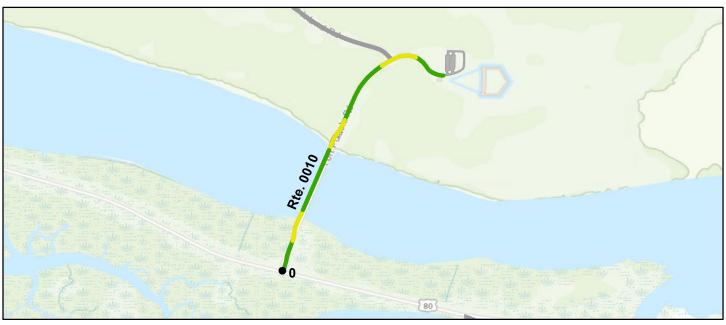
ROUTE 0010: FORT PULASKI ROAD

Route (Condition Legend – Pav	ement Condi	tion Rating (PCR)		
Poor (0 - 60	_		(85 - 94)	Excellent (Not Ra	ted
	,	dition scores at 0.10-mile			100		
Inspection Date:	2/3/2021	Beginning Section MP	0				
Paved Length (Miles	s): 0.9	Section Length (MI)	0.9				
Surface Type:	ASPHALT	Route Summary				•	
Roadway Condition	Information						
Pavement Condition	n Rating (PCR)	85	85				
Surface Condition Ra	ating (SCR)	87	87				
Roughness Condition	n Index (RCI)	82	82				
Distress Index Value	es						
Structural Crack Inc	dex	97	97				
Alligator Crack Inde	ex	100	100				
Longitudinal Crack	Index	97	97				
Transverse Cracking	g Index	87	87				
Patching Index		94	94				
Rutting Index		98	98				
International Rough	nness Index (IRI)	163	163				
Lane & Width Infor	mation						
Number of Lanes		2	2				
Paved Width (ft)		21.1	21.1				
Lane Width (ft)		10.6	10.6

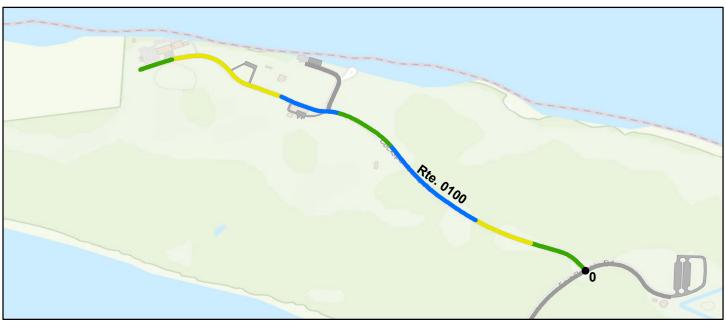
ROUTE 0100: COCKSPUR ISLAND ROAD

Route Condition Legend – Pavement Condition Rating (PCR)							
Poor (0 - 60	_		(85 - 94)	Excellent (Not Ra	ted
*	•	dition scores at 0.10-mile		,	100	and formulas.	
Inspection Date:	2/3/2021	Beginning Section MP	0				
Paved Length (Mile	s): 0.86	Section Length (MI)	0.86				
Surface Type:	ASPHALT	Route Summary				•	
Roadway Condition	Information						
Pavement Condition	n Rating (PCR)	86	86				
Surface Condition Ra	ating (SCR)	85	85				
Roughness Condition	n Index (RCI)	88	88				
Distress Index Value	Distress Index Values						
Structural Crack Inc	dex	99	99				
Alligator Crack Ind	ex	100	100				
Longitudinal Crack	Index	99	99				
Transverse Cracking	g Index	85	85				
Patching Index		100	100				
Rutting Index		100	100				
International Roughness Index (IRI)		146	146				
Lane & Width Information							
Number of Lanes		2	2				
Paved Width (ft)		20.1	20.1				
Lane Width (ft)		9.9	9.9
