# FORA Cycle 6

## Final Report

### Road Inventory and Condition Assessment of Paved Routes Fort Raleigh National Historic Site

**Report Date: March 2022**

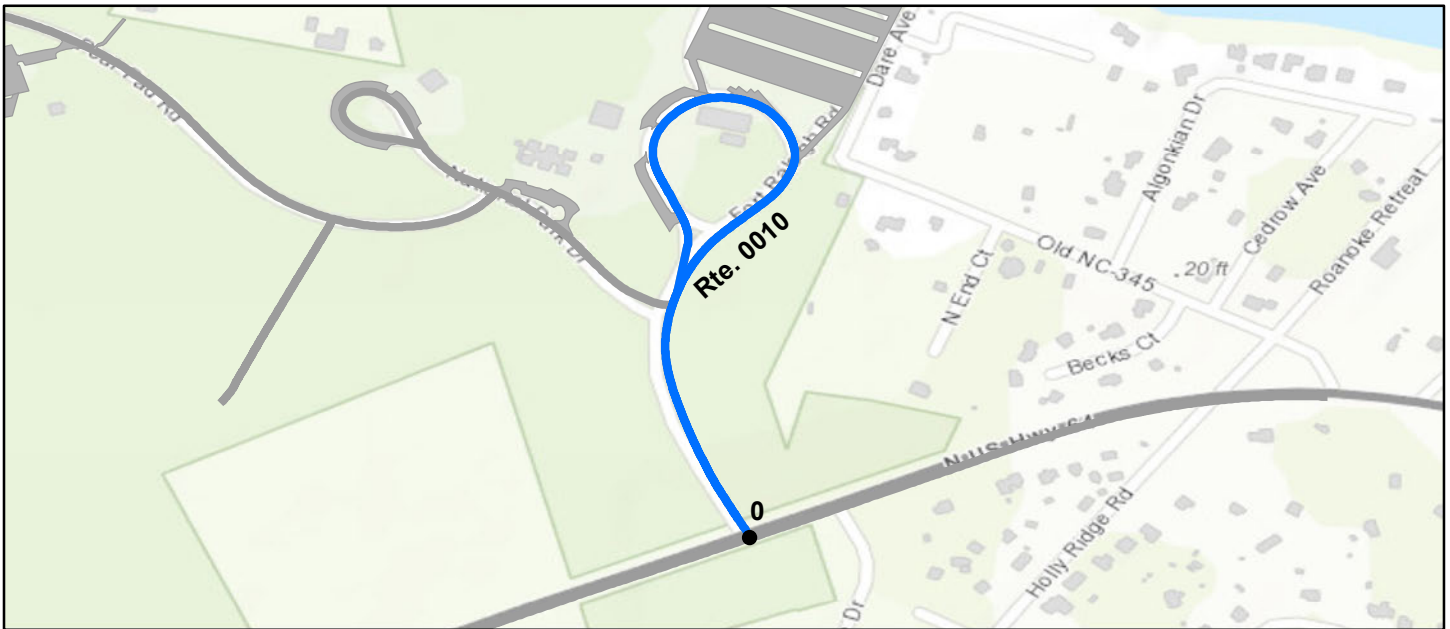
## ROUTE 0010: FR RD FORT RALEIGH ROAD

Colors on map represent condition scores at 0.10-mile intervals. See Appendix for definitions and formulas.

<b>Inspection Date:</b> 5/27/2021	<b>Beginning Section MP</b>	0				
<b>Paved Length (Miles):</b> 0.5	<b>Section Length (MI)</b>	0.5				
<b>Surface Type:</b> ASPHALT	<b>Route Summary</b>					
<b>Roadway Condition Information</b>						
Pavement Condition Rating (PCR)	99	99				
Surface Condition Rating (SCR)	99	99				
Roughness Condition Index (RCI)	N/A	N/A				
<b>Distress Index Values</b>						
Structural Crack Index	100	100				
Alligator Crack Index	100	100				
Longitudinal Crack Index	100	100				
Transverse Cracking Index	100	100				
Patching Index	100	100				
Rutting Index	99	99				
International Roughness Index (IRI)	N/A	N/A				
<b>Lane &amp; Width Information</b>						
Number of Lanes	1	1				
Paved Width (ft)	22.3	22.3				
Lane Width (ft)	16.9	16.9

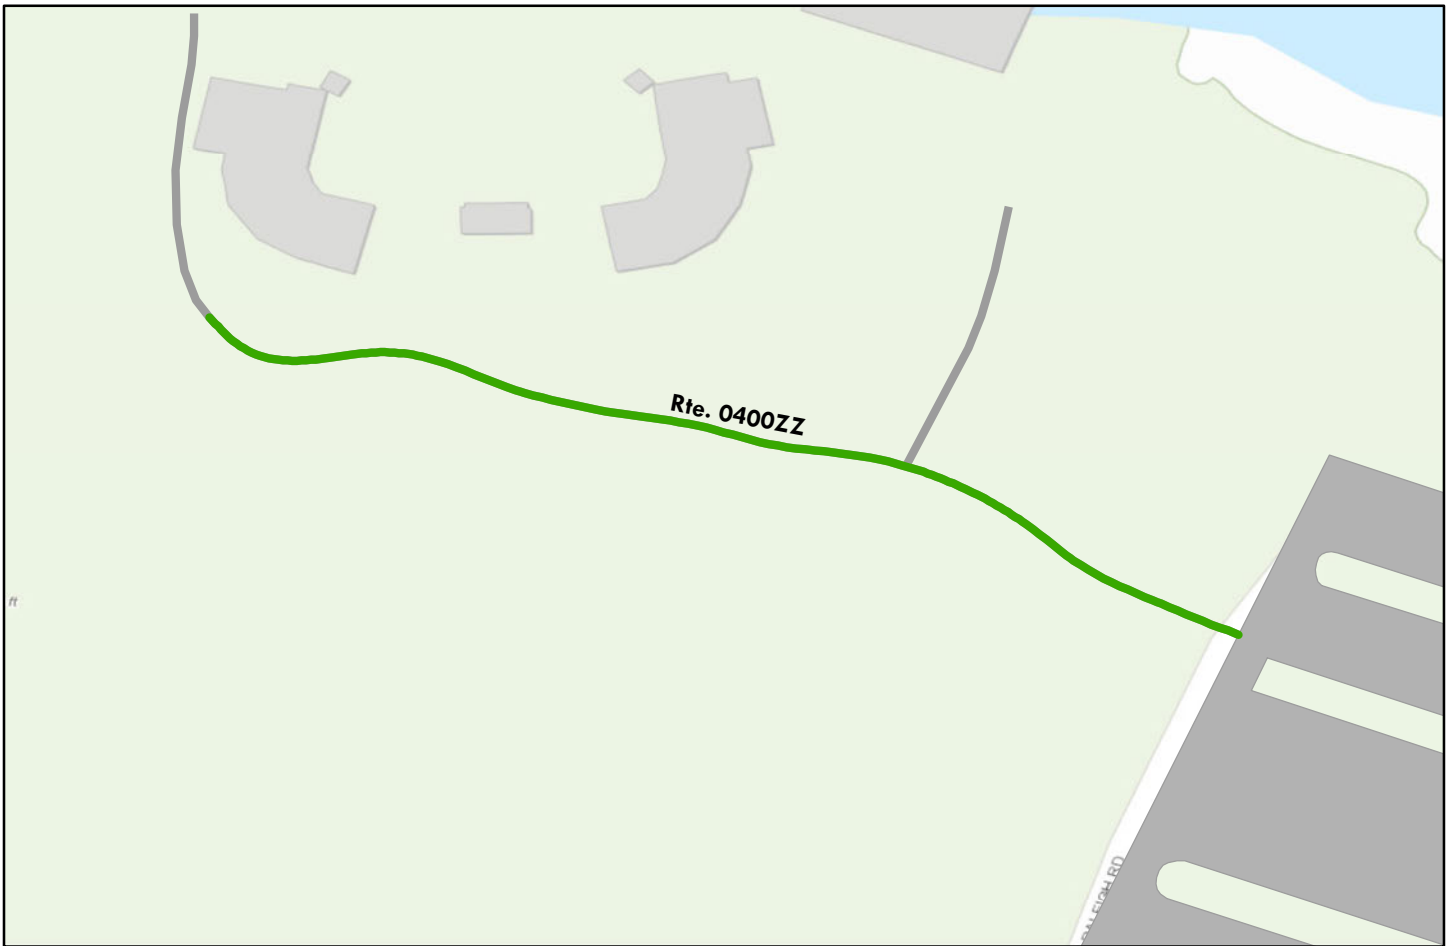
## ROUTE 0400ZZ: FR RD THEATER ACCESS ROADS

**Note:** The weighted average summary PCR value is calculated from only the sections of road where the PCR was collected. The overall PCR for the summary route may not reflect individual subcomponent ratings.

Route Condition Legend – Pavement Condition Rating (PCR)						
<b>Poor (0 - 60)</b>	<b>Fair (61- 84)</b>	<b>Good (85 - 94)</b>	<b>Excellent (95 - 100)</b>	<b>Not Rated</b>		
See Appendix for definitions and formulas						
<b>Inspection Date:</b>	5/27/2021					
<b>Paved Length (Miles):</b>	0.11					
<b>Surface Type:</b>	ASPHALT	<b>Route Summary</b>				
<b>Roadway Condition Information</b>						
Pavement Condition Rating (PCR)	93					
<b>Lane &amp; Width Information</b>						
Number of Lanes	1					
Paved Width (ft)	12.1					
Lane Width (ft)	12.1

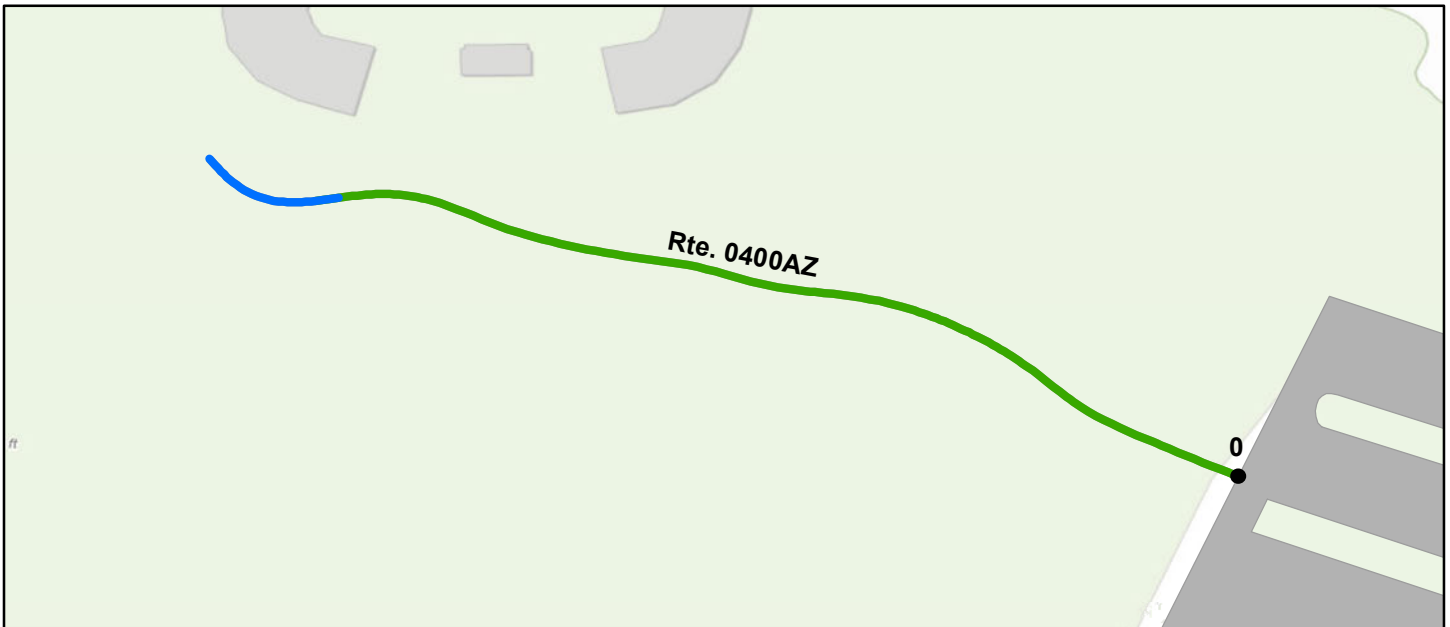
## ROUTE 0400AZ: FR RD THEATER ACCESS ROAD

Colors on map represent condition scores at 0.10-mile intervals. See Appendix for definitions and formulas.

<b>Inspection Date:</b> 5/27/2021	<b>Beginning Section MP</b>	0				
<b>Paved Length (Miles):</b> 0.11	<b>Section Length (MI)</b>	0.11				
<b>Surface Type:</b> ASPHALT	<b>Route Summary</b>					
<b>Roadway Condition Information</b>						
Pavement Condition Rating (PCR)	93	93				
Surface Condition Rating (SCR)	93	93				
Roughness Condition Index (RCI)	N/A	N/A				
<b>Distress Index Values</b>						
Structural Crack Index	95	95				
Alligator Crack Index	100	100				
Longitudinal Crack Index	95	95				
Transverse Cracking Index	93	93				
Patching Index	100	100				
Rutting Index	97	97				
International Roughness Index (IRI)	N/A	N/A				
<b>Lane &amp; Width Information</b>						
Number of Lanes	1	1				
Paved Width (ft)	12.1	12.1				
Lane Width (ft)	12.1	12.1

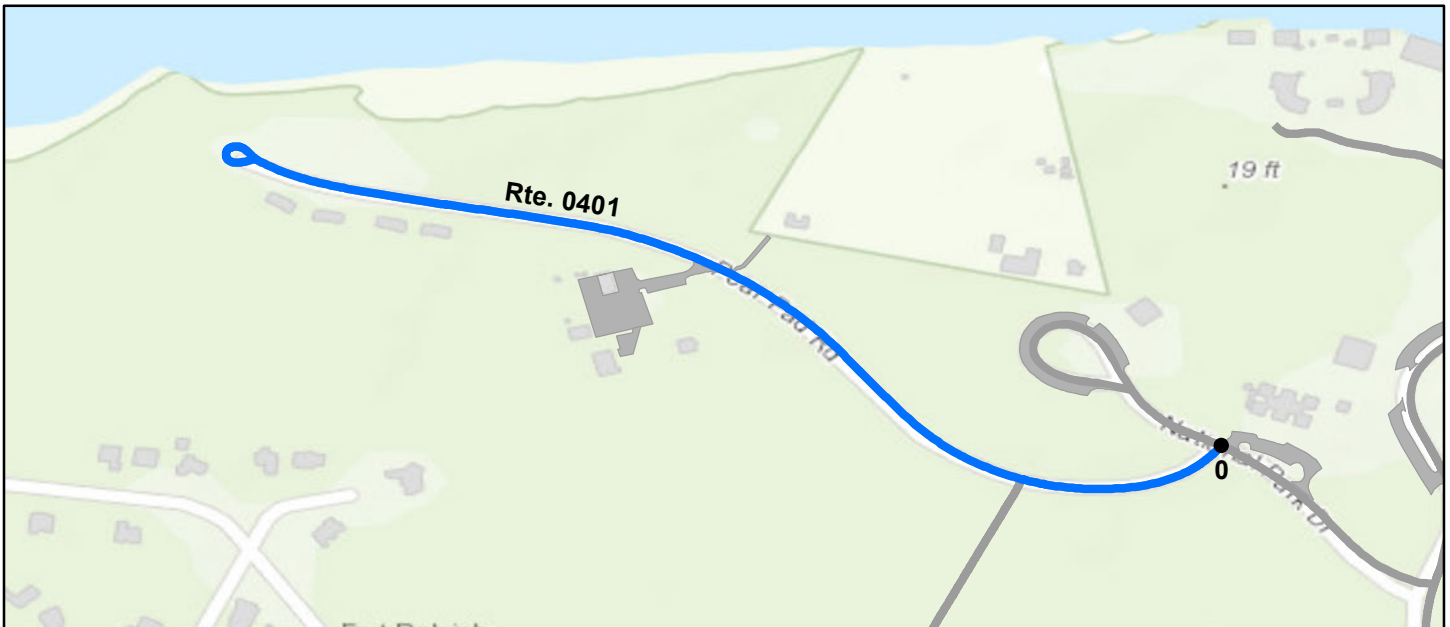
## ROUTE 0401: FR RD PEAR PAD ROAD

Colors on map represent condition scores at 0.10-mile intervals. See Appendix for definitions and formulas.

<b>Inspection Date:</b> 5/27/2021	<b>Beginning Section MP</b>	0				
<b>Paved Length (Miles):</b> 0.55	<b>Section Length (MI)</b>	0.55				
<b>Surface Type:</b> ASPHALT	<b>Route Summary</b>					
<b>Roadway Condition Information</b>						
Pavement Condition Rating (PCR)	99	99				
Surface Condition Rating (SCR)	99	99				
Roughness Condition Index (RCI)	N/A	N/A				
<b>Distress Index Values</b>						
Structural Crack Index	100	100				
Alligator Crack Index	100	100				
Longitudinal Crack Index	100	100				
Transverse Cracking Index	100	100				
Patching Index	100	100				
Rutting Index	99	99				
International Roughness Index (IRI)	N/A	N/A				
<b>Lane &amp; Width Information</b>						
Number of Lanes	2	2				
Paved Width (ft)	17.9	17.9				
Lane Width (ft)	9.5	9.5

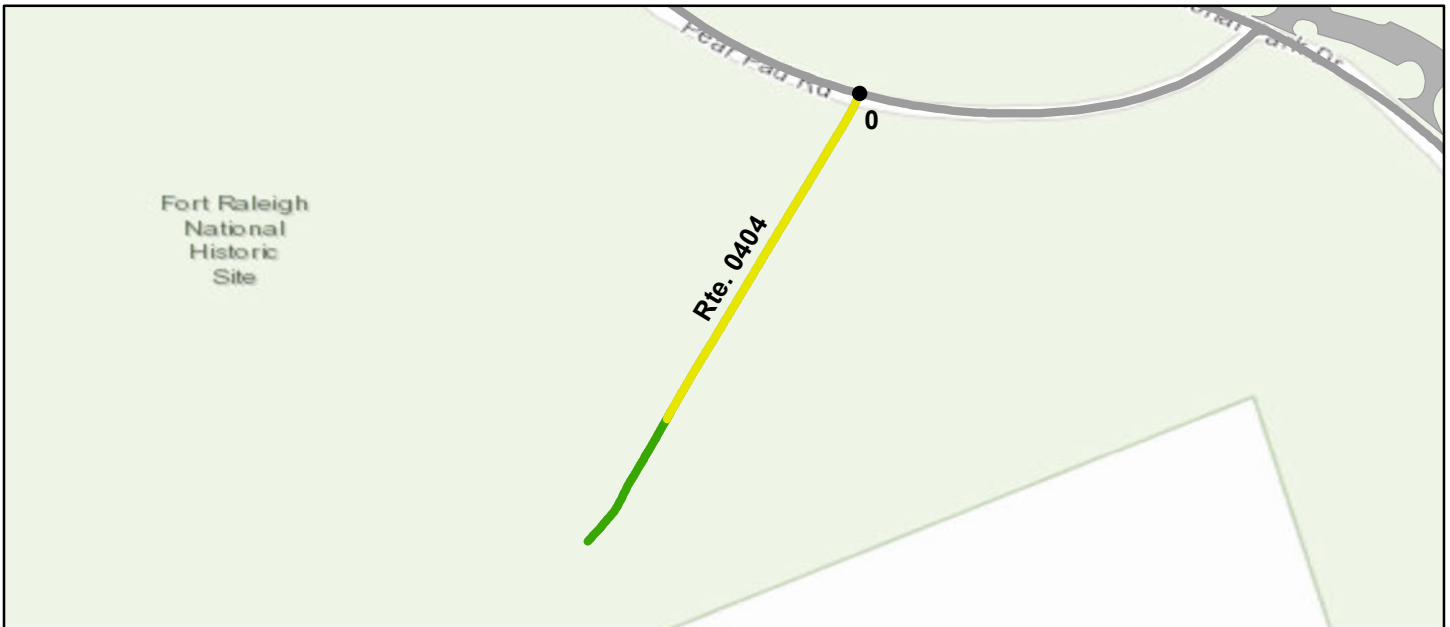
## ROUTE 0404: FR RD WATER TOWER ROAD

Colors on map represent condition scores at 0.10-mile intervals. See Appendix for definitions and formulas.

<b>Inspection Date:</b> 5/27/2021	<b>Beginning Section MP</b>	0				
<b>Paved Length (Miles):</b> 0.14	<b>Section Length (MI)</b>	0.14				
<b>Surface Type:</b> ASPHALT	<b>Route Summary</b>					
<b>Roadway Condition Information</b>						
Pavement Condition Rating (PCR)	80	80				
Surface Condition Rating (SCR)	80	80				
Roughness Condition Index (RCI)	N/A	N/A				
<b>Distress Index Values</b>						
Structural Crack Index	96	96				
Alligator Crack Index	100	100				
Longitudinal Crack Index	96	96				
Transverse Cracking Index	80	80				
Patching Index	100	100				
Rutting Index	98	98				
International Roughness Index (IRI)	N/A	N/A				
<b>Lane &amp; Width Information</b>						
Number of Lanes	1	1				
Paved Width (ft)	7.5	7.5				
Lane Width (ft)	7.5	7.5

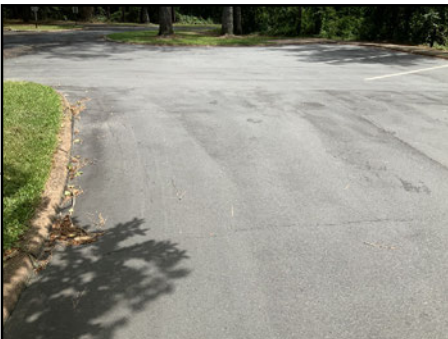
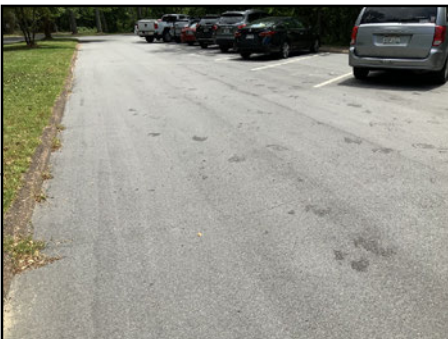
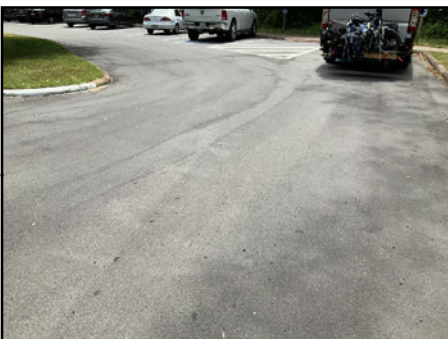
## ROUTE 0900AZ: FR RD VISITOR CENTER LOOP PARKING A

Inspection Date	FMSS Number	User Access	Surface Type
5/6/2021	104946	PUBLIC	ASPHALT
Area (Sq. Ft.)	Lane Miles (11' Widths)	Curb Reveal (Inches)	Curb Recommendation
9,517	0.164	3	DO NOTHING
Curb Type		Curb & Gutter Type	
CONCRETE		NO CURB AND GUTTER	
Pavement Recommendation		Condition Rating / PCR	
PREVENTIVE MAINTENANCE		GOOD / 90

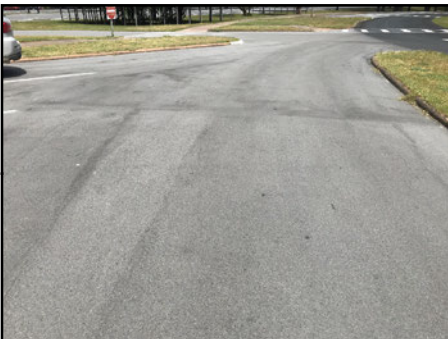
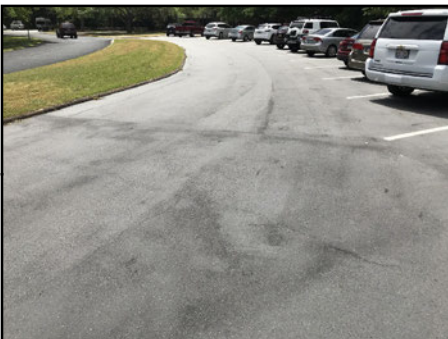
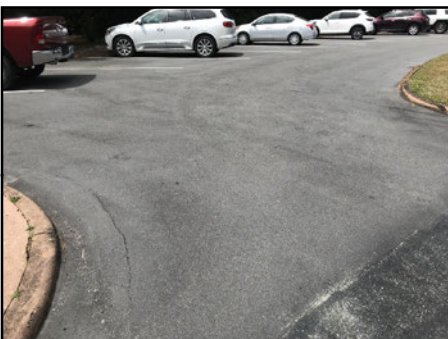
## ROUTE 0900BZ: FR RD VISITOR CENTER LOOP PARKING B

Inspection Date	FMSS Number	User Access	Surface Type
5/6/2021	104946	PUBLIC	ASPHALT
Area (Sq. Ft.)	Lane Miles (11' Widths)	Curb Reveal (Inches)	Curb Recommendation
8,021	0.138	3	DO NOTHING
Curb Type		Curb & Gutter Type	
CONCRETE		NO CURB AND GUTTER	
Pavement Recommendation		Condition Rating / PCR	
PREVENTIVE MAINTENANCE		GOOD / 90

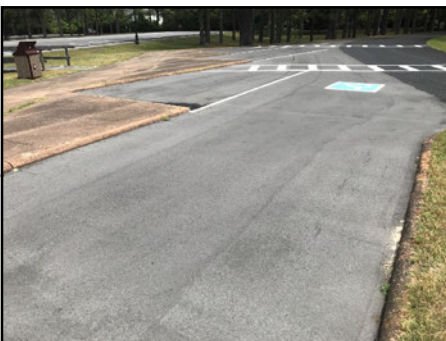
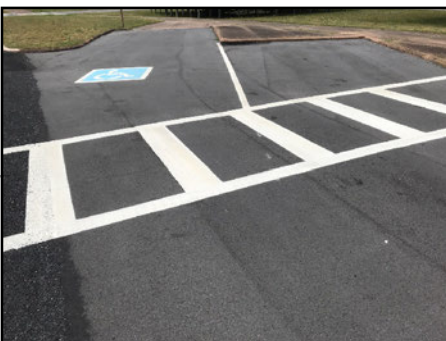
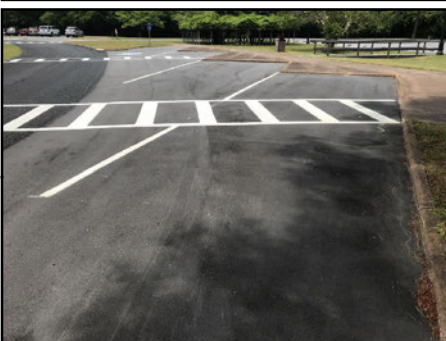
## ROUTE 0900CZ: FR RD VISITOR CENTER LOOP PARKING C

Inspection Date	FMSS Number	User Access	Surface Type
5/6/2021	104946	PUBLIC	ASPHALT
Area (Sq. Ft.)	Lane Miles (11' Widths)	Curb Reveal (Inches)	Curb Recommendation
3,875	0.067	3	DO NOTHING
Curb Type		Curb & Gutter Type	
CONCRETE		NO CURB AND GUTTER	
Pavement Recommendation		Condition Rating / PCR	
PREVENTIVE MAINTENANCE		GOOD / 90

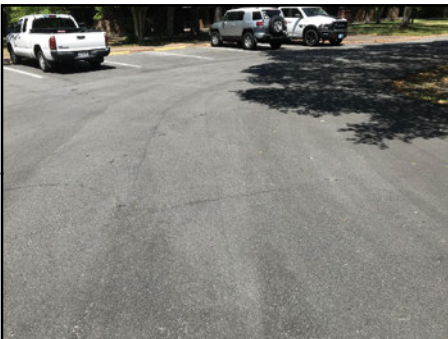
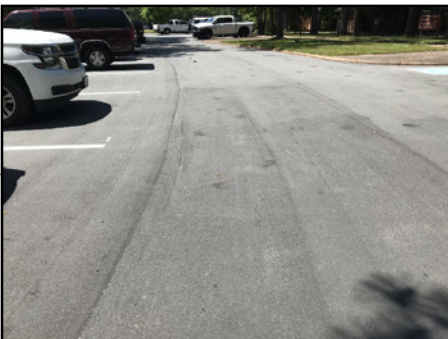
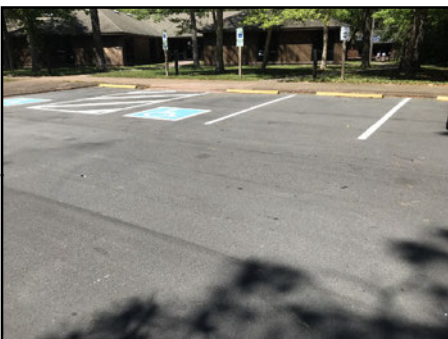
## ROUTE 0901: FR RD GROUP HEADQUARTERS PARKING

Inspection Date	FMSS Number	User Access	Surface Type
5/6/2021	93047	NONPUBLIC	ASPHALT
Area (Sq. Ft.)	Lane Miles (11' Widths)	Curb Reveal (Inches)	Curb Recommendation
11,757	0.202	3	DO NOTHING
Curb Type		Curb & Gutter Type	
CONCRETE		NO CURB AND GUTTER	
Pavement Recommendation		Condition Rating / PCR	
PREVENTIVE MAINTENANCE		GOOD / 90

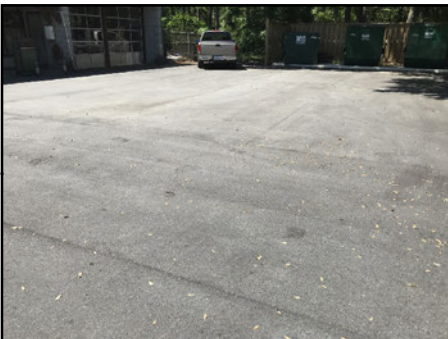
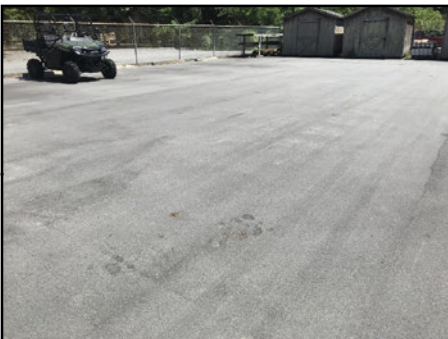
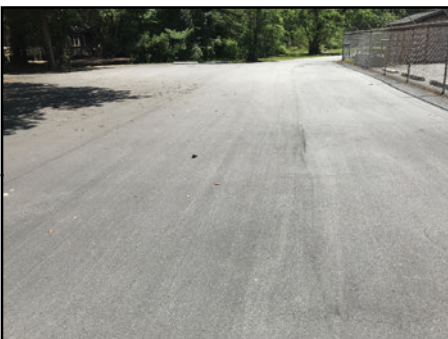
## ROUTE 0902: FR RD MAINTENANCE AREA PARKING

Inspection Date	FMSS Number	User Access	Surface Type
5/6/2021	93046	NONPUBLIC	ASPHALT
Area (Sq. Ft.)	Lane Miles (11' Widths)	Curb Reveal (Inches)	Curb Recommendation
28,550	0.55	NOT APPLICABLE	NOT APPLICABLE
Curb Type		Curb & Gutter Type	
NO CURB		NO CURB AND GUTTER	
Pavement Recommendation		Condition Rating / PCR	
PREVENTIVE MAINTENANCE		GOOD / 90

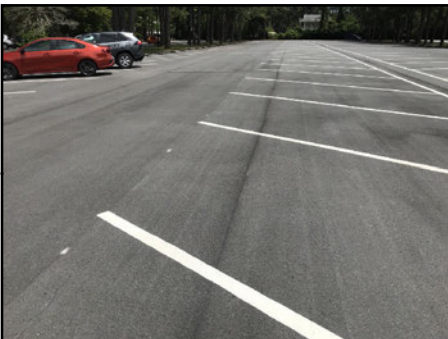
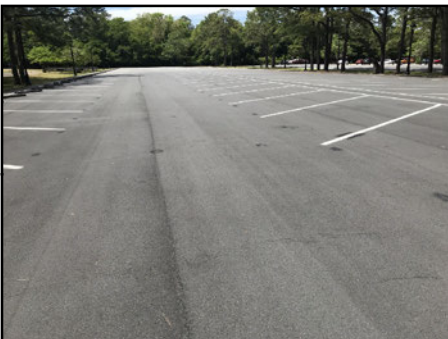
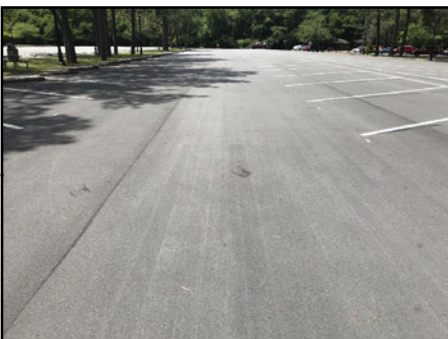
## ROUTE 0903: FR RD THEATER PARKING

Inspection Date	FMSS Number	User Access	Surface Type
5/6/2021	89488	PUBLIC	ASPHALT
Area (Sq. Ft.)	Lane Miles (11' Widths)	Curb Reveal (Inches)	Curb Recommendation
191,816	3.301	NOT APPLICABLE	NOT APPLICABLE
Curb Type		Curb & Gutter Type	
NO CURB		NO CURB AND GUTTER	
Pavement Recommendation		Condition Rating / PCR	
PREVENTIVE MAINTENANCE		GOOD / 90

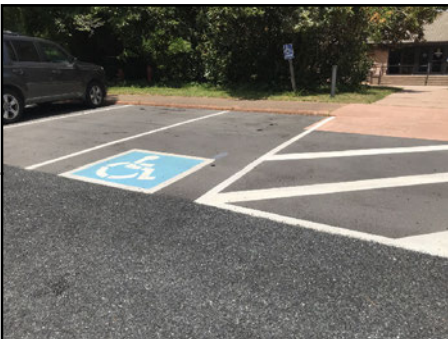
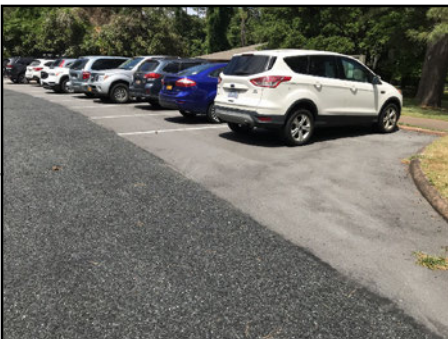
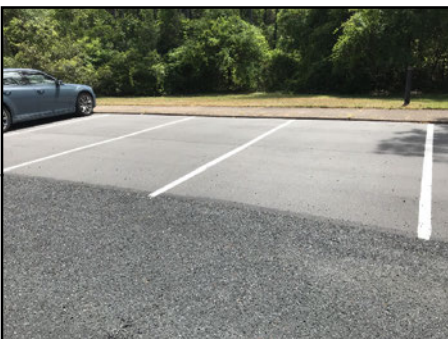
## ROUTE 0904: FR RD ELIZABETHAN GARDEN PARKING

Inspection Date	FMSS Number	User Access	Surface Type
5/6/2021	93048	PUBLIC	ASPHALT
Area (Sq. Ft.)	Lane Miles (11' Widths)	Curb Reveal (Inches)	Curb Recommendation
16,198	0.279	3	DO NOTHING
Curb Type		Curb & Gutter Type	
CONCRETE		NO CURB AND GUTTER	
Pavement Recommendation		Condition Rating / PCR	
PREVENTIVE MAINTENANCE		GOOD / 90

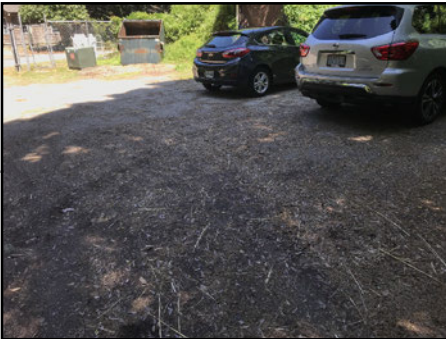
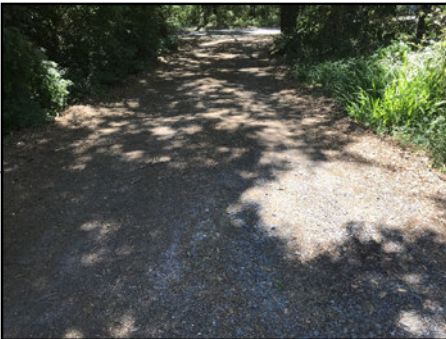
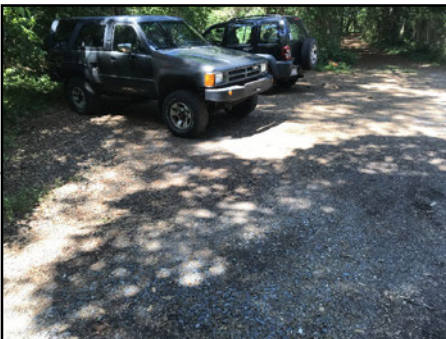
## ROUTE 0905: ELIZABETHAN GARDEN MAINTENANCE FACILITY

Inspection Date	FMSS Number	User Access	Surface Type
5/6/2021	104950	NONPUBLIC	ASPHALT
Area (Sq. Ft.)	Lane Miles (11' Widths)	Curb Reveal (Inches)	Curb Recommendation
1,405	0.024	NOT APPLICABLE	NOT APPLICABLE
Curb Type		Curb & Gutter Type	
NO CURB		NO CURB AND GUTTER	
Pavement Recommendation		Condition Rating / PCR	
RECONSTRUCTION		POOR / 0

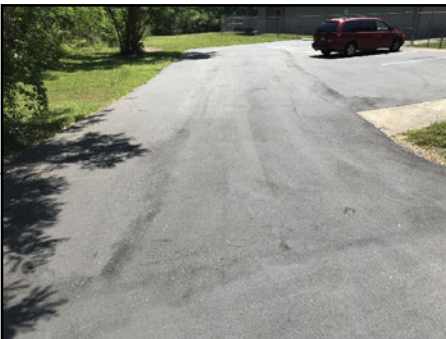
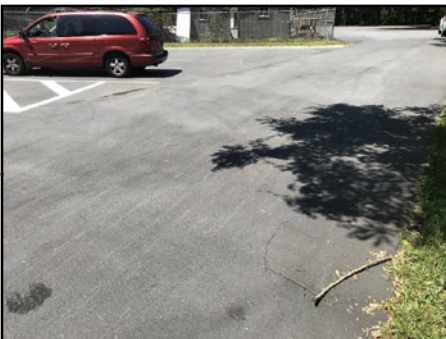
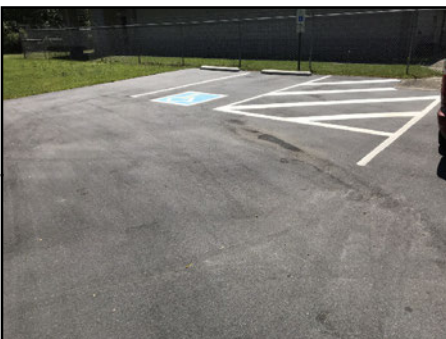
## ROUTE 0908: MRC PARKING

Inspection Date	FMSS Number	User Access	Surface Type
5/6/2021	113565	NONPUBLIC	ASPHALT
Area (Sq. Ft.)	Lane Miles (11' Widths)	Curb Reveal (Inches)	Curb Recommendation
3,031	0.052	NOT APPLICABLE	NOT APPLICABLE
Curb Type		Curb & Gutter Type	
NO CURB		NO CURB AND GUTTER	
Pavement Recommendation		Condition Rating / PCR	
PREVENTIVE MAINTENANCE		GOOD / 90
