# FOUS Cycle 6

## Final Report

### Road Inventory and Condition Assessment of Paved Routes Fort Union Trading Post National Historic Site

**Report Date: January 2018**

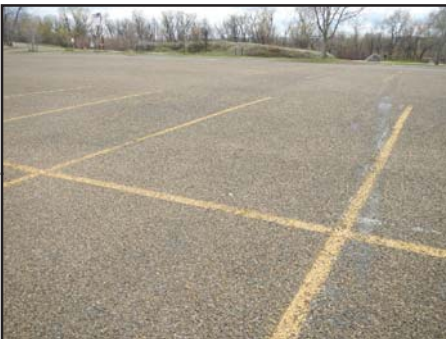
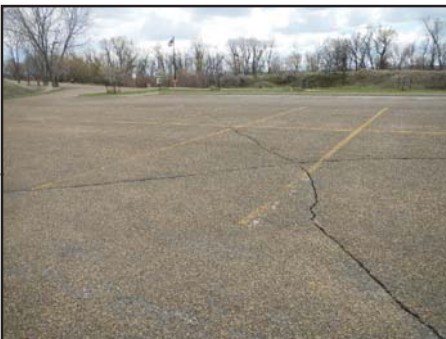
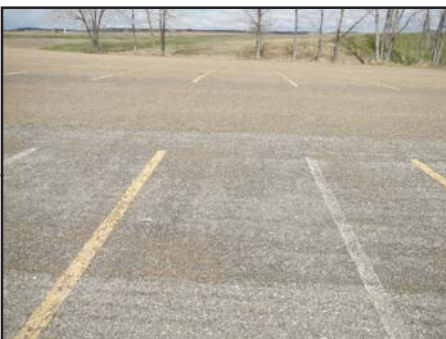
Inspection Date	FMSS Number	User Access	Surface Type
5/1/2017	16573	PUBLIC	ASPHALT
Area (Sq. Ft.)	Lane Miles (11' Widths)	Curb Reveal (Inches)	Curb Recommendation
36,515	0.629	2	DO NOTHING
Curb Type		Curb & Gutter Type	
CONCRETE		NO CURB AND GUTTER	
Pavement Recommendation		Condition Rating / PCR	
PREVENTIVE MAINTENANCE		GOOD / 90

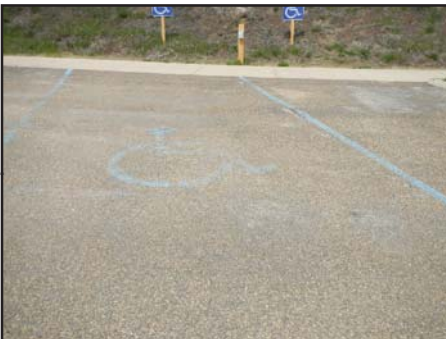
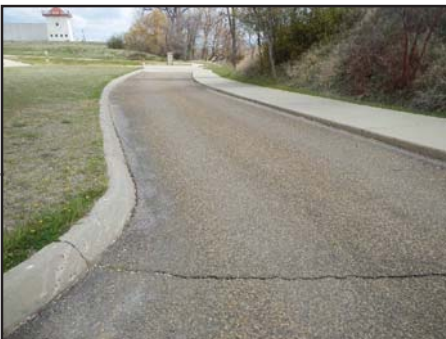
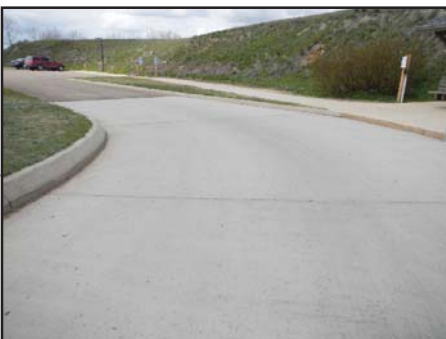
## ROUTE 0901: ACCESSIBLE PARKING LOT

Inspection Date	FMSS Number	User Access	Surface Type
5/1/2017	16575	PUBLIC	ASPHALT
Area (Sq. Ft.)	Lane Miles (11' Widths)	Curb Reveal (Inches)	Curb Recommendation
11,577	0.199	4	DO NOTHING
Curb Type		Curb & Gutter Type	
CONCRETE		NO CURB AND GUTTER	
Pavement Recommendation		Condition Rating / PCR	
PREVENTIVE MAINTENANCE		GOOD / 90

Note: Parking area consists of multiple surface types: 1 part Asphalt at 8,528 square feet; 1 part Concrete at 3,049 square feet.

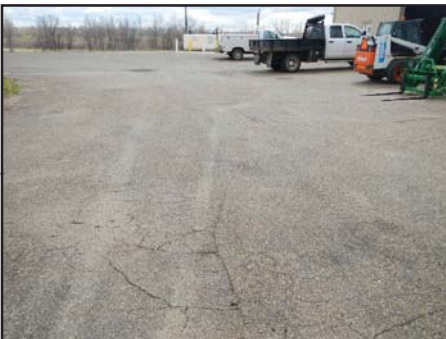
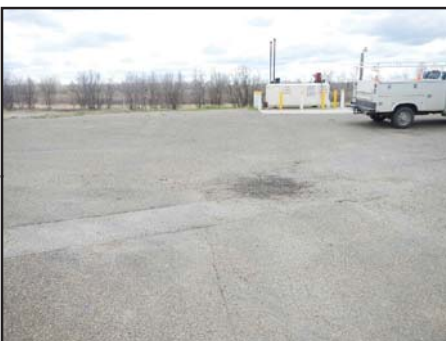
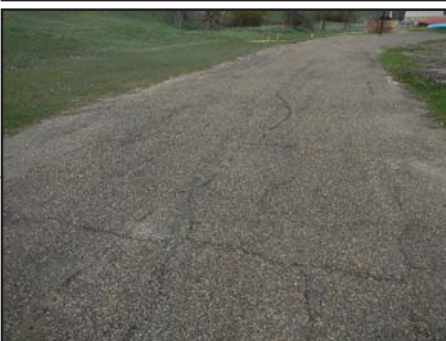
## ROUTE 0903: MAINTENANCE / SHOP AREA PARKING

Inspection Date	FMSS Number	User Access	Surface Type
5/1/2017	59474	NONPUBLIC	ASPHALT
Area (Sq. Ft.)	Lane Miles (11' Widths)	Curb Reveal (Inches)	Curb Recommendation
12,328	0.212	NOT APPLICABLE	NOT APPLICABLE
Curb Type		Curb & Gutter Type	
NO CURB		NO CURB AND GUTTER	
Pavement Recommendation		Condition Rating / PCR	
HEAVY 3R TREATMENTS		POOR / 53

Note: Parking area consists of multiple surface types: 1 part Asphalt at 12,161 square feet; 1 part Concrete at 167 square feet.
