FOVA Cycle 6

Final Report

Road Inventory and Condition Assessment of Paved Routes Fort Vancouver National Historic Site

Report Date: February 2016

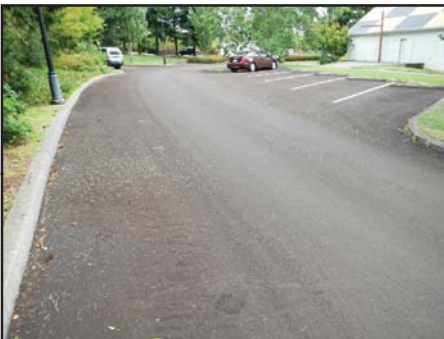
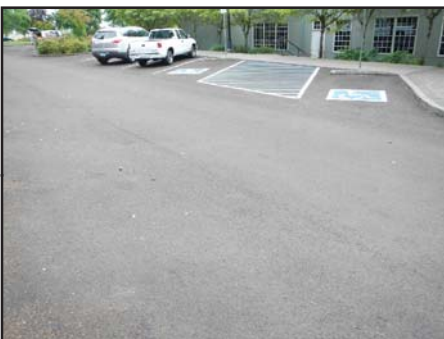
ROUTE 0904: PEARSON PARKING

Inspection Date	FMSS Number	User Access	Surface Type
8/5/2015	116536	PUBLIC	ASPHALT
Area (Sq. Ft.)	Lane Miles (11' Widths)	Curb Reveal (Inches)	Curb Recommendation
23,943	0.412	6	DO NOTHING
Curb Type		Curb & Gutter Type	
CONCRETE		NO CURB AND GUTTER	
Pavement Recommendation		Condition Rating / PCR	
DO NOTHING		EXCELLENT / 97

The parking area consists of multiple surface types, one part asphalt at 23,559 square feet; one part brick pavers at 384 square feet.

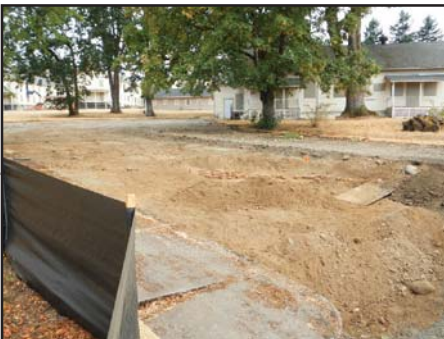
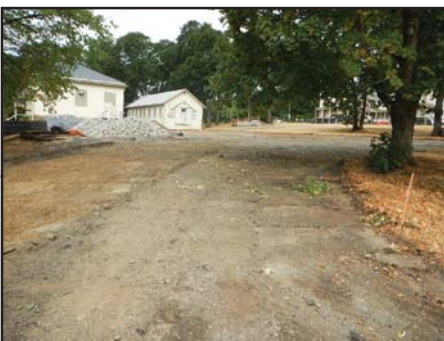
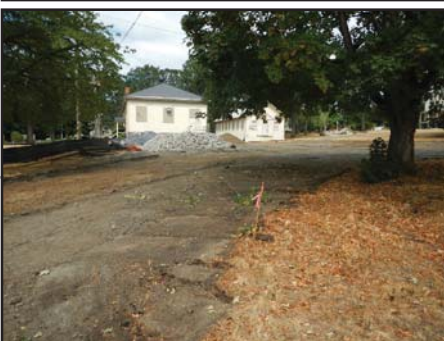
ROUTE 0905AZ: EAST BARRACKS PARKING A

Inspection Date	FMSS Number	User Access	Surface Type
8/5/2015	236408	PUBLIC	ASPHALT
Area (Sq. Ft.)	Lane Miles (11' Widths)	Curb Reveal (Inches)	Curb Recommendation
17,150	0.295	NOT APPLICABLE	NOT APPLICABLE
Curb Type		Curb & Gutter Type	
NOT APPLICABLE		NOT APPLICABLE	
Pavement Recommendation		Condition Rating / PCR	
NOT APPLICABLE		NOT RATED / -1

Parking area was not rated because the parking area is under construction. (GPS shown is from aerial)

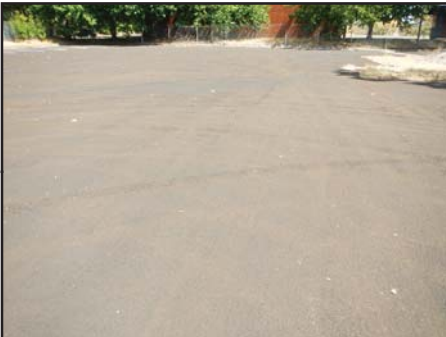
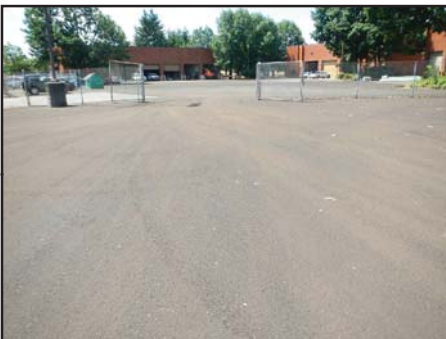
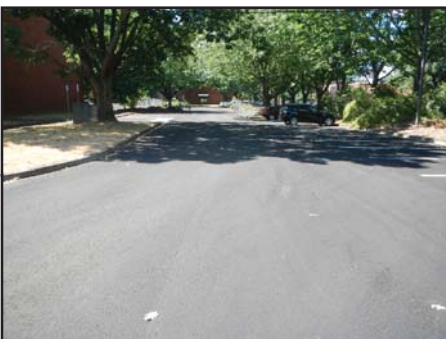
ROUTE 0906AZ: SOUTH BARRACKS PARKING A

Inspection Date	FMSS Number	User Access	Surface Type
8/5/2015	236409	NONPUBLIC	ASPHALT
Area (Sq. Ft.)	Lane Miles (11' Widths)	Curb Reveal (Inches)	Curb Recommendation
246,483	4.244	6	DO NOTHING
Curb Type		Curb & Gutter Type	
CONCRETE		CONCRETE	
Pavement Recommendation		Condition Rating / PCR	
PREVENTIVE MAINTENANCE		GOOD / 90

The parking area consists of multiple surface types, one part asphalt at 200,518 square feet; one part concrete at 45,965 square feet.

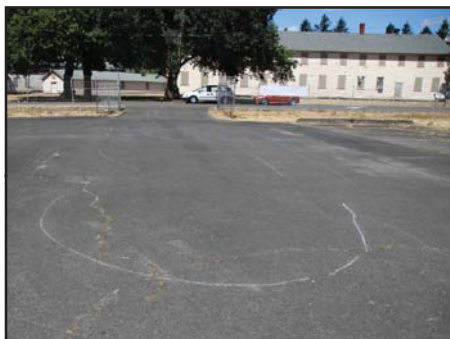
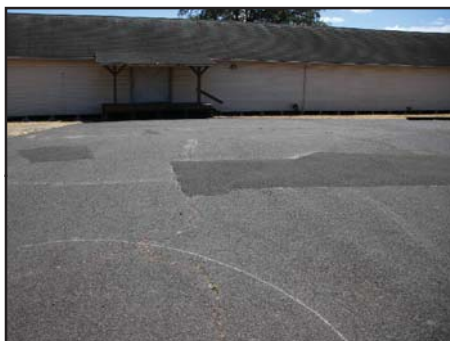
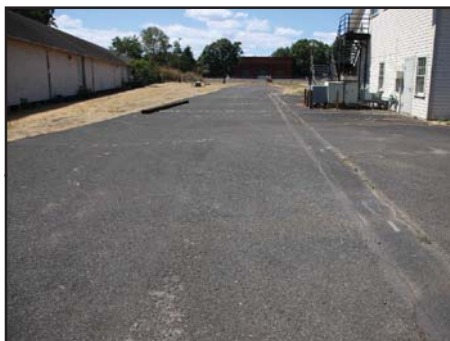
ROUTE 0906BZ: SOUTH BARRACKS PARKING B

Inspection Date	FMSS Number	User Access	Surface Type
8/6/2015	236409	PUBLIC	ASPHALT
Area (Sq. Ft.)	Lane Miles (11' Widths)	Curb Reveal (Inches)	Curb Recommendation
39,520	0.68	NOT APPLICABLE	NOT APPLICABLE
Curb Type		Curb & Gutter Type	
NO CURB		NO CURB AND GUTTER	
Pavement Recommendation		Condition Rating / PCR	
HEAVY 3R TREATMENTS		POOR / 53

The parking area consists of multiple surface types, one part asphalt at 38,252 square feet; one part concrete at 1,268 square feet.
