# FOWA Cycle 6

## Final Report

### Road Inventory and Condition Assessment of Paved Routes Fort Washington Park *Part of the National Capital Parks - East*

**Report Date: November 2019**

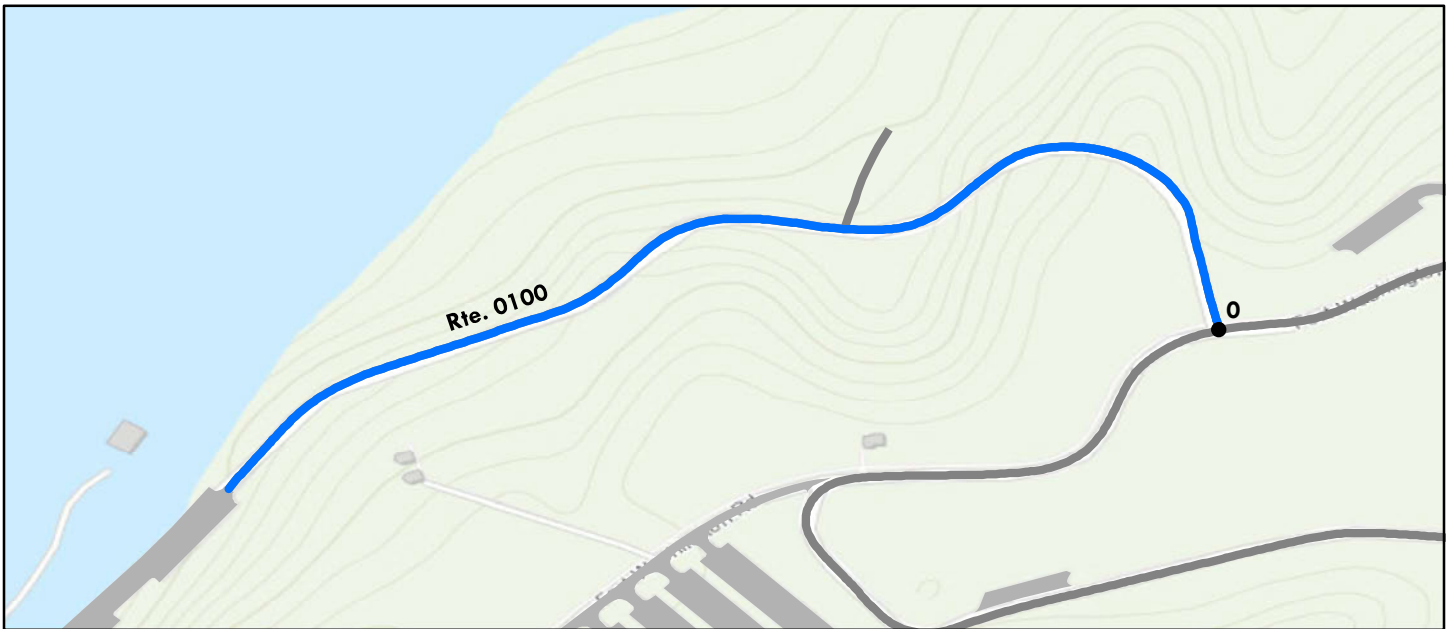
<b>Inspection Date:</b> 3/24/2018	<b>Beginning Section MP</b>	0				
<b>Paved Length (Miles):</b> 0.38	<b>Section Length (MI)</b>	0.38				
<b>Surface Type:</b> ASPHALT	<b>Route Summary</b>					
<b>Roadway Condition Information</b>						
Pavement Condition Rating (PCR)	98	98				
Surface Condition Rating (SCR)	98	98				
Roughness Condition Index (RCI)	N/A	N/A				
<b>Distress Index Values</b>						
Structural Crack Index	98	98				
Alligator Crack Index	100	100				
Longitudinal Crack Index	98	98				
Transverse Cracking Index	99	99				
Patching Index	100	100				
Rutting Index	99	99				
International Roughness Index (IRI)	N/A	N/A				
<b>Lane &amp; Width Information</b>						
Number of Lanes	2	2				
Paved Width (ft)	20.4	20.4				
Lane Width (ft)	9.5	9.5

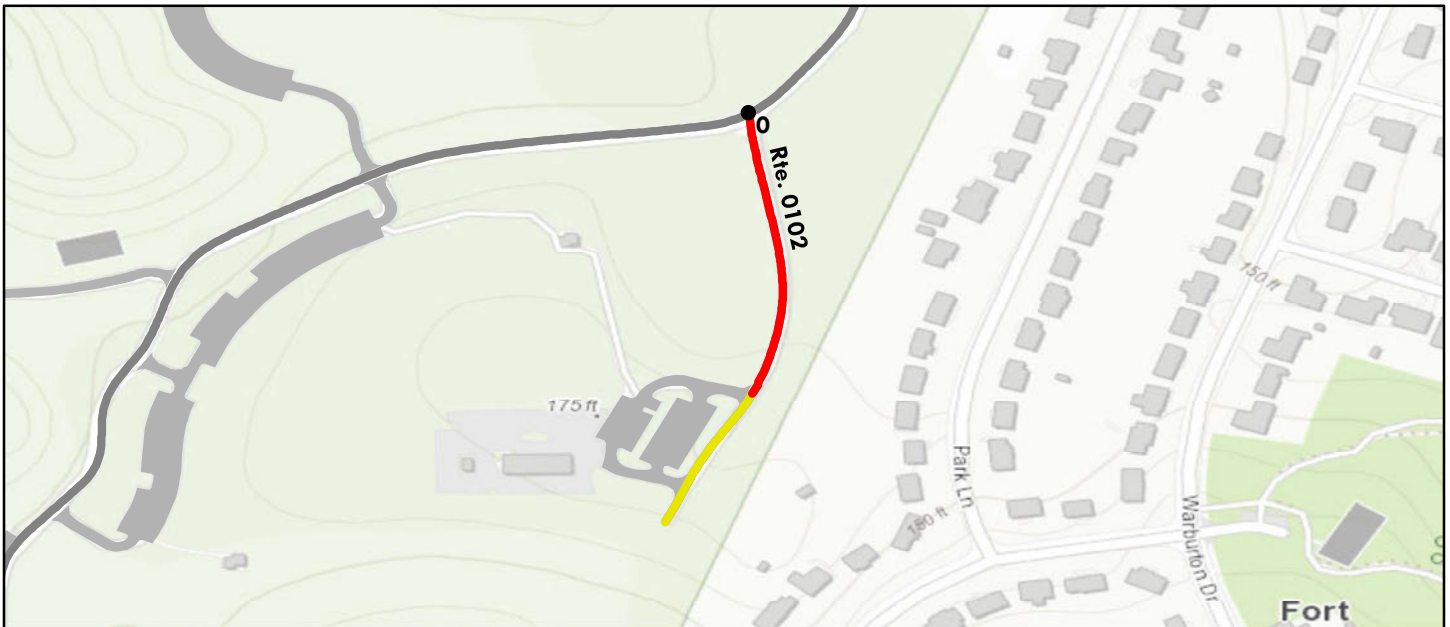
<b>Inspection Date:</b> 3/24/2018	<b>Beginning Section MP</b>	0				
<b>Paved Length (Miles):</b> 0.15	<b>Section Length (MI)</b>	0.15				
<b>Surface Type:</b> ASPHALT	<b>Route Summary</b>					
<b>Roadway Condition Information</b>						
Pavement Condition Rating (PCR)	26	26				
Surface Condition Rating (SCR)	26	26				
Roughness Condition Index (RCI)	N/A	N/A				
<b>Distress Index Values</b>						
Structural Crack Index	83	83				
Alligator Crack Index	99	99				
Longitudinal Crack Index	84	84				
Transverse Cracking Index	26	26				
Patching Index	100	100				
Rutting Index	99	99				
International Roughness Index (IRI)	N/A	N/A				
<b>Lane &amp; Width Information</b>						
Number of Lanes	2	2				
Paved Width (ft)	18.6	18.6				
Lane Width (ft)	9.2	9.2

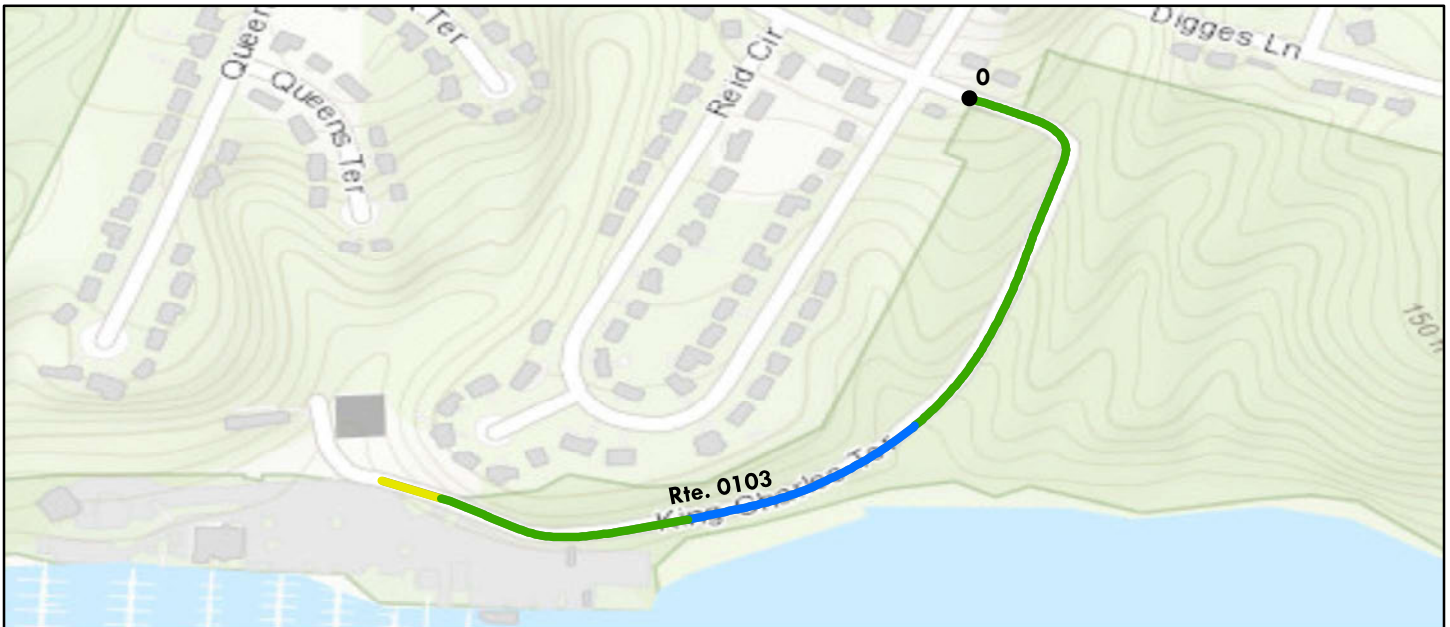
<b>Inspection Date:</b>	3/24/2018	<b>Beginning Section MP</b>	0				
<b>Paved Length (Miles):</b>	0.43	<b>Section Length (MI)</b>	0.42				
<b>Surface Type:</b>	ASPHALT	<b>Route Summary</b>					
<b>Roadway Condition Information</b>							
Pavement Condition Rating (PCR)	94	94					
Surface Condition Rating (SCR)	94	94					
Roughness Condition Index (RCI)	N/A	N/A					
<b>Distress Index Values</b>							
Structural Crack Index	94	94					
Alligator Crack Index	98	98					
Longitudinal Crack Index	96	96					
Transverse Cracking Index	95	95					
Patching Index	100	100					
Rutting Index	99	99					
International Roughness Index (IRI)	N/A	N/A					
<b>Lane &amp; Width Information</b>							
Number of Lanes	2	2					
Paved Width (ft)	19.6	19.6					
Lane Width (ft)	9.5	9.5

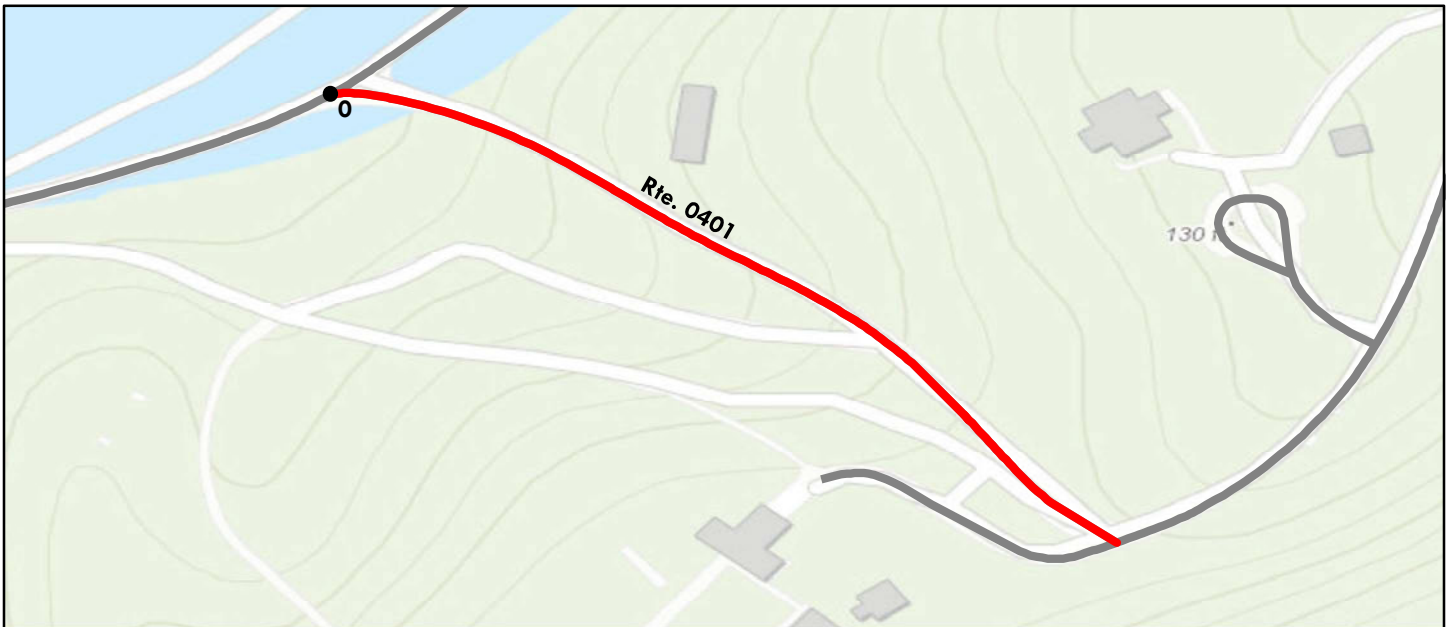
Route Condition Legend – Pavement Condition Rating (PCR)							
Poor (0 - 60)		Fair (61- 84)		Good (85 - 94)		Excellent (95 - 100)	
						Not Rated	
Colors on map represent condition scores at 0.10-mile intervals. See Appendix for definitions and formulas.							
Inspection Date: 3/24/2018		Beginning Section MP	0				
Paved Length (Miles): 0.13		Section Length (MI)	0.13				
Surface Type: ASPHALT		Route Summary					
Roadway Condition Information							
Pavement Condition Rating (PCR)		0	0				
Surface Condition Rating (SCR)		0	0				
Roughness Condition Index (RCI)		N/A	N/A				
Distress Index Values							
Structural Crack Index		0	0				
Alligator Crack Index		54	54				
Longitudinal Crack Index		30	30				
Transverse Cracking Index		0	0				
Patching Index		96	96				
Rutting Index		83	83				
International Roughness Index (IRI)		N/A	N/A				
Lane & Width Information							
Number of Lanes		1	1				
Paved Width (ft)		13.6	13.6

**Note:** Road is in very poor condition with badly deteriorated asphalt.

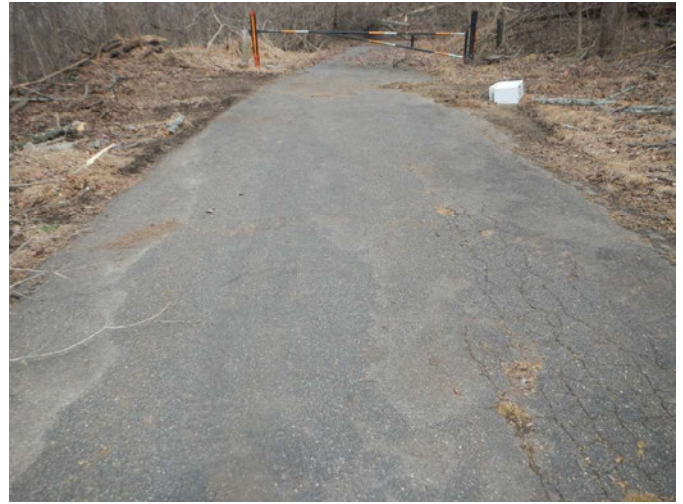
**FOWA\_0407\_3203.JPG**

Route Condition Legend – Pavement Condition Rating (PCR)						
Poor (0 - 60)	Fair (61- 84)	Good (85 - 94)	Excellent (95 - 100)	Not Rated		
See Appendix for definitions and formulas						
Inspection Date:	3/14/2018	Beginning Section MP	0.00			
Paved Length (Miles):	0.04	Section Length (MI)	0.04			
Surface Type:	ASPHALT	Route Summary				
Roadway Condition Information						
Pavement Condition Rating (PCR)	73	73				
Surface Condition Rating (SCR)	73	73				
Roughness Condition Index (RCI)	N/A	N/A				
Distress Index Values						
Structural Crack Index	N/A	N/A				
Alligator Crack Index	73	73				
Longitudinal Crack Index	90	90				
Transverse Cracking Index	90	90				
Patching Index	97	97				
Rutting Index	90	90				
International Roughness Index (IRI)	N/A	N/A				
Lane & Width Information						
Number of Lanes	1	1				
Paved Width (ft)	12.2	12.2				
Lane Width (ft)	12.2	12.2

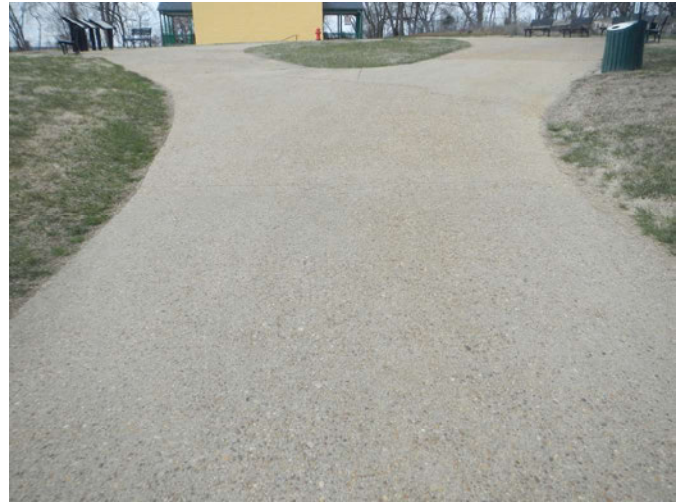
FOWA\_0410\_3230.JPG

Route Condition Legend – Pavement Condition Rating (PCR)							
Poor (0 - 60)		Fair (61- 84)		Good (85 - 94)		Excellent (95 - 100)	
Not Rated							
See Appendix for definitions and formulas							
Inspection Date: 3/14/2018		Beginning Section MP		0.00			
Paved Length (Miles): 0.05		Section Length (MI)		0.05			
Surface Type: CONCRETE		Route Summary					
Roadway Condition Information							
Pavement Condition Rating (PCR)		90		90			
Surface Condition Rating (SCR)		90		90			
Roughness Condition Index (RCI)		N/A		N/A			
Distress Index Values							
Structural Crack Index		N/A		N/A			
Alligator Crack Index		N/A		N/A			
Longitudinal Crack Index		N/A		N/A			
Transverse Cracking Index		N/A		N/A			
Patching Index		N/A		N/A			
Rutting Index		N/A		N/A			
International Roughness Index (IRI)		N/A		N/A			
Lane & Width Information							
Number of Lanes		1		1			
Paved Width (ft)		13.5		13.5			
Lane Width (ft)		13.5		13.5

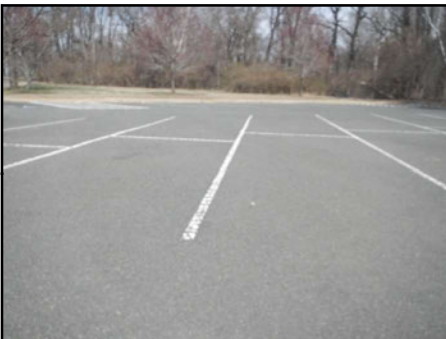
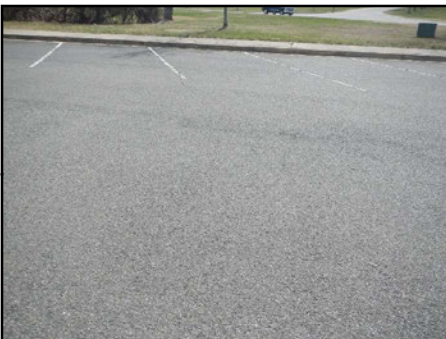
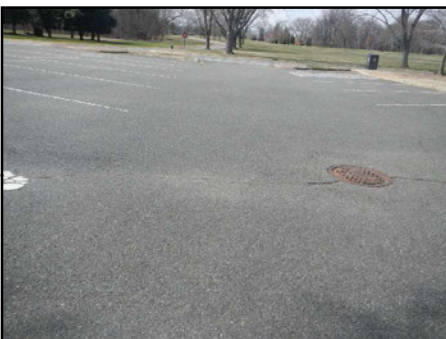
Inspection Date	FMSS Number	User Access	Surface Type
3/14/2018	21449	PUBLIC	ASPHALT
Area (Sq. Ft.)	Lane Miles (11' Widths)	Curb Reveal (Inches)	Curb Recommendation
11,697	0.201	NOT APPLICABLE	LIGHT REPAIR
Curb Type		Curb & Gutter Type	
NO CURB		CONCRETE	
Pavement Recommendation		Condition Rating / PCR	
PREVENTIVE MAINTENANCE		GOOD / 90	
<b>Route Condition Legend – Pavement Condition Rating (PCR)</b>			
<b>Poor (0 - 60)</b>	<b>Fair (61- 84)</b>	<b>Good (85 - 94)</b>	<b>Excellent (95 - 100)</b>
<b>Not Rated</b>			
See Appendix for definitions and formulas

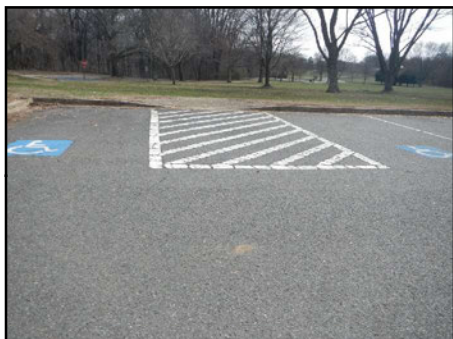
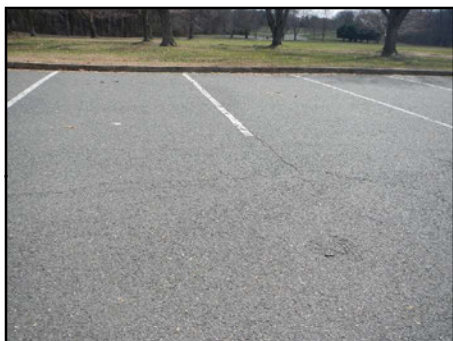
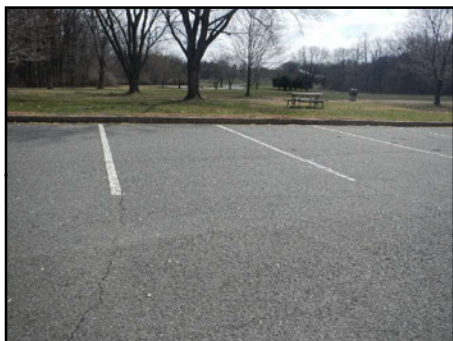
## ROUTE 0902: FOWA PICNIC AREA 2 PARKING

Inspection Date	FMSS Number	User Access	Surface Type	
3/14/2018	52755	PUBLIC	ASPHALT	
Area (Sq. Ft.)	Lane Miles (11' Widths)	Curb Reveal (Inches)	Curb Recommendation	
10,024	0.173	NOT APPLICABLE	DO NOTHING	
Curb Type		Curb & Gutter Type		
NO CURB		CONCRETE		
Pavement Recommendation		Condition Rating / PCR		
PREVENTIVE MAINTENANCE		GOOD / 90		
<b>Route Condition Legend – Pavement Condition Rating (PCR)</b>				
<b>Poor (0 - 60)</b>	<b>Fair (61- 84)</b>	<b>Good (85 - 94)</b>	<b>Excellent (95 - 100)</b>	<b>Not Rated</b>
See Appendix for definitions and formulas

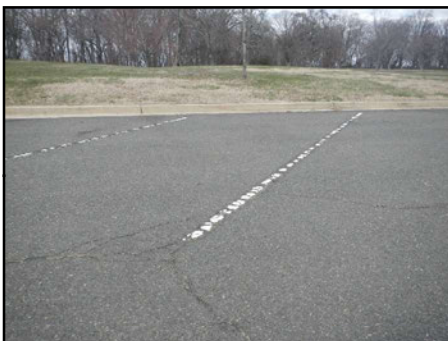
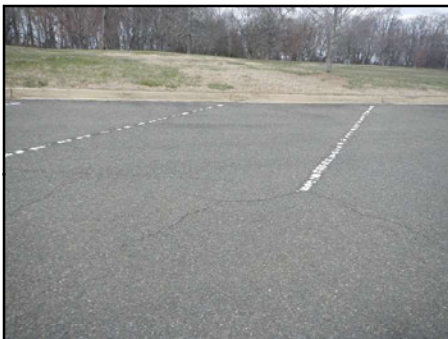
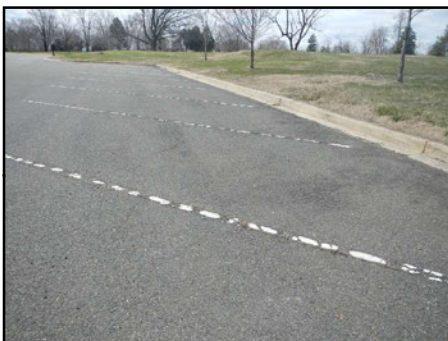
ADJACENT TO ROUTE 0010 (WASHINGTON DRIVE)

Inspection Date	FMSS Number	User Access	Surface Type	
3/14/2018	52754	PUBLIC	ASPHALT	
Area (Sq. Ft.)	Lane Miles (11' Widths)	Curb Reveal (Inches)	Curb Recommendation	
4,076	0.07	NOT APPLICABLE	DO NOTHING	
Curb Type		Curb & Gutter Type		
NO CURB		CONCRETE		
Pavement Recommendation		Condition Rating / PCR		
PREVENTIVE MAINTENANCE		GOOD / 90		
<b>Route Condition Legend – Pavement Condition Rating (PCR)</b>				
<div>Poor (0 - 60)</div>	<div>Fair (61- 84)</div>	<div>Good (85 - 94)</div>	<div>Excellent (95 - 100)</div>	<div>Not Rated</div>
See Appendix for definitions and formulas

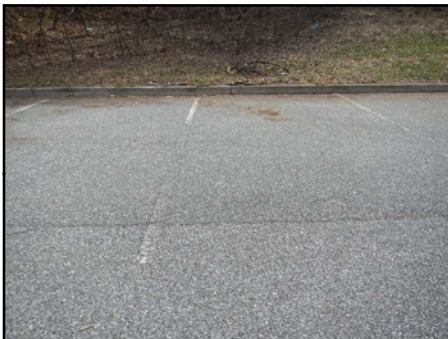
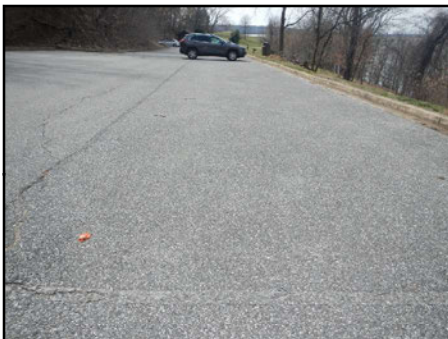
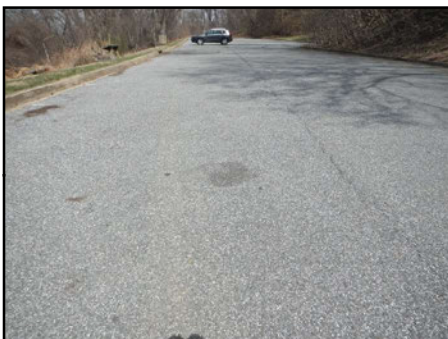
## ROUTE 0905: L'ENFANT ROAD PARKING AREA

Inspection Date	FMSS Number	User Access	Surface Type
3/14/2018	52757	PUBLIC	ASPHALT
Area (Sq. Ft.)	Lane Miles (11' Widths)	Curb Reveal (Inches)	Curb Recommendation
21,258	0.366	NOT APPLICABLE	DO NOTHING
Curb Type		Curb & Gutter Type	
NO CURB		CONCRETE	
Pavement Recommendation		Condition Rating / PCR	
PREVENTIVE MAINTENANCE		GOOD / 90

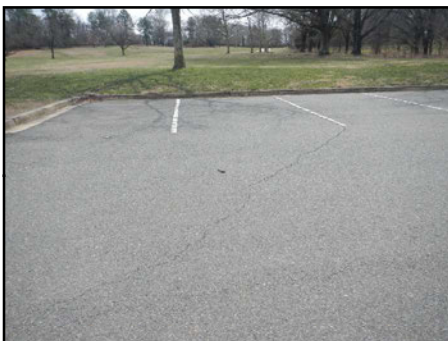
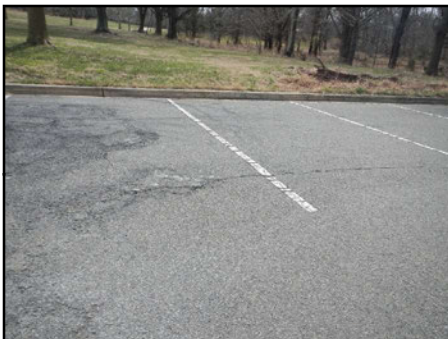
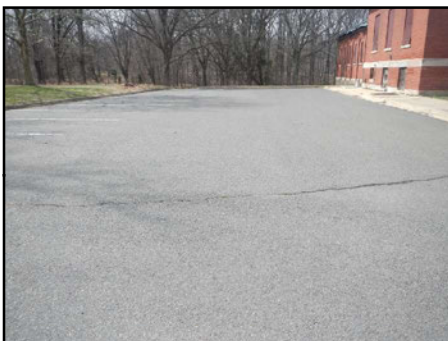
## ROUTE 0906: OLD QUARTERS PARKING

Inspection Date	FMSS Number	User Access	Surface Type	
3/14/2018	21450	PUBLIC	ASPHALT	
Area (Sq. Ft.)	Lane Miles (11' Widths)	Curb Reveal (Inches)	Curb Recommendation	
4,720	0.081	NOT APPLICABLE	DO NOTHING	
Curb Type		Curb & Gutter Type		
NO CURB		CONCRETE		
Pavement Recommendation		Condition Rating / PCR		
PREVENTIVE MAINTENANCE		GOOD / 90		
<b>Route Condition Legend – Pavement Condition Rating (PCR)</b>				
<div>Poor (0 - 60)</div>	<div>Fair (61- 84)</div>	<div>Good (85 - 94)</div>	<div>Excellent (95 - 100)</div>	<div>Not Rated</div>
See Appendix for definitions and formulas

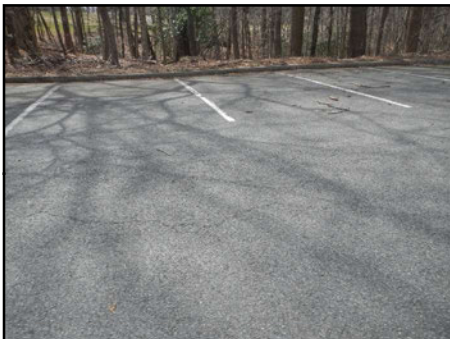
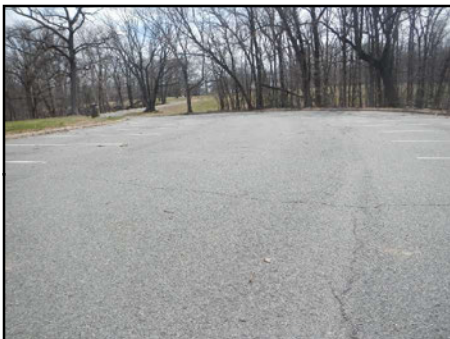
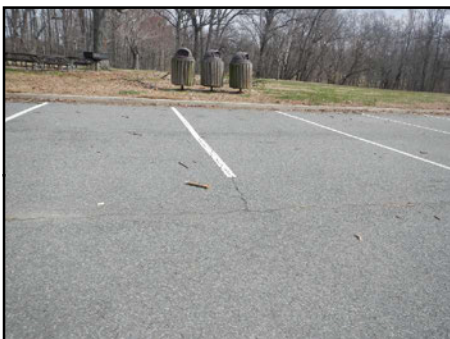
## ROUTE 0907: FOWA PICNIC AREA A PARKING

Inspection Date	FMSS Number	User Access	Surface Type
3/14/2018	21451	PUBLIC	ASPHALT
Area (Sq. Ft.)	Lane Miles (11' Widths)	Curb Reveal (Inches)	Curb Recommendation
20,365	0.351	NOT APPLICABLE	DO NOTHING
Curb Type		Curb & Gutter Type	
NO CURB		CONCRETE	
Pavement Recommendation		Condition Rating / PCR	
PREVENTIVE MAINTENANCE		GOOD / 90	
<b>Route Condition Legend – Pavement Condition Rating (PCR)</b>			
<b>Poor (0 - 60)</b>	<b>Fair (61- 84)</b>	<b>Good (85 - 94)</b>	<b>Excellent (95 - 100)</b>
<b>Not Rated</b>			
See Appendix for definitions and formulas

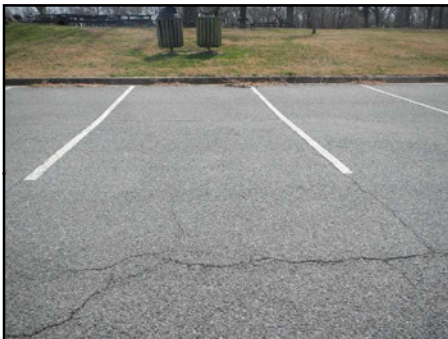
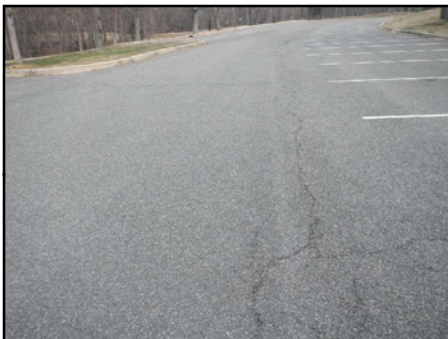
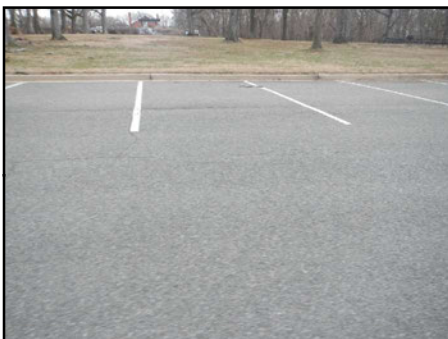
## ROUTE 0908: FOWA PICNIC AREA B PARKING

Inspection Date	FMSS Number	User Access	Surface Type	
3/14/2018	21454	PUBLIC	ASPHALT	
Area (Sq. Ft.)	Lane Miles (11' Widths)	Curb Reveal (Inches)	Curb Recommendation	
46,136	0.794	NOT APPLICABLE	DO NOTHING	
Curb Type		Curb & Gutter Type		
NO CURB		CONCRETE		
Pavement Recommendation		Condition Rating / PCR		
PREVENTIVE MAINTENANCE		GOOD / 90		
<b>Route Condition Legend – Pavement Condition Rating (PCR)</b>				
<b>Poor (0 - 60)</b>	<b>Fair (61- 84)</b>	<b>Good (85 - 94)</b>	<b>Excellent (95 - 100)</b>	<b>Not Rated</b>
See Appendix for definitions and formulas

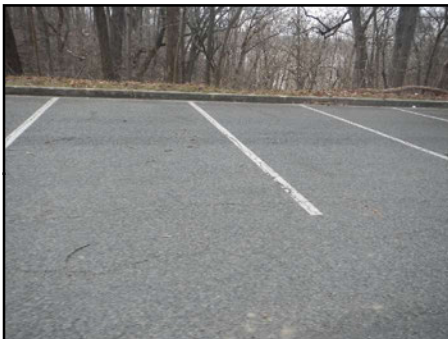
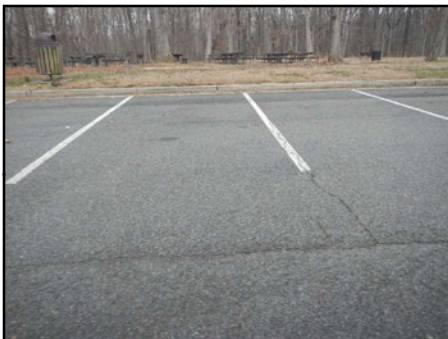
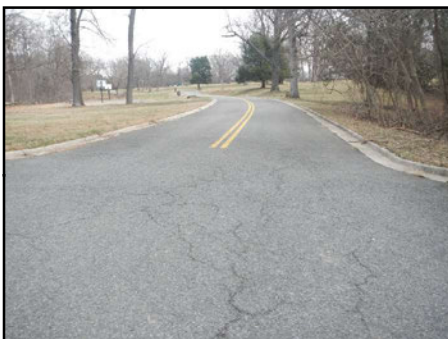
## ROUTE 0909: FOWA PICNIC AREA C PARKING

Inspection Date	FMSS Number	User Access	Surface Type	
3/14/2018	21461	PUBLIC	ASPHALT	
Area (Sq. Ft.)	Lane Miles (11' Widths)	Curb Reveal (Inches)	Curb Recommendation	
19,736	0.34	NOT APPLICABLE	DO NOTHING	
Curb Type		Curb & Gutter Type		
NO CURB		CONCRETE		
Pavement Recommendation		Condition Rating / PCR		
PREVENTIVE MAINTENANCE		GOOD / 90		
<b>Route Condition Legend – Pavement Condition Rating (PCR)</b>				
<div>Poor (0 - 60)</div>	<div>Fair (61- 84)</div>	<div>Good (85 - 94)</div>	<div>Excellent (95 - 100)</div>	<div>Not Rated</div>
See Appendix for definitions and formulas

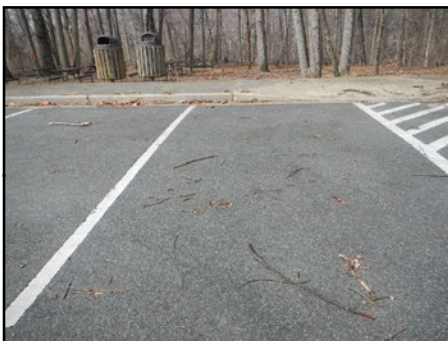
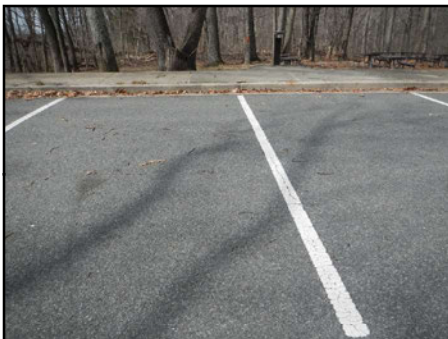
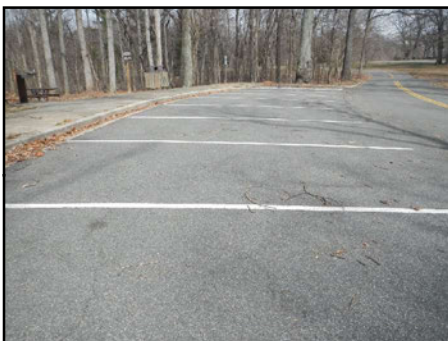
## ROUTE 0910: FOWA PICNIC PARKING D-1

Inspection Date	FMSS Number	User Access	Surface Type	
3/14/2018	21457	PUBLIC	ASPHALT	
Area (Sq. Ft.)	Lane Miles (11' Widths)	Curb Reveal (Inches)	Curb Recommendation	
2,104	0.036	NOT APPLICABLE	DO NOTHING	
Curb Type		Curb & Gutter Type		
NO CURB		CONCRETE		
Pavement Recommendation		Condition Rating / PCR		
PREVENTIVE MAINTENANCE		GOOD / 90		
<b>Route Condition Legend – Pavement Condition Rating (PCR)</b>				
<div>Poor (0 - 60)</div>	<div>Fair (61- 84)</div>	<div>Good (85 - 94)</div>	<div>Excellent (95 - 100)</div>	<div>Not Rated</div>
See Appendix for definitions and formulas

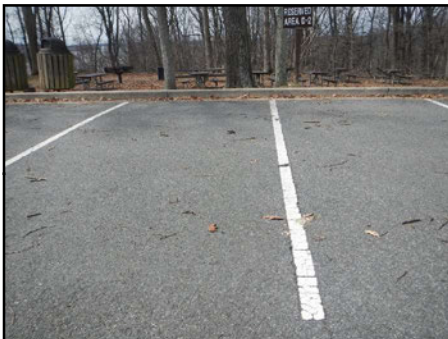
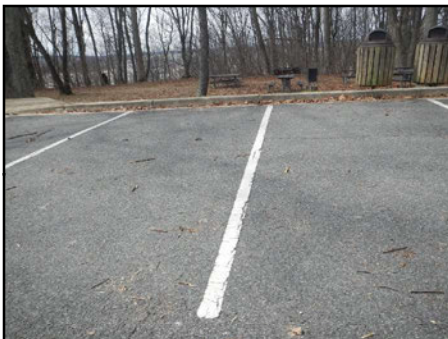
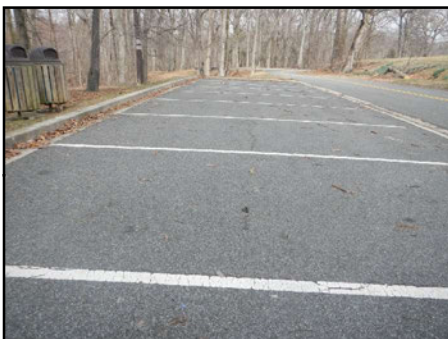
## ROUTE 0911: FOWA PICNIC PARKING D-2

Inspection Date	FMSS Number	User Access	Surface Type
3/14/2018	21459	PUBLIC	ASPHALT
Area (Sq. Ft.)	Lane Miles (11' Widths)	Curb Reveal (Inches)	Curb Recommendation
2,127	0.037	NOT APPLICABLE	DO NOTHING
Curb Type		Curb & Gutter Type	
NO CURB		CONCRETE	
Pavement Recommendation		Condition Rating / PCR	
PREVENTIVE MAINTENANCE		GOOD / 90	
<b>Route Condition Legend – Pavement Condition Rating (PCR)</b>			
<b>Poor (0 - 60)</b>	<b>Fair (61- 84)</b>	<b>Good (85 - 94)</b>	<b>Excellent (95 - 100)</b>
<b>Not Rated</b>			
See Appendix for definitions and formulas

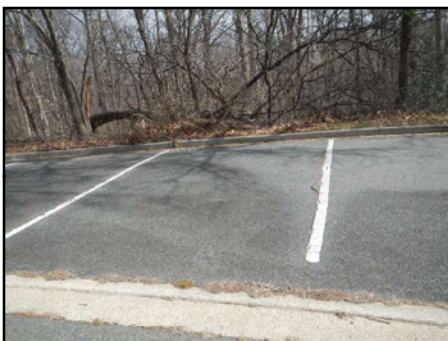
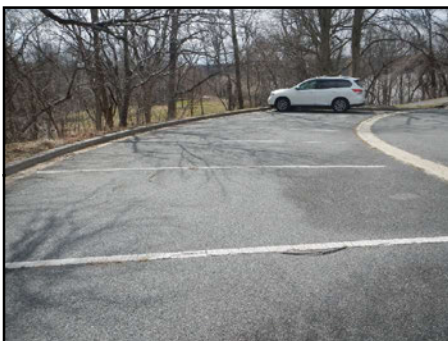
## ROUTE 0912: FOWA PICNIC PARKING D-3

Inspection Date	FMSS Number	User Access	Surface Type	
3/14/2018	21473	PUBLIC	ASPHALT	
Area (Sq. Ft.)	Lane Miles (11' Widths)	Curb Reveal (Inches)	Curb Recommendation	
2,129	0.037	NOT APPLICABLE	DO NOTHING	
Curb Type		Curb & Gutter Type		
NO CURB		CONCRETE		
Pavement Recommendation		Condition Rating / PCR		
PREVENTIVE MAINTENANCE		GOOD / 90		
<b>Route Condition Legend – Pavement Condition Rating (PCR)</b>				
<div>Poor (0 - 60)</div>	<div>Fair (61- 84)</div>	<div>Good (85 - 94)</div>	<div>Excellent (95 - 100)</div>	<div>Not Rated</div>
See Appendix for definitions and formulas

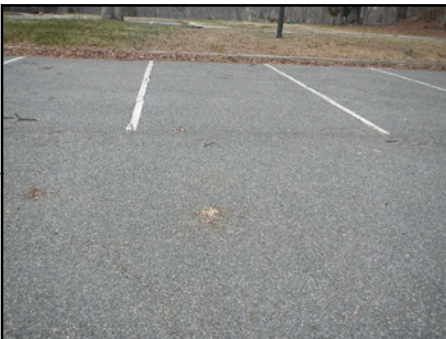
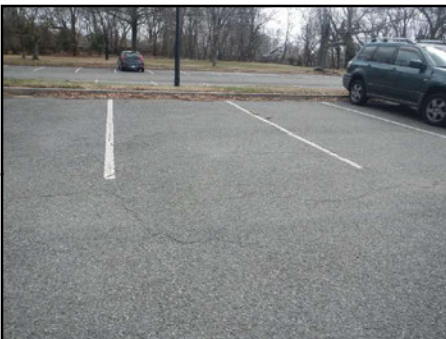
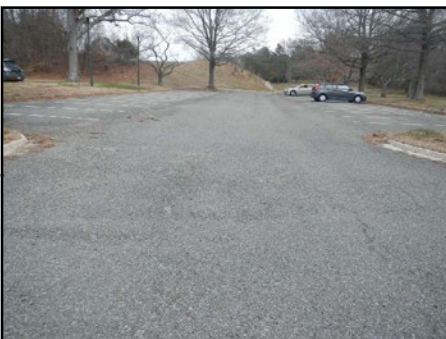
## ROUTE 0913: MAINTENANCE / PARK POLICE PARKING

Inspection Date	FMSS Number	User Access	Surface Type
3/14/2018	21445	PUBLIC	ASPHALT
Area (Sq. Ft.)	Lane Miles (11' Widths)	Curb Reveal (Inches)	Curb Recommendation
22,492	0.387	NOT APPLICABLE	LIGHT REPAIR
Curb Type		Curb & Gutter Type	
NO CURB		CONCRETE	
Pavement Recommendation		Condition Rating / PCR	
PREVENTIVE MAINTENANCE		GOOD / 90	
<b>Route Condition Legend – Pavement Condition Rating (PCR)</b>			
<b>Poor (0 - 60)</b>	<b>Fair (61- 84)</b>	<b>Good (85 - 94)</b>	<b>Excellent (95 - 100)</b>
<b>Not Rated</b>			
See Appendix for definitions and formulas
