FRHI Cycle 6

Final Report

Road Inventory and Condition Assessment of Paved Routes Friendship Hill National Historic Site

Report Date: August 2021

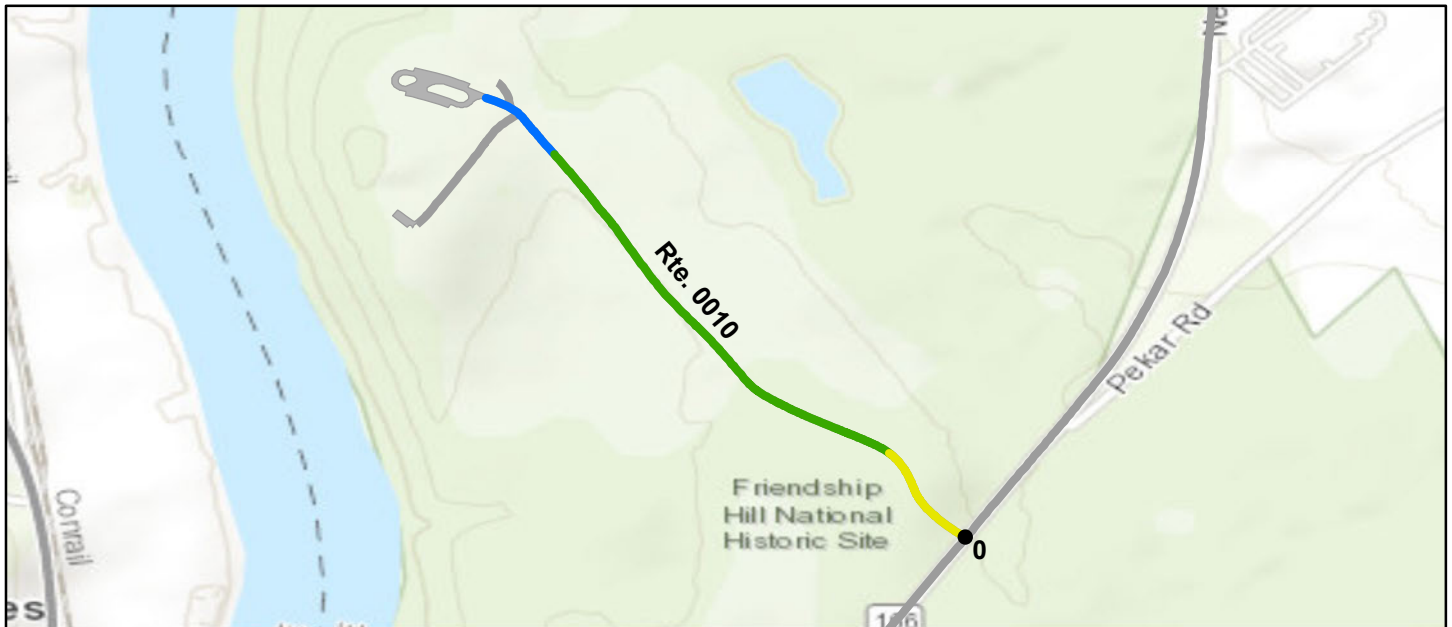
ROUTE 0010: ENTRANCE ROAD

Inspection Date:	11/5/2020	Beginning Section MP	0				
Paved Length (Miles):	0.58	Section Length (MI)	0.58				
Surface Type:	ASPHALT	Route Summary					
Roadway Condition Information							
Pavement Condition Rating (PCR)	88	88					
Surface Condition Rating (SCR)	95	95					
Roughness Condition Index (RCI)	77	77					
Distress Index Values							
Structural Crack Index	95	95					
Alligator Crack Index	100	100					
Longitudinal Crack Index	95	95					
Transverse Cracking Index	100	100					
Patching Index	100	100					
Rutting Index	99	99					
International Roughness Index (IRI)	177	177					
Lane & Width Information							
Number of Lanes	2	2					
Paved Width (ft)	18.5	18.5					
Lane Width (ft)	9.2	9.2

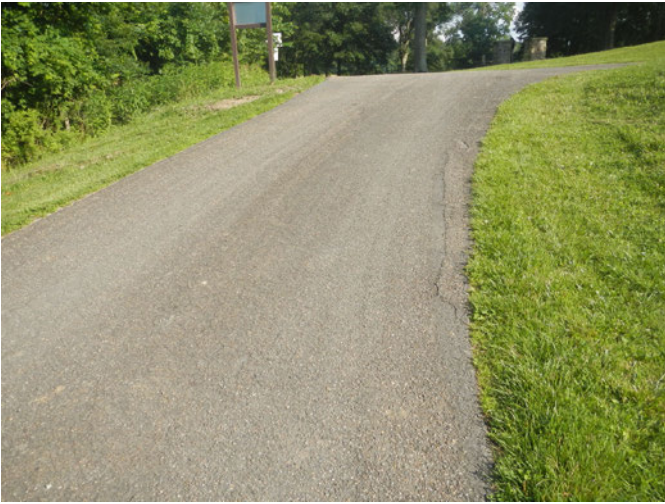
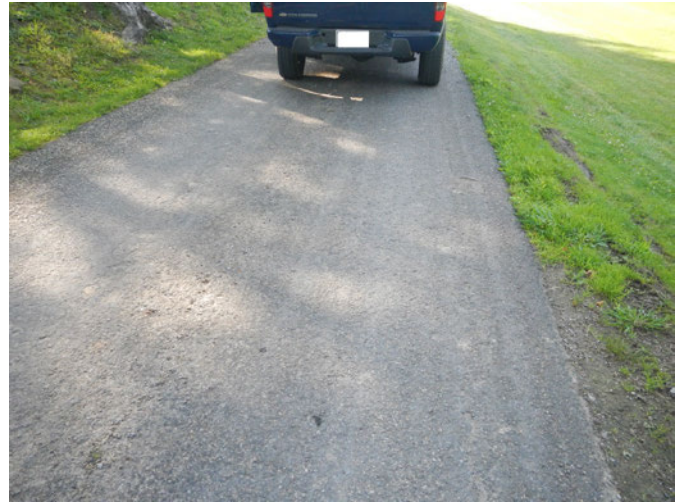
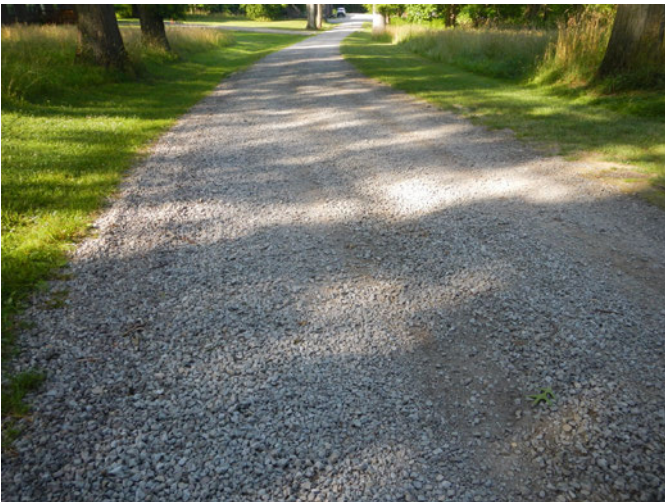
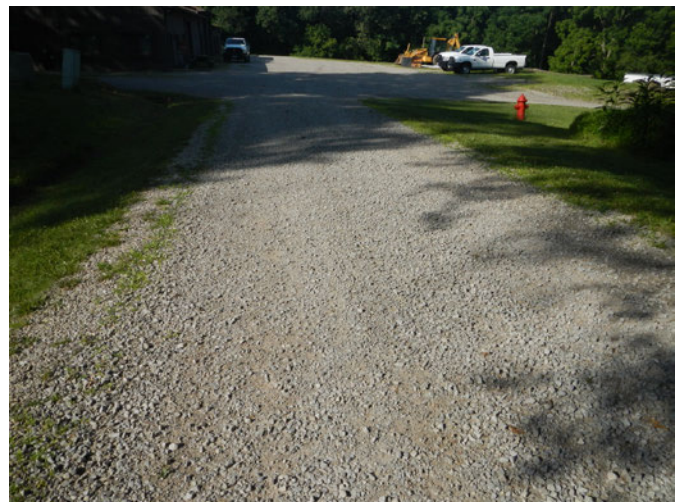
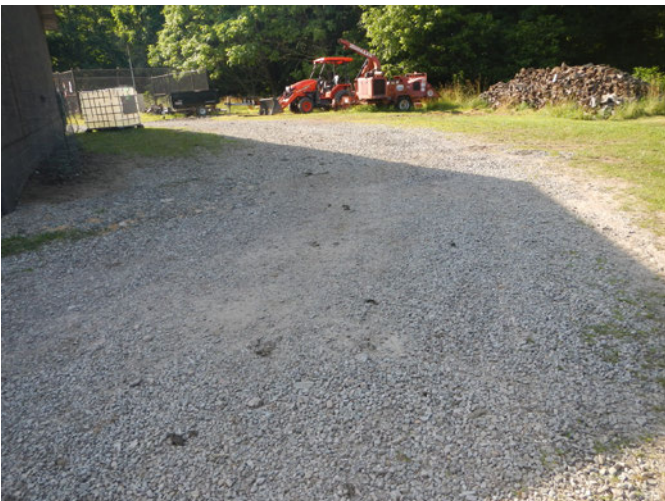
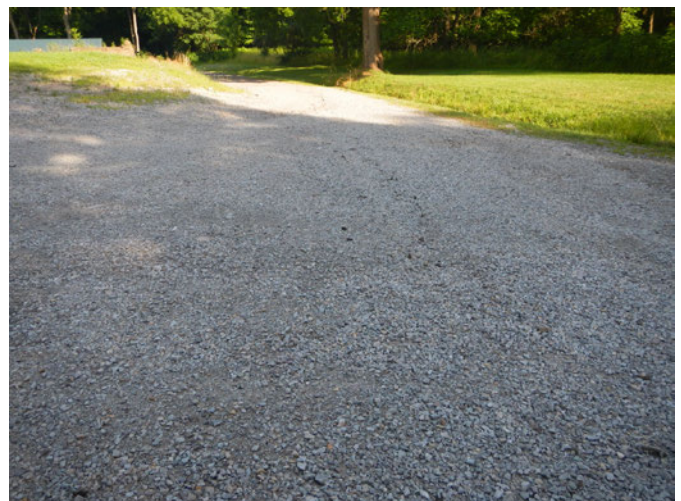
ROUTE 0401AZ: MAINTENANCE ACCESS ROAD AS

Subcomponent of Route FRHI-0401ZZ
Manual Rating

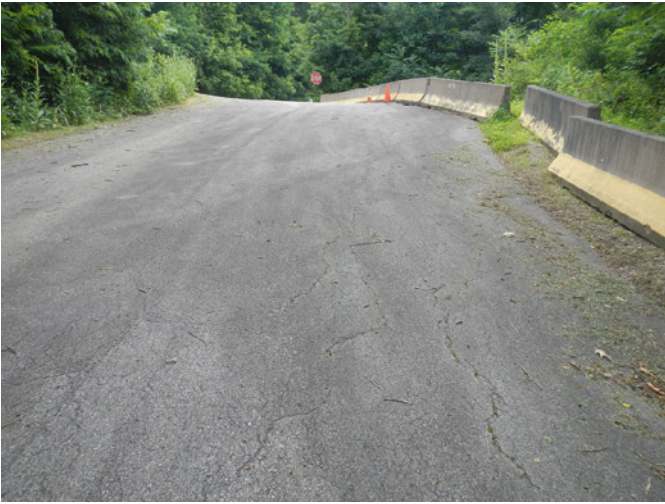
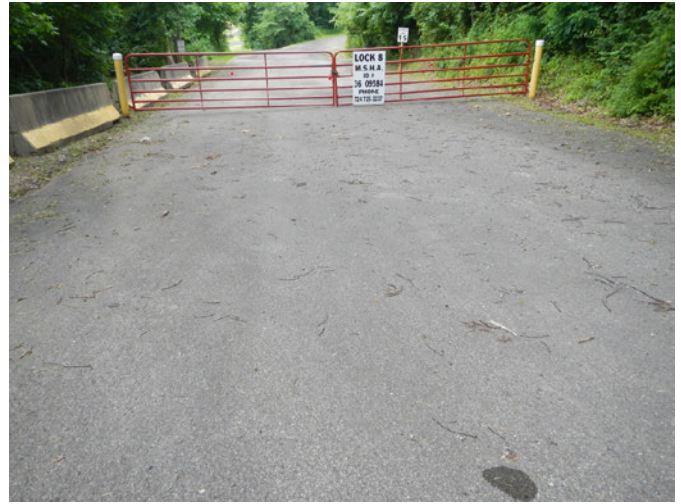
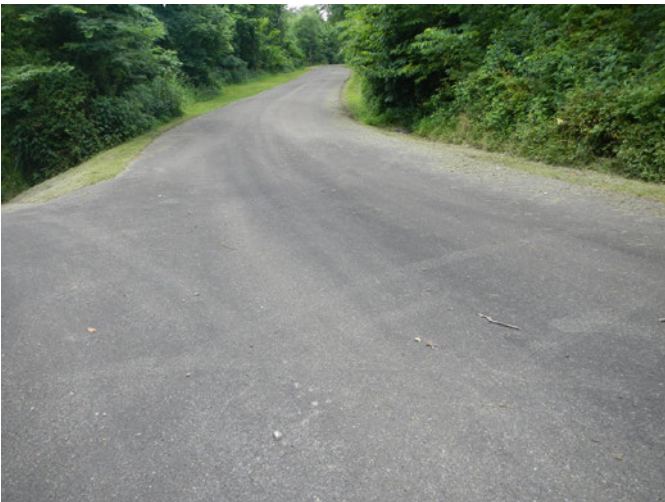
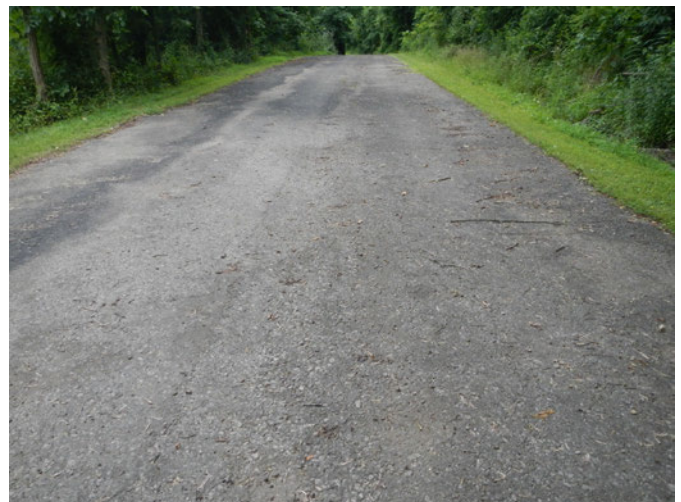
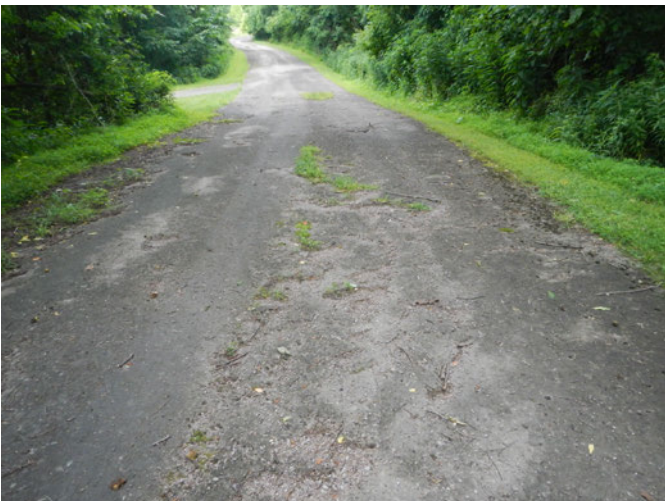
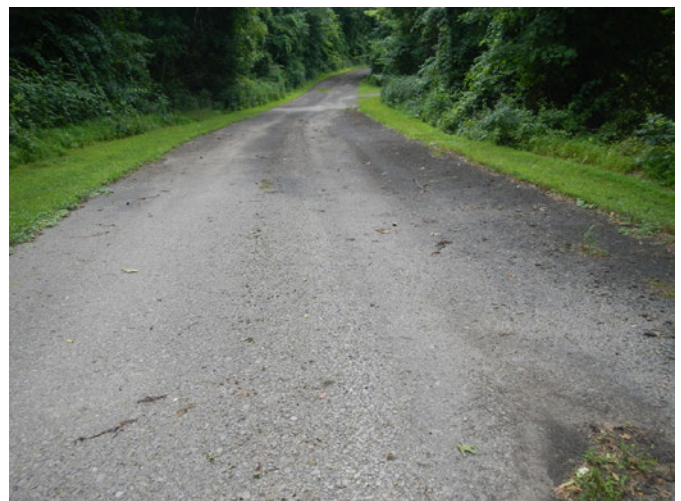
ROUTE 0404: COAL YARD ACCESS ROAD

Inspection Date: 6/26/2019	Beginning Section MP	0.00				
Paved Length (Miles): 0.24	Section Length (MI)	0.24				
Surface Type: ASPHALT	Route Summary					
Roadway Condition Information						
Pavement Condition Rating (PCR)	53	53				
Surface Condition Rating (SCR)	53	53				
Roughness Condition Index (RCI)	N/A	N/A				
Distress Index Values						
Structural Crack Index	N/A	N/A				
Alligator Crack Index	73	73				
Longitudinal Crack Index	97	97				
Transverse Cracking Index	90	90				
Patching Index	97	97				
Rutting Index	53	53				
International Roughness Index (IRI)	N/A	N/A				
Lane & Width Information						
Number of Lanes	2	2				
Paved Width (ft)	26	26				
Lane Width (ft)	13	13

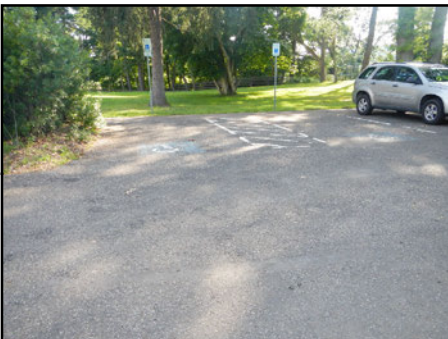
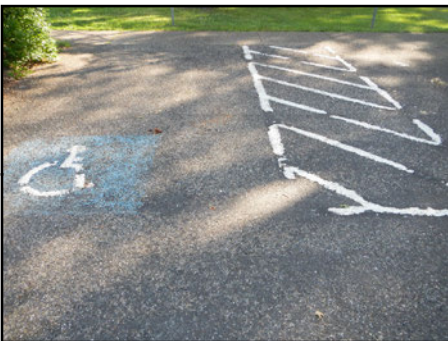
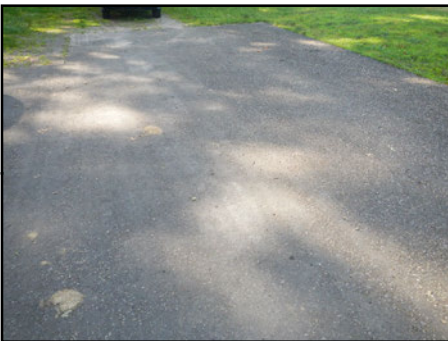
ROUTE 0904: HANDICAPPED PARKING

Inspection Date	FMSS Number	User Access	Surface Type
6/26/2019	102756	PUBLIC	ASPHALT
Area (Sq. Ft.)	Lane Miles (11' Widths)	Curb Reveal (Inches)	Curb Recommendation
3,737	0.064	NOT APPLICABLE	NOT APPLICABLE
Curb Type		Curb & Gutter Type	
NO CURB		NO CURB AND GUTTER	
Pavement Recommendation		Condition Rating / PCR	
LIGHT 3R TREATMENTS		FAIR / 73
