GEWA Cycle 6

Final Report

Road Inventory and Condition Assessment of Paved Routes George Washington Birthplace National Monument

Report Date: October 2021

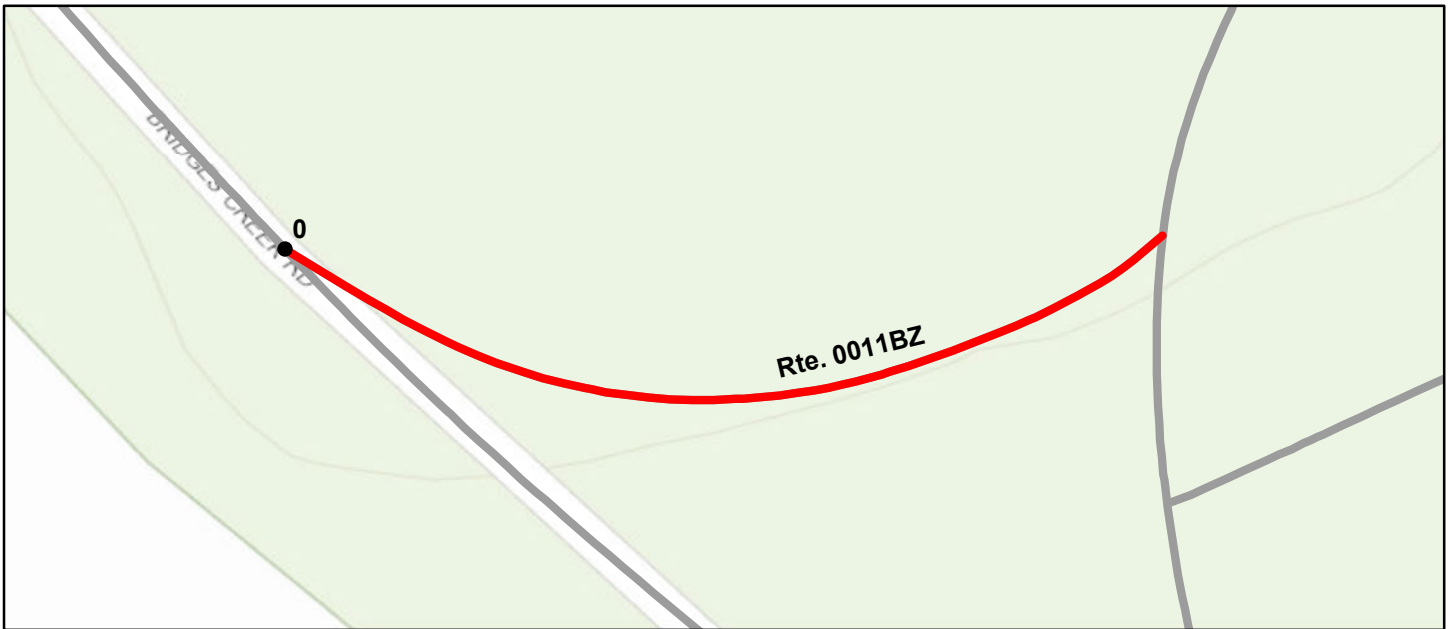
Subcomponent of Route GEWA-0011ZZ

Inspection Date:	12/11/2020	Beginning Section MP	0				
Paved Length (Miles):	0.06	Section Length (MI)	0.06				
Surface Type:	ASPHALT	Route Summary					
Roadway Condition Information							
Pavement Condition Rating (PCR)	30	30					
Surface Condition Rating (SCR)	30	30					
Roughness Condition Index (RCI)	N/A	N/A					
Distress Index Values							
Structural Crack Index	30	30					
Alligator Crack Index	100	100					
Longitudinal Crack Index	30	30					
Transverse Cracking Index	38	38					
Patching Index	100	100					
Rutting Index	94	94					
International Roughness Index (IRI)	N/A	N/A					
Lane & Width Information							
Number of Lanes	1	1					
Paved Width (ft)	16.8	16.8					
Lane Width (ft)	16.8	16.8

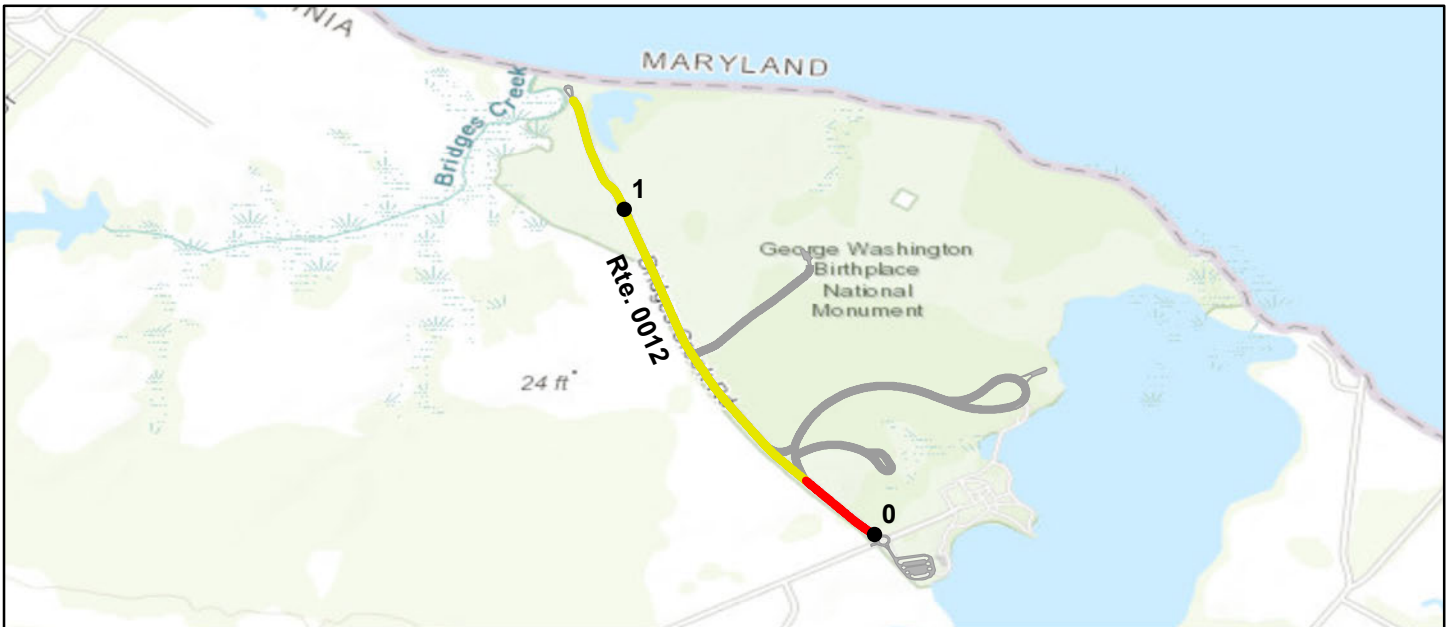
ROUTE 0012: BRIDGES CREEK ROAD

Inspection Date:	12/11/2020	Beginning Section MP	0	1			
Paved Length (Miles):	1.31	Section Length (MI)	1	0.31			
Surface Type:	ASPHALT	Route Summary					
Roadway Condition Information							
Pavement Condition Rating (PCR)	69	69	68				
Surface Condition Rating (SCR)	78	78	76				
Roughness Condition Index (RCI)	56	56	57				
Distress Index Values							
Structural Crack Index	95	96	90				
Alligator Crack Index	100	100	100				
Longitudinal Crack Index	95	96	90				
Transverse Cracking Index	78	78	76				
Patching Index	100	99	100				
Rutting Index	98	98	98				
International Roughness Index (IRI)	256	258	251				
Lane & Width Information							
Number of Lanes	2	2	2				
Paved Width (ft)	17.3	17.3	17.3				
Lane Width (ft)	8.7	8.7	8.7

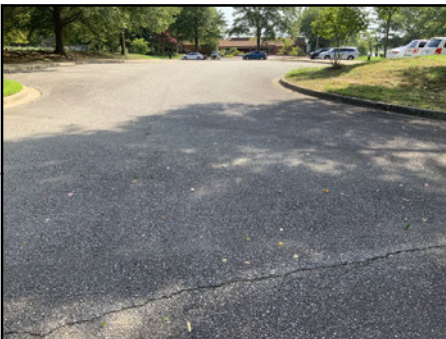
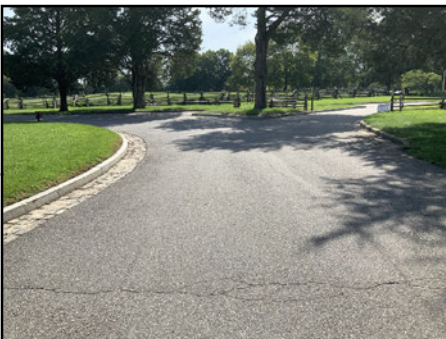
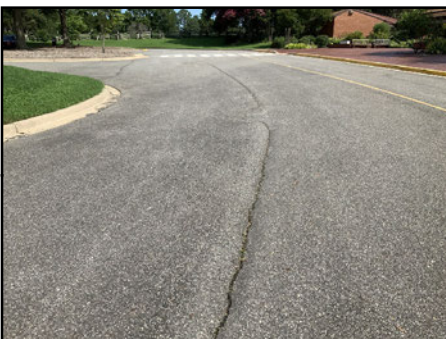
ROUTE 0902: LOG HOUSE PARKING

Inspection Date	FMSS Number	User Access	Surface Type
8/24/2020	104697	PUBLIC	CONCRETE
Area (Sq. Ft.)	Lane Miles (11' Widths)	Curb Reveal (Inches)	Curb Recommendation
3,175	0.055	NOT APPLICABLE	NOT APPLICABLE
Curb Type		Curb & Gutter Type	
NO CURB		NO CURB AND GUTTER	
Pavement Recommendation		Condition Rating / PCR	
LIGHT 3R TREATMENTS		FAIR / 73

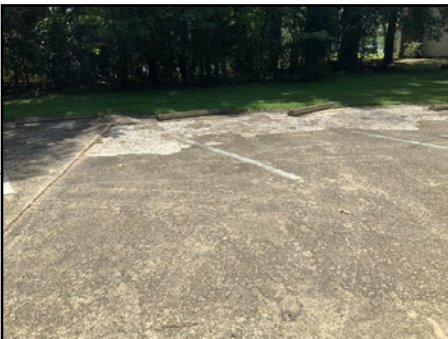
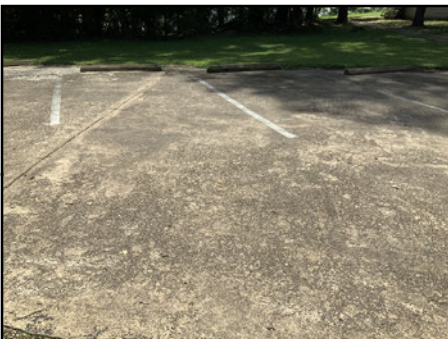
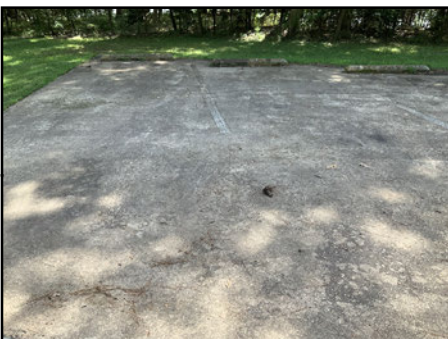
ROUTE 0903: PICNIC AREA PARKING

Inspection Date	FMSS Number	User Access	Surface Type
8/24/2020	104698	PUBLIC	ASPHALT
Area (Sq. Ft.)	Lane Miles (11' Widths)	Curb Reveal (Inches)	Curb Recommendation
16,545	0.285	NOT APPLICABLE	NOT APPLICABLE
Curb Type		Curb & Gutter Type	
NO CURB		NO CURB AND GUTTER	
Pavement Recommendation		Condition Rating / PCR	
HEAVY 3R TREATMENTS		POOR / 53

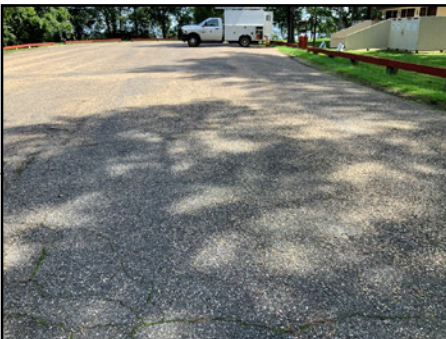
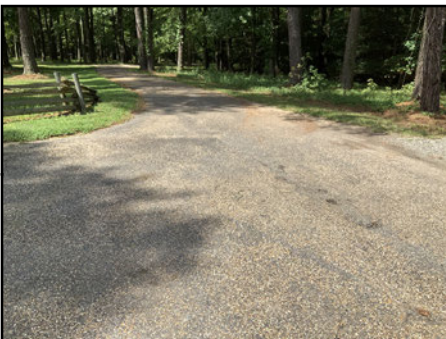
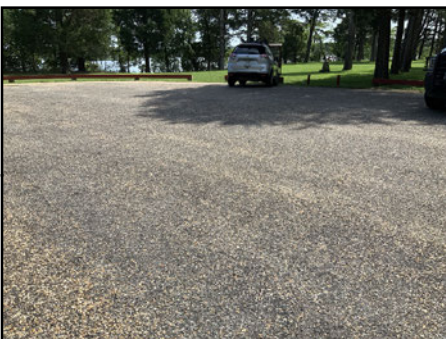
ROUTE 0904: MAINTENANCE AREA

Inspection Date	FMSS Number	User Access	Surface Type
8/24/2020	104700	NONPUBLIC	ASPHALT
Area (Sq. Ft.)	Lane Miles (11' Widths)	Curb Reveal (Inches)	Curb Recommendation
11,796	0.203	NOT APPLICABLE	NOT APPLICABLE
Curb Type		Curb & Gutter Type	
NO CURB		NO CURB AND GUTTER	
Pavement Recommendation		Condition Rating / PCR	
RECONSTRUCTION		POOR / 30

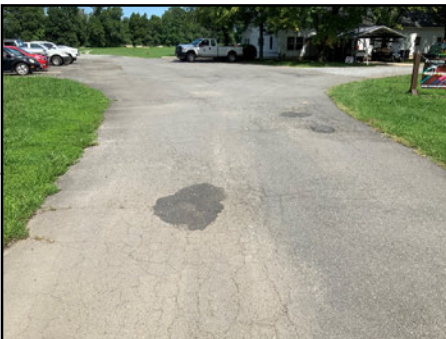
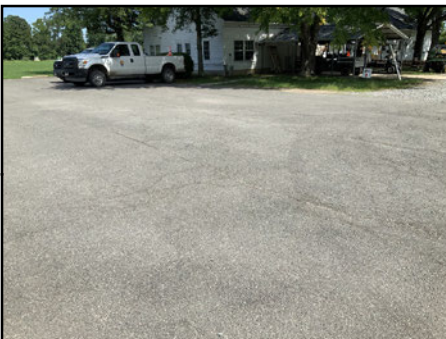
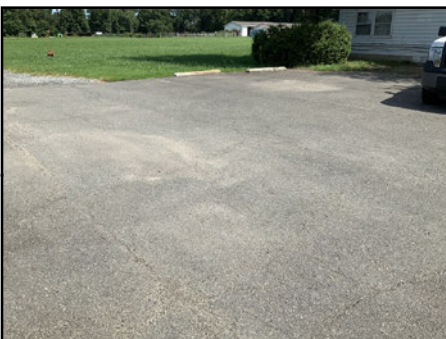
ROUTE 0905: BURIAL GROUND PARKING

Inspection Date	FMSS Number	User Access	Surface Type
8/24/2020	104705	PUBLIC	ASPHALT
Area (Sq. Ft.)	Lane Miles (11' Widths)	Curb Reveal (Inches)	Curb Recommendation
7,120	0.123	NOT APPLICABLE	NOT APPLICABLE
Curb Type		Curb & Gutter Type	
NO CURB		NO CURB AND GUTTER	
Pavement Recommendation		Condition Rating / PCR	
PREVENTIVE MAINTENANCE		GOOD / 90

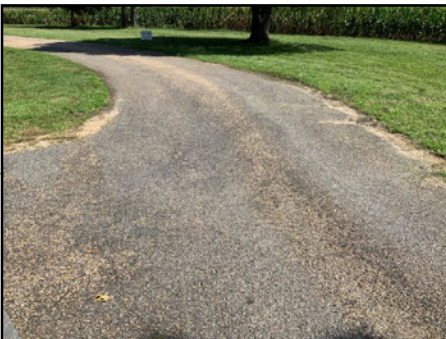
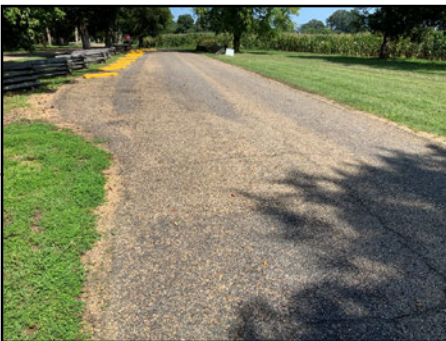
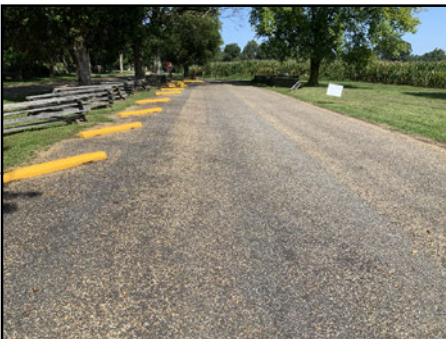
ROUTE 0906: BEACH PARKING

Inspection Date	FMSS Number	User Access	Surface Type
8/24/2020	104701	PUBLIC	ASPHALT
Area (Sq. Ft.)	Lane Miles (11' Widths)	Curb Reveal (Inches)	Curb Recommendation
8,126	0.14	NOT APPLICABLE	NOT APPLICABLE
Curb Type		Curb & Gutter Type	
NO CURB		NO CURB AND GUTTER	
Pavement Recommendation		Condition Rating / PCR	
HEAVY 3R TREATMENTS		POOR / 53
