Final Report

Road Inventory and Condition Assessment of Paved Routes Gila Cliff Dwellings National Monument

**Federal Highway Administration
Eastern Federal Lands Highway Division
Road Inventory Program (RIP)**

Report Date: May 2017

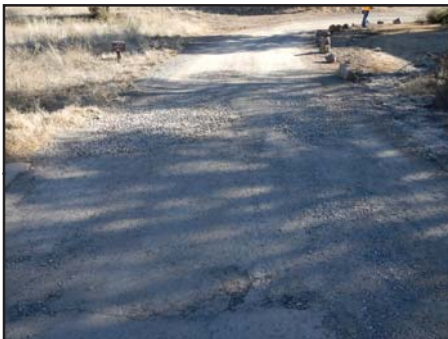
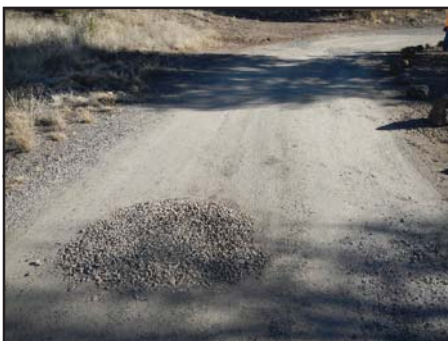
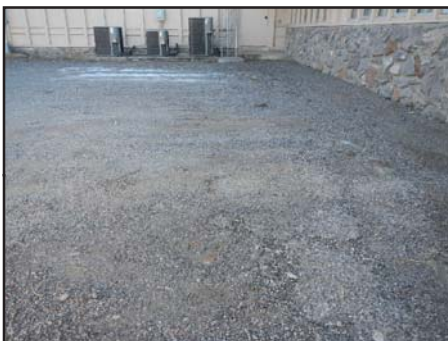
ROUTE 0901: ADMINISTRATIVE PARKING

Inspection Date	FMSS Number	User Access	Surface Type
1/22/2016	91739	NONPUBLIC	ASPHALT
Area (Sq. Ft.)	Lane Miles (11' Widths)	Curb Reveal (Inches)	Curb Recommendation
3,191	0.055	NOT APPLICABLE	NOT APPLICABLE
Curb Type		Curb & Gutter Type	
NO CURB		NO CURB AND GUTTER	
Pavement Recommendation		Condition Rating / PCR	
RECONSTRUCTION		POOR / 0

Note: This paved parking has deteriorated to an unpaved state. Only traces of asphalt were visible.

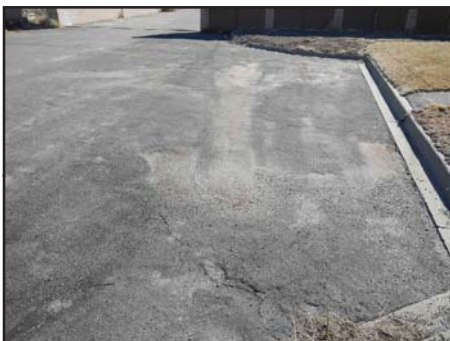
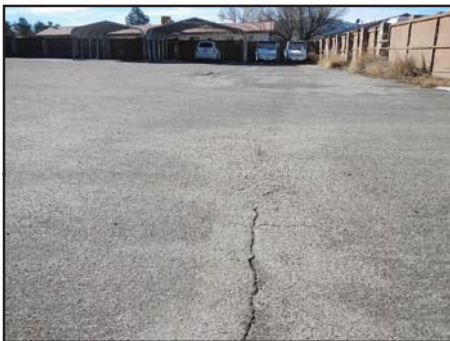
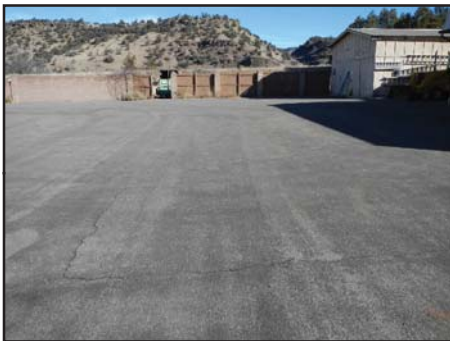
ROUTE 0903: MAINTENANCE AREA PARKING

Inspection Date	FMSS Number	User Access	Surface Type
1/22/2016	91740	NONPUBLIC	ASPHALT
Area (Sq. Ft.)	Lane Miles (11' Widths)	Curb Reveal (Inches)	Curb Recommendation
16,724	0.288	NOT APPLICABLE	DO NOTHING
Curb Type		Curb & Gutter Type	
NO CURB		CONCRETE	
Pavement Recommendation		Condition Rating / PCR	
LIGHT 3R TREATMENTS		FAIR / 73

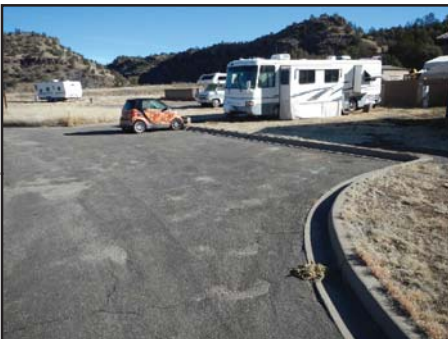
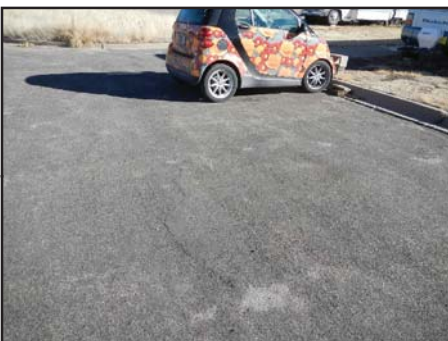
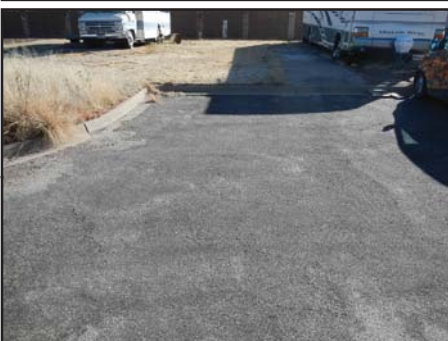
ROUTE 0904A: RESIDENCE PARKING A

Inspection Date	FMSS Number	User Access	Surface Type
1/22/2016	91741	NONPUBLIC	ASPHALT
Area (Sq. Ft.)	Lane Miles (11' Widths)	Curb Reveal (Inches)	Curb Recommendation
1,642	0.028	NOT APPLICABLE	DO NOTHING
Curb Type		Curb & Gutter Type	
NO CURB		CONCRETE	
Pavement Recommendation		Condition Rating / PCR	
LIGHT 3R TREATMENTS		FAIR / 73

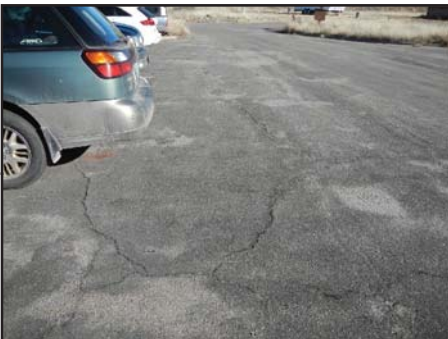
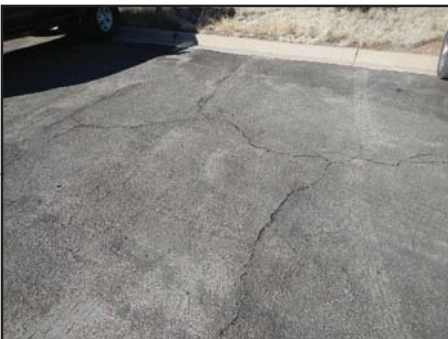
ROUTE 0904B: RESIDENCE PARKING B

Inspection Date	FMSS Number	User Access	Surface Type
1/22/2016	104988	NONPUBLIC	ASPHALT
Area (Sq. Ft.)	Lane Miles (11' Widths)	Curb Reveal (Inches)	Curb Recommendation
1,569	0.027	NOT APPLICABLE	DO NOTHING
Curb Type		Curb & Gutter Type	
NO CURB		CONCRETE	
Pavement Recommendation		Condition Rating / PCR	
LIGHT 3R TREATMENTS		FAIR / 73

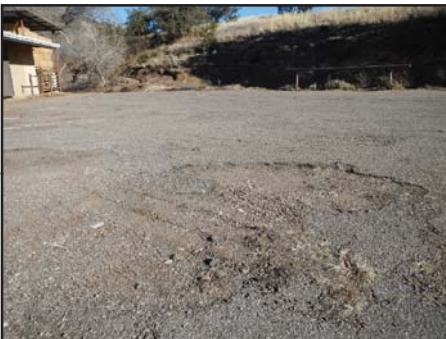
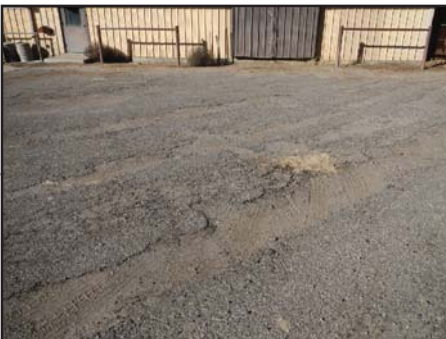
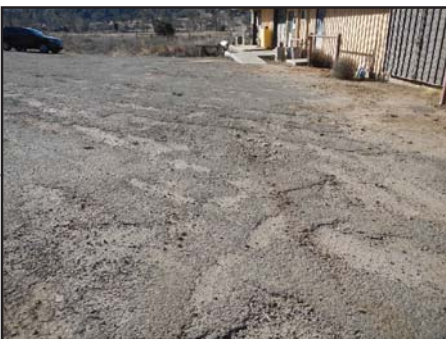
ROUTE 0908: BARN PARKING

Inspection Date	FMSS Number	User Access	Surface Type
1/22/2016	104995	NONPUBLIC	ASPHALT
Area (Sq. Ft.)	Lane Miles (11' Widths)	Curb Reveal (Inches)	Curb Recommendation
5,149	0.089	NOT APPLICABLE	NOT APPLICABLE
Curb Type		Curb & Gutter Type	
NO CURB		NO CURB AND GUTTER	
Pavement Recommendation		Condition Rating / PCR	
RECONSTRUCTION		POOR / 30

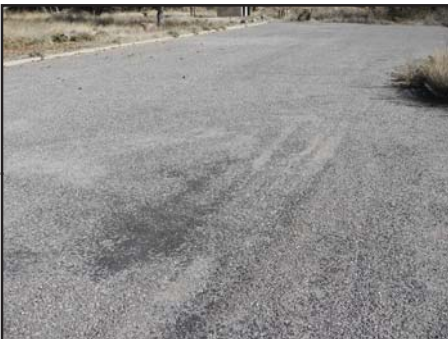
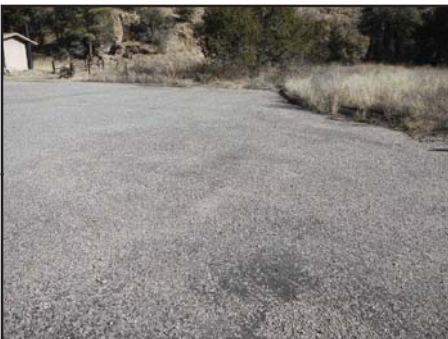
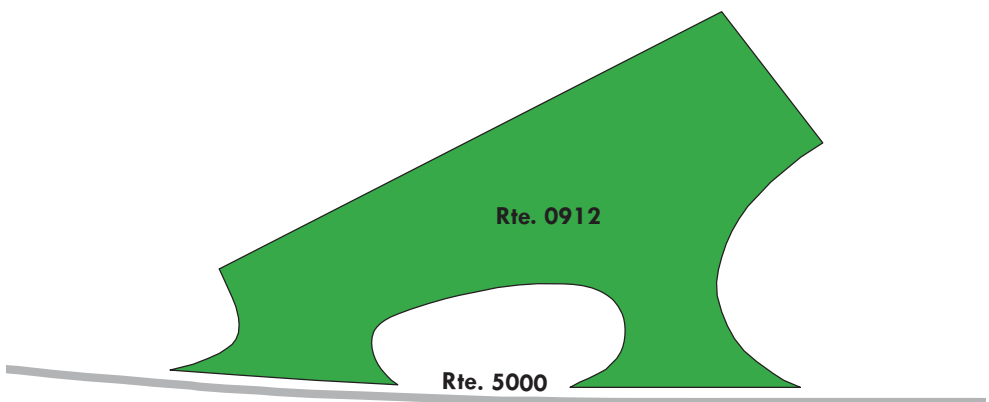
ROUTE 0912: LOWER SCORPION CAMPGROUND PARKING

Inspection Date	FMSS Number	User Access	Surface Type
1/22/2016	105000	PUBLIC	ASPHALT
Area (Sq. Ft.)	Lane Miles (11' Widths)	Curb Reveal (Inches)	Curb Recommendation
10,876	0.187	NOT APPLICABLE	DO NOTHING
Curb Type		Curb & Gutter Type	
NO CURB		CONCRETE	
Pavement Recommendation		Condition Rating / PCR	
PREVENTIVE MAINTENANCE		GOOD / 90

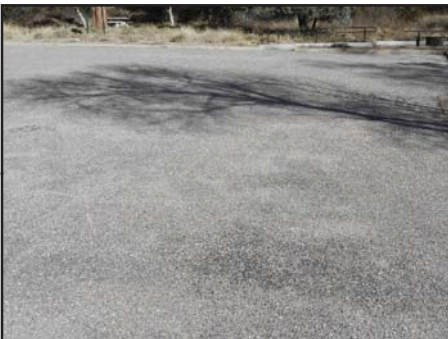
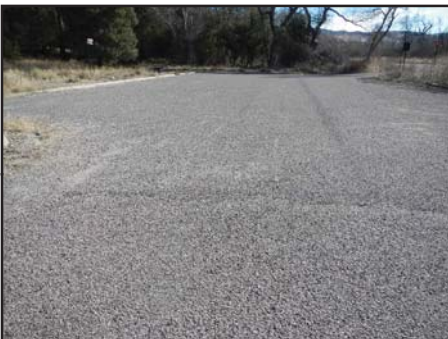
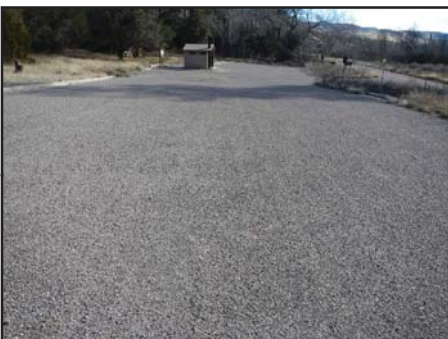
ROUTE 0913: UPPER SCORPION CAMPGROUND PARKING

Inspection Date	FMSS Number	User Access	Surface Type
1/22/2016	105001	PUBLIC	ASPHALT
Area (Sq. Ft.)	Lane Miles (11' Widths)	Curb Reveal (Inches)	Curb Recommendation
17,381	0.299	NOT APPLICABLE	DO NOTHING
Curb Type		Curb & Gutter Type	
NO CURB		CONCRETE	
Pavement Recommendation		Condition Rating / PCR	
PREVENTIVE MAINTENANCE		GOOD / 90

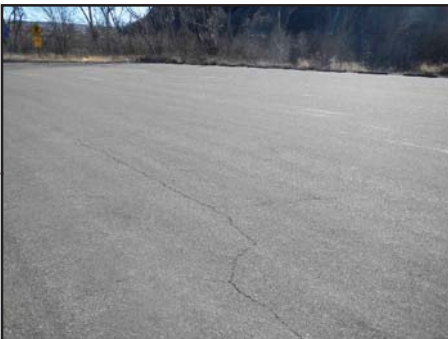
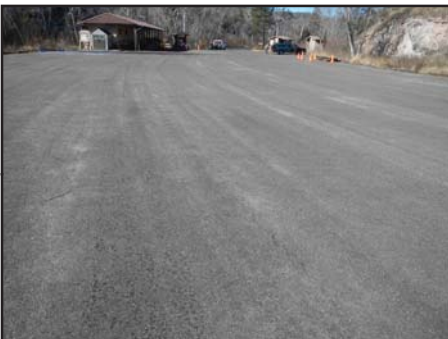
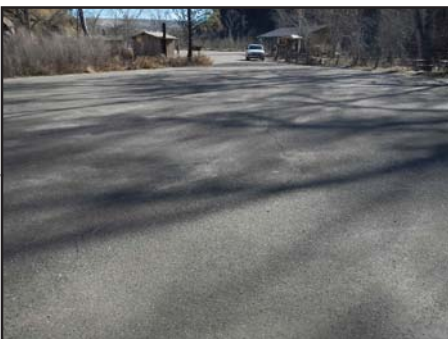
ROUTE 0914: CLIFF DWELLINGS TRAILHEAD PARKING

Inspection Date	FMSS Number	User Access	Surface Type
1/22/2016	91746	PUBLIC	ASPHALT
Area (Sq. Ft.)	Lane Miles (11' Widths)	Curb Reveal (Inches)	Curb Recommendation
36,285	0.625	NOT APPLICABLE	NOT APPLICABLE
Curb Type		Curb & Gutter Type	
NO CURB		NO CURB AND GUTTER	
Pavement Recommendation		Condition Rating / PCR	
PREVENTIVE MAINTENANCE		GOOD / 90
