**GLBA
Cycle 6**

Final Report

**Road Inventory and Condition Assessments for
Glacier Bay National Park & Preserve**

**Federal Highway Administration
Eastern Federal Lands Highway Division
Road Inventory Program (RIP)**

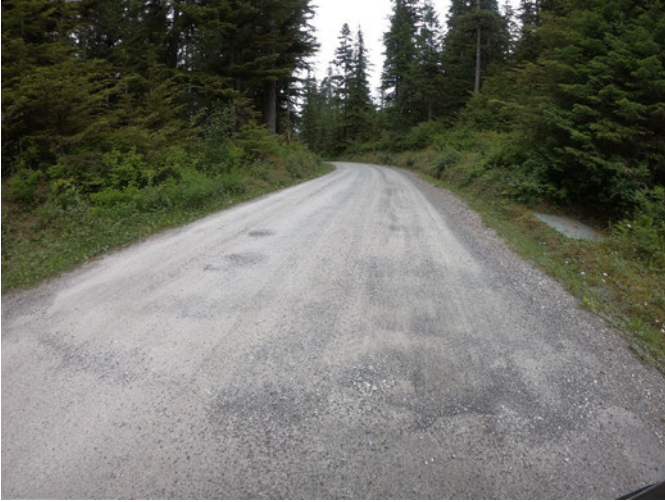
GLBA_0400_0.012

Begin MP	End MP	Section Length	# of Lanes	Lane Width	Road Width	Treatment Recommendation	Treatment Cost	Unpaved Rating (Paser +)	Crown Severity	Drainage Severity	Rutting, Washboard Severity	Potholes / Loose Aggregate Severity	
0.00	0.24	0.24	1	12.0	12.0	Light Rehabilitation	\$23,500	3	Low	Med	Med	High	
Route Level Data:			0.24	1	12.0	12.00	Light Rehabilitation	\$23,500	3	Low	Med	Med	High

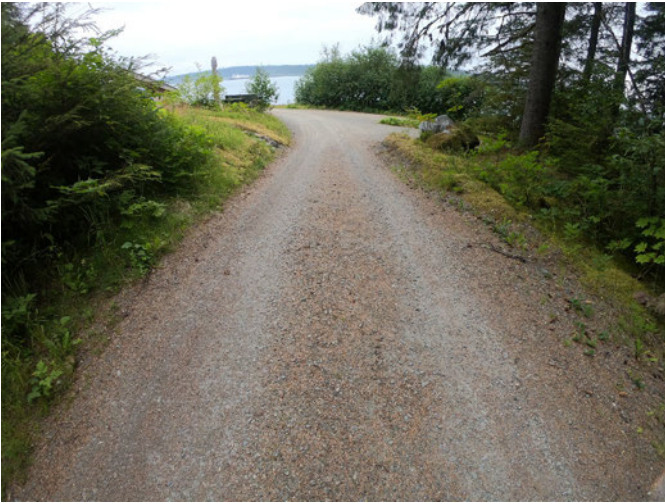
GLBA_0403_0.004

Begin MP	End MP	Section Length	# of Lanes	Lane Width	Road Width	Treatment Recommendation	Treatment Cost	Unpaved Rating (Paser +)	Crown Severity	Drainage Severity	Rutting, Washboard Severity	Potholes / Loose Aggregate Severity
0.00	0.27	0.26	1	12.0	12.0	Light Rehabilitation	\$26,500	3	Med	Med	Low	Low
Route Level Data:		0.27	1	12.0	12.00	Light Rehabilitation	\$26,500	3	Med	Med	Low	Low

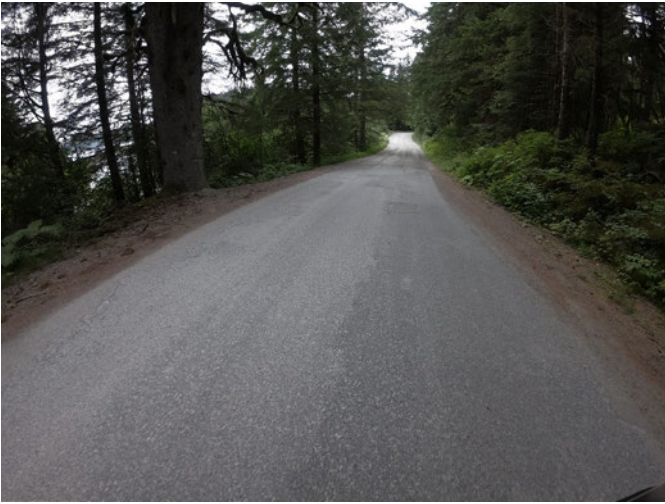
GLBA_0404_0.010

Begin MP	End MP	Section Length	# of Lanes	Lane Width	Road Width	Treatment Recommendation	Treatment Cost	Unpaved Rating (Paser +)	Crown Severity	Drainage Severity	Rutting, Washboard Severity	Potholes / Loose Aggregate Severity
0.00	0.18	0.18	2	8.0	16.0	Light Rehabilitation	\$18,200	3	Med	Med	Med	Low
Route Level Data:		0.18	2	8.0	16.00	Light Rehabilitation	\$18,200	3	Med	Med	Med	Low

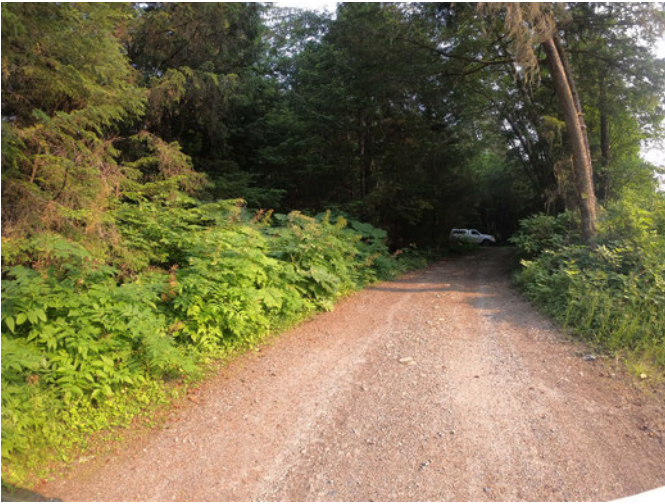
GLBA_0405AZ_0.000

Begin MP	End MP	Section Length	# of Lanes	Lane Width	Road Width	Treatment Recommendation	Treatment Cost	Unpaved Rating (Paser +)	Crown Severity	Drainage Severity	Rutting, Washboard Severity	Potholes / Loose Aggregate Severity
0.00	0.03	0.03	1	12.0	12.0	Routine Maintenance	\$320	4	Med	Low	Med	Med
Route Level Data:		0.03	1	12.0	12.00	Routine Maintenance	\$320	4	Med	Low	Med	Med

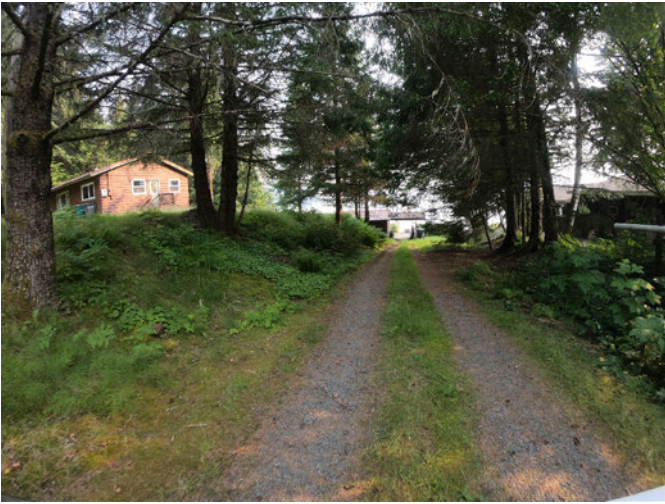
GLBA_0405BZ_0.000

Begin MP	End MP	Section Length	# of Lanes	Lane Width	Road Width	Treatment Recommendation	Treatment Cost	Unpaved Rating (Paser +)	Crown Severity	Drainage Severity	Rutting, Washboard Severity	Potholes / Loose Aggregate Severity	
0.00	0.03	0.03	1	12.0	12.0	Routine Maintenance	\$260	4	Med	Low	Med	Med	
Route Level Data:			0.03	1	12.0	12.00	Routine Maintenance	\$260	4	Med	Low	Med	Med

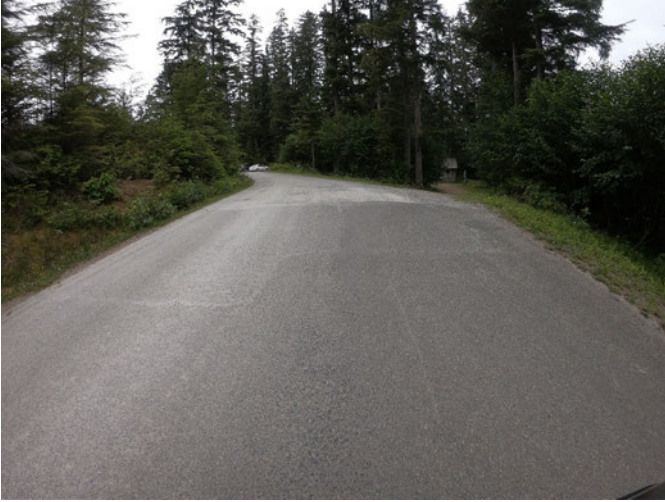
GLBA_0406_0.017

Begin MP	End MP	Section Length	# of Lanes	Lane Width	Road Width	Treatment Recommendation	Treatment Cost	Unpaved Rating (Paser +)	Crown Severity	Drainage Severity	Rutting, Washboard Severity	Potholes / Loose Aggregate Severity
0.00	0.15	0.15	2	7.5	15.0	Heavy Rehabilitation	\$24,000	2	Med	High	Low	Med
Route Level Data:		0.15	2	7.5	15.00	Heavy Rehabilitation	\$24,000	2	Med	High	Low	Med

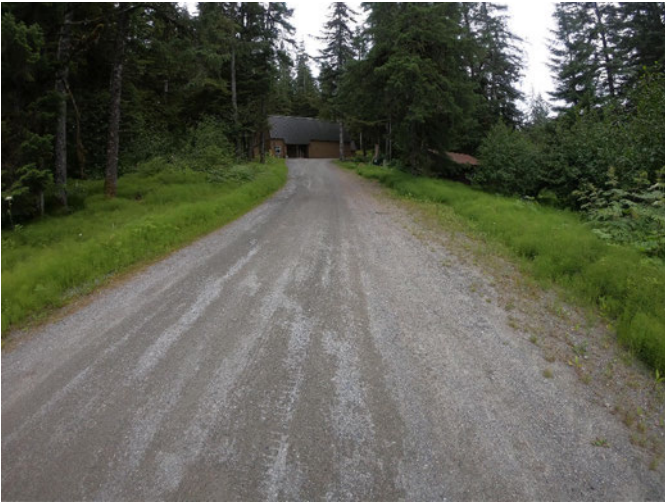
GLBA_0407_0.012

Begin MP	End MP	Section Length	# of Lanes	Lane Width	Road Width	Treatment Recommendation	Treatment Cost	Unpaved Rating (Paser +)	Crown Severity	Drainage Severity	Rutting, Washboard Severity	Potholes / Loose Aggregate Severity
0.00	0.05	0.05	2	10.0	20.0	Heavy Rehabilitation	\$7,360	2	Med	High	High	Med
Route Level Data:		0.05	2	10.0	20.00	Heavy Rehabilitation	\$7,360	2	Med	High	High	Med

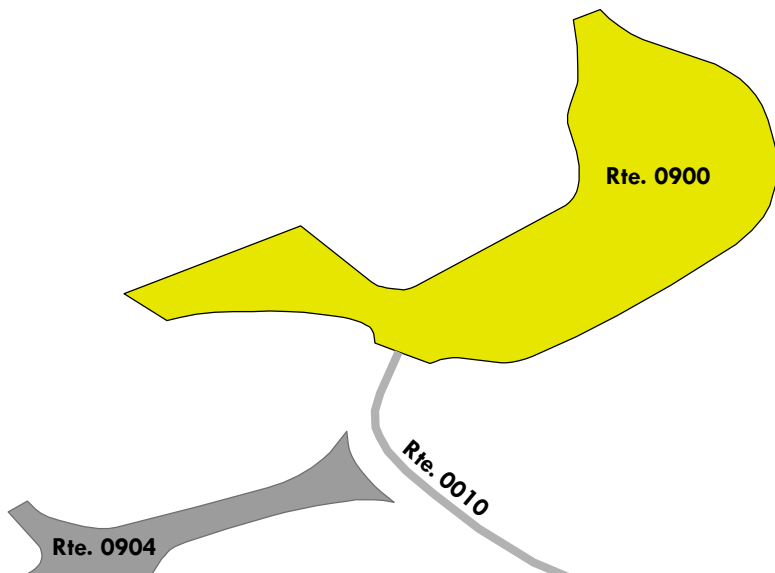
Inspection Date	FMSS Number	User Access	Surface Type
7/13/2019	74091	PUBLIC	ASPHALT
Area (Sq. Ft.)	Lane Miles (11' Widths)	Curb Reveal (Inches)	Curb Recommendation
32,941	0.567	NOT APPLICABLE	NOT APPLICABLE
Curb Type		Curb & Gutter Type	
NO CURB		NO CURB AND GUTTER	
Pavement Recommendation		Condition Rating / PCR	
LIGHT 3R TREATMENTS		FAIR / 73

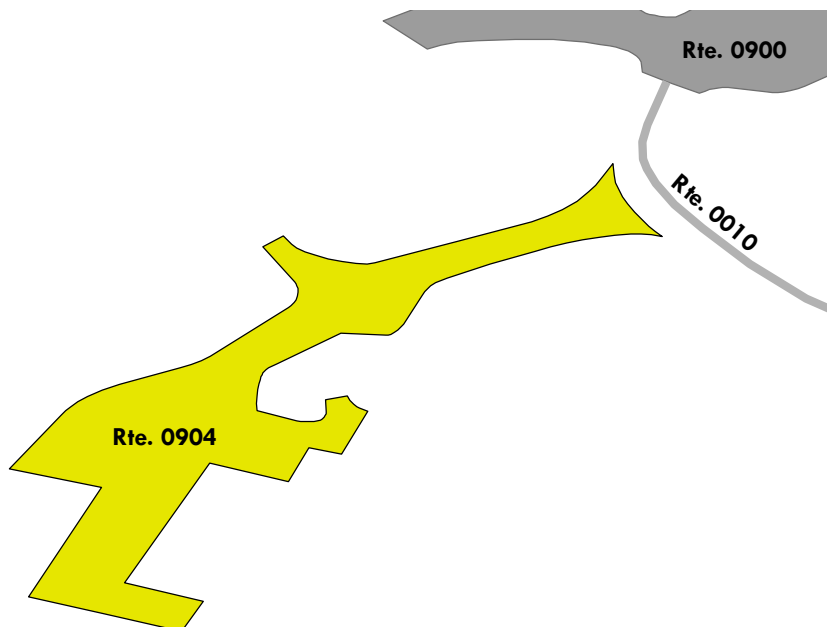
ROUTE 0904: UTILITY COMPLEX PARKING AREA

Inspection Date	FMSS Number	User Access	Surface Type
7/12/2019	74106	PUBLIC	ASPHALT
Area (Sq. Ft.)	Lane Miles (11' Widths)	Curb Reveal (Inches)	Curb Recommendation
23,846	0.411	NOT APPLICABLE	NOT APPLICABLE
Curb Type		Curb & Gutter Type	
NO CURB		NO CURB AND GUTTER	
Pavement Recommendation		Condition Rating / PCR	
LIGHT 3R TREATMENTS		FAIR / 73

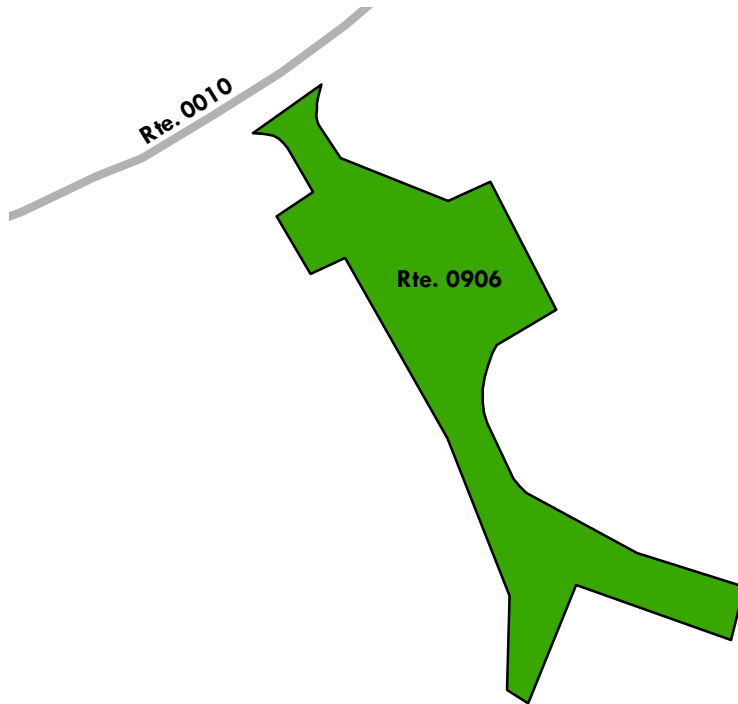
ROUTE 0906: LODGE HOUSING PARKING AREA (SERVICE ROAD F)

Inspection Date	FMSS Number	User Access	Surface Type
7/13/2019	73529	PUBLIC	GRAVEL
Area (Sq. Ft.)	Lane Miles (11' Widths)	Curb Reveal (Inches)	Curb Recommendation
12,487	0.215	NOT APPLICABLE	NOT APPLICABLE
Curb Type		Curb & Gutter Type	
NO CURB		NO CURB AND GUTTER	
Treatment Recommendation		Condition Rating	
ROUTINE MAINTENANCE		4

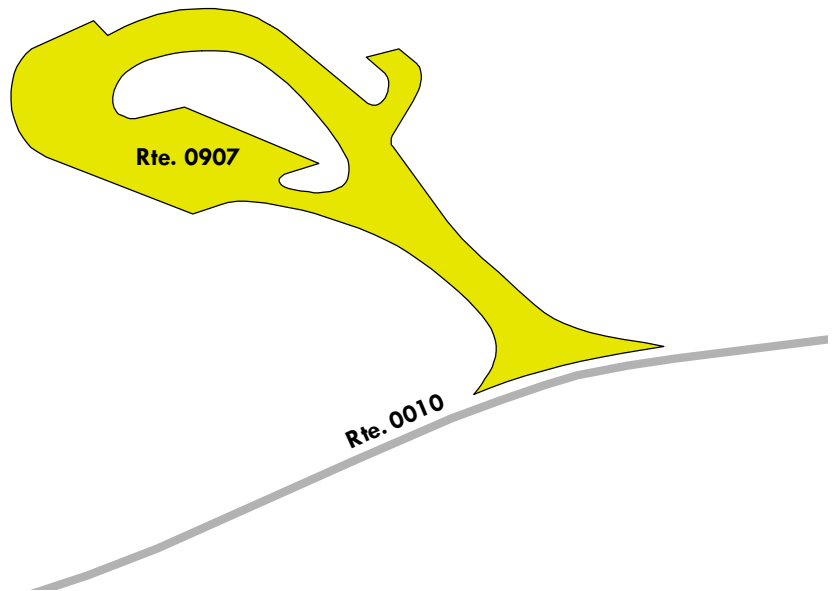
ROUTE 0907: LODGE PARKING AREA

Inspection Date	FMSS Number	User Access	Surface Type
7/12/2019	74115	PUBLIC	ASPHALT
Area (Sq. Ft.)	Lane Miles (11' Widths)	Curb Reveal (Inches)	Curb Recommendation
18,987	0.327	NOT APPLICABLE	NOT APPLICABLE
Curb Type		Curb & Gutter Type	
NO CURB		NO CURB AND GUTTER	
Pavement Recommendation		Condition Rating / PCR	
LIGHT 3R TREATMENTS		FAIR / 73
