GRBA Cycle 6

Final Report

Road Inventory and Condition Assessment of Paved Routes Great Basin National Park

Report Date: December 2016

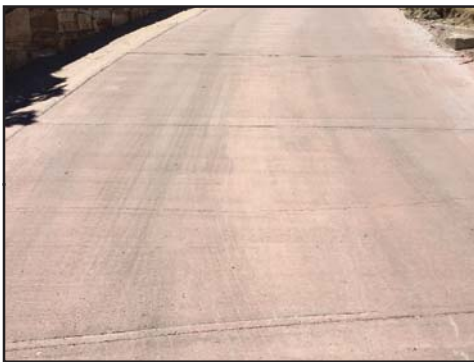
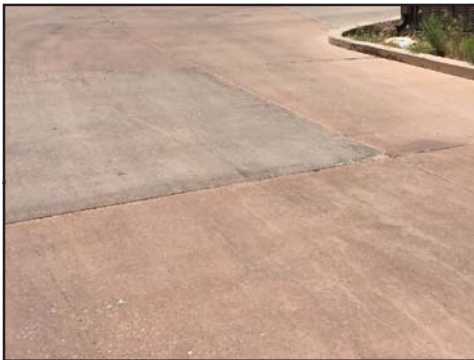
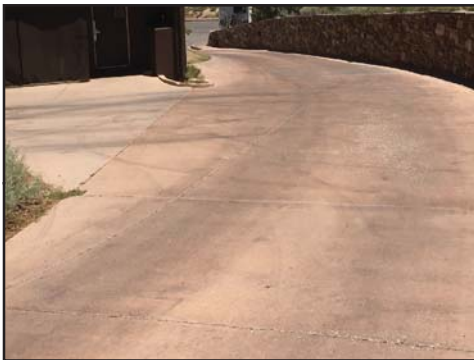
Inspection Date	FMSS Number	User Access	Surface Type
7/14/2016	91505	NONPUBLIC	CONCRETE
Area (Sq. Ft.)	Lane Miles (11' Widths)	Pavement Recommendation	
3,650	0.063	LIGHT 3R TREATMENTS	
Condition Rating / PCR			
FAIR / 73			
Route Condition Legend – Pavement Condition Rating (PCR)			
Poor (0 - 60)	Fair (61- 84)	Good (85 - 94)	Excellent (95 - 100)
Not Rated			
See Appendix for definitions and formulas

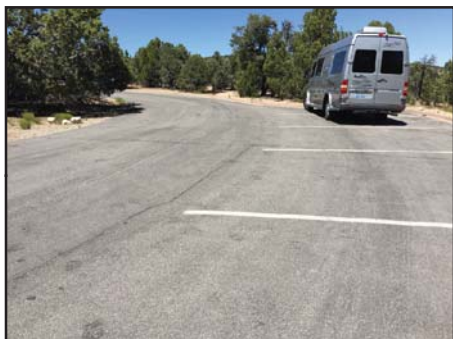
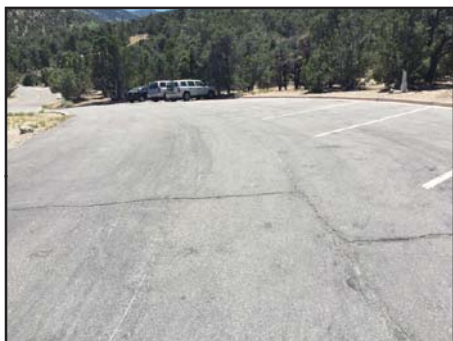
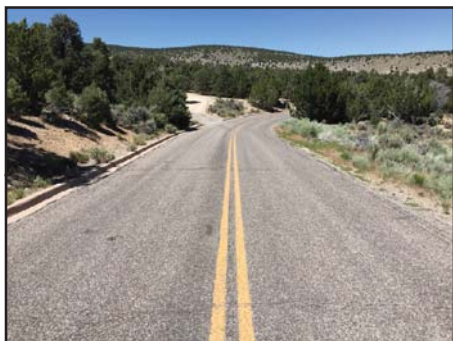
ROUTE 0901: VISITOR CENTER PICNIC AREA

Inspection Date	FMSS Number	User Access	Surface Type
7/14/2016	91558	PUBLIC	ASPHALT
Area (Sq. Ft.)	Lane Miles (11' Widths)	Curb Reveal (Inches)	Curb Recommendation
29,464	0.507	NOT APPLICABLE	LIGHT REPAIR
Curb Type		Curb & Gutter Type	
NO CURB		CONCRETE	
Pavement Recommendation		Condition Rating / PCR	
LIGHT 3R TREATMENTS		FAIR / 73

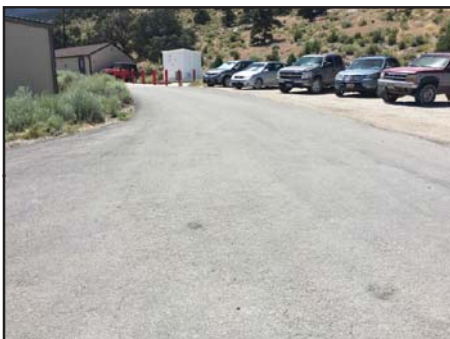
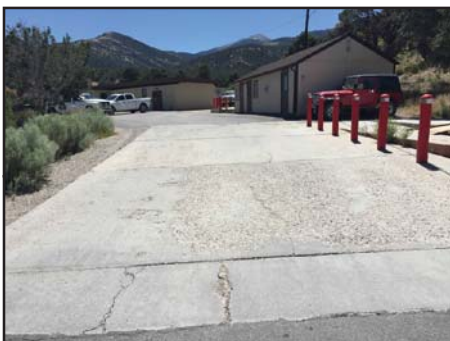
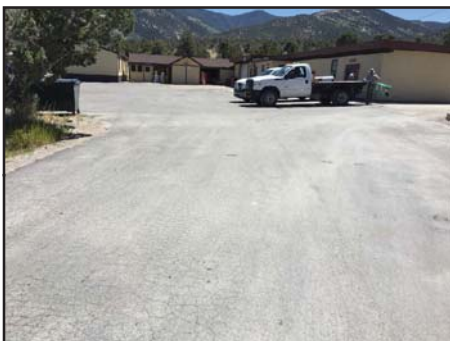
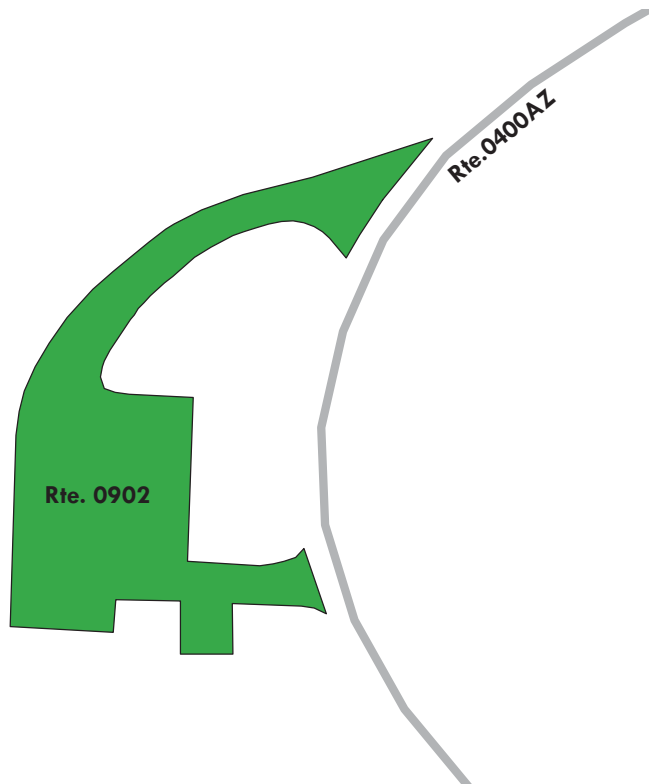
ROUTE 0902: MAINTENANCE YARD

Inspection Date	FMSS Number	User Access	Surface Type
7/14/2016	103835	NONPUBLIC	ASPHALT
Area (Sq. Ft.)	Lane Miles (11' Widths)	Curb Reveal (Inches)	Curb Recommendation
15,604	0.269	NOT APPLICABLE	NOT APPLICABLE
Curb Type		Curb & Gutter Type	
NO CURB		NO CURB AND GUTTER	
Pavement Recommendation		Condition Rating / PCR	
PREVENTIVE MAINTENANCE		GOOD / 90

Parking area consists of multiple surface types: 2 parts Asphalt at 14,743 square feet; 1 part Concrete at 894 square feet.

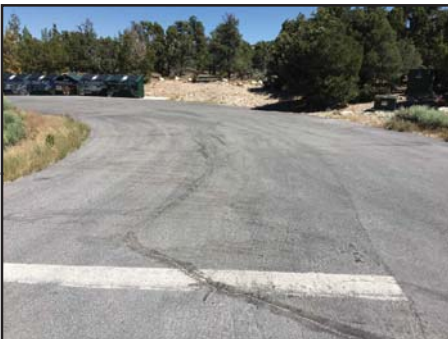
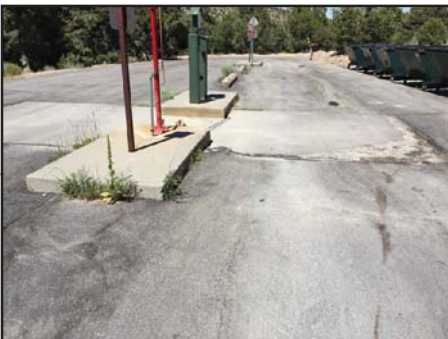
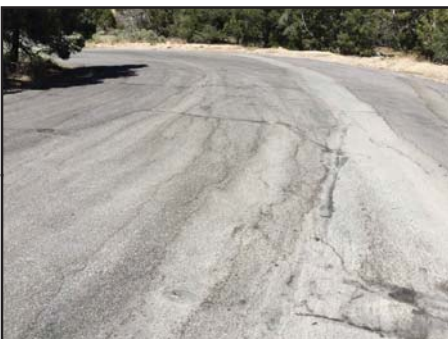
ROUTE 0903: R.V. DUMP STATION

Inspection Date	FMSS Number	User Access	Surface Type
7/14/2016	91553	PUBLIC	ASPHALT
Area (Sq. Ft.)	Lane Miles (11' Widths)	Curb Reveal (Inches)	Curb Recommendation
12,978	0.223	NOT APPLICABLE	NOT APPLICABLE
Curb Type		Curb & Gutter Type	
NO CURB		NO CURB AND GUTTER	
Pavement Recommendation		Condition Rating / PCR	
PREVENTIVE MAINTENANCE		GOOD / 90

Parking area consists of multiple surface types: 1 part Asphalt at 12,735 square feet; 1 part Concrete at 243 square feet.

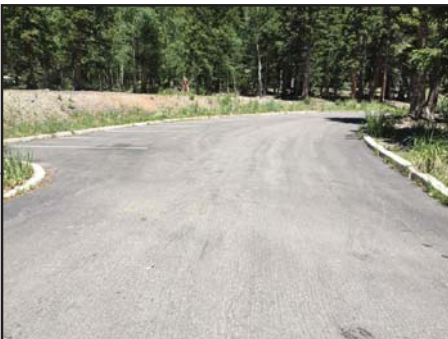
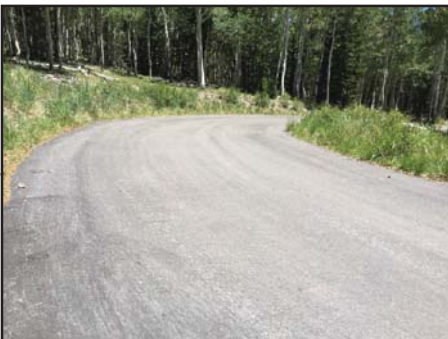
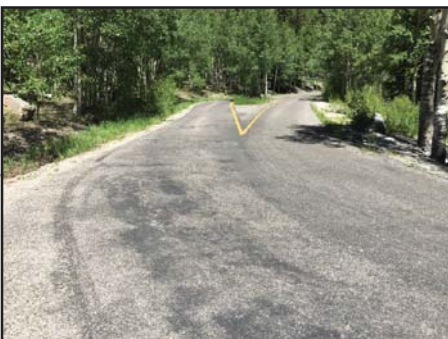
ROUTE 0904: BRISTLECONE PARKING AREA

Inspection Date	FMSS Number	User Access	Surface Type
7/14/2016	91294	PUBLIC	ASPHALT
Area (Sq. Ft.)	Lane Miles (11' Widths)	Curb Reveal (Inches)	Curb Recommendation
31,879	0.549	5	LIGHT REPAIR
Curb Type		Curb & Gutter Type	
CONCRETE		NO CURB AND GUTTER	
Pavement Recommendation		Condition Rating / PCR	
PREVENTIVE MAINTENANCE		GOOD / 90

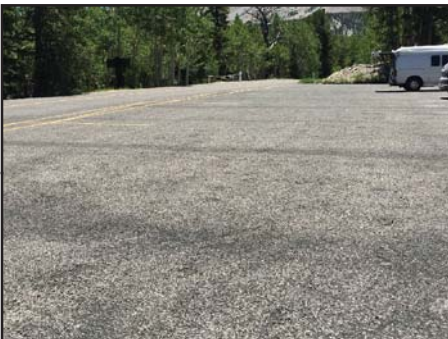
Inspection Date	FMSS Number	User Access	Surface Type
7/14/2016	103839	PUBLIC	ASPHALT
Area (Sq. Ft.)	Lane Miles (11' Widths)	Curb Reveal (Inches)	Curb Recommendation
8,675	0.149	6	MODERATE REPAIR
Curb Type		Curb & Gutter Type	
ASPHALT		NO CURB AND GUTTER	
Pavement Recommendation		Condition Rating / PCR	
PREVENTIVE MAINTENANCE		GOOD / 90
