GWCA Cycle 6

Final Report

Road Inventory and Condition Assessment of Paved Routes George Washington Carver National Monument

Report Date: May 2018

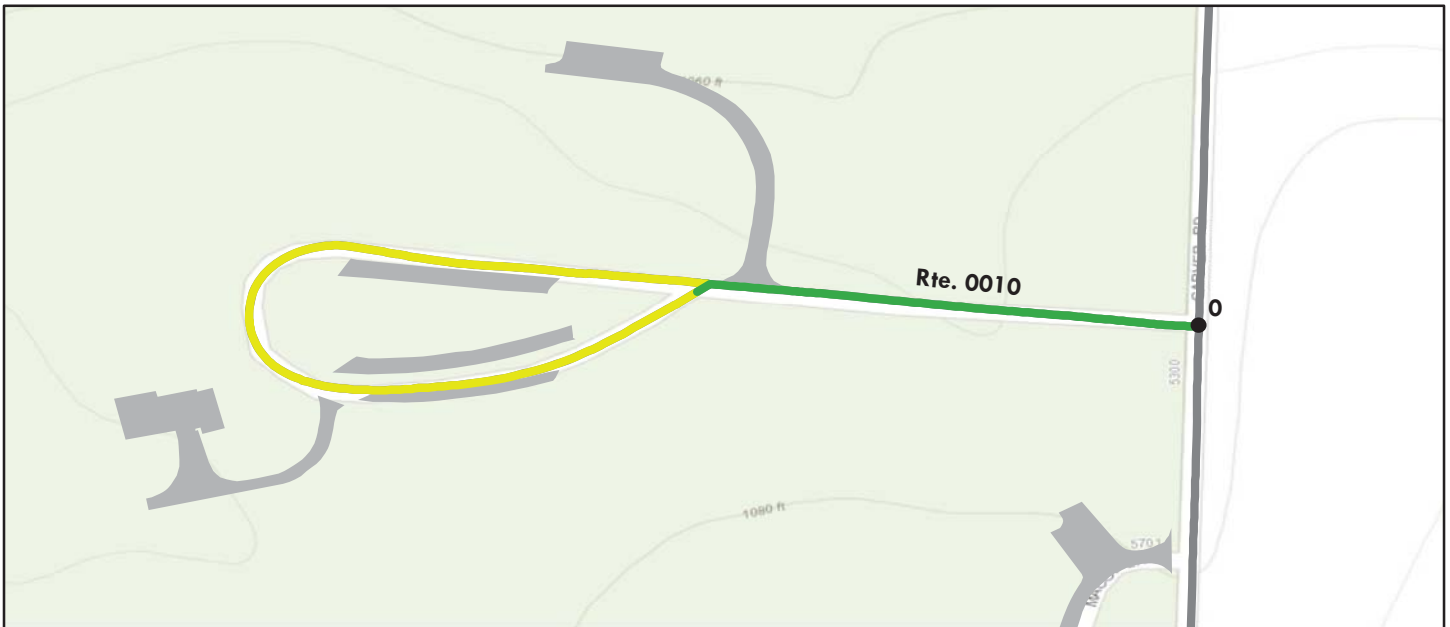
ROUTE 0010: PARK ENTRANCE ROAD

Colors on map represent condition scores at 0.10-mile intervals. See Appendix for definitions and formulas.

Inspection Date: 11/5/2017	Beginning Section MP	0				
Paved Length (Miles): 0.3	Section Length (MI)	0.3				
Surface Type: ASPHALT	Route Summary					
Roadway Condition Information						
Pavement Condition Rating (PCR)	77	77				
Surface Condition Rating (SCR)	77	77				
Roughness Condition Index (RCI)	N/A	N/A				
Distress Index Values						
Structural Crack Index	77	77				
Alligator Crack Index	100	100				
Longitudinal Crack Index	77	77				
Transverse Cracking Index	88	88				
Patching Index	100	100				
Rutting Index	97	97				
International Roughness Index (IRI)	N/A	N/A				
Lane & Width Information						
Number of Lanes	1	1				
Paved Width (ft)	16.3	16.3				
Lane Width (ft)	12	12

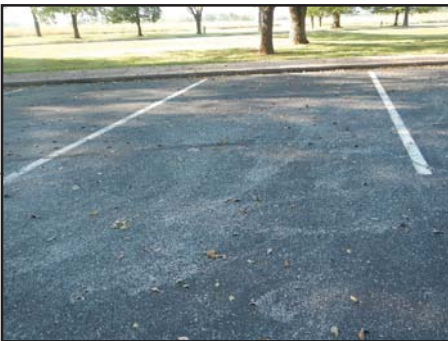
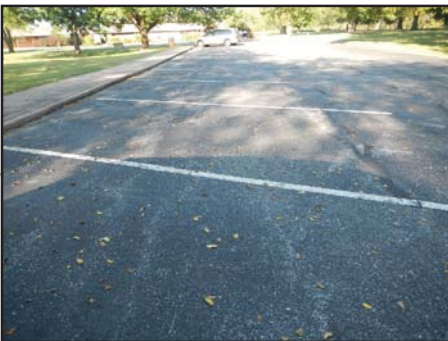
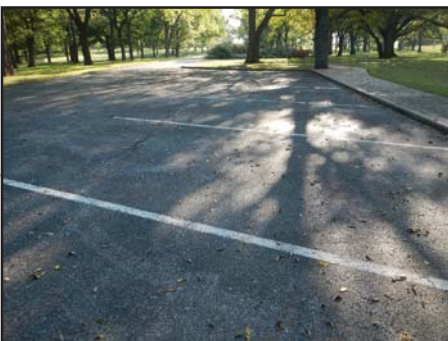
ROUTE 0900AZ: VISITOR CENTER PARKING A

Inspection Date	FMSS Number	User Access	Surface Type
9/23/2017	79609	PUBLIC	ASPHALT
Area (Sq. Ft.)	Lane Miles (11' Widths)	Curb Reveal (Inches)	Curb Recommendation
4,837	0.083	4	DO NOTHING
Curb Type		Curb & Gutter Type	
CONCRETE		NO CURB AND GUTTER	
Pavement Recommendation		Condition Rating / PCR	
PREVENTIVE MAINTENANCE		GOOD / 90

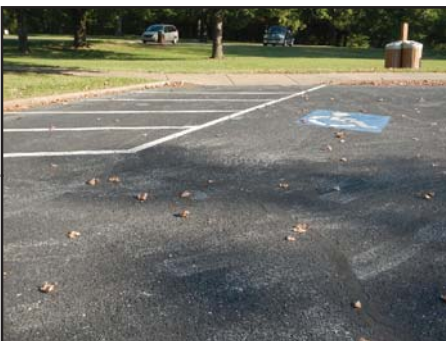
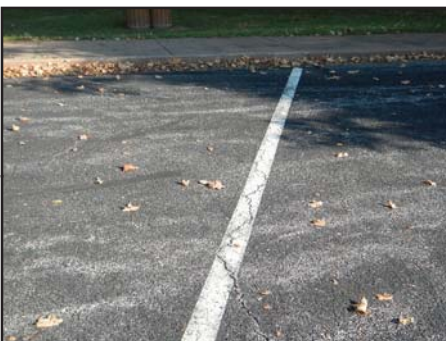
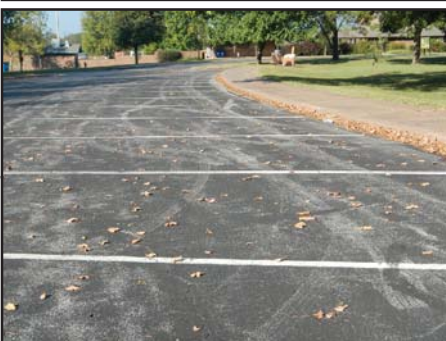
ROUTE 0900BZ: VISITOR CENTER PARKING B

Inspection Date	FMSS Number	User Access	Surface Type
9/23/2017	79609	PUBLIC	ASPHALT
Area (Sq. Ft.)	Lane Miles (11' Widths)	Curb Reveal (Inches)	Curb Recommendation
4,822	0.083	4	DO NOTHING
Curb Type		Curb & Gutter Type	
CONCRETE		NO CURB AND GUTTER	
Pavement Recommendation		Condition Rating / PCR	
PREVENTIVE MAINTENANCE		GOOD / 90

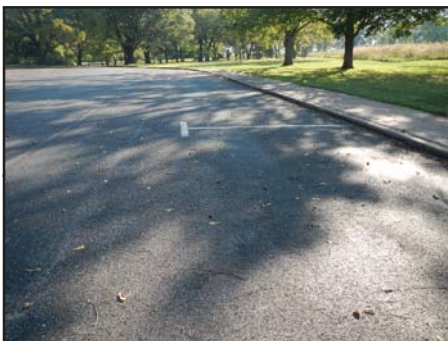
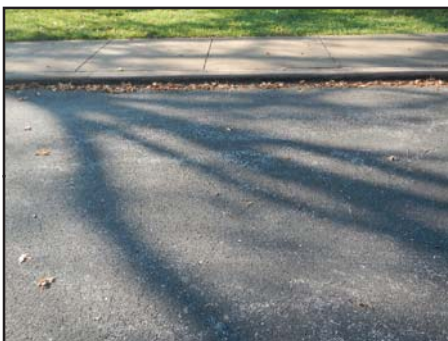
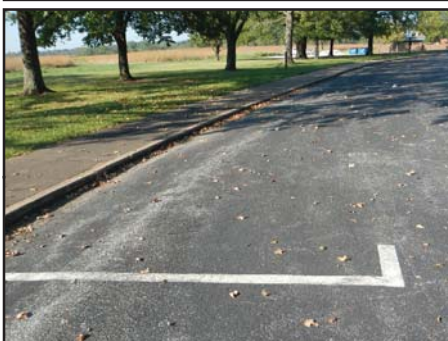
ROUTE 0900CZ: VISITOR CENTER RV / BUS PARKING

Inspection Date	FMSS Number	User Access	Surface Type
9/23/2017	79609	PUBLIC	ASPHALT
Area (Sq. Ft.)	Lane Miles (11' Widths)	Curb Reveal (Inches)	Curb Recommendation
2,520	0.043	4	DO NOTHING
Curb Type		Curb & Gutter Type	
CONCRETE		NO CURB AND GUTTER	
Pavement Recommendation		Condition Rating / PCR	
PREVENTIVE MAINTENANCE		GOOD / 90

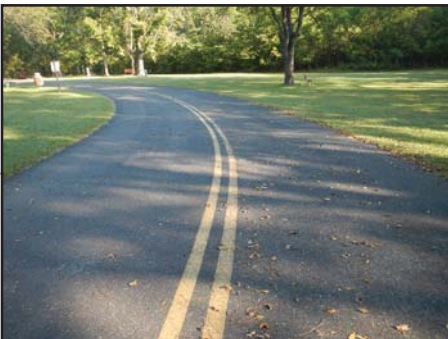
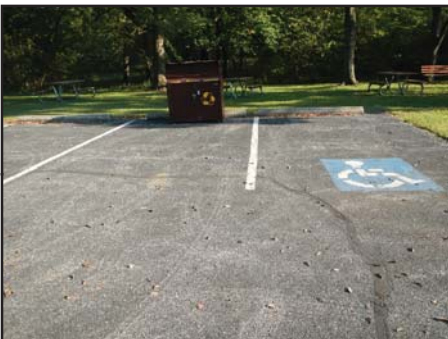
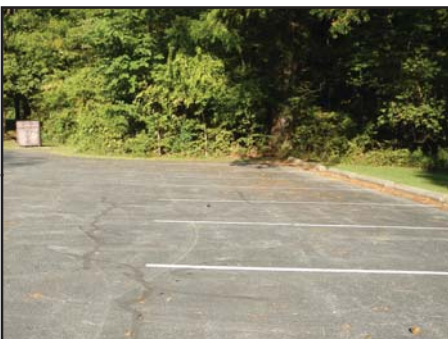
ROUTE 0901: PICNIC AREA PARKING

Inspection Date	FMSS Number	User Access	Surface Type
9/23/2017	71200	PUBLIC	ASPHALT
Area (Sq. Ft.)	Lane Miles (11' Widths)	Curb Reveal (Inches)	Curb Recommendation
11,738	0.202	NOT APPLICABLE	NOT APPLICABLE
Curb Type		Curb & Gutter Type	
NO CURB		NO CURB AND GUTTER	
Pavement Recommendation		Condition Rating / PCR	
PREVENTIVE MAINTENANCE		GOOD / 90

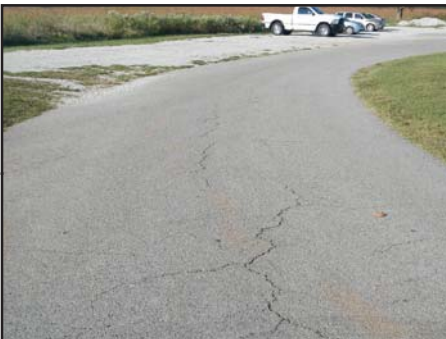
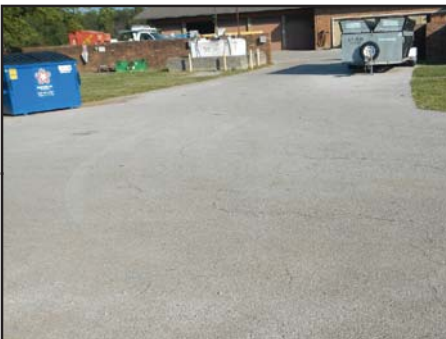
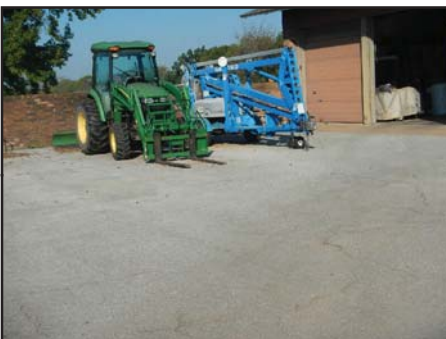
ROUTE 0902: MAINTENANCE AREA PARKING

Inspection Date	FMSS Number	User Access	Surface Type
9/23/2017	104140	NONPUBLIC	ASPHALT
Area (Sq. Ft.)	Lane Miles (11' Widths)	Curb Reveal (Inches)	Curb Recommendation
12,275	0.211	4	DO NOTHING
Curb Type		Curb & Gutter Type	
CONCRETE		NO CURB AND GUTTER	
Pavement Recommendation		Condition Rating / PCR	
PREVENTIVE MAINTENANCE		GOOD / 90

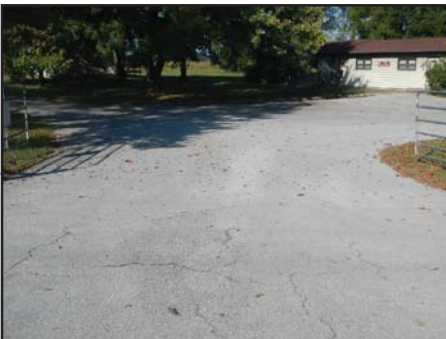
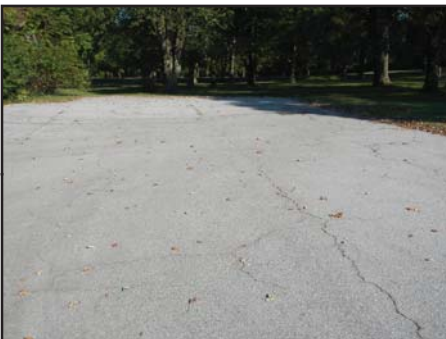
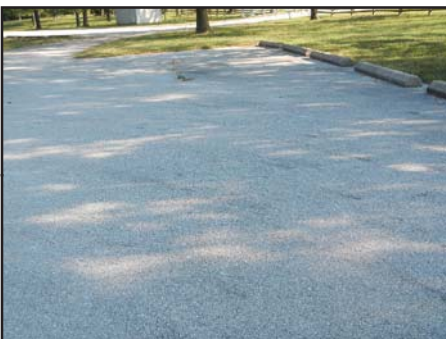
ROUTE 0903: ADMINISTRATIVE PARKING AREAS

Inspection Date	FMSS Number	User Access	Surface Type
9/23/2017	71201	NONPUBLIC	ASPHALT
Area (Sq. Ft.)	Lane Miles (11' Widths)	Curb Reveal (Inches)	Curb Recommendation
20,120	0.346	NOT APPLICABLE	NOT APPLICABLE
Curb Type		Curb & Gutter Type	
NO CURB		NO CURB AND GUTTER	
Pavement Recommendation		Condition Rating / PCR	
PREVENTIVE MAINTENANCE		GOOD / 90
