HAMP Cycle 6

Final Report

Road Inventory and Condition Assessment of Paved Routes Hampton National Historic Site

Report Date: January 2022

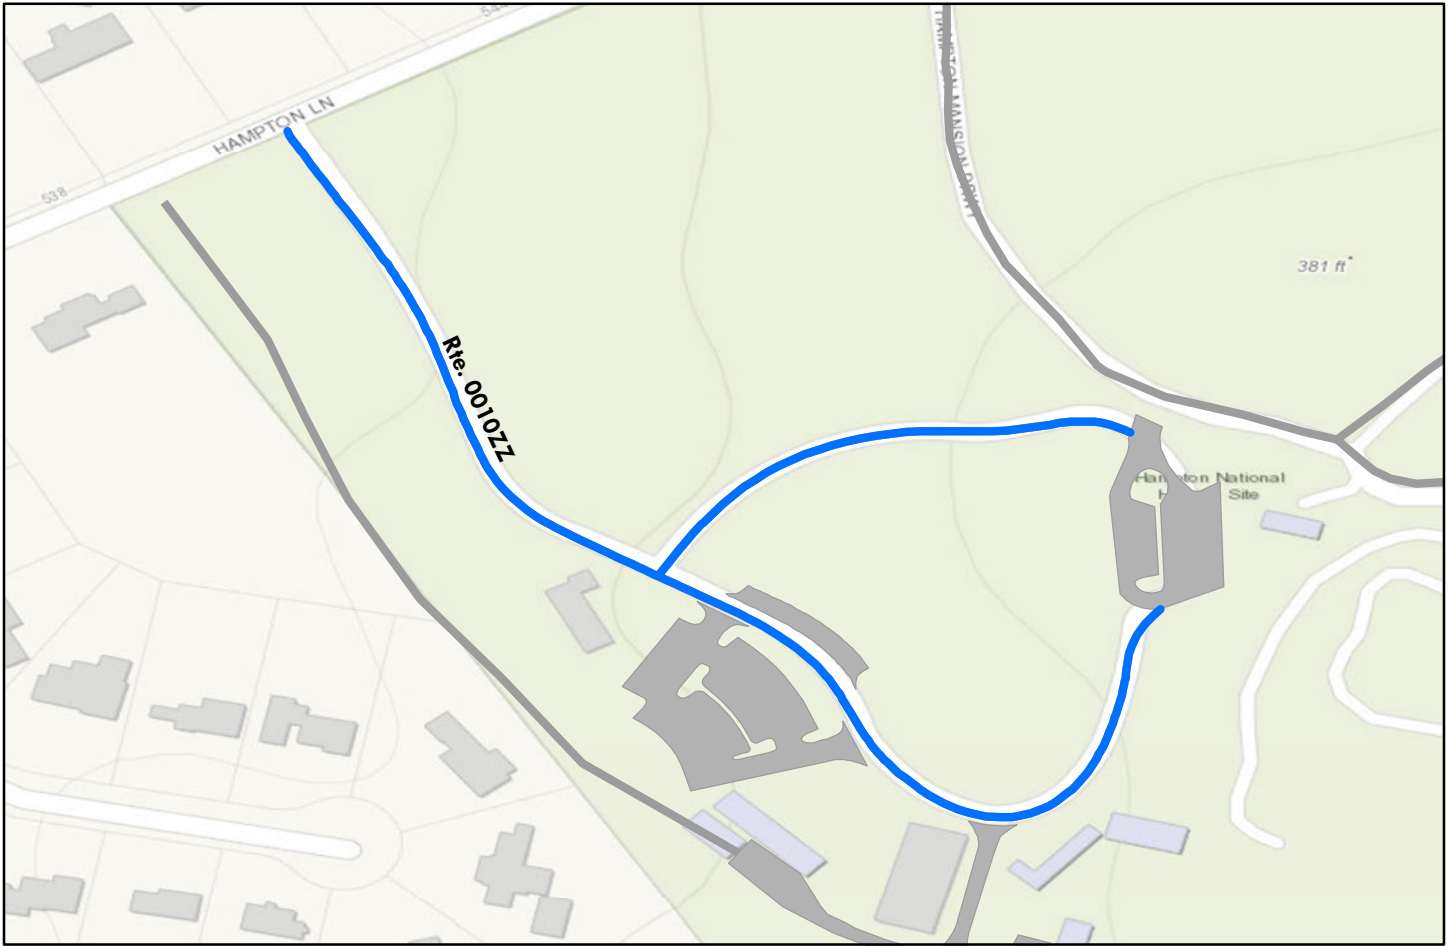
ROUTE 0010ZZ: MAIN ENTRANCE ROAD

Note: The weighted average summary PCR value is calculated from only the sections of road where the PCR was collected. The overall PCR for the summary route may not reflect individual subcomponent ratings.

Route Condition Legend – Pavement Condition Rating (PCR)						
Poor (0 - 60)	Fair (61- 84)	Good (85 - 94)	Excellent (95 - 100)	Not Rated		
See Appendix for definitions and formulas						
Inspection Date:	4/20/2021					
Paved Length (Miles):	0.33					
Surface Type:	ASPHALT	Route Summary				
Roadway Condition Information						
Pavement Condition Rating (PCR)	98					
Lane & Width Information						
Number of Lanes	2					
Paved Width (ft)	23.8					
Lane Width (ft)	13.7

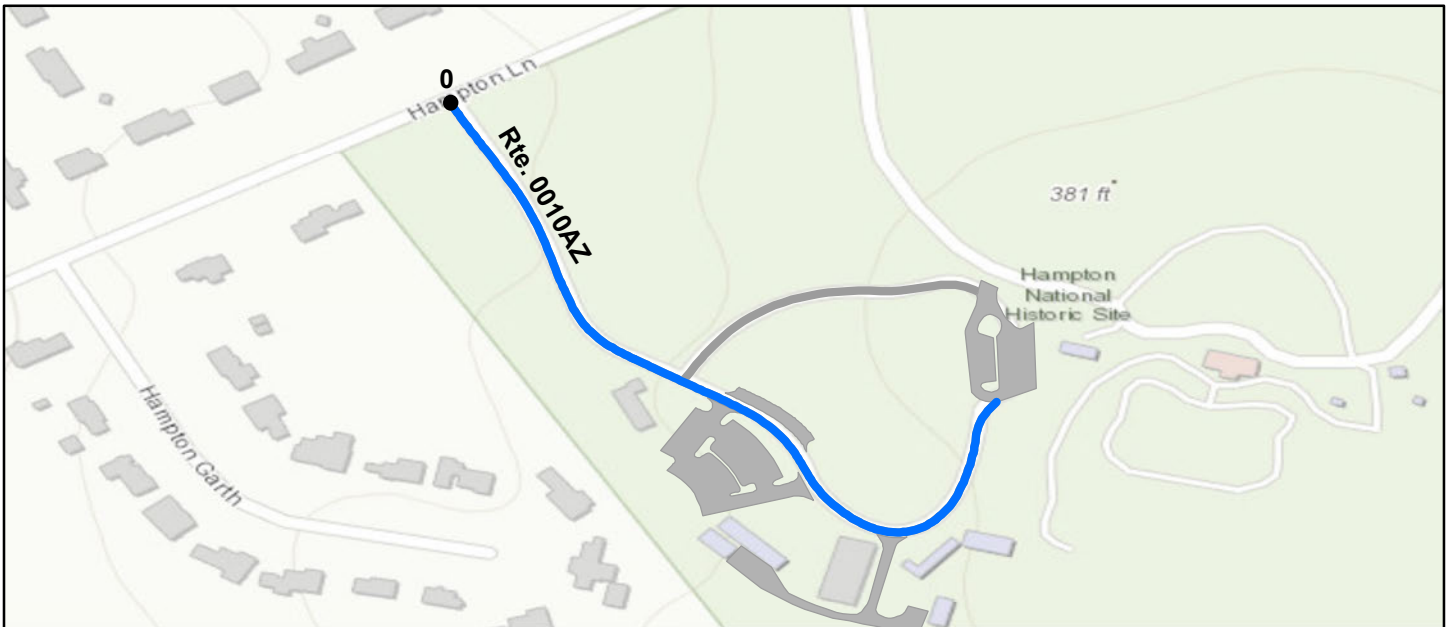
ROUTE 0010AZ: MAIN ENTRANCE ROAD A

Subcomponent of Route HAMP-0010ZZ
Data Collection Vehicle (DCV) Rating

Colors on map represent condition scores at 0.10-mile intervals. See Appendix for definitions and formulas.

Inspection Date:	4/20/2021	Beginning Section MP	0				
Paved Length (Miles):	0.24	Section Length (MI)	0.24				
Surface Type:	ASPHALT	Route Summary					
Roadway Condition Information							
Pavement Condition Rating (PCR)	98	98					
Surface Condition Rating (SCR)	98	98					
Roughness Condition Index (RCI)	N/A	N/A					
Distress Index Values							
Structural Crack Index	98	98					
Alligator Crack Index	100	100					
Longitudinal Crack Index	98	98					
Transverse Cracking Index	99	99					
Patching Index	100	100					
Rutting Index	98	98					
International Roughness Index (IRI)	N/A	N/A					
Lane & Width Information							
Number of Lanes	2	2					
Paved Width (ft)	24.7	24.7					
Lane Width (ft)	13.4	13.4

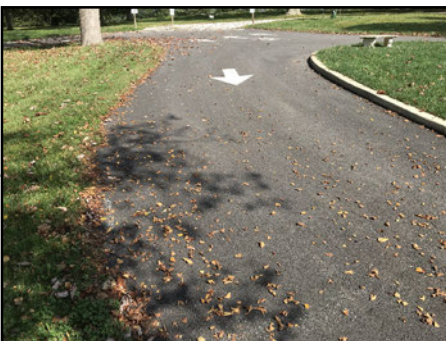
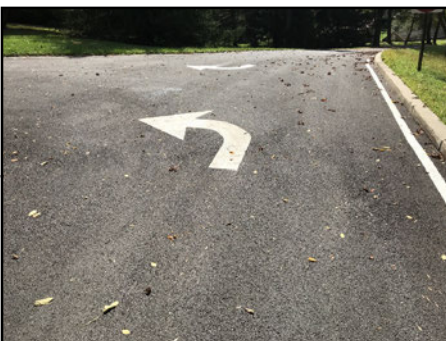
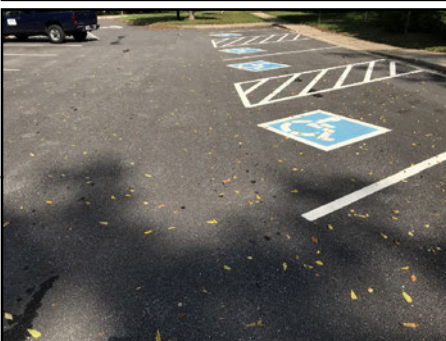
Inspection Date	FMSS Number	User Access	Surface Type
9/28/2020	107554	PUBLIC	ASPHALT
Area (Sq. Ft.)	Lane Miles (11' Widths)	Curb Reveal (Inches)	Curb Recommendation
11,939	0.206	6	DO NOTHING
Curb Type		Curb & Gutter Type	
CONCRETE		CONCRETE	
Pavement Recommendation		Condition Rating / PCR	
PREVENTIVE MAINTENANCE		GOOD / 90

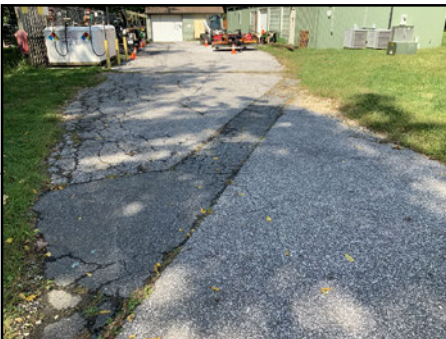
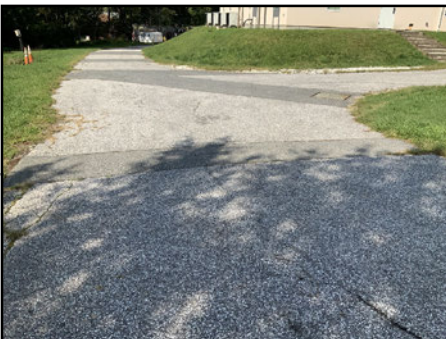
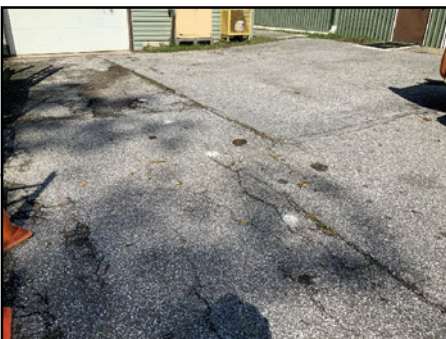
ROUTE 0902: GARDEN / MAINTENANCE AREA

Inspection Date	FMSS Number	User Access	Surface Type
9/28/2020	104709	NONPUBLIC	ASPHALT
Area (Sq. Ft.)	Lane Miles (11' Widths)	Curb Reveal (Inches)	Curb Recommendation
9,006	0.155	NOT APPLICABLE	NOT APPLICABLE
Curb Type		Curb & Gutter Type	
NO CURB		NO CURB AND GUTTER	
Pavement Recommendation		Condition Rating / PCR	
LIGHT 3R TREATMENTS		FAIR / 73

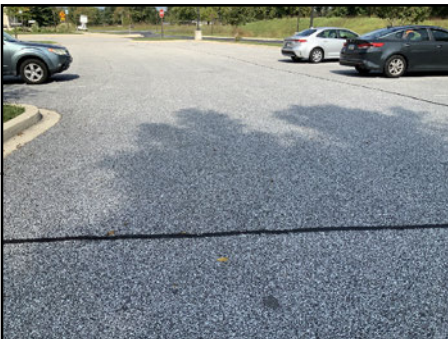
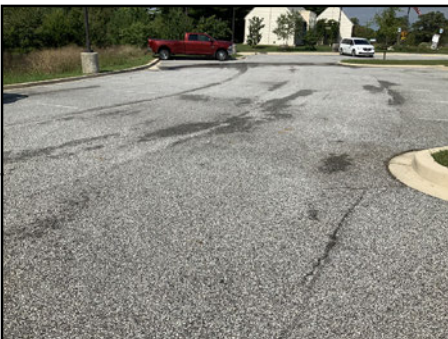
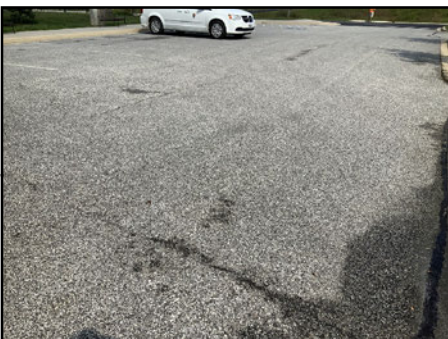
ROUTE 0903: LOWER VISITOR PARKING

Inspection Date	FMSS Number	User Access	Surface Type
9/28/2020	94406	PUBLIC	ASPHALT
Area (Sq. Ft.)	Lane Miles (11' Widths)	Curb Reveal (Inches)	Curb Recommendation
19,112	0.329	NOT APPLICABLE	DO NOTHING
Curb Type		Curb & Gutter Type	
NO CURB		CONCRETE	
Pavement Recommendation		Condition Rating / PCR	
PREVENTIVE MAINTENANCE		GOOD / 90

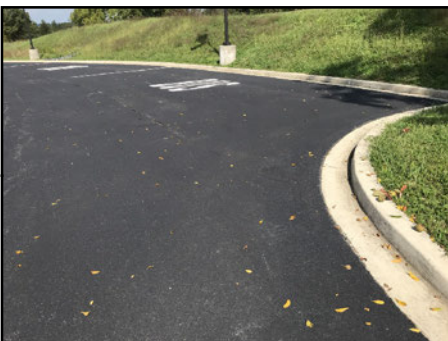
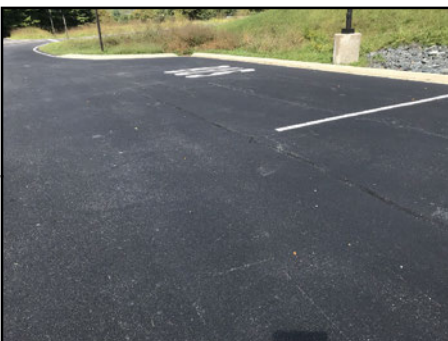
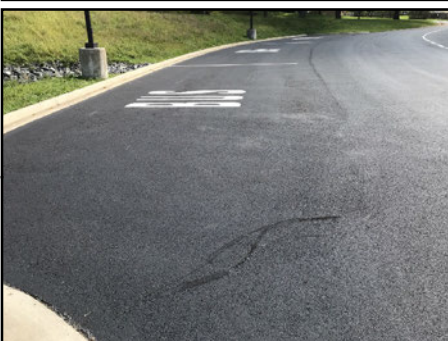
ROUTE 0907: TOUR BUS PARKING

Inspection Date	FMSS Number	User Access	Surface Type
9/28/2020	115871	PUBLIC	ASPHALT
Area (Sq. Ft.)	Lane Miles (11' Widths)	Curb Reveal (Inches)	Curb Recommendation
2,600	0.045	NOT APPLICABLE	DO NOTHING
Curb Type		Curb & Gutter Type	
NO CURB		CONCRETE	
Pavement Recommendation		Condition Rating / PCR	
PREVENTIVE MAINTENANCE		GOOD / 90
