# HOCU Cycle 6

## Final Report

### Road Inventory and Condition Assessment of Paved Routes Hopewell Culture National Historical Park

**Report Date: August 2021**

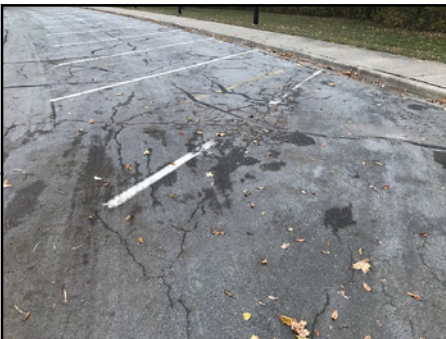
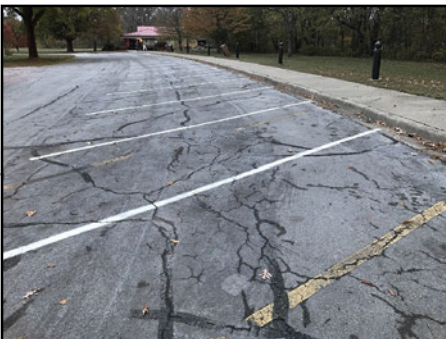
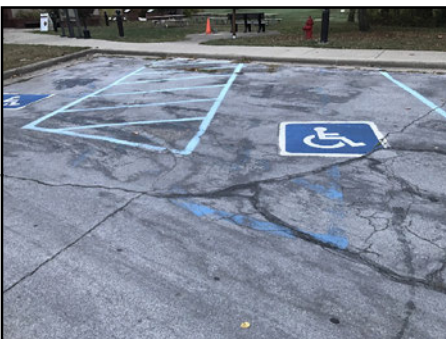
Rte. 0904

Inspection Date	FMSS Number	User Access	Surface Type
10/18/2020	55696	PUBLIC	ASPHALT
Area (Sq. Ft.)	Lane Miles (11' Widths)	Curb Reveal (Inches)	Curb Recommendation
4,196	0.072	NOT APPLICABLE	LIGHT REPAIR
Curb Type		Curb & Gutter Type	
NO CURB		CONCRETE	
Pavement Recommendation		Condition Rating / PCR	
HEAVY 3R TREATMENTS		POOR / 53

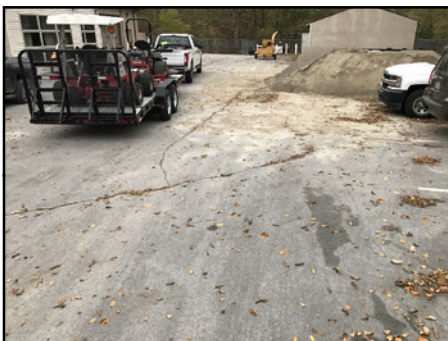
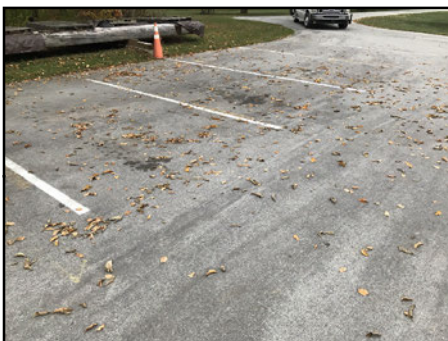
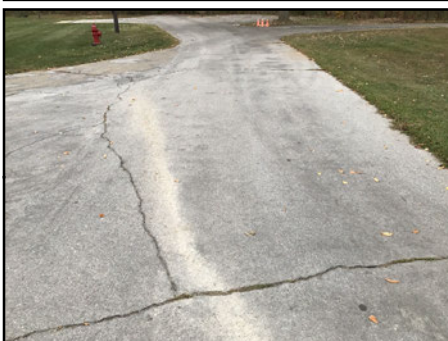
## ROUTE 0901Z: MAINTENANCE AREA PARKING

Inspection Date	FMSS Number	User Access	Surface Type
10/18/2020	55700	NONPUBLIC	ASPHALT
Area (Sq. Ft.)	Lane Miles (11' Widths)	Curb Reveal (Inches)	Curb Recommendation
16,364	0.282	NOT APPLICABLE	NOT APPLICABLE
Curb Type		Curb & Gutter Type	
NO CURB		NO CURB AND GUTTER	
Pavement Recommendation		Condition Rating / PCR	
PREVENTIVE MAINTENANCE		GOOD / 90

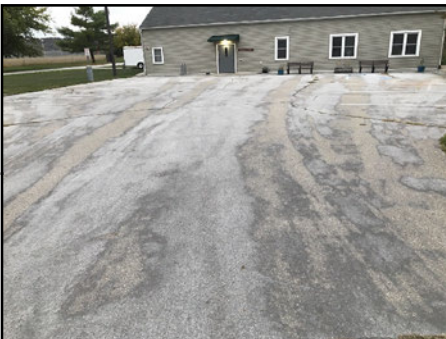
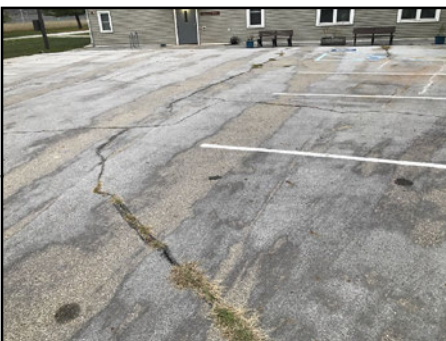
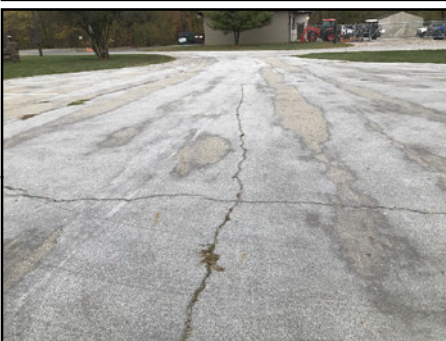
## ROUTE 0902Z: RESOURCE MANAGEMENT PARKING

Inspection Date	FMSS Number	User Access	Surface Type
10/18/2020	55700	NONPUBLIC	ASPHALT
Area (Sq. Ft.)	Lane Miles (11' Widths)	Curb Reveal (Inches)	Curb Recommendation
5,269	0.091	0	NOT APPLICABLE
Curb Type		Curb & Gutter Type	
NO CURB		NO CURB AND GUTTER	
Pavement Recommendation		Condition Rating / PCR	
LIGHT 3R TREATMENTS		FAIR / 73

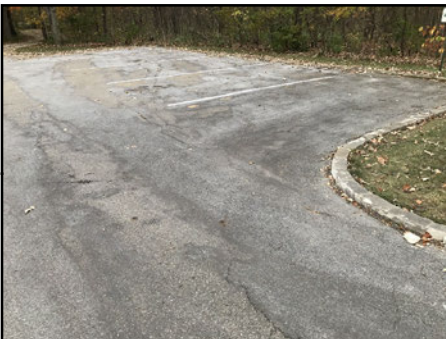
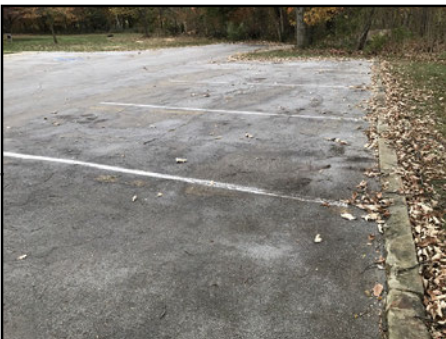
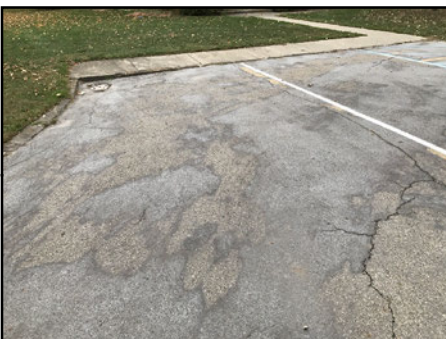
## ROUTE 0903Z: ADMINISTRATIVE PARKING

Inspection Date	FMSS Number	User Access	Surface Type
10/18/2020	55700	NONPUBLIC	ASPHALT
Area (Sq. Ft.)	Lane Miles (11' Widths)	Curb Reveal (Inches)	Curb Recommendation
3,024	0.052	3	MODERATE REPAIR
Curb Type		Curb & Gutter Type	
STONE		NO CURB AND GUTTER	
Pavement Recommendation		Condition Rating / PCR	
LIGHT 3R TREATMENTS		FAIR / 73

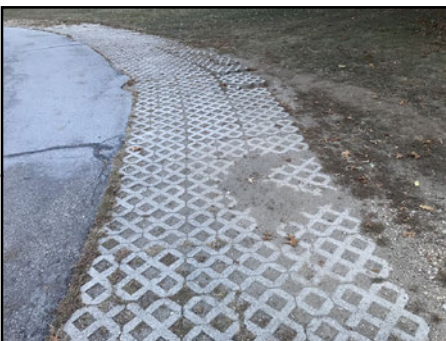
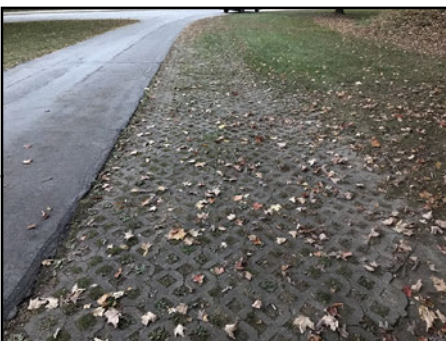
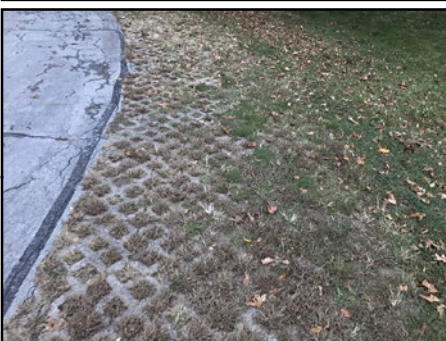
## ROUTE 0904: OVERFLOW PARKING

Inspection Date	FMSS Number	User Access	Surface Type
10/18/2020	104452	PUBLIC	BRICK PAVERS
Area (Sq. Ft.)	Lane Miles (11' Widths)	Curb Reveal (Inches)	Curb Recommendation
1,236	0.021	NOT APPLICABLE	NOT APPLICABLE
Curb Type		Curb & Gutter Type	
NO CURB		NO CURB AND GUTTER	
Pavement Recommendation		Condition Rating / PCR	
LIGHT 3R TREATMENTS		FAIR / 73

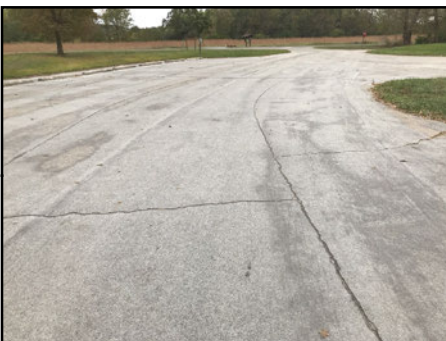
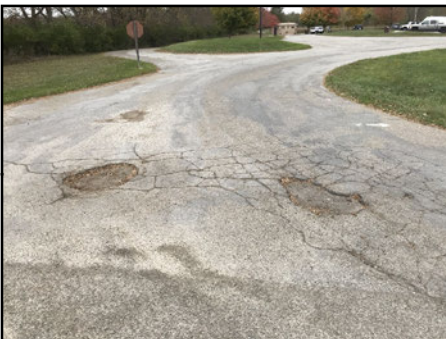
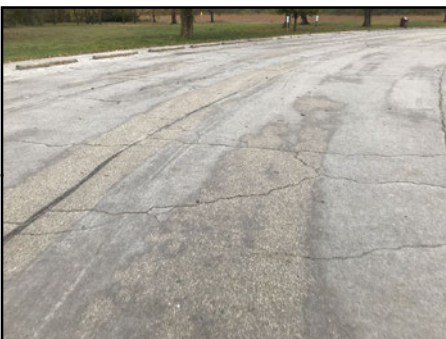
## ROUTE 0905: HOPEWELL PARKING

Inspection Date	FMSS Number	User Access	Surface Type
10/18/2020	67400	PUBLIC	ASPHALT
Area (Sq. Ft.)	Lane Miles (11' Widths)	Curb Reveal (Inches)	Curb Recommendation
33,658	0.579	NOT APPLICABLE	NOT APPLICABLE
Curb Type		Curb & Gutter Type	
NO CURB		NO CURB AND GUTTER	
Pavement Recommendation		Condition Rating / PCR	
LIGHT 3R TREATMENTS		FAIR / 73

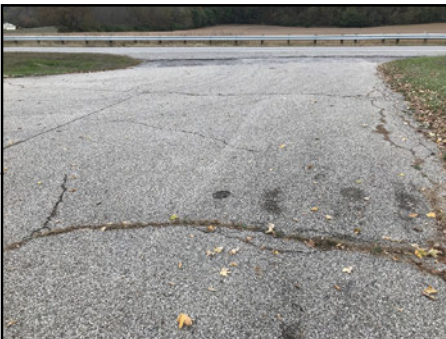
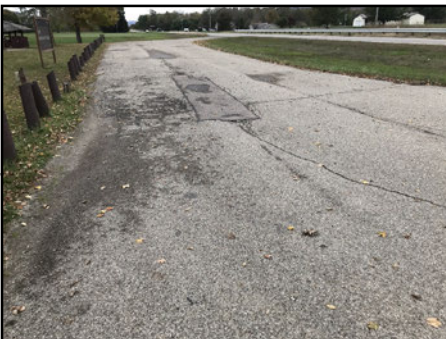
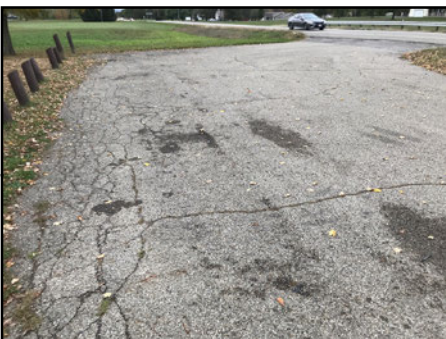
## ROUTE 0906AZ: SEIP PARKING A

Inspection Date	FMSS Number	User Access	Surface Type
10/18/2020	N/A	PUBLIC	ASPHALT
Area (Sq. Ft.)	Lane Miles (11' Widths)	Curb Reveal (Inches)	Curb Recommendation
8,404	0.145	NOT APPLICABLE	NOT APPLICABLE
Curb Type		Curb & Gutter Type	
NO CURB		NO CURB AND GUTTER	
Pavement Recommendation		Condition Rating / PCR	
HEAVY 3R TREATMENTS		POOR / 53

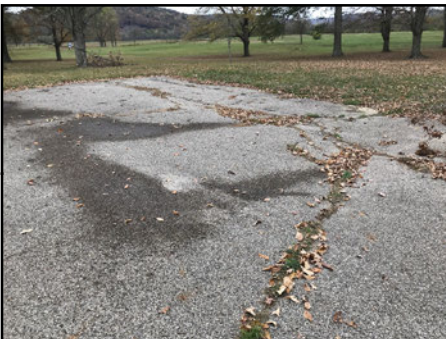
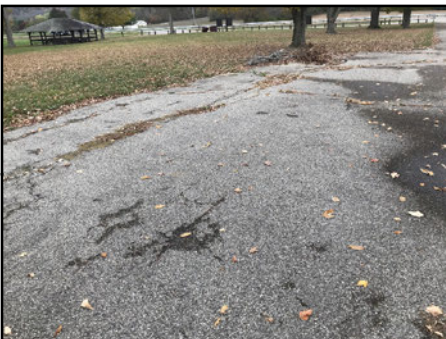
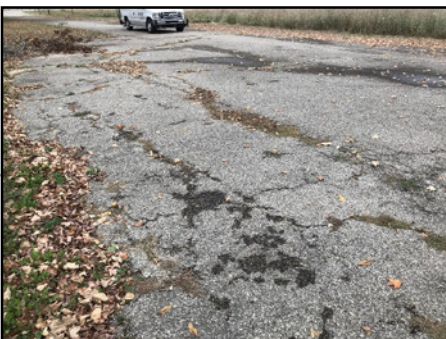
## ROUTE 0906BZ: SEIP PARKING B

Inspection Date	FMSS Number	User Access	Surface Type
10/18/2020	N/A	PUBLIC	ASPHALT
Area (Sq. Ft.)	Lane Miles (11' Widths)	Curb Reveal (Inches)	Curb Recommendation
1,681	0.262	NOT APPLICABLE	NOT APPLICABLE
Curb Type		Curb & Gutter Type	
NO CURB		NO CURB AND GUTTER	
Pavement Recommendation		Condition Rating / PCR	
RECONSTRUCTION		POOR / 30

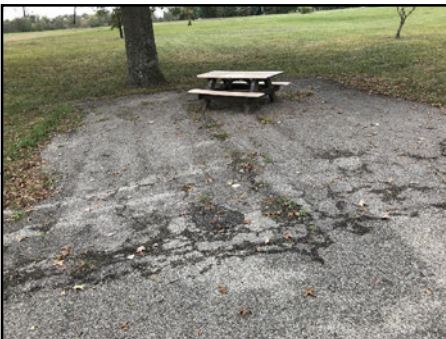
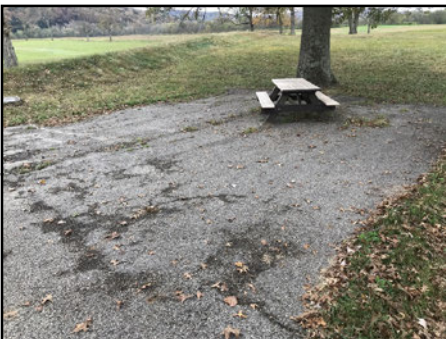
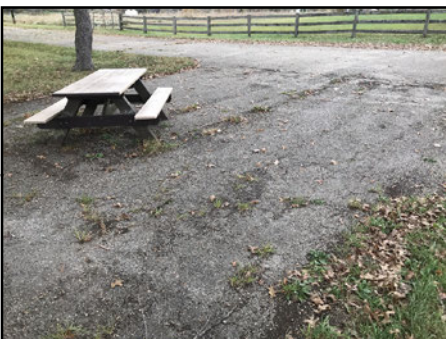
## ROUTE 0906CZ: SEIP PARKING C

Inspection Date	FMSS Number	User Access	Surface Type
10/18/2020	N/A	PUBLIC	ASPHALT
Area (Sq. Ft.)	Lane Miles (11' Widths)	Curb Reveal (Inches)	Curb Recommendation
1,122	0.019	NOT APPLICABLE	NOT APPLICABLE
Curb Type		Curb & Gutter Type	
NO CURB		NO CURB AND GUTTER	
Pavement Recommendation		Condition Rating / PCR	
RECONSTRUCTION		POOR / 30

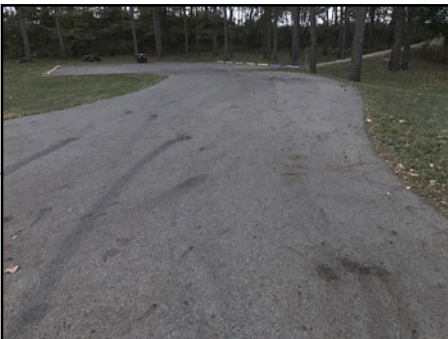
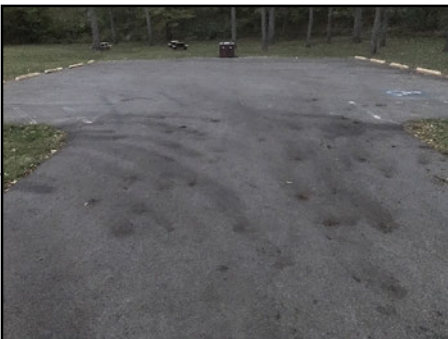
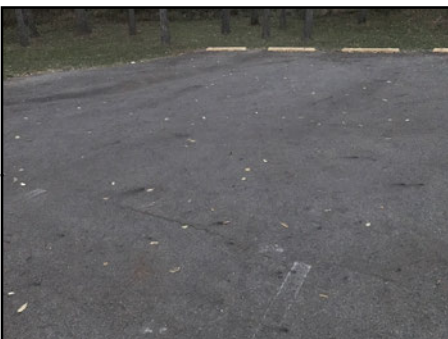
## ROUTE 0907: HOPETOWN EARTHWORK PARKING

Inspection Date	FMSS Number	User Access	Surface Type
10/18/2020	243274	PUBLIC	ASPHALT
Area (Sq. Ft.)	Lane Miles (11' Widths)	Curb Reveal (Inches)	Curb Recommendation
5,839	0.101	NOT APPLICABLE	NOT APPLICABLE
Curb Type		Curb & Gutter Type	
NO CURB		NO CURB AND GUTTER	
Pavement Recommendation		Condition Rating / PCR	
PREVENTIVE MAINTENANCE		GOOD / 90
