HOFU Cycle 6

Final Report

Road Inventory and Condition Assessment of Paved Routes Hopewell Furnace National Historic Site

**Federal Highway Administration
Eastern Federal Lands Highway Division
Road Inventory Program (RIP)**

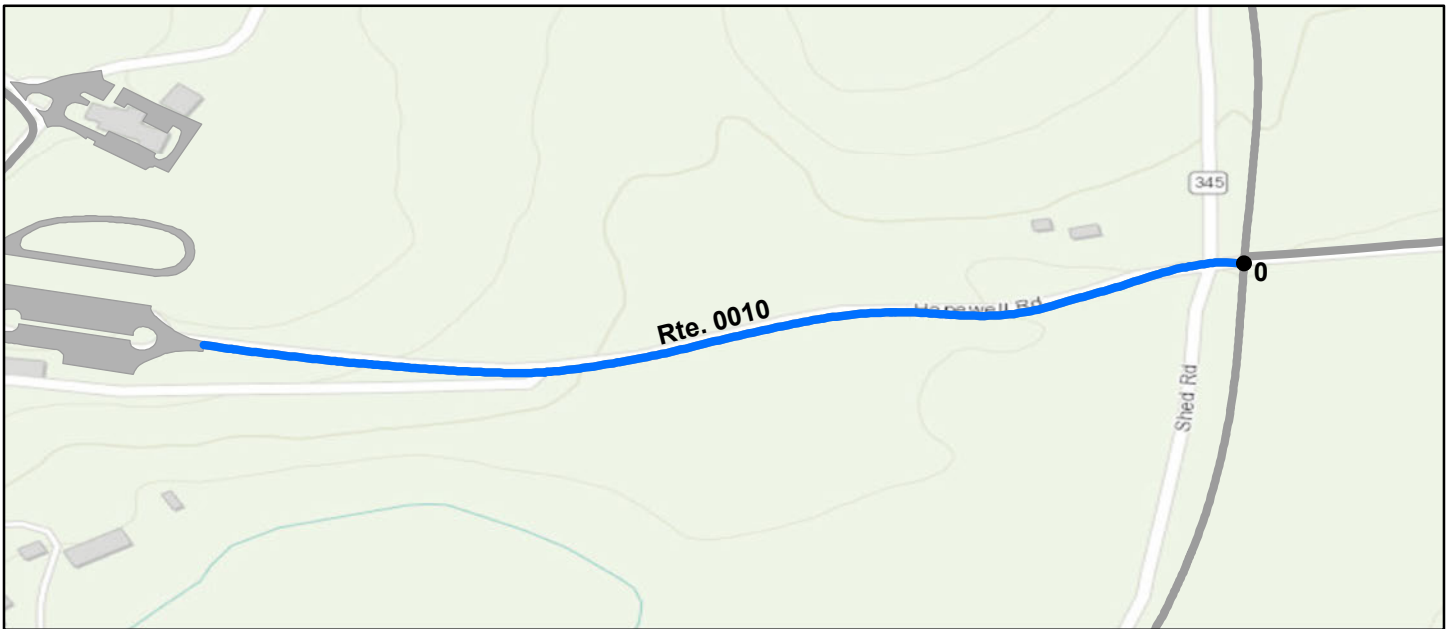
ROUTE 0010: ENTRANCE ROAD

Route Condition Legend – Pavement Condition Rating (PCR)										
Poor (0 - 60)		Fair (61- 84)		Good (85 - 94)		Excellent (95 - 100)		Not Rated		
Colors on map represent condition scores at 0.10-mile intervals. See Appendix for definitions and formulas.										
Inspection Date:	4/21/2021	Beginning Section MP	0							
Paved Length (Miles):	0.3	Section Length (MI)	0.3							
Surface Type:	ASPHALT	Route Summary								
Roadway Condition Information										
Pavement Condition Rating (PCR)		99	99							
Surface Condition Rating (SCR)		99	99							
Roughness Condition Index (RCI)		N/A	N/A							
Distress Index Values										
Structural Crack Index		100	100							
Alligator Crack Index		100	100							
Longitudinal Crack Index		100	100							
Transverse Cracking Index		99	99							
Patching Index		100	100							
Rutting Index		100	100							
International Roughness Index (IRI)		N/A	N/A							
Lane & Width Information

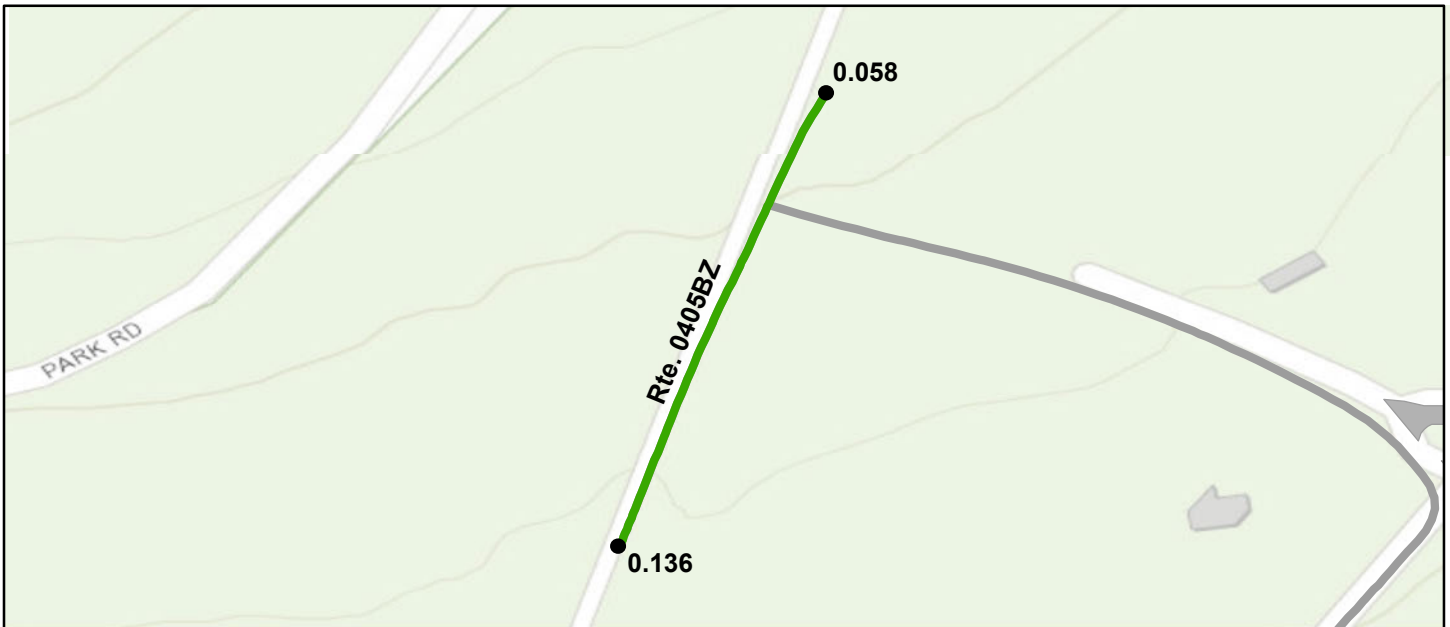
Subcomponent of Route HOFU-0405ZZ

Route Condition Legend – Pavement Condition Rating (PCR)						
Poor (0 - 60)	Fair (61- 84)	Good (85 - 94)	Excellent (95 - 100)	Not Rated		
Colors on map represent condition scores at 0.10-mile intervals. See Appendix for definitions and formulas.						
Inspection Date: 4/21/2021	Beginning Section MP	0.06				
Paved Length (Miles): 0.08	Section Length (MI)	0.08				
Surface Type: ASPHALT	Route Summary					
Roadway Condition Information						
Pavement Condition Rating (PCR)	89	89				
Surface Condition Rating (SCR)	89	89				
Roughness Condition Index (RCI)	N/A	N/A				
Distress Index Values						
Structural Crack Index	89	89				
Alligator Crack Index	100	100				
Longitudinal Crack Index	89	89				
Transverse Cracking Index	97	97				
Patching Index	100	100				
Rutting Index	92	92				
International Roughness Index (IRI)	N/A	N/A				
Lane & Width Information						
Number of Lanes	1	1				
Paved Width (ft)	8.8	8.8				
Lane Width (ft)	8.8	8.8

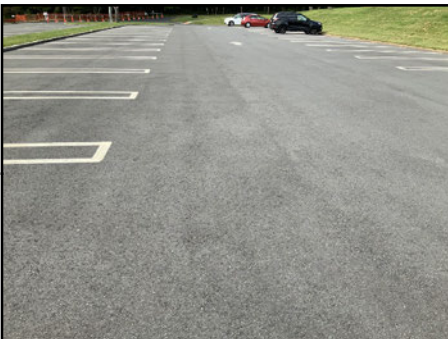
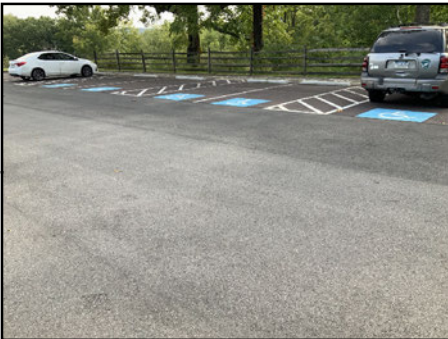
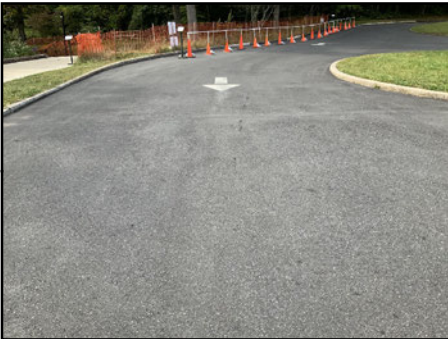
Inspection Date	FMSS Number	User Access	Surface Type
9/25/2020	19308	PUBLIC	ASPHALT
Area (Sq. Ft.)	Lane Miles (11' Widths)	Curb Reveal (Inches)	Curb Recommendation
29,672	0.511	3	LIGHT REPAIR
Curb Type		Curb & Gutter Type	
CONCRETE		NO CURB AND GUTTER	
Pavement Recommendation		Condition Rating / PCR	
PREVENTIVE MAINTENANCE		GOOD / 90

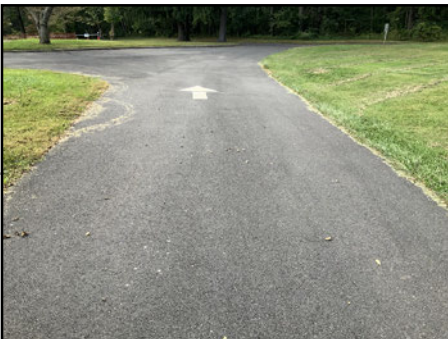
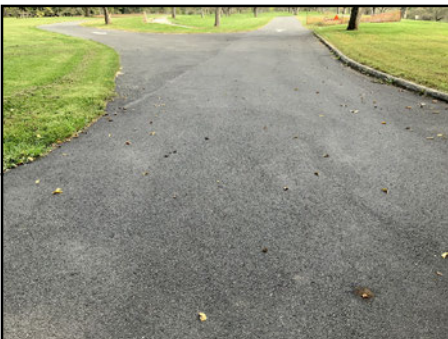
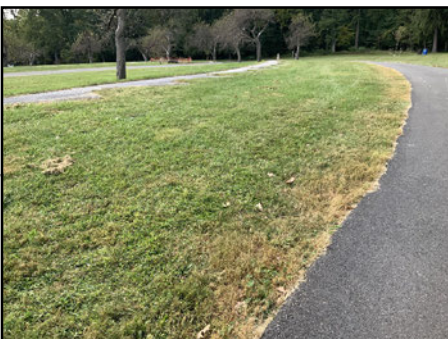
ROUTE 0901: UPPER VISITOR CENTER PARKING

Inspection Date	FMSS Number	User Access	Surface Type
9/25/2020	19307	PUBLIC	ASPHALT
Area (Sq. Ft.)	Lane Miles (11' Widths)	Curb Reveal (Inches)	Curb Recommendation
9,253	0.159	3	LIGHT REPAIR
Curb Type		Curb & Gutter Type	
CONCRETE		NO CURB AND GUTTER	
Pavement Recommendation		Condition Rating / PCR	
PREVENTIVE MAINTENANCE		GOOD / 90

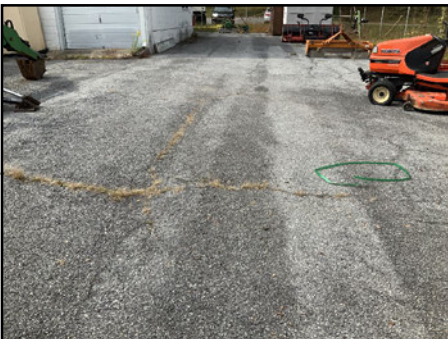
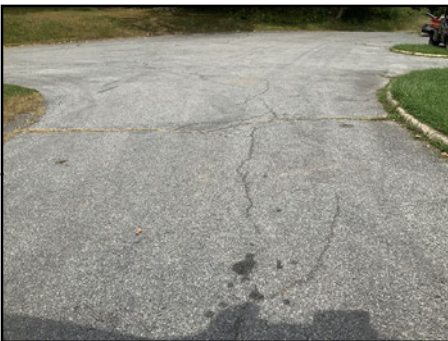
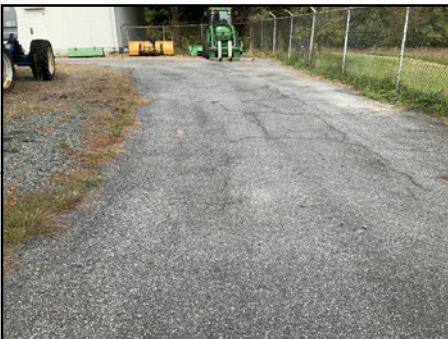
ROUTE 0903: MAINTENANCE AREA PARKING

Inspection Date	FMSS Number	User Access	Surface Type
9/25/2020	103660	NONPUBLIC	ASPHALT
Area (Sq. Ft.)	Lane Miles (11' Widths)	Curb Reveal (Inches)	Curb Recommendation
16,655	0.287	3	LIGHT REPAIR
Curb Type		Curb & Gutter Type	
CONCRETE		NO CURB AND GUTTER	
Pavement Recommendation		Condition Rating / PCR	
HEAVY 3R TREATMENTS		POOR / 53

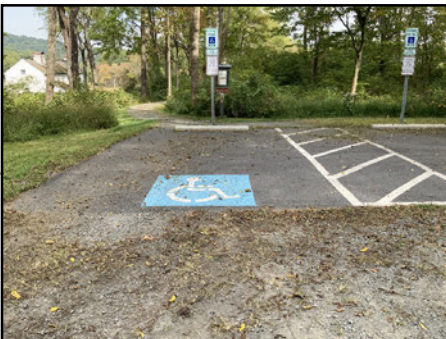
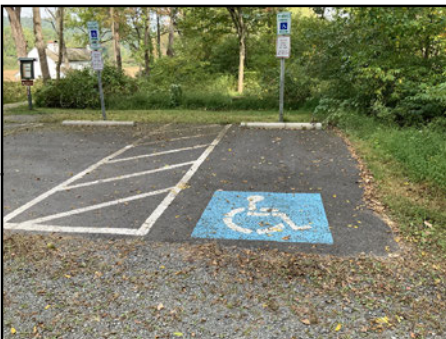
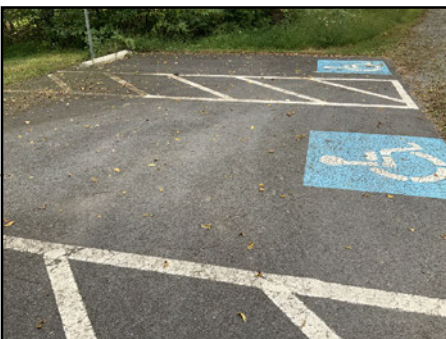
ROUTE 0905: LOWER VILLAGE ADA PARKING

Inspection Date	FMSS Number	User Access	Surface Type
9/25/2020	253463	PUBLIC	ASPHALT
Area (Sq. Ft.)	Lane Miles (11' Widths)	Curb Reveal (Inches)	Curb Recommendation
2,013	0.035	NOT APPLICABLE	NOT APPLICABLE
Curb Type		Curb & Gutter Type	
NO CURB		NO CURB AND GUTTER	
Pavement Recommendation		Condition Rating / PCR	
PREVENTIVE MAINTENANCE		GOOD / 90
