Final Report

Road Inventory and Condition Assessment of Paved Routes Homestead National Monument of America

Report Date: July 2018

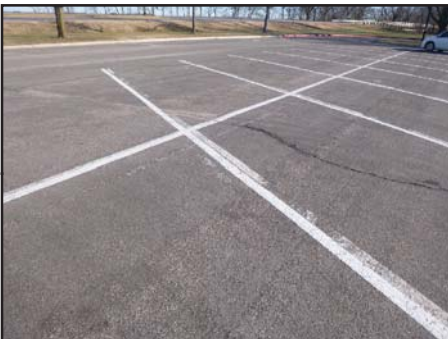
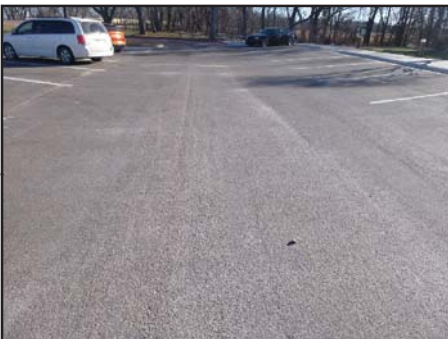
Inspection Date	FMSS Number	User Access	Surface Type
12/7/2017	61030	PUBLIC	ASPHALT
Area (Sq. Ft.)	Lane Miles (11' Widths)	Curb Reveal (Inches)	Curb Recommendation
31,367	0.54	NOT APPLICABLE	LIGHT REPAIR
Curb Type		Curb & Gutter Type	
NO CURB		CONCRETE	
Pavement Recommendation		Condition Rating / PCR	
PREVENTIVE MAINTENANCE		GOOD / 90

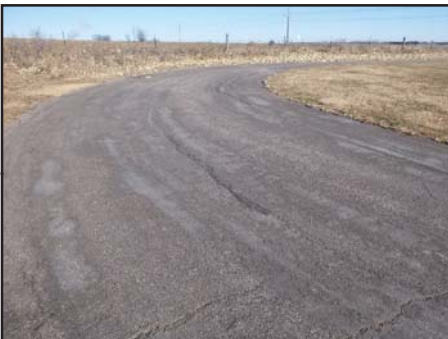
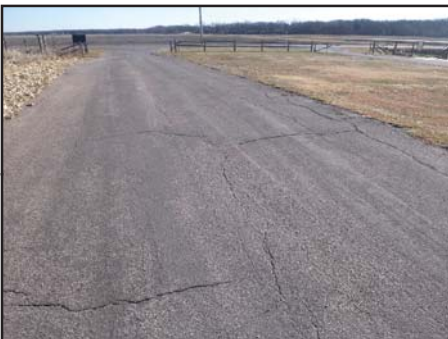
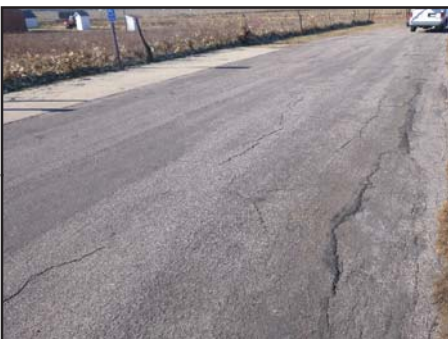
ROUTE 0901B: FREEMAN SCHOOL PARKING

Inspection Date	FMSS Number	User Access	Surface Type
12/7/2017	81569	PUBLIC	ASPHALT
Area (Sq. Ft.)	Lane Miles (11' Widths)	Curb Reveal (Inches)	Curb Recommendation
8,012	0.138	NOT APPLICABLE	NOT APPLICABLE
Curb Type		Curb & Gutter Type	
NO CURB		NO CURB AND GUTTER	
Pavement Recommendation		Condition Rating / PCR	
LIGHT 3R TREATMENTS		FAIR / 73

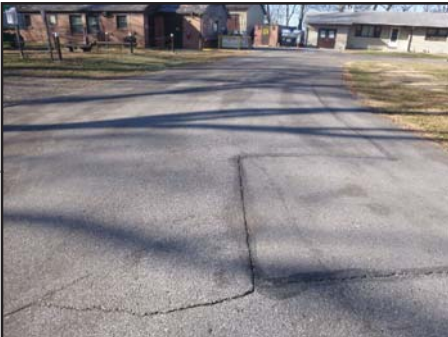
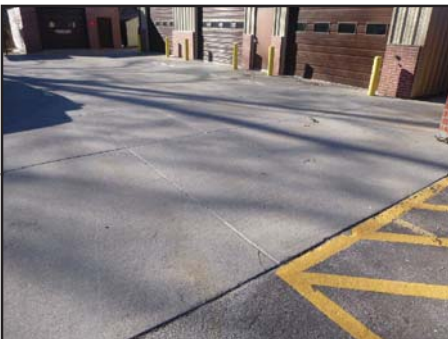
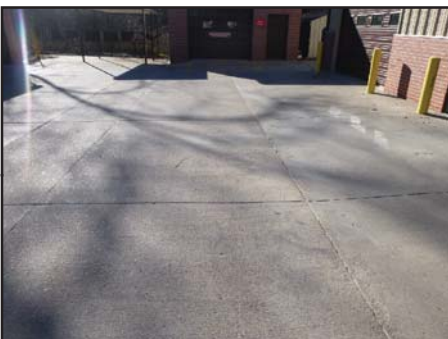
ROUTE 0902: RESIDENCE/ MAINTENANCE PARKING

Inspection Date	FMSS Number	User Access	Surface Type
12/7/2017	61067	NONPUBLIC	ASPHALT
Area (Sq. Ft.)	Lane Miles (11' Widths)	Curb Reveal (Inches)	Curb Recommendation
12,840	0.221	NOT APPLICABLE	LIGHT REPAIR
Curb Type		Curb & Gutter Type	
NO CURB		CONCRETE	
Pavement Recommendation		Condition Rating / PCR	
PREVENTIVE MAINTENANCE		GOOD / 90

Note: Parking area consists of multiple surface types: 1 part Asphalt at 7,647 square feet; 1 part Concrete at 5,193 square feet.

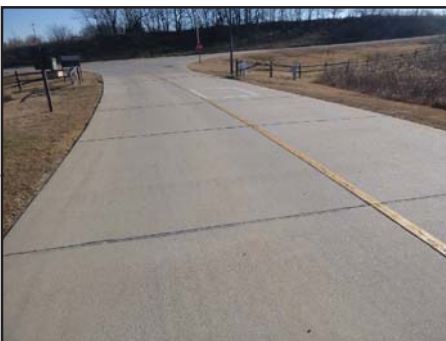
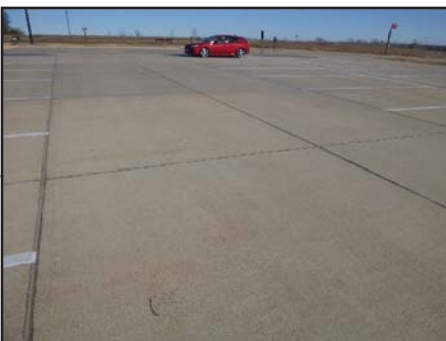
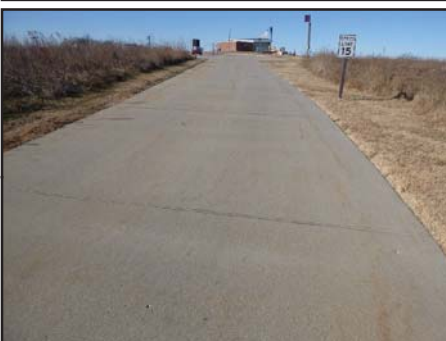
ROUTE 0903: HERITAGE CENTER PARKING LOT

Inspection Date	FMSS Number	User Access	Surface Type
12/7/2017	90097	PUBLIC	CONCRETE
Area (Sq. Ft.)	Lane Miles (11' Widths)	Curb Reveal (Inches)	Curb Recommendation
87,294	1.503	5	DO NOTHING
Curb Type		Curb & Gutter Type	
CONCRETE		NO CURB AND GUTTER	
Pavement Recommendation		Condition Rating / PCR	
PREVENTIVE MAINTENANCE		GOOD / 90
