# HUTR Cycle 6

## Final Report

### Road Inventory and Condition Assessment of Paved Routes Hubbell Trading Post National Historic Site

Report Date: March 2017

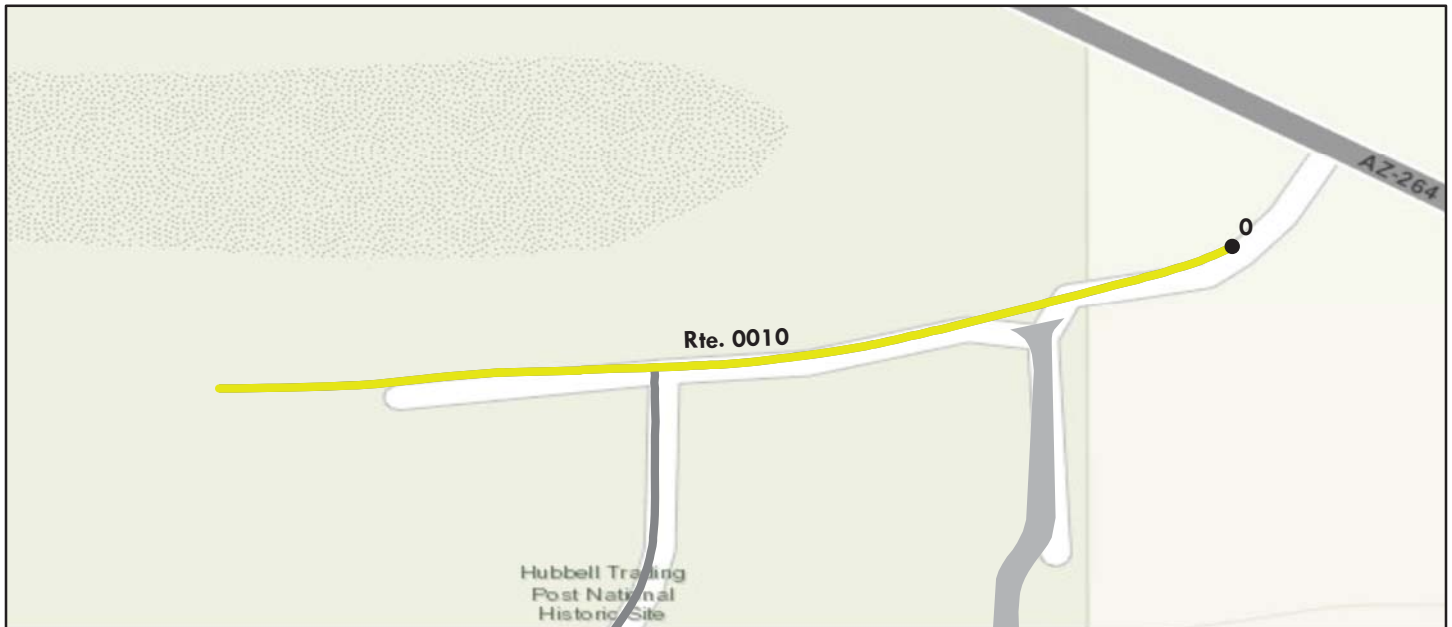
## ROUTE 0010: ENTRANCE ROAD

Route Condition Legend – Pavement Condition Rating (PCR)						
Poor (0 - 60)	Fair (61- 84)	Good (85 - 94)	Excellent (95 - 100)	Not Rated		
See Appendix for definitions and formulas						
<b>Inspection Date:</b> 11/3/2016	<b>Beginning Section MP</b>	0				
<b>Paved Length (Miles):</b> 0.14	<b>Section Length (MI)</b>	0.14				
<b>Surface Type:</b> ASPHALT	<b>Route Summary</b>					
<b>Roadway Condition Information</b>						
Pavement Condition Rating (PCR)	87	87				
Surface Condition Rating (SCR)	87	87				
Roughness Condition Index (RCI)	N/A	N/A				
<b>Distress Index Values</b>						
Structural Crack Index	87	87				
Alligator Crack Index	100	100				
Longitudinal Crack Index	87	87				
Transverse Cracking Index	90	90				
Patching Index	100	100				
Rutting Index	89	89				
International Roughness Index (IRI)	N/A	N/A				
<b>Lane &amp; Width Information</b>						
Number of Lanes	2	2				
Paved Width (ft)	21.3	21.3				
Lane Width (ft)	11	11

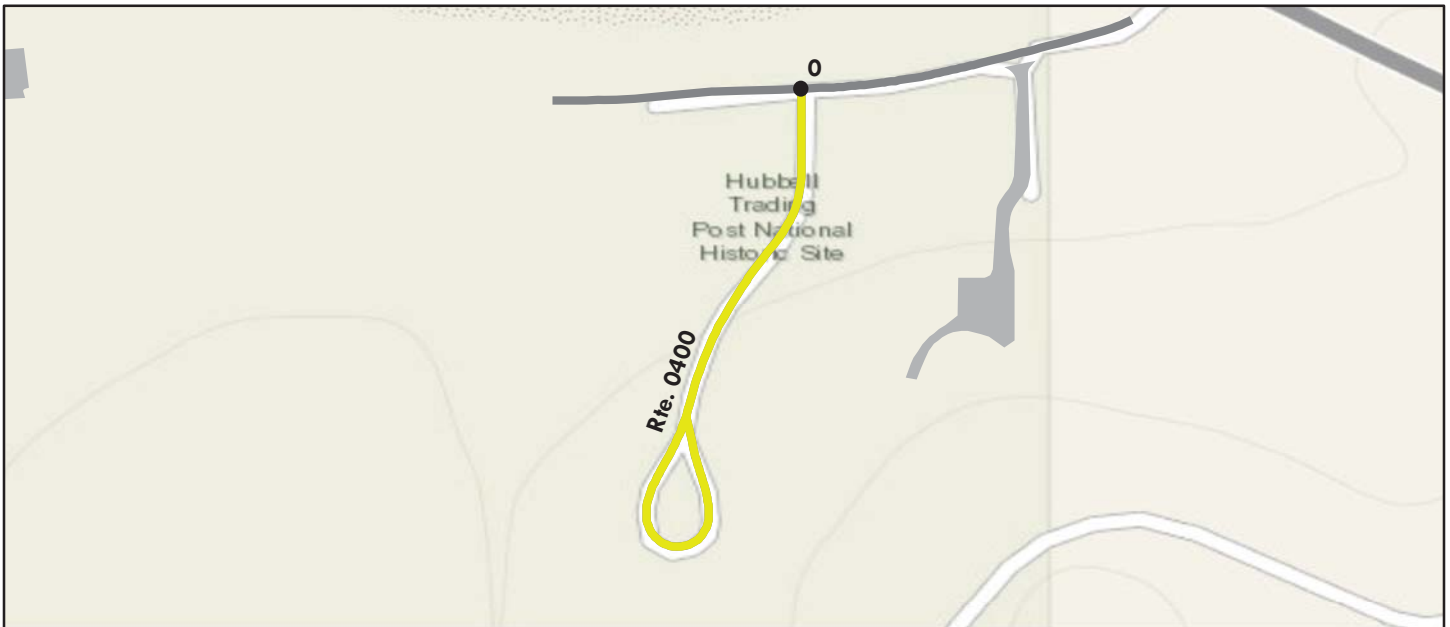
## ROUTE 0400: RESIDENCE ROAD

Route Condition Legend – Pavement Condition Rating (PCR)						
Poor (0 - 60)	Fair (61- 84)	Good (85 - 94)	Excellent (95 - 100)	Not Rated		
See Appendix for definitions and formulas						
<b>Inspection Date:</b> 11/3/2016	<b>Beginning Section MP</b>	0				
<b>Paved Length (Miles):</b> 0.18	<b>Section Length (MI)</b>	0.18				
<b>Surface Type:</b> ASPHALT	<b>Route Summary</b>					
<b>Roadway Condition Information</b>						
Pavement Condition Rating (PCR)	80	80				
Surface Condition Rating (SCR)	80	80				
Roughness Condition Index (RCI)	N/A	N/A				
<b>Distress Index Values</b>						
Structural Crack Index	87	87				
Alligator Crack Index	100	100				
Longitudinal Crack Index	87	87				
Transverse Cracking Index	80	80				
Patching Index	100	100				
Rutting Index	99	99				
International Roughness Index (IRI)	N/A	N/A				
<b>Lane &amp; Width Information</b>						
Number of Lanes	2	2				
Paved Width (ft)	22.1	22.1				
Lane Width (ft)	13	13

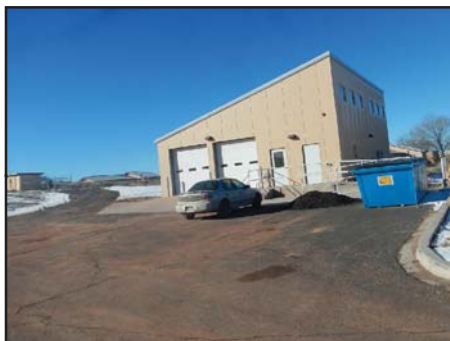
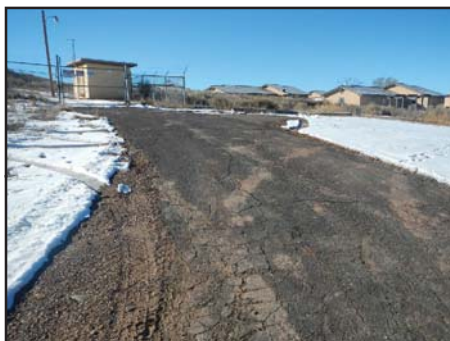
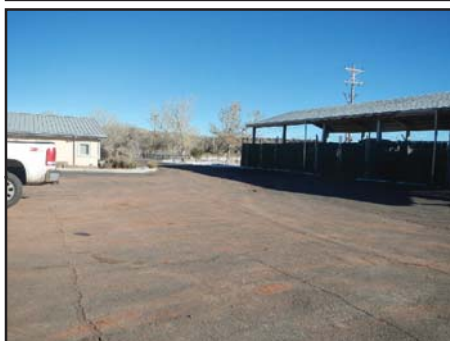
Inspection Date	FMSS Number	User Access	Surface Type
1/13/2016	74186	NONPUBLIC	ASPHALT
Area (Sq. Ft.)	Lane Miles (11' Widths)	Curb Reveal (Inches)	Curb Recommendation
15,047	0.259	NOT APPLICABLE	DO NOTHING
Curb Type		Curb & Gutter Type	
NO CURB		CONCRETE	
Pavement Recommendation		Condition Rating / PCR	
HEAVY 3R TREATMENTS		POOR / 53

Parking area consists of multiple surface types: 1 part Asphalt at 14,017 square feet; 1 part Concrete at 1,030 square feet.

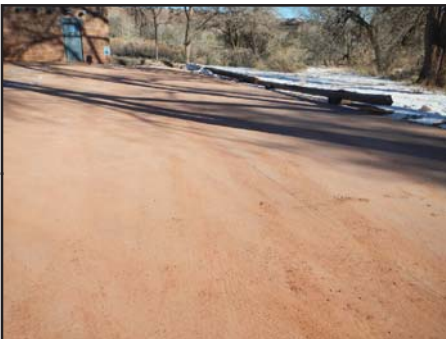
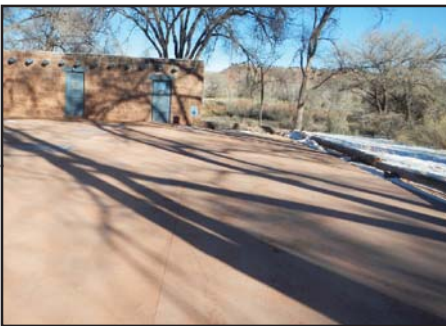
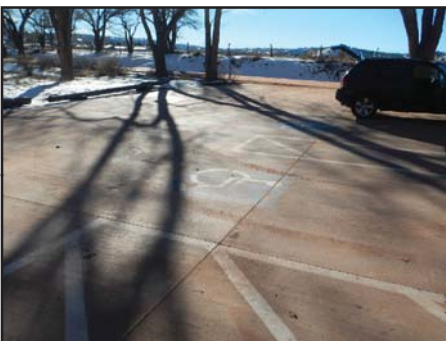
## ROUTE 0903: COMFORT STATION PARKING

Inspection Date	FMSS Number	User Access	Surface Type
1/13/2016	237478	PUBLIC	CONCRETE
Area (Sq. Ft.)	Lane Miles (11' Widths)	Curb Reveal (Inches)	Curb Recommendation
3,051	0.053	NOT APPLICABLE	NOT APPLICABLE
Curb Type		Curb & Gutter Type	
NO CURB		NO CURB AND GUTTER	
Pavement Recommendation		Condition Rating / PCR	
DO NOTHING		EXCELLENT / 97
