JEFF Cycle 6

Final Report

Road Inventory and Condition Assessment of Paved Routes Gateway Arch National Park

**Federal Highway Administration
Eastern Federal Lands Highway Division
Road Inventory Program (RIP)**

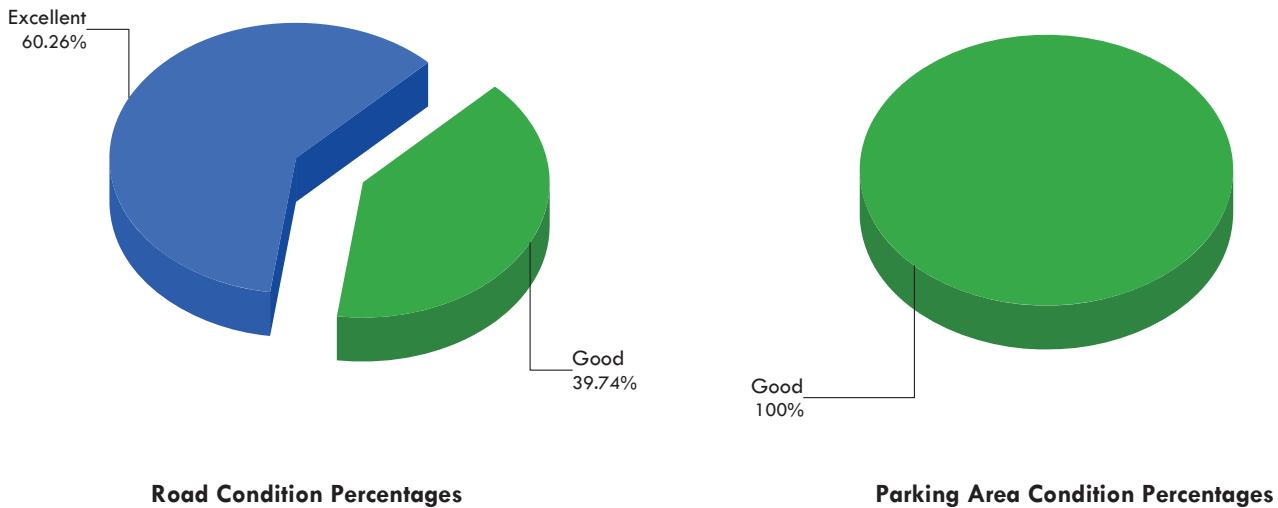
Figure 1: Pavement Condition Rating Breakdown for Paved Roads and Parking Areas

Parkwide Condition Percentages

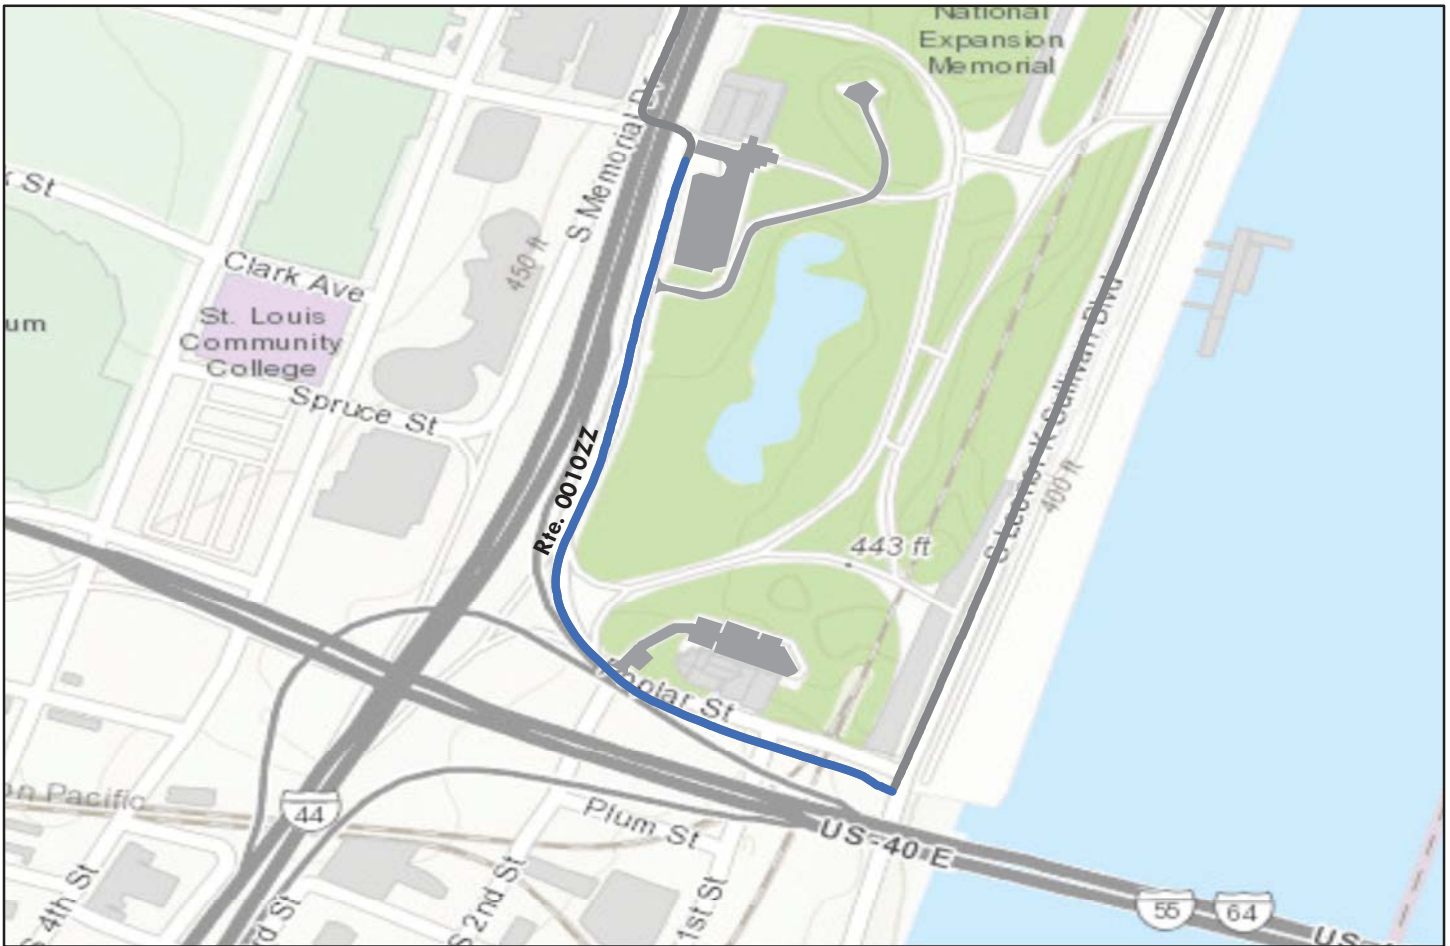
ROUTE 0010ZZ: POPLAR STREET AND MEMORIAL DRIVE

Note: The weighted average summary PCR value is calculated from only the sections of road where the PCR was collected. The overall PCR for the summary route may not reflect individual subcomponent ratings.

Inspection Date:	11/2/2017					
Paved Length (Miles):	0.4					
Surface Type:	ASPHALT	Route Summary				
Roadway Condition Information						
Pavement Condition Rating (PCR)	95					
Lane & Width Information						
Number of Lanes	1					
Paved Width (ft)	21.4					
Lane Width (ft)	13.3

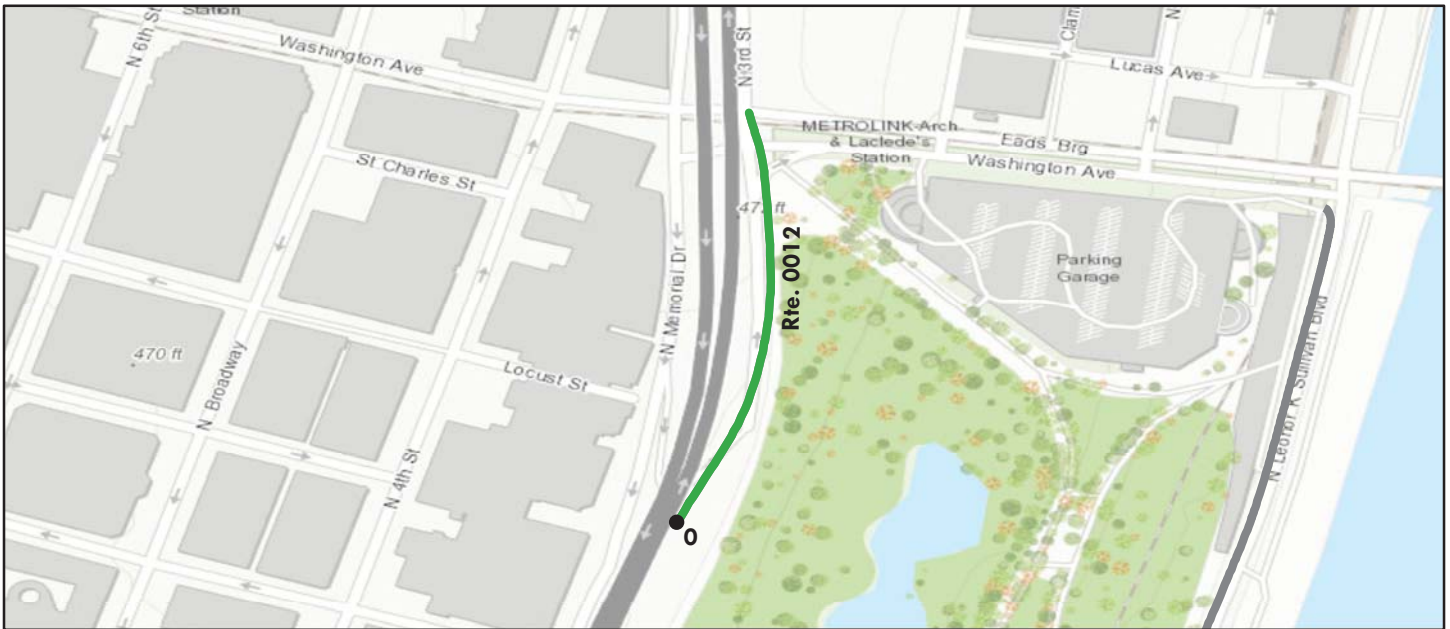
ROUTE 0012: MEMORIAL DRIVE EAST LANE

Route Condition Legend – Pavement Condition Rating (PCR)					
Poor (0 - 60)	Fair (61- 84)	Good (85 - 94)	Excellent (95 - 100)	Not Rated	
Colors on map represent condition scores at 0.10-mile intervals. See Appendix for definitions and formulas.					
Inspection Date:	11/2/2017	Beginning Section MP	0		
Paved Length (Miles):	0.18	Section Length (MI)	0.17		
Surface Type:	CONCRETE	Route Summary			
Roadway Condition Information					
Pavement Condition Rating (PCR)	90	90			
Surface Condition Rating (SCR)	N/A	N/A			
Roughness Condition Index (RCI)	N/A	N/A			
Distress Index Values					
Structural Crack Index	N/A	N/A			
Alligator Crack Index	N/A	N/A			
Longitudinal Crack Index	N/A	N/A			
Transverse Cracking Index	N/A	N/A			
Patching Index	N/A	N/A			
Rutting Index	N/A	N/A			
International Roughness Index (IRI)	N/A	N/A			
Lane & Width Information					
Number of Lanes	1	1			
Paved Width (ft)	24.4	24.4			
Lane Width (ft)	12.3	12.3

NOTE: Because Route 0012 is concrete, the RIP Data Collection Vehicle (DCV) drove the route for video and GPS, but not for condition. The DCV only collects roughness on concrete roads when the speed limit is at least 25 mph and the length is at least 0.5 miles. The PCR assigned to this road is from a manual rating.

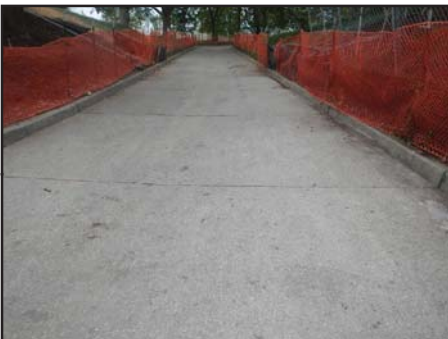
ROUTE 0900AZ: VISITOR CENTER SERVICE ROAD AND PARKING

Inspection Date	FMSS Number	User Access	Surface Type
9/18/2017	101975	NONPUBLIC	CONCRETE
Area (Sq. Ft.)	Lane Miles (11' Widths)	Curb Reveal (Inches)	Curb Recommendation
16,381	0.282	5	DO NOTHING
Curb Type		Curb & Gutter Type	
CONCRETE		NO CURB AND GUTTER	
Pavement Recommendation		Condition Rating / PCR	
PREVENTIVE MAINTENANCE		GOOD / 90

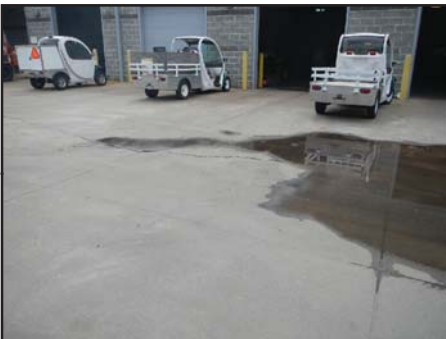
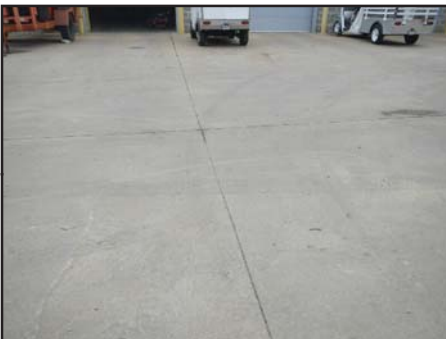
ROUTE 0900CZ: MAINTENANCE YARD

Inspection Date	FMSS Number	User Access	Surface Type
9/18/2017	101975	NONPUBLIC	CONCRETE
Area (Sq. Ft.)	Lane Miles (11' Widths)	Curb Reveal (Inches)	Curb Recommendation
23,178	0.399	5	DO NOTHING
Curb Type		Curb & Gutter Type	
CONCRETE		NO CURB AND GUTTER	
Pavement Recommendation		Condition Rating / PCR	
PREVENTIVE MAINTENANCE		GOOD / 90

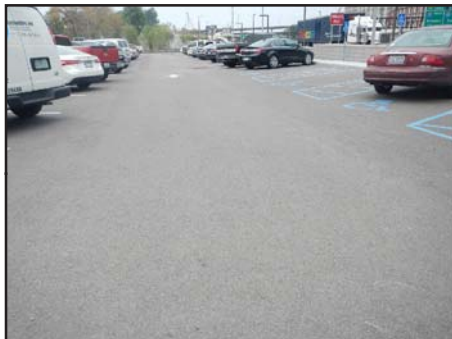
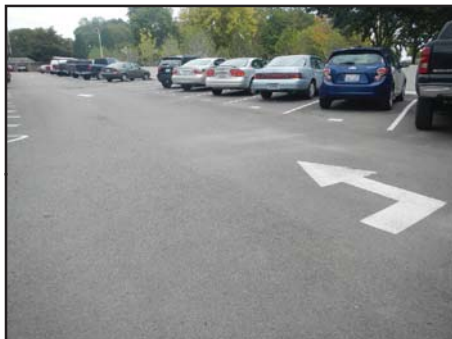
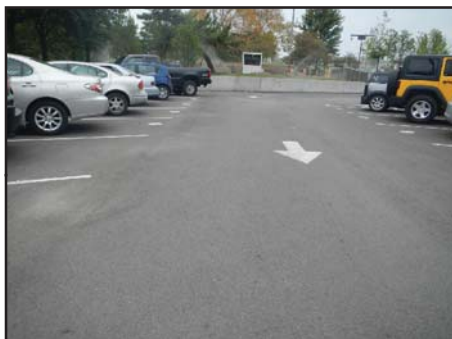
ROUTE 0901: OLD CATHEDRAL PARKING AREA

Inspection Date	FMSS Number	User Access	Surface Type
9/18/2017	101976	PUBLIC	ASPHALT
Area (Sq. Ft.)	Lane Miles (11' Widths)	Curb Reveal (Inches)	Curb Recommendation
36,122	0.622	5	DO NOTHING
Curb Type		Curb & Gutter Type	
CONCRETE		NO CURB AND GUTTER	
Pavement Recommendation		Condition Rating / PCR	
PREVENTIVE MAINTENANCE		GOOD / 90

Note: Parking area consists of multiple surface types: 3 parts Asphalt at 31,389 square feet; 1 part Brick at 4,733 square feet.
