# JODA Cycle 6

## Final Report

### Road Inventory and Condition Assessment of Paved Routes John Day Fossil Beds National Monument

**Report Date: February 2016**

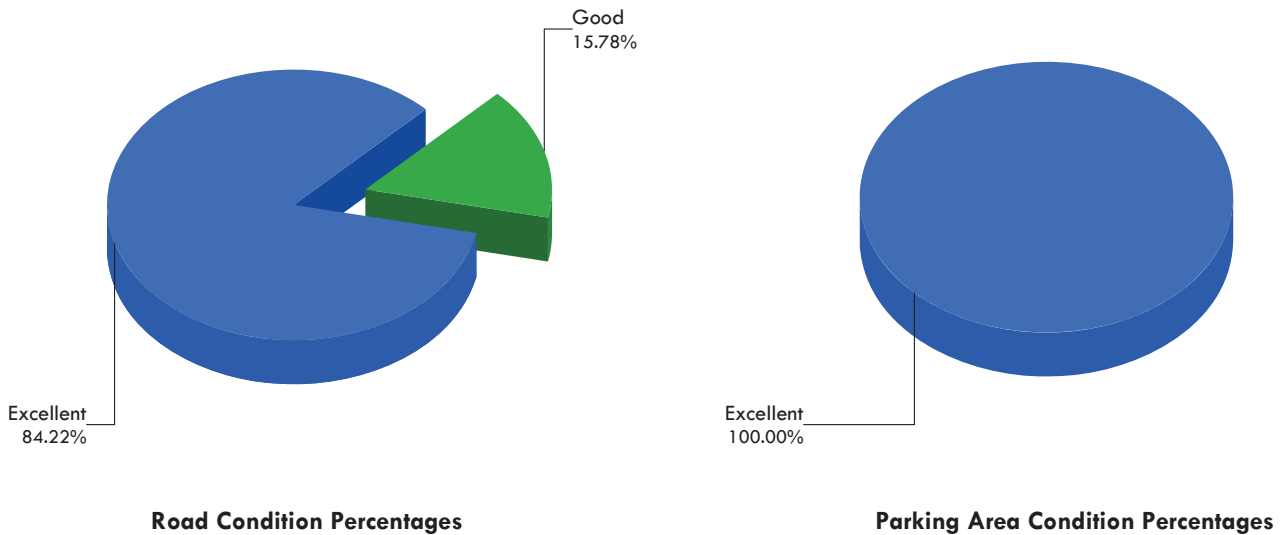
Figure 1: Pavement Condition Rating Breakdown for Paved Roads and Parking Areas

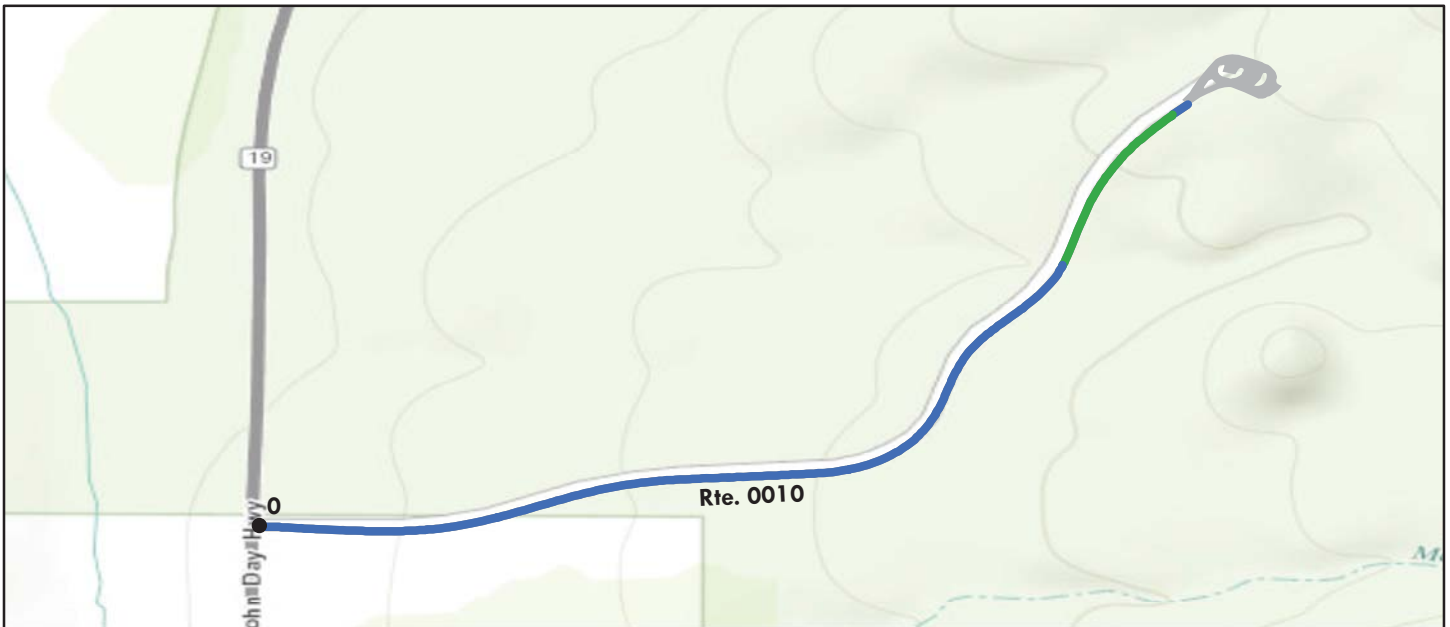
## ROUTE 0010: FOREE ROAD

Route Condition Legend – Pavement Condition Rating (PCR)							
Poor (0 - 60)		Fair (61- 84)		Good (85 - 94)		Excellent (95 - 100)	Not Rated
See Appendix for definitions and formulas							
<b>Inspection Date:</b>	8/1/2015	<b>Beginning Section MP</b>	0				
<b>Paved Length (Miles):</b>	0.51	<b>Section Length (MI)</b>	0.51				
<b>Surface Type:</b>	ASPHALT	<b>Route Summary</b>					
<b>Roadway Condition Information</b>							
Pavement Condition Rating (PCR)		97	97				
Surface Condition Rating (SCR)		96	96				
Roughness Condition Index (RCI)		99	99				
<b>Distress Index Values</b>							
Structural Crack Index		100	100				
Alligator Crack Index		100	100				
Longitudinal Crack Index		100	100				
Transverse Cracking Index		96	96				
Patching Index		100	100				
Rutting Index		99	99				
International Roughness Index (IRI)		118	118				
<b>Lane &amp; Width Information</b>							
Number of Lanes		2	2				
Paved Width (ft)		24.3	24.3

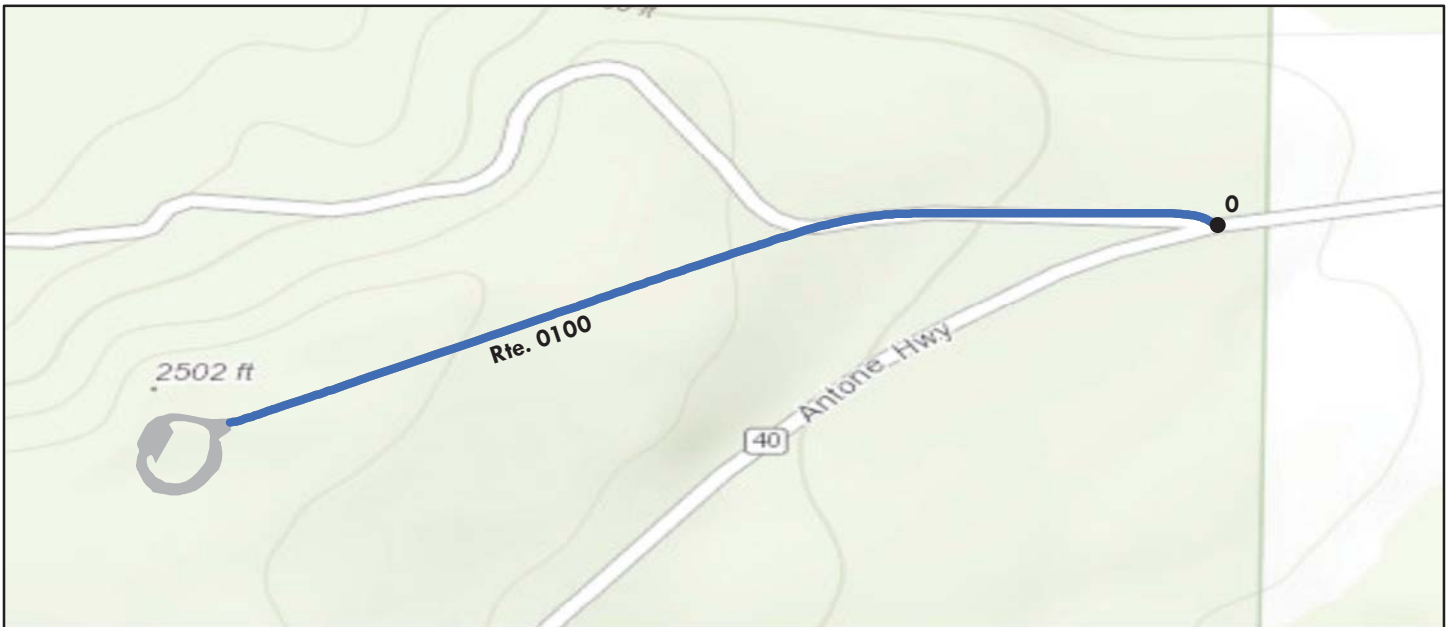
## ROUTE 0100: MASCALL OVERLOOK ROAD

Route Condition Legend – Pavement Condition Rating (PCR)						
Poor (0 - 60)	Fair (61- 84)	Good (85 - 94)	Excellent (95 - 100)	Not Rated		
See Appendix for definitions and formulas						
<b>Inspection Date:</b> 8/1/2015	<b>Beginning Section MP</b>	0				
<b>Paved Length (Miles):</b> 0.38	<b>Section Length (MI)</b>	0.38				
<b>Surface Type:</b> ASPHALT	<b>Route Summary</b>					
<b>Roadway Condition Information</b>						
Pavement Condition Rating (PCR)	99	99				
Surface Condition Rating (SCR)	99	99				
Roughness Condition Index (RCI)	N/A	N/A				
<b>Distress Index Values</b>						
Structural Crack Index	100	100				
Alligator Crack Index	100	100				
Longitudinal Crack Index	100	100				
Transverse Cracking Index	100	100				
Patching Index	100	100				
Rutting Index	99	99				
International Roughness Index (IRI)	N/A	N/A				
<b>Lane &amp; Width Information</b>						
Number of Lanes	2	2				
Paved Width (ft)	20.8	20.8

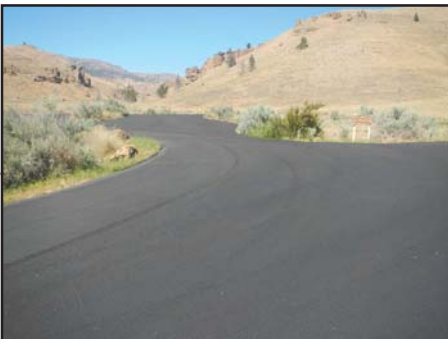
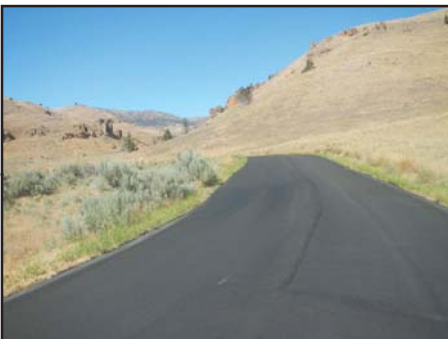
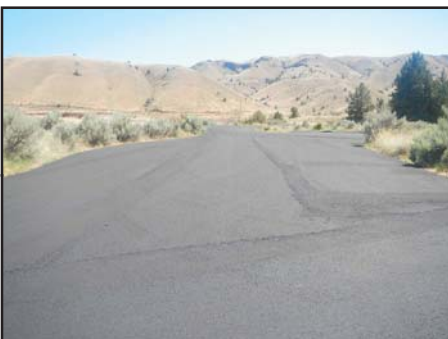
Inspection Date	FMSS Number	User Access	Surface Type
6/13/2015	28812	PUBLIC	ASPHALT
Area (Sq. Ft.)	Lane Miles (11' Widths)	Curb Reveal (Inches)	Curb Recommendation
35,798	0.616	7	DO NOTHING
Curb Type		Curb & Gutter Type	
WOOD		NO CURB AND GUTTER	
Pavement Recommendation		Condition Rating / PCR	
DO NOTHING		EXCELLENT / 97

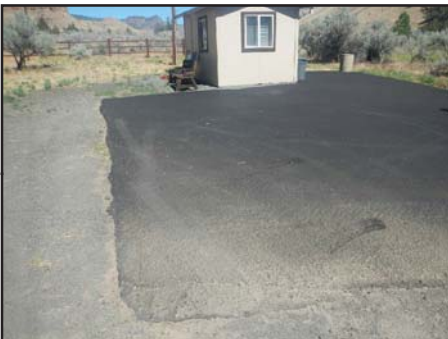
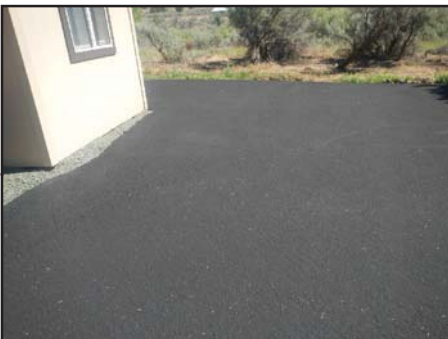
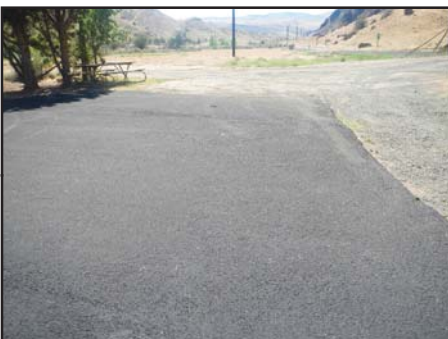
## ROUTE 0901: CLARNO RANGERS OFFICE PARKING

Inspection Date	FMSS Number	User Access	Surface Type
6/13/2015	28830	NONPUBLIC	ASPHALT
Area (Sq. Ft.)	Lane Miles (11' Widths)	Curb Reveal (Inches)	Curb Recommendation
884	0.015	NOT APPLICABLE	NOT APPLICABLE
Curb Type		Curb & Gutter Type	
NO CURB		NO CURB AND GUTTER	
Pavement Recommendation		Condition Rating / PCR	
DO NOTHING		EXCELLENT / 97

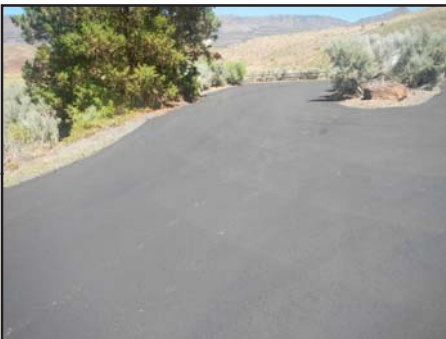
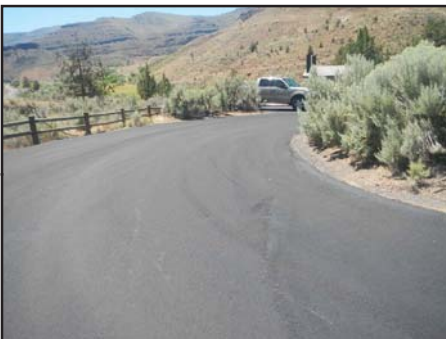
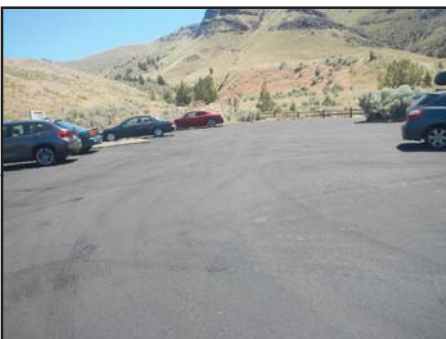
## ROUTE 0908: BLUE BASIN PARKING

Inspection Date	FMSS Number	User Access	Surface Type
6/13/2015	29056	PUBLIC	ASPHALT
Area (Sq. Ft.)	Lane Miles (11' Widths)	Curb Reveal (Inches)	Curb Recommendation
18,668	0.321	NOT APPLICABLE	NOT APPLICABLE
Curb Type		Curb & Gutter Type	
NO CURB		NO CURB AND GUTTER	
Pavement Recommendation		Condition Rating / PCR	
DO NOTHING		EXCELLENT / 97

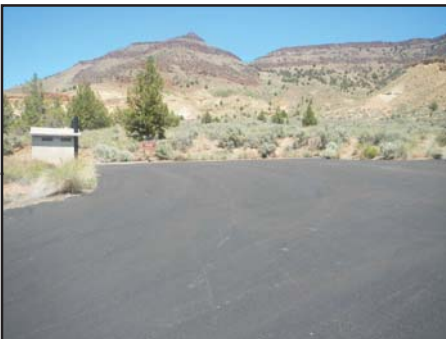
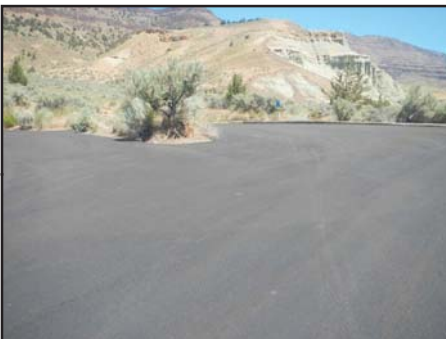
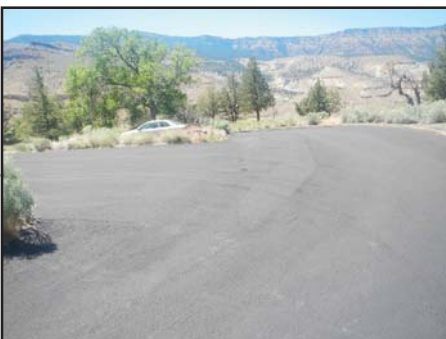
## ROUTE 0909: FOREE PARKING

Inspection Date	FMSS Number	User Access	Surface Type
6/13/2015	29073	PUBLIC	ASPHALT
Area (Sq. Ft.)	Lane Miles (11' Widths)	Curb Reveal (Inches)	Curb Recommendation
15,773	0.272	7	DO NOTHING
Curb Type		Curb & Gutter Type	
WOOD		NO CURB AND GUTTER	
Pavement Recommendation		Condition Rating / PCR	
DO NOTHING		EXCELLENT / 97

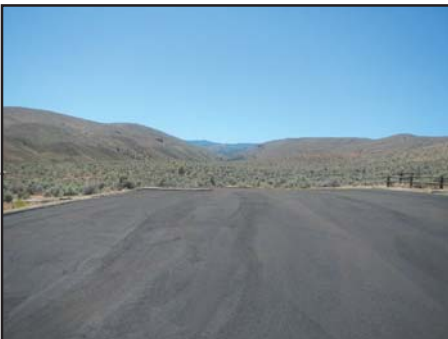
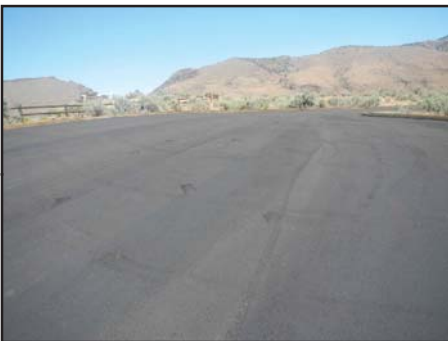
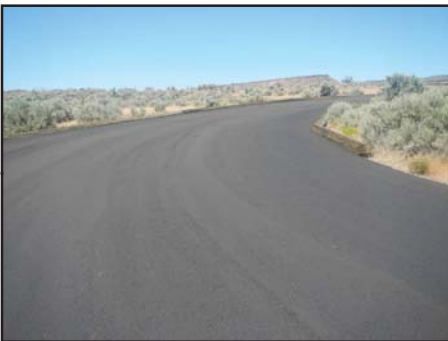
## ROUTE 0911: MASCALL OVERLOOK PARKING

Inspection Date	FMSS Number	User Access	Surface Type
6/13/2015	29084	PUBLIC	ASPHALT
Area (Sq. Ft.)	Lane Miles (11' Widths)	Curb Reveal (Inches)	Curb Recommendation
16,296	0.281	6	DO NOTHING
Curb Type		Curb & Gutter Type	
WOOD		NO CURB AND GUTTER	
Pavement Recommendation		Condition Rating / PCR	
DO NOTHING		EXCELLENT / 97

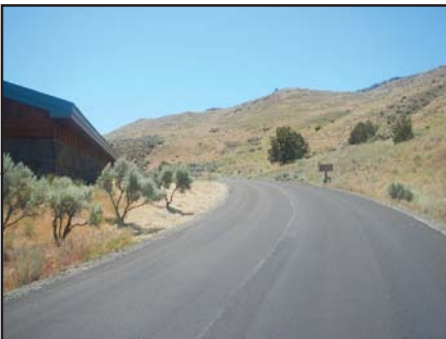
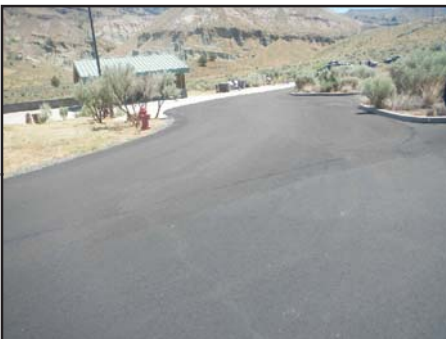
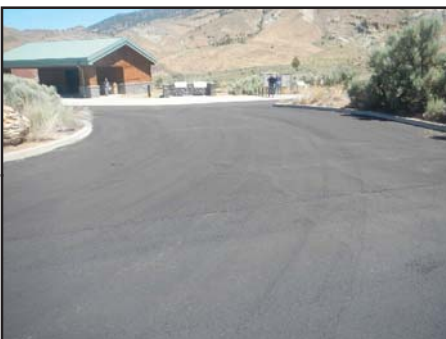
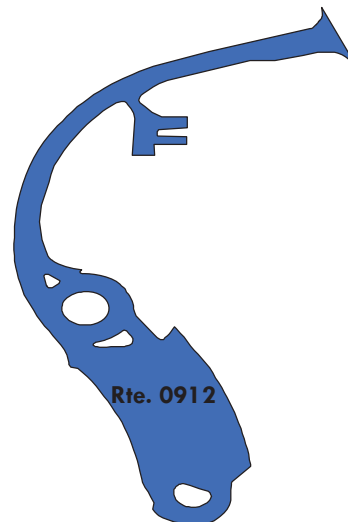
## ROUTE 0912: PALEONTOLOGY CENTER PARKING

Inspection Date	FMSS Number	User Access	Surface Type
6/13/2015	37151	PUBLIC	ASPHALT
Area (Sq. Ft.)	Lane Miles (11' Widths)	Curb Reveal (Inches)	Curb Recommendation
61,774	1.064	6	DO NOTHING
Curb Type		Curb & Gutter Type	
CONCRETE		NO CURB AND GUTTER	
Pavement Recommendation		Condition Rating / PCR	
DO NOTHING		EXCELLENT / 97

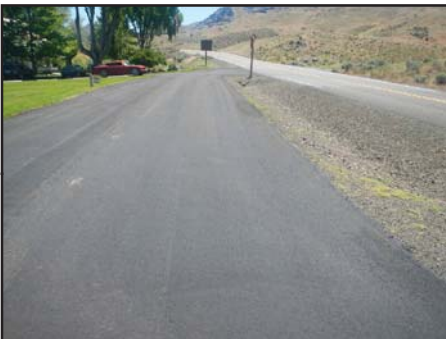
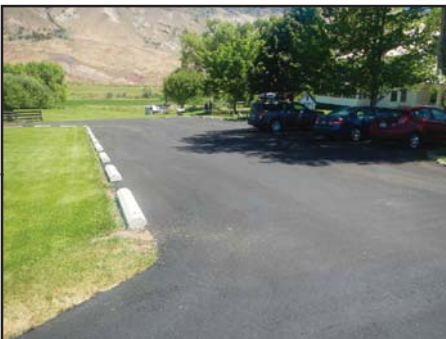
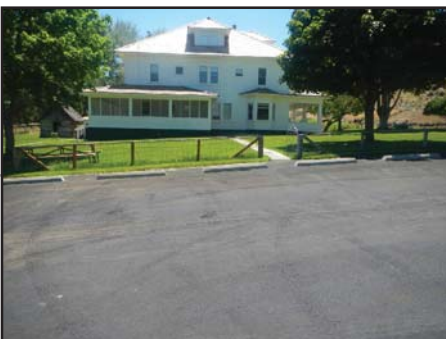
## ROUTE 0914: CANT RANCH VISITORS PARKING

Inspection Date	FMSS Number	User Access	Surface Type
6/13/2015	29156	PUBLIC	ASPHALT
Area (Sq. Ft.)	Lane Miles (11' Widths)	Curb Reveal (Inches)	Curb Recommendation
16,453	0.283	NOT APPLICABLE	NOT APPLICABLE
Curb Type		Curb & Gutter Type	
NO CURB		NO CURB AND GUTTER	
Pavement Recommendation		Condition Rating / PCR	
DO NOTHING		EXCELLENT / 97
