JODR Cycle 6

Final Report

Road Inventory and Condition Assessment of Paved Routes John D. Rockefeller, Jr. Memorial Parkway

Report Date: May 2017

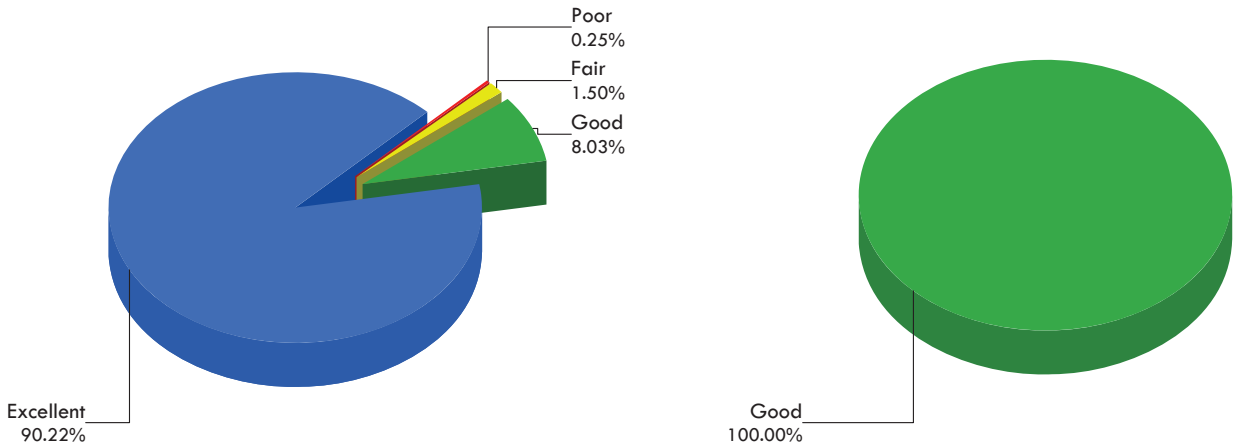
Figure 1: Pavement Condition Rating Breakdown for Paved Roads and Parking Areas

Road Condition Percentages

Parking Area Condition Percentages

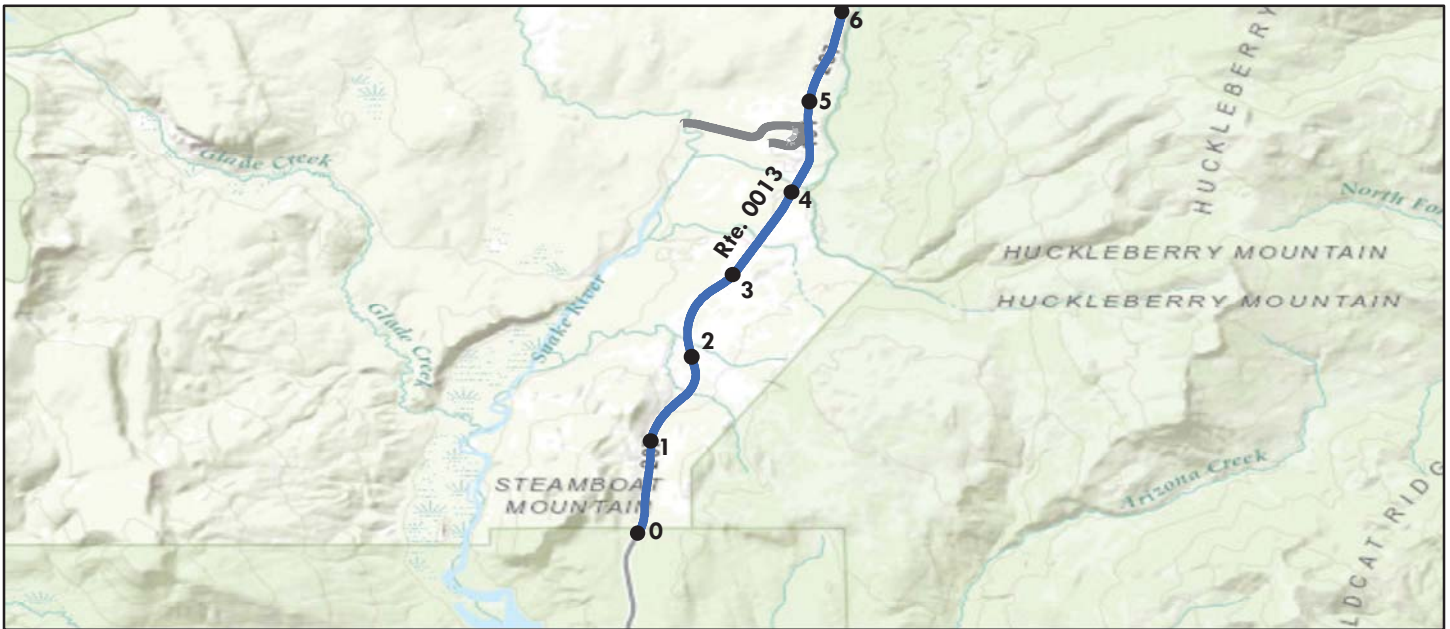
ROUTE 0013: JDR PARKWAY ROAD

Route Condition Legend – Pavement Condition Rating (PCR)						
Poor (0 - 60)	Fair (61- 84)	Good (85 - 94)	Excellent (95 - 100)	Not Rated		
See Appendix for definitions and formulas						
Inspection Date: 9/15/2016	Beginning Section MP	0	1	2	3	4
Paved Length (Miles): 6.56	Section Length (MI)	1	1	1	1	1
Surface Type: ASPHALT	Route Summary					
Roadway Condition Information						
Pavement Condition Rating (PCR)	99	100	100	100	100	100
Surface Condition Rating (SCR)	99	100	100	100	100	100
Roughness Condition Index (RCI)	100	100	100	100	100	100
Distress Index Values						
Structural Crack Index	100	100	100	100	100	100
Alligator Crack Index	100	100	100	100	100	100
Longitudinal Crack Index	100	100	100	100	100	100
Transverse Cracking Index	100	100	100	100	100	100
Patching Index	100	100	100	100	100	100
Rutting Index	99	100	100	100	100	100
International Roughness Index (IRI)	50	48	47	47	44	59
Lane & Width Information

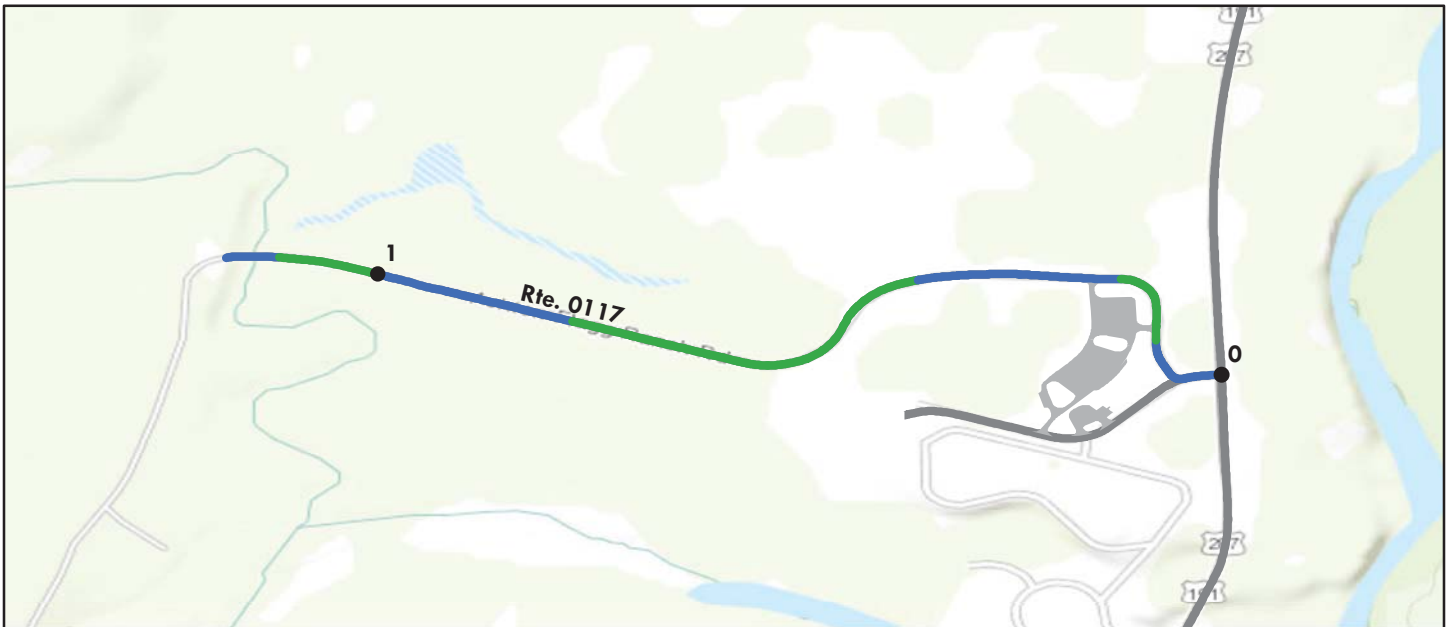
ROUTE 0117: GRASSY LAKE ROAD

Route Condition Legend – Pavement Condition Rating (PCR)						
Poor (0 - 60)	Fair (61- 84)	Good (85 - 94)	Excellent (95 - 100)	Not Rated		
See Appendix for definitions and formulas						
Inspection Date: 9/15/2016	Beginning Section MP	0	1			
Paved Length (Miles): 1.15	Section Length (MI)	1	0.15			
Surface Type: ASPHALT	Route Summary					
Roadway Condition Information						
Pavement Condition Rating (PCR)	93	94	88			
Surface Condition Rating (SCR)	99	99	98			
Roughness Condition Index (RCI)	85	86	74			
Distress Index Values						
Structural Crack Index	100	99	100			
Alligator Crack Index	100	100	100			
Longitudinal Crack Index	100	99	100			
Transverse Cracking Index	100	100	100			
Patching Index	100	100	100			
Rutting Index	99	99	98			
International Roughness Index (IRI)	155	150	188			
Lane & Width Information						
Number of Lanes	2	2	2			
Paved Width (ft)	24.2	24.8	20.2			
Lane Width (ft)	10.7	10.8	10.1

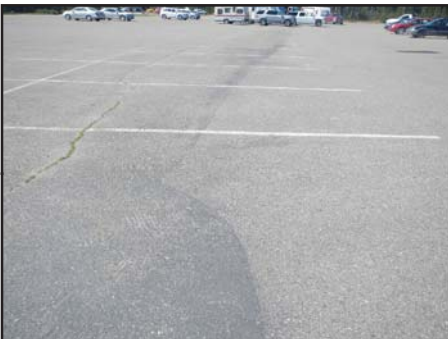
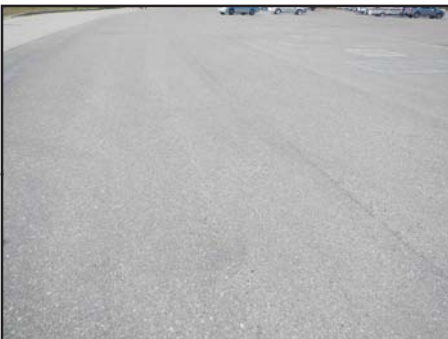
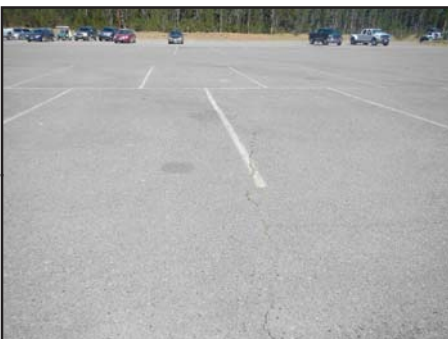
ROUTE 0979: FLAGG SOUTH PARKING

Inspection Date	FMSS Number	User Access	Surface Type
7/25/2016	35935	PUBLIC	ASPHALT
Area (Sq. Ft.)	Lane Miles (11' Widths)	Curb Reveal (Inches)	Curb Recommendation
112,244	1.933	NOT APPLICABLE	LIGHT REPAIR
Curb Type		Curb & Gutter Type	
NO CURB		CONCRETE	
Pavement Recommendation		Condition Rating / PCR	
PREVENTIVE MAINTENANCE		GOOD / 90

Parking area consists of multiple surface types: 1 part Asphalt at 107,331 square feet; 1 part Concrete at 4,913 square feet.

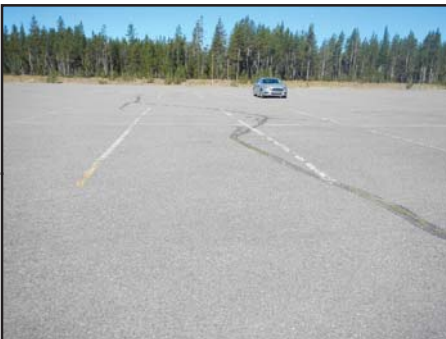
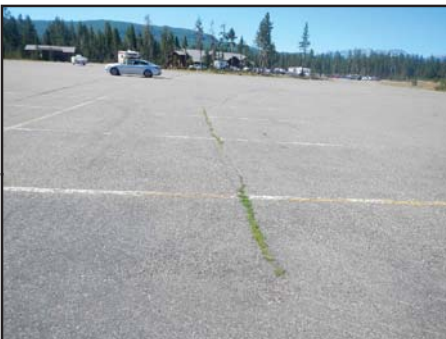
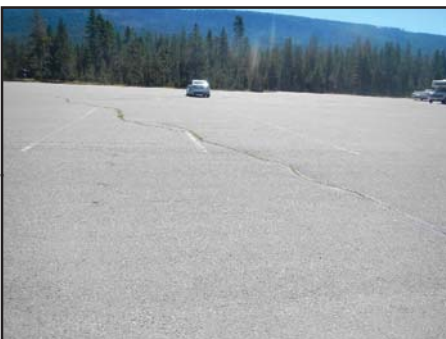
ROUTE 0980: FLAGG NORTH PARKING

Inspection Date	FMISS Number	User Access	Surface Type
7/25/2016	35936	PUBLIC	ASPHALT
Area (Sq. Ft.)	Lane Miles (11' Widths)	Curb Reveal (Inches)	Curb Recommendation
77,933	1.342	NOT APPLICABLE	NOT APPLICABLE
Curb Type		Curb & Gutter Type	
NO CURB		NO CURB AND GUTTER	
Pavement Recommendation		Condition Rating / PCR	
PREVENTIVE MAINTENANCE		GOOD / 90

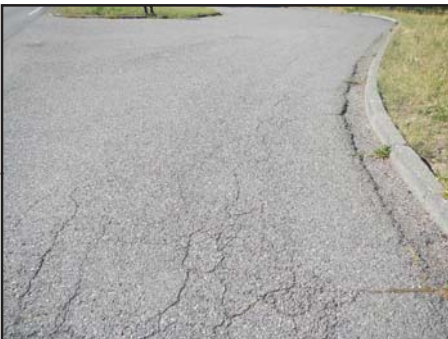
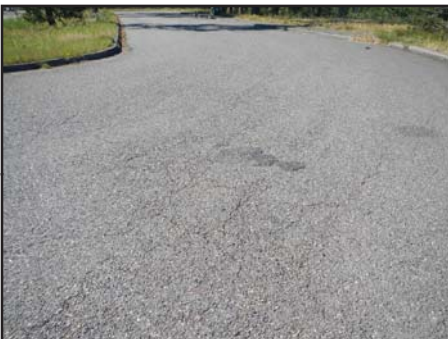
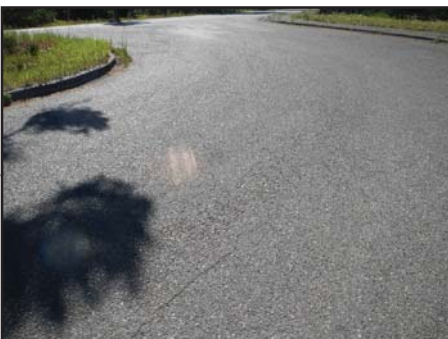
ROUTE 0981: JDR NORTH BOUNDARY PARKING

Inspection Date	FMSS Number	User Access	Surface Type
7/25/2016	36257	PUBLIC	ASPHALT
Area (Sq. Ft.)	Lane Miles (11' Widths)	Curb Reveal (Inches)	Curb Recommendation
10,390	0.179	NOT APPLICABLE	LIGHT REPAIR
Curb Type		Curb & Gutter Type	
NO CURB		CONCRETE	
Pavement Recommendation		Condition Rating / PCR	
PREVENTIVE MAINTENANCE		GOOD / 90

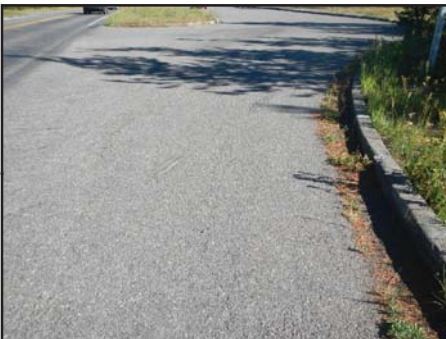
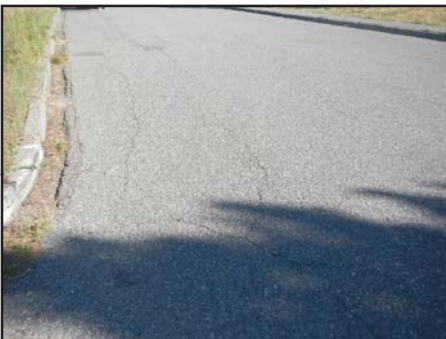
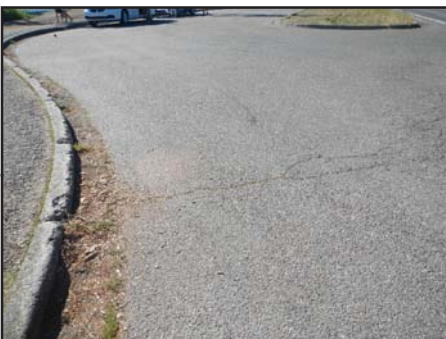
ROUTE 0982: YELLOWSTONE NATIONAL PARK SOUTH BOUNDARY PARKING

Inspection Date	FMSS Number	User Access	Surface Type
7/25/2016	36790	PUBLIC	ASPHALT
Area (Sq. Ft.)	Lane Miles (11' Widths)	Curb Reveal (Inches)	Curb Recommendation
10,838	0.187	NOT APPLICABLE	LIGHT REPAIR
Curb Type		Curb & Gutter Type	
NO CURB		CONCRETE	
Pavement Recommendation		Condition Rating / PCR	
PREVENTIVE MAINTENANCE		GOOD / 90

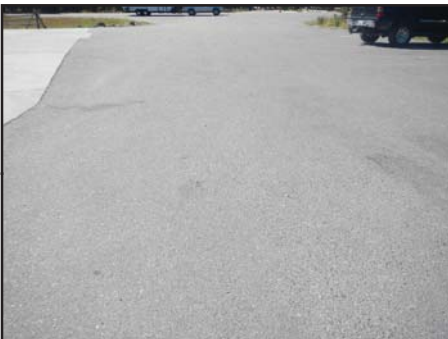
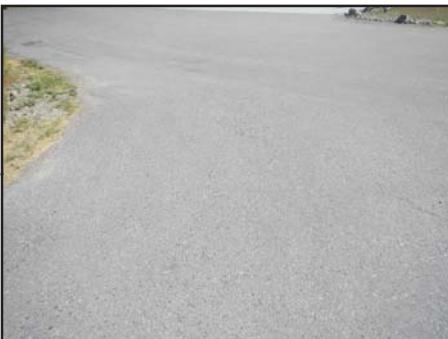
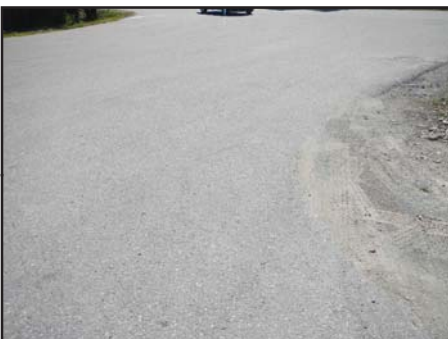
ROUTE 1018: FLAGG RANCH GAS STATION

Inspection Date	FMSS Number	User Access	Surface Type
7/25/2016	116794	PUBLIC	ASPHALT
Area (Sq. Ft.)	Lane Miles (11' Widths)	Curb Reveal (Inches)	Curb Recommendation
30,127	0.519	NOT APPLICABLE	NOT APPLICABLE
Curb Type		Curb & Gutter Type	
NO CURB		NO CURB AND GUTTER	
Pavement Recommendation		Condition Rating / PCR	
PREVENTIVE MAINTENANCE		GOOD / 90

Parking area consists of multiple surface types: 1 part Asphalt at 24,759 square feet; 1 part Concrete at 5,368 square feet.
