# JOFL Cycle 6

# Final Report

# Road Inventory and Condition Assessment of Paved Routes Johnstown Flood National Memorial

**Report Date: June 2021**

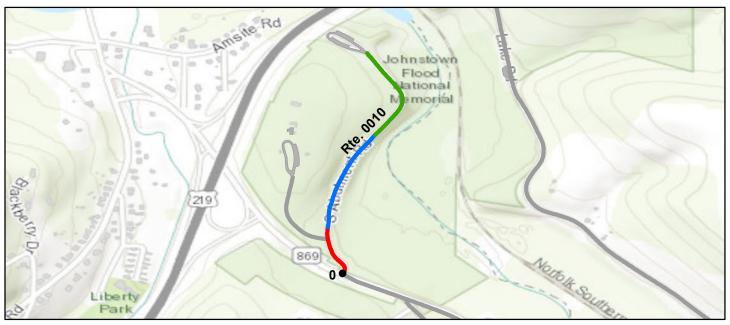
ROUTE 0010: SOUTH ABUTMENT ROAD

Route (	Condition Legend – Pav	ement Condi	ition Rating (	PCR)		
Poor (0 - 60	_		(85 - 94)	Excellent (		Not Ra	ted
`	<u> </u>	dition scores at 0.10-mile		,	5		
Inspection Date:	11/12/2020	<b>Beginning Section MP</b>	0				
Paved Length (Mile	es): 0.49	Section Length (MI)	0.49				
Surface Type:	ASPHALT	Route Summary					
Roadway Condition	n Information						
Pavement Condition	on Rating (PCR)	87	87				
Surface Condition R	Rating (SCR)	87	87				
Roughness Condition	on Index (RCI)	N/A	N/A				
Distress Index Valu	es						
Structural Crack In	dex	87	87				
Alligator Crack Inc	dex	100	100				
Longitudinal Crack	x Index	87	87				
Transverse Crackir	ng Index	92	92				
Patching Index		100	100				
Rutting Index		99	99				
International Roug	hness Index (IRI)	N/A	N/A				
Lane & Width Info	rmation						
Number of Lanes		2	2				
Paved Width (ft)		20	20				
Lane Width (ft)		10	10
