# JOMU Cycle 6

## Final Report

### Road Inventory and Condition Assessment of Paved Routes John Muir National Historic Site

Report Date: August 2015

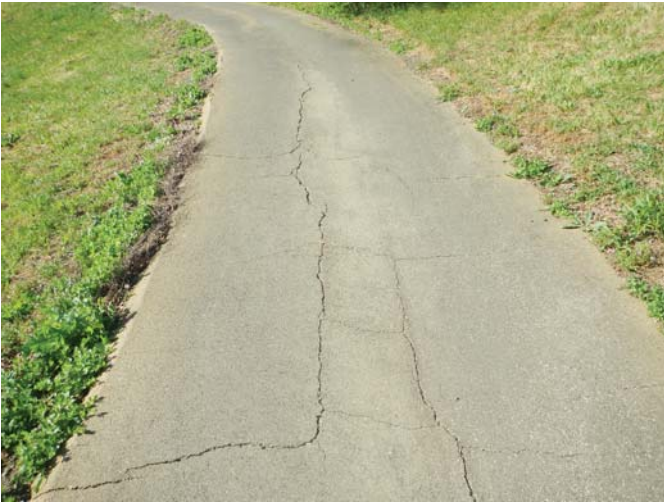
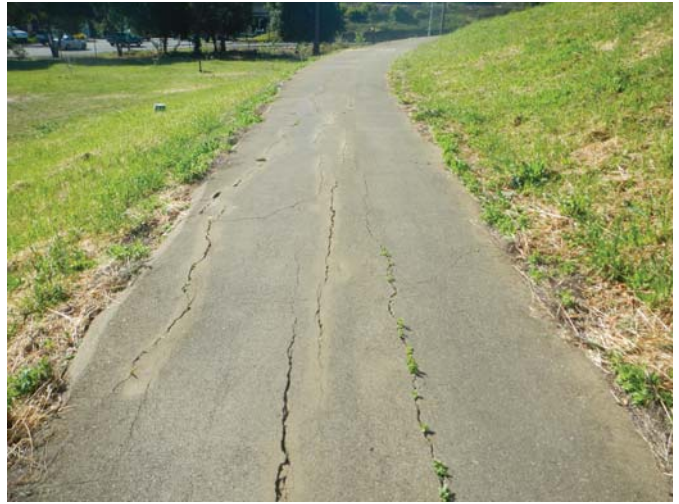
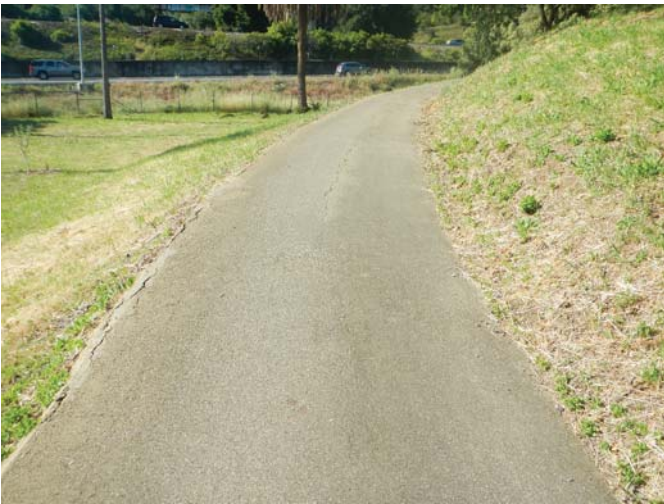
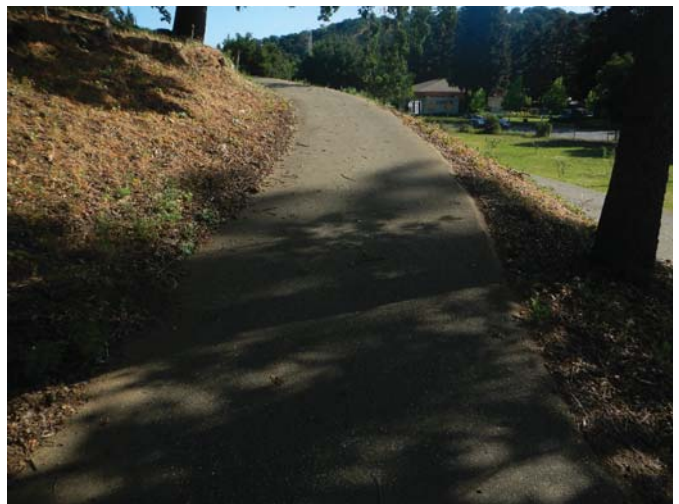
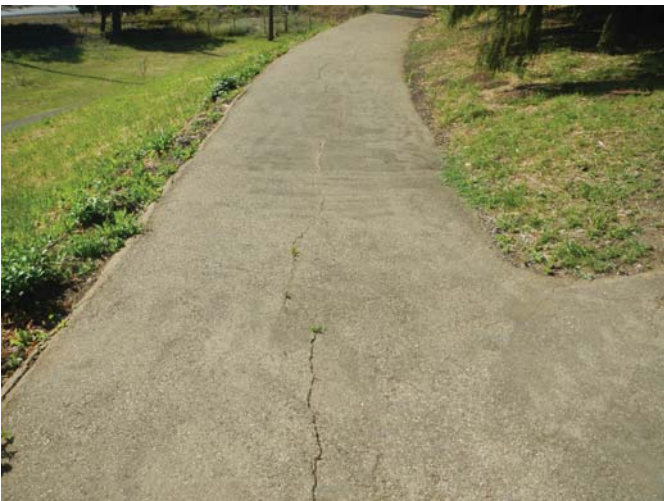
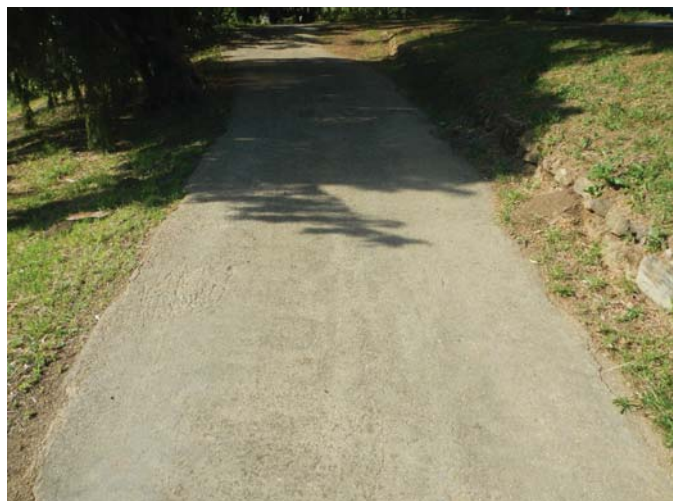
## ROUTE 0400: HANDICAP ACCESS ROAD

<b>Inspection Date:</b> 5/5/2014	<b>Beginning Section MP</b>	0.00				
<b>Paved Length (Miles):</b> 0.12	<b>Section Length (MI)</b>	0.12				
<b>Surface Type:</b> ASPHALT	<b>Route Summary</b>					
<b>Roadway Condition Information</b>						
Pavement Condition Rating (PCR)	53	53				
Surface Condition Rating (SCR)	53	53				
Roughness Condition Index (RCI)	N/A	N/A				
<b>Distress Index Values</b>						
Structural Crack Index	N/A	N/A				
Alligator Crack Index	N/A	N/A				
Longitudinal Crack Index	N/A	N/A				
Transverse Cracking Index	N/A	N/A				
Patching Index	N/A	N/A				
Rutting Index	N/A	N/A				
International Roughness Index (IRI)	N/A	N/A				
<b>Lane &amp; Width Information</b>						
Number of Lanes	1	1				
Paved Width (ft)	7.2	7.2				
Lane Width (ft)	7.2	7.2

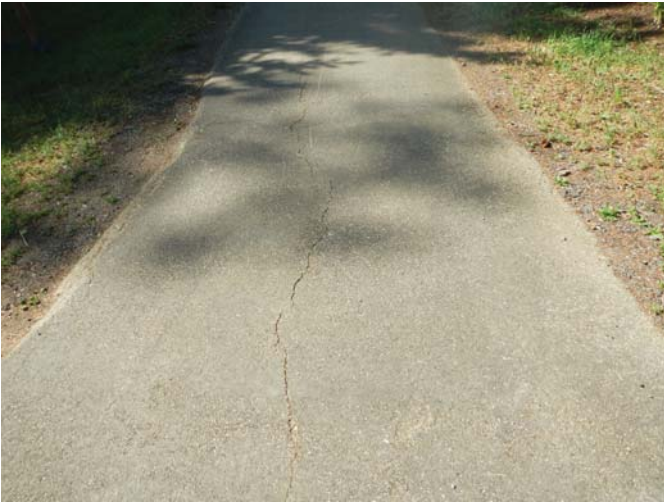
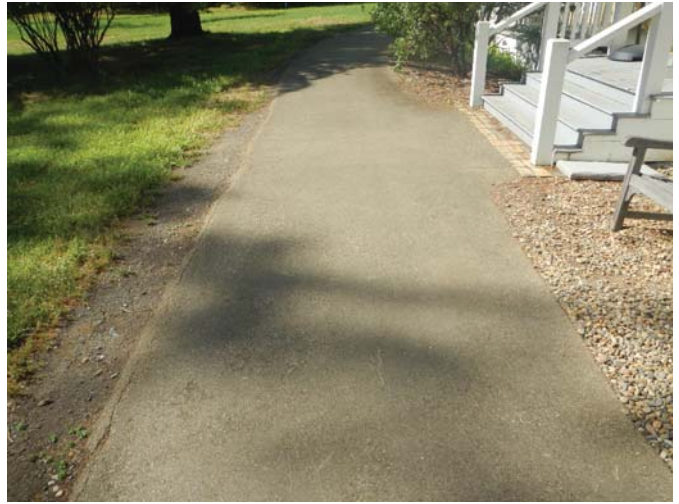
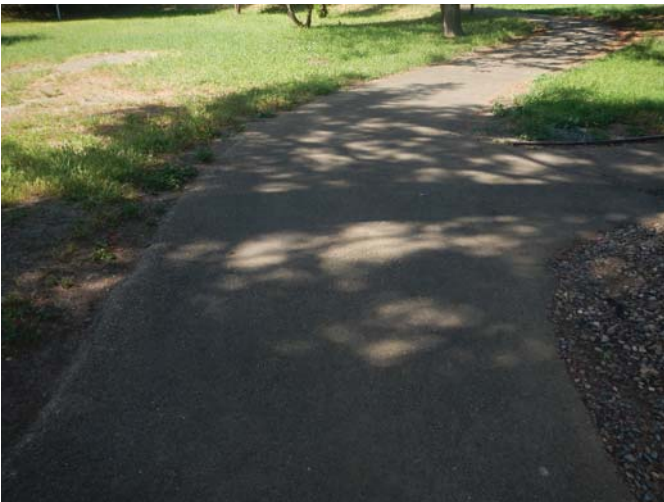
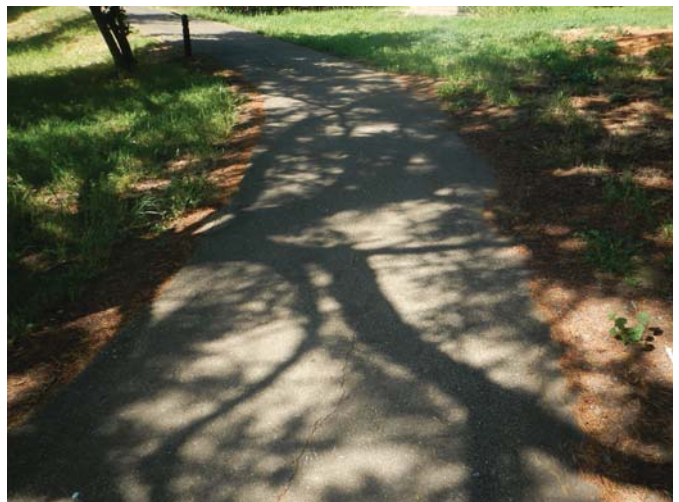
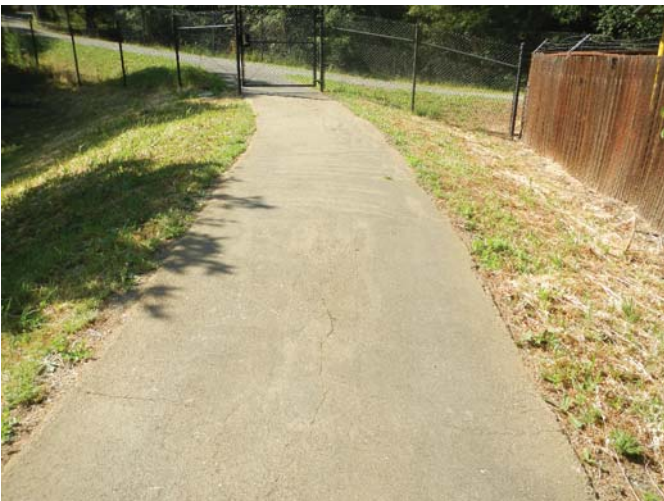
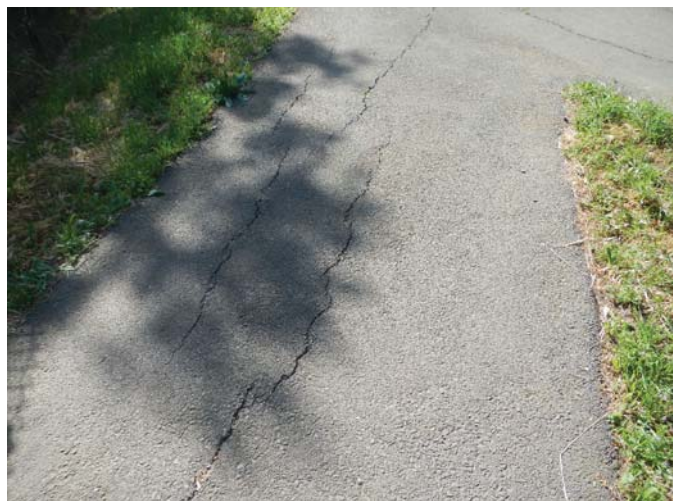
## ROUTE 0401: JOHN MUIR ACCESS ROAD

<b>Inspection Date:</b> 5/5/2014	<b>Beginning Section MP</b>	0.00				
<b>Paved Length (Miles):</b> 0.05	<b>Section Length (MI)</b>	0.05				
<b>Surface Type:</b> ASPHALT	<b>Route Summary</b>					
<b>Roadway Condition Information</b>						
Pavement Condition Rating (PCR)	90	90				
Surface Condition Rating (SCR)	90	90				
Roughness Condition Index (RCI)	N/A	N/A				
<b>Distress Index Values</b>						
Structural Crack Index	N/A	N/A				
Alligator Crack Index	N/A	N/A				
Longitudinal Crack Index	N/A	N/A				
Transverse Cracking Index	N/A	N/A				
Patching Index	N/A	N/A				
Rutting Index	N/A	N/A				
International Roughness Index (IRI)	N/A	N/A				
<b>Lane &amp; Width Information</b>						
Number of Lanes	1	1				
Paved Width (ft)	7	7				
Lane Width (ft)	7	7

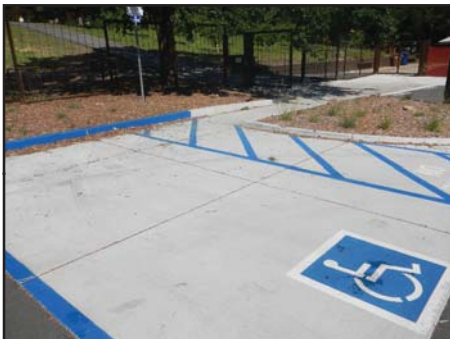
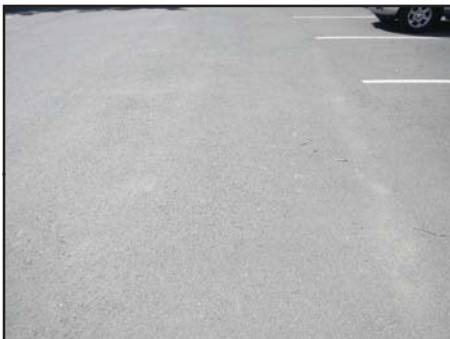
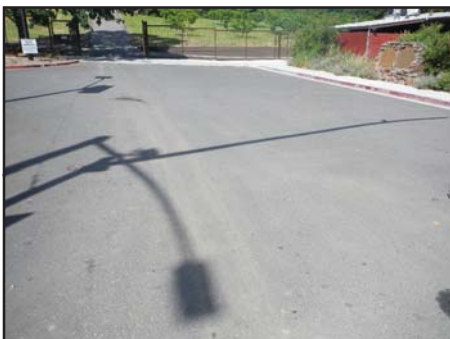
Inspection Date	FMSS Number	User Access	Surface Type
5/5/2014	76042	PUBLIC	ASPHALT
Area (Sq. Ft.)	Lane Miles (11' Widths)	Curb Reveal (Inches)	Curb Recommendation
8,884	0.153	NOT APPLICABLE	DO NOTHING
Curb Type		Curb & Gutter Type	
NO CURB		CONCRETE	
Pavement Recommendation		Condition Rating / PCR	
DO NOTHING		EXCELLENT / 97

Parking area consists of multiple surface types. 1 part Asphalt at 8,551 square feet; 1 part Concrete at 333 square feet.

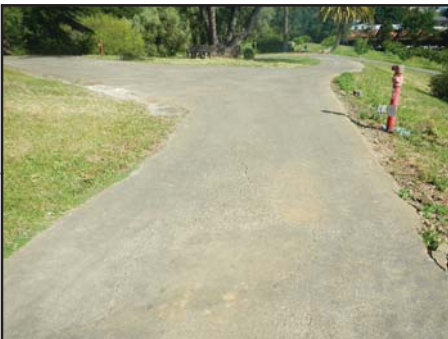
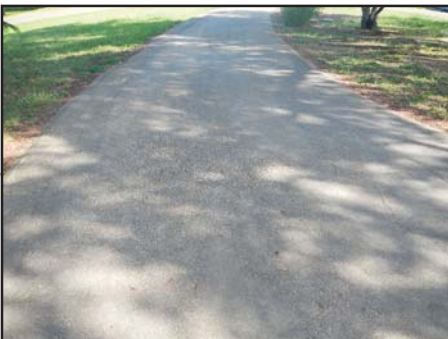
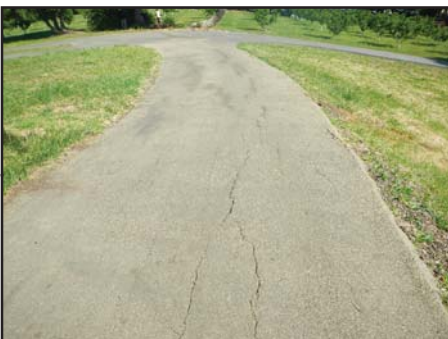
## ROUTE 0901: JOHN MUIR HOME ACCESS PARKING

Inspection Date	FMSS Number	User Access	Surface Type
5/5/2014	230501	NONPUBLIC	ASPHALT
Area (Sq. Ft.)	Lane Miles (11' Widths)	Curb Reveal (Inches)	Curb Recommendation
4,966	0.086	NOT APPLICABLE	NOT APPLICABLE
Curb Type		Curb & Gutter Type	
NO CURB		NO CURB AND GUTTER	
Pavement Recommendation		Condition Rating / PCR	
HEAVY 3R TREATMENTS		POOR / 53

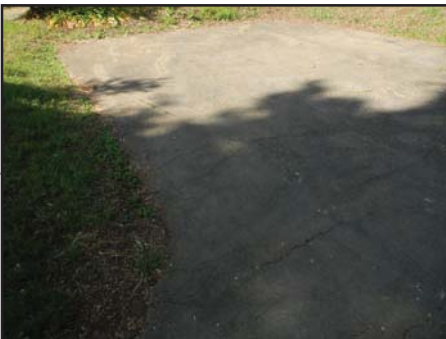
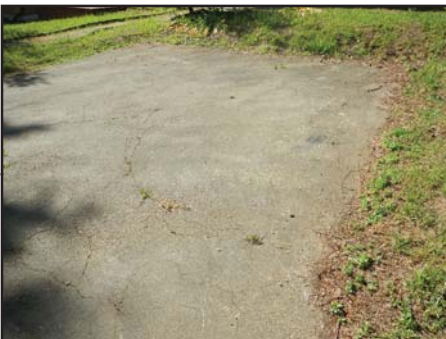
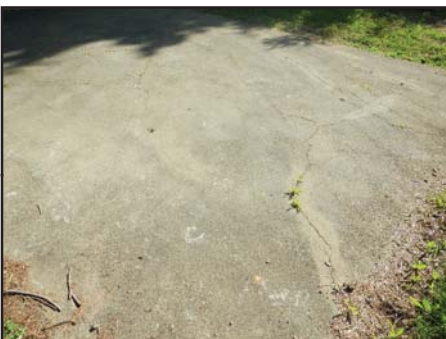
## ROUTE 0902: MARTINEZ ADOBE ACCESS PARKING

Inspection Date	FMSS Number	User Access	Surface Type
5/5/2014	230502	NONPUBLIC	ASPHALT
Area (Sq. Ft.)	Lane Miles (11' Widths)	Curb Reveal (Inches)	Curb Recommendation
359	0.006	NOT APPLICABLE	NOT APPLICABLE
Curb Type		Curb & Gutter Type	
NO CURB		NO CURB AND GUTTER	
Pavement Recommendation		Condition Rating / PCR	
HEAVY 3R TREATMENTS		POOR / 53

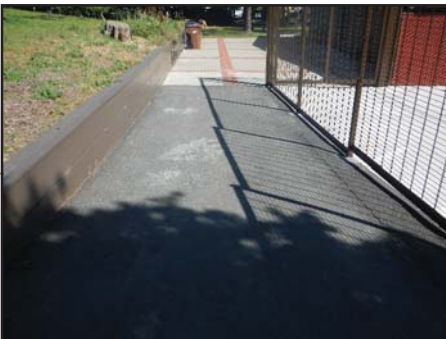
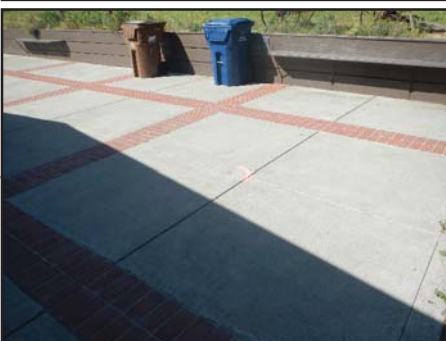
## ROUTE 0903: VISITOR CENTER PATIO HANDICAP ACCESS

Inspection Date	FMSS Number	User Access	Surface Type
5/5/2014	229913	NONPUBLIC	CONCRETE
Area (Sq. Ft.)	Lane Miles (11' Widths)	Curb Reveal (Inches)	Curb Recommendation
1,817	0.031	NOT APPLICABLE	NOT APPLICABLE
Curb Type		Curb & Gutter Type	
NO CURB		NO CURB AND GUTTER	
Pavement Recommendation		Condition Rating / PCR	
DO NOTHING		EXCELLENT / 97

Parking area consists of multiple surface types. 1 part Asphalt at 1,533 square feet; 1 part Concrete at 284 square feet.

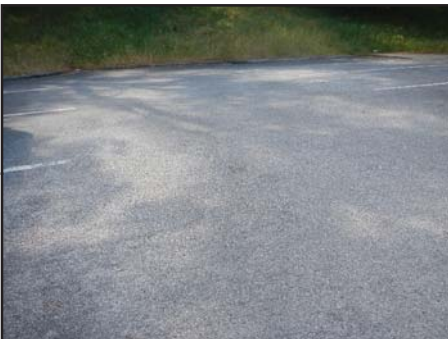
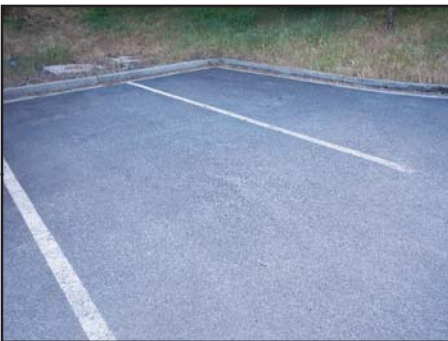
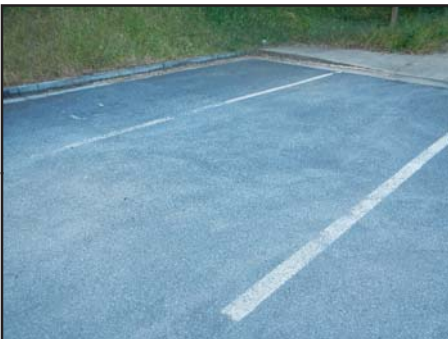
## ROUTE 0904AZ: MAINTENANCE PARKING A

Inspection Date	FMSS Number	User Access	Surface Type
5/5/2014	108060	NONPUBLIC	ASPHALT
Area (Sq. Ft.)	Lane Miles (11' Widths)	Curb Reveal (Inches)	Curb Recommendation
2,766	0.048	NOT APPLICABLE	DO NOTHING
Curb Type		Curb & Gutter Type	
NO CURB		CONCRETE	
Pavement Recommendation		Condition Rating / PCR	
PREVENTIVE MAINTENANCE		GOOD / 90

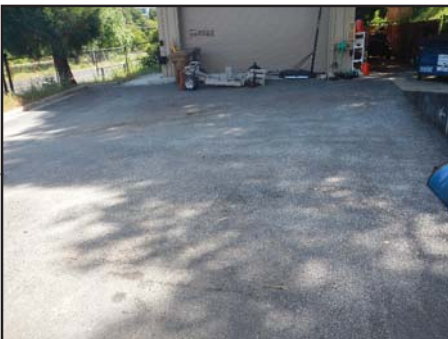
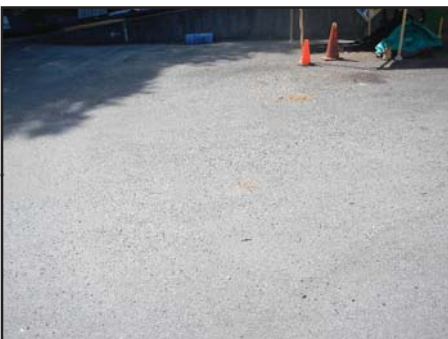
## ROUTE 0904BZ: MAINTENANCE PARKING B

Inspection Date	FMSS Number	User Access	Surface Type
5/5/2014	108060	NONPUBLIC	ASPHALT
Area (Sq. Ft.)	Lane Miles (11' Widths)	Curb Reveal (Inches)	Curb Recommendation
2,151	0.037	NOT APPLICABLE	DO NOTHING
Curb Type		Curb & Gutter Type	
NO CURB		CONCRETE	
Pavement Recommendation		Condition Rating / PCR	
PREVENTIVE MAINTENANCE		GOOD / 90
