JOTR Cycle 6

Final Report

Road Inventory and Condition Assessment of Paved Routes Joshua Tree National Park

Report Date: December 2015

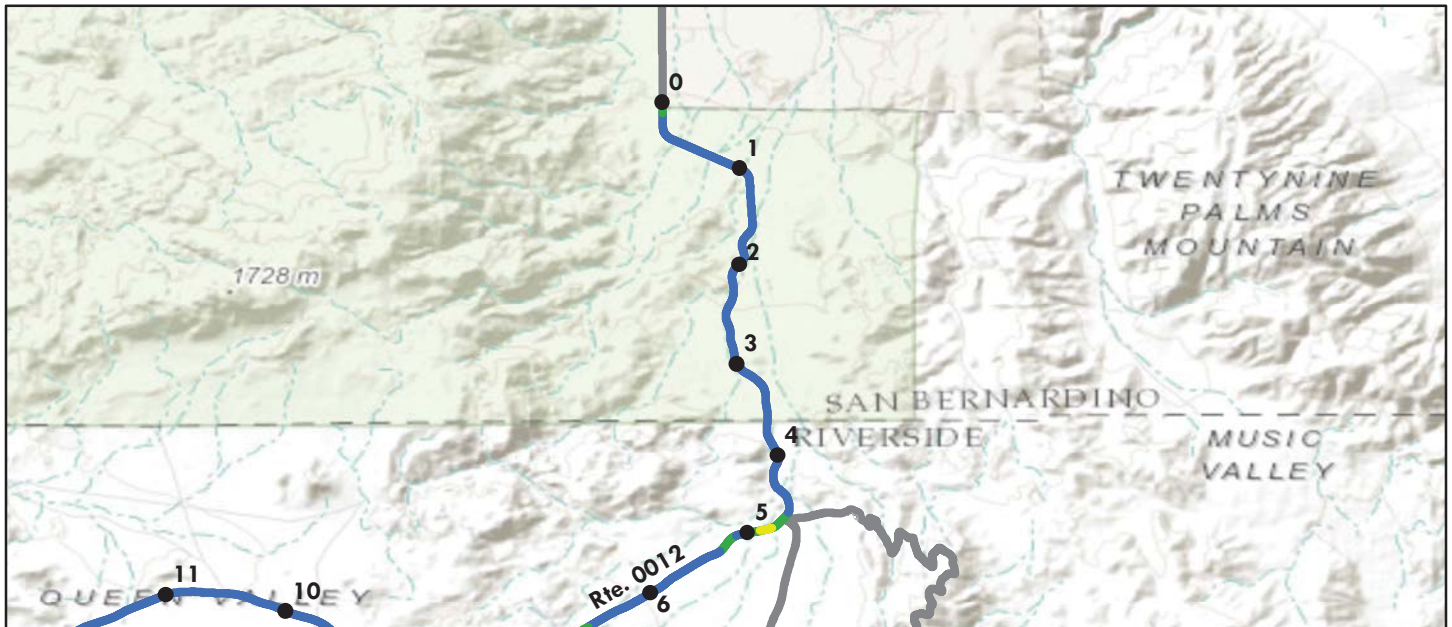
ROUTE 0012: EAST-WEST HIGHWAY

Route Condition Legend – Pavement Condition Rating (PCR)						
Poor (0 - 60)	Fair (61- 84)	Good (85 - 94)	Excellent (95 - 100)	Not Rated		
See Appendix for definitions and formulas						
Inspection Date: 5/18/2015	Beginning Section MP	0	1	2	3	4
Paved Length (Miles): 25.46	Section Length (MI)	1	1	1	1	1
Surface Type: ASPHALT	Route Summary					
Roadway Condition Information						
Pavement Condition Rating (PCR)	97	99	99	100	100	97
Surface Condition Rating (SCR)	95	98	99	100	100	99
Roughness Condition Index (RCI)	100	100	100	100	100	93
Distress Index Values						
Structural Crack Index	98	100	100	100	100	100
Alligator Crack Index	100	100	100	100	100	100
Longitudinal Crack Index	98	100	100	100	100	100
Transverse Cracking Index	95	98	99	100	100	99
Patching Index	100	100	100	100	100	100
Rutting Index	99	100	100	100	100	99
International Roughness Index (IRI)	111	86	66	61	66	131
Lane & Width Information						
Number of Lanes	2	2	2	2	2	2

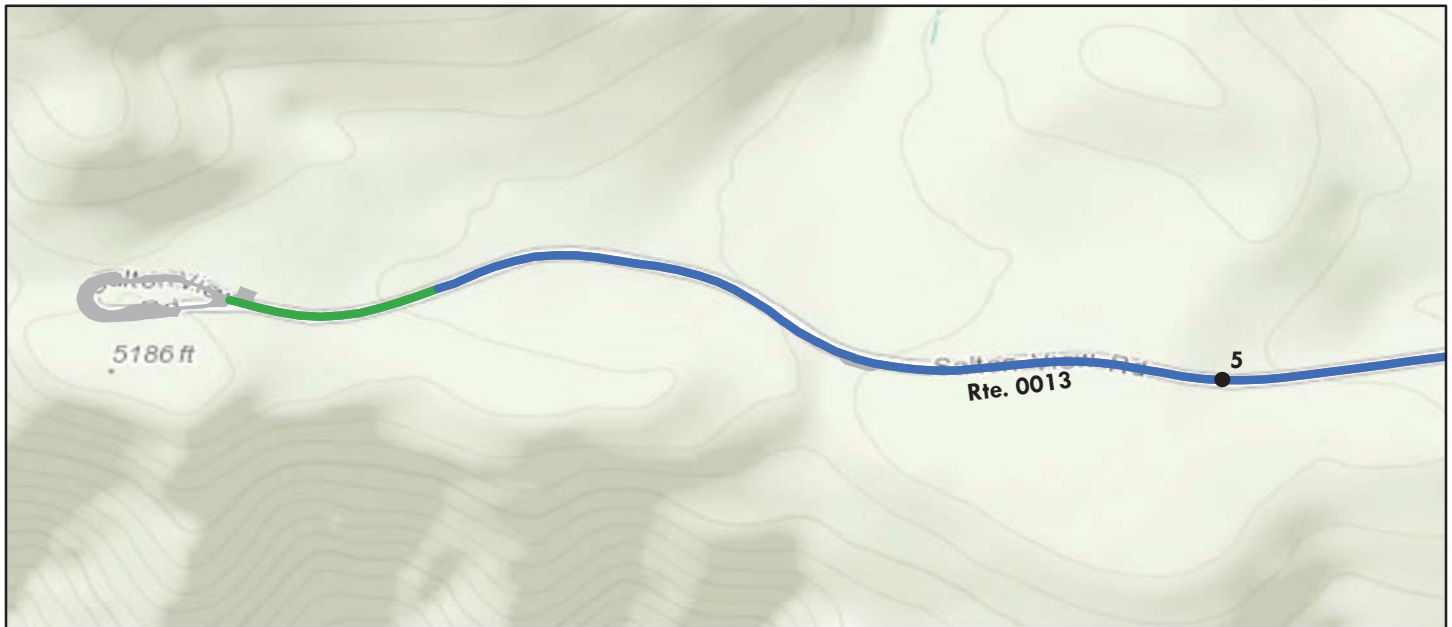
ROUTE 0013: KEY'S VIEW ROAD

Route Condition Legend – Pavement Condition Rating (PCR)						
Poor (0 - 60)	Fair (61- 84)	Good (85 - 94)	Excellent (95 - 100)	Not Rated		
See Appendix for definitions and formulas						
Inspection Date: 5/18/2015	Beginning Section MP	5				
Paved Length (Miles): 5.5	Section Length (MI)	0.5				
Surface Type: ASPHALT	Route Summary					
Roadway Condition Information						
Pavement Condition Rating (PCR)	99	98				
Surface Condition Rating (SCR)	99	97				
Roughness Condition Index (RCI)	100	100				
Distress Index Values						
Structural Crack Index	99	100				
Alligator Crack Index	100	100				
Longitudinal Crack Index	99	100				
Transverse Cracking Index	99	97				
Patching Index	100	100				
Rutting Index	100	99				
International Roughness Index (IRI)	89	108				
Lane & Width Information						
Number of Lanes	2	2				
Paved Width (ft)	21.9	23.2				
Lane Width (ft)	9.5	9.4

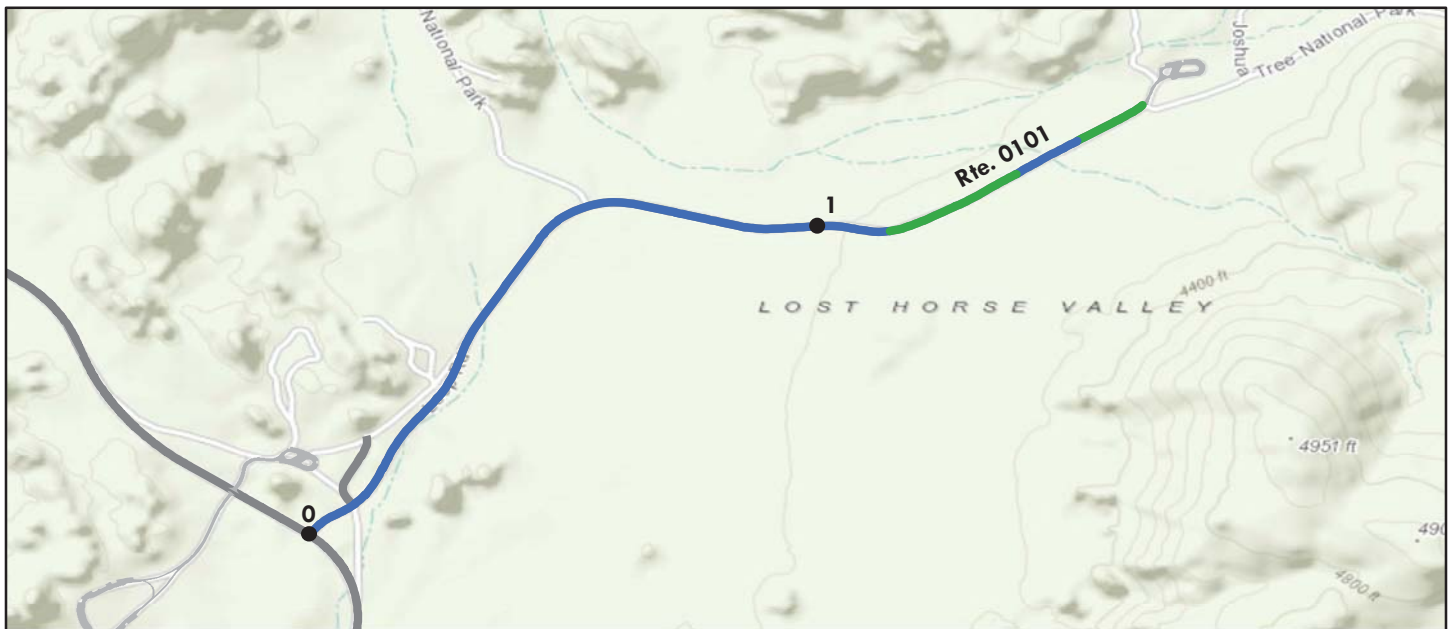
ROUTE 0101: BARKER DAM ROAD

Route Condition Legend – Pavement Condition Rating (PCR)						
Poor (0 - 60)	Fair (61- 84)	Good (85 - 94)	Excellent (95 - 100)	Not Rated		
See Appendix for definitions and formulas						
Inspection Date: 5/18/2015	Beginning Section MP	0	1			
Paved Length (Miles): 1.51	Section Length (MI)	1	0.51			
Surface Type: ASPHALT	Route Summary					
Roadway Condition Information						
Pavement Condition Rating (PCR)	98	99	95			
Surface Condition Rating (SCR)	99	99	99			
Roughness Condition Index (RCI)	97	100	88			
Distress Index Values						
Structural Crack Index	100	100	100			
Alligator Crack Index	100	100	100			
Longitudinal Crack Index	100	100	100			
Transverse Cracking Index	100	100	100			
Patching Index	100	100	100			
Rutting Index	99	99	99			
International Roughness Index (IRI)	122	108	147			
Lane & Width Information						
Number of Lanes	2	2	2			
Paved Width (ft)	22.4	22	23.3			
Lane Width (ft)	9.7	9.8	9.4

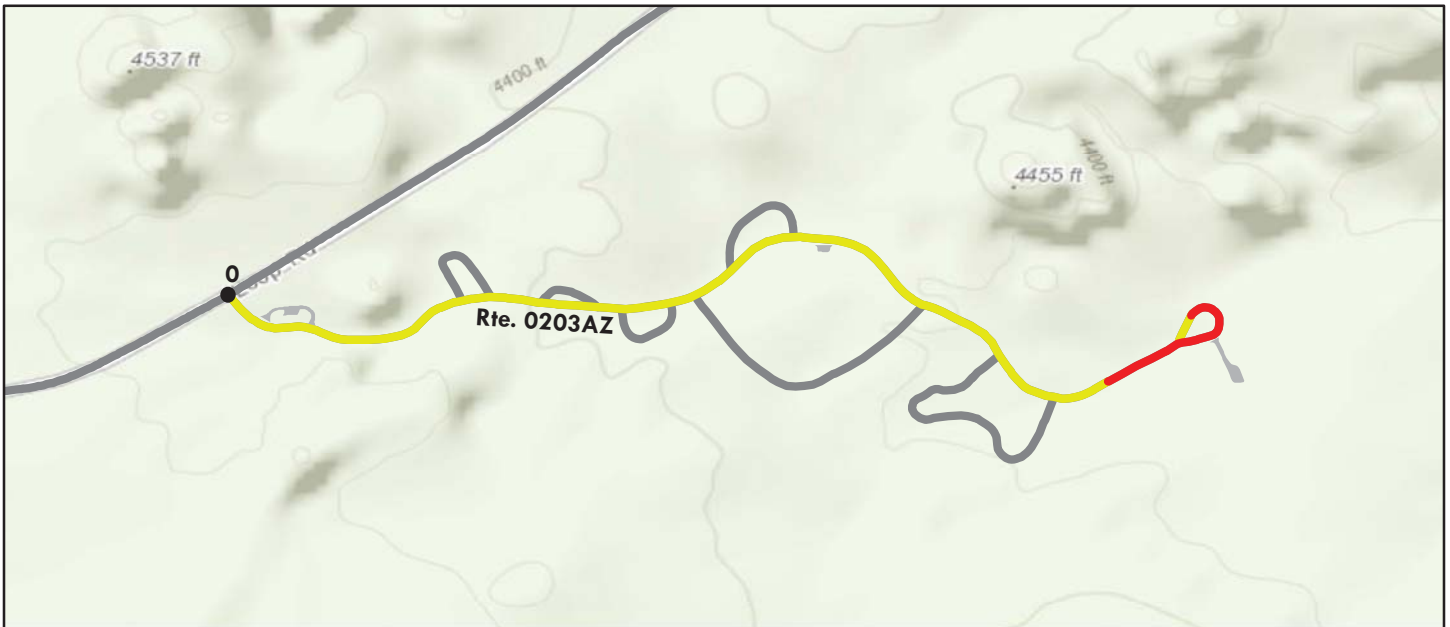
ROUTE 0203AZ: JUMBO ROCKS CAMPGROUND LOOP A

Route Condition Legend – Pavement Condition Rating (PCR)						
Poor (0 - 60)	Fair (61- 84)	Good (85 - 94)	Excellent (95 - 100)	Not Rated		
See Appendix for definitions and formulas						
Inspection Date: 5/18/2015	Beginning Section MP	0				
Paved Length (Miles): 0.72	Section Length (MI)	0.72				
Surface Type: ASPHALT	Route Summary					
Roadway Condition Information						
Pavement Condition Rating (PCR)	65	65				
Surface Condition Rating (SCR)	65	65				
Roughness Condition Index (RCI)	N/A	N/A				
Distress Index Values						
Structural Crack Index	86	86				
Alligator Crack Index	100	100				
Longitudinal Crack Index	86	86				
Transverse Cracking Index	65	65				
Patching Index	100	100				
Rutting Index	97	97				
International Roughness Index (IRI)	N/A	N/A				
Lane & Width Information						
Number of Lanes	2	2				
Paved Width (ft)	18.4	18.4				
Lane Width (ft)	9.8	9.8

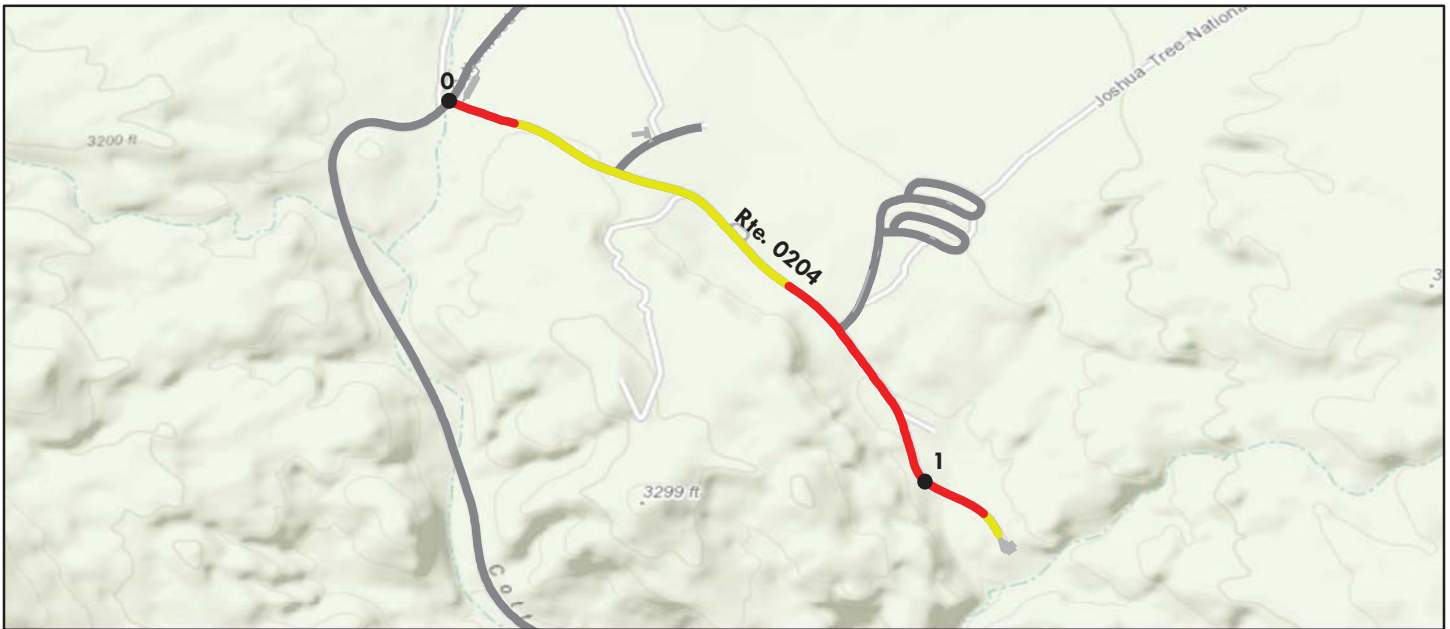
ROUTE 0204: COTTONWOOD SPRINGS CAMPGROUND AND TRAILHEAD

Route Condition Legend – Pavement Condition Rating (PCR)						
Poor (0 - 60)	Fair (61- 84)	Good (85 - 94)	Excellent (95 - 100)	Not Rated		
See Appendix for definitions and formulas						
Inspection Date: 5/18/2015	Beginning Section MP	0	1			
Paved Length (Miles): 1.14	Section Length (MI)	1	0.14			
Surface Type: ASPHALT	Route Summary					
Roadway Condition Information						
Pavement Condition Rating (PCR)	63	64	54			
Surface Condition Rating (SCR)	64	64	62			
Roughness Condition Index (RCI)	61	64	42			
Distress Index Values						
Structural Crack Index	78	78	81			
Alligator Crack Index	100	100	100			
Longitudinal Crack Index	78	78	81			
Transverse Cracking Index	64	64	62			
Patching Index	100	100	100			
Rutting Index	97	97	99			
International Roughness Index (IRI)	237	224	328			
Lane & Width Information						
Number of Lanes	2	2	2			
Paved Width (ft)	26.1	26.1	27			
Lane Width (ft)	12.2	12.1	13.1

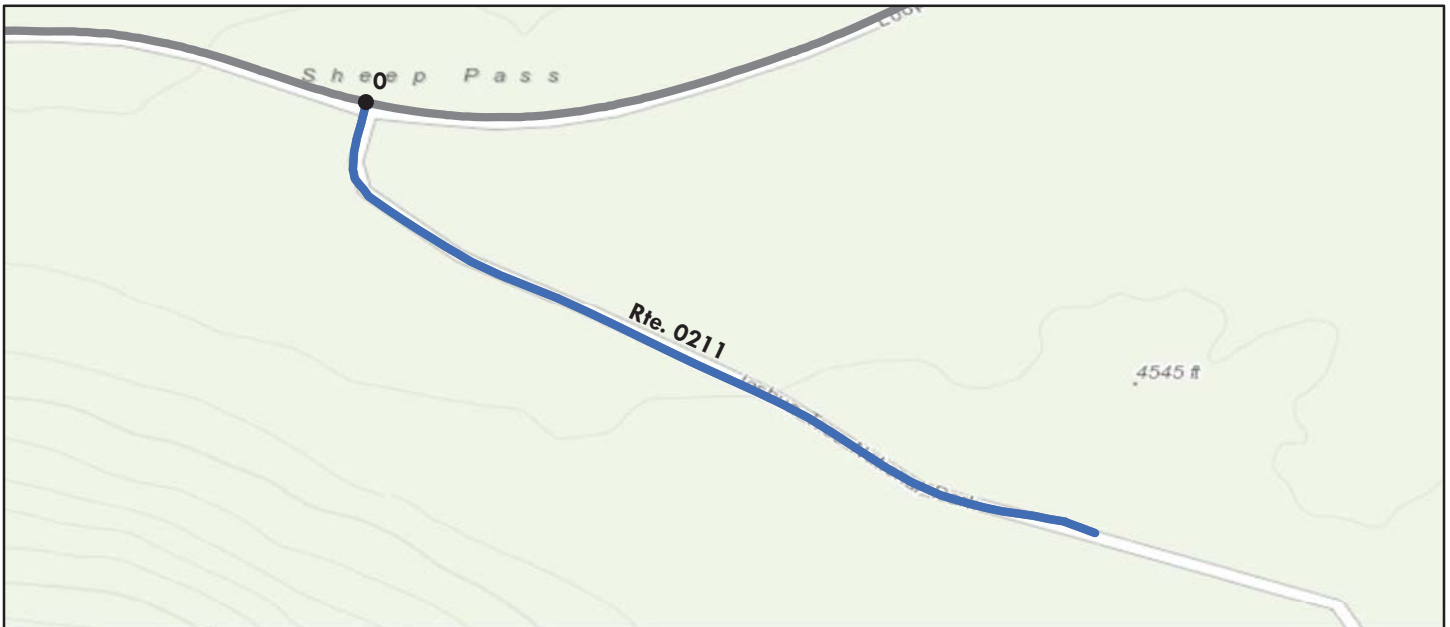
ROUTE 0211: SHEEP PASS CAMPGROUND ENTRANCE ROAD

Route Condition Legend – Pavement Condition Rating (PCR)						
Poor (0 - 60)	Fair (61- 84)	Good (85 - 94)	Excellent (95 - 100)	Not Rated		
See Appendix for definitions and formulas						
Inspection Date: 5/18/2015	Beginning Section MP	0				
Paved Length (Miles): 0.29	Section Length (MI)	0.29				
Surface Type: ASPHALT	Route Summary					
Roadway Condition Information						
Pavement Condition Rating (PCR)	99	99				
Surface Condition Rating (SCR)	99	99				
Roughness Condition Index (RCI)	N/A	N/A				
Distress Index Values						
Structural Crack Index	100	100				
Alligator Crack Index	100	100				
Longitudinal Crack Index	100	100				
Transverse Cracking Index	100	100				
Patching Index	100	100				
Rutting Index	99	99				
International Roughness Index (IRI)	N/A	N/A				
Lane & Width Information						
Number of Lanes	2	2				
Paved Width (ft)	18.4	18.4				
Lane Width (ft)	9.2	9.2

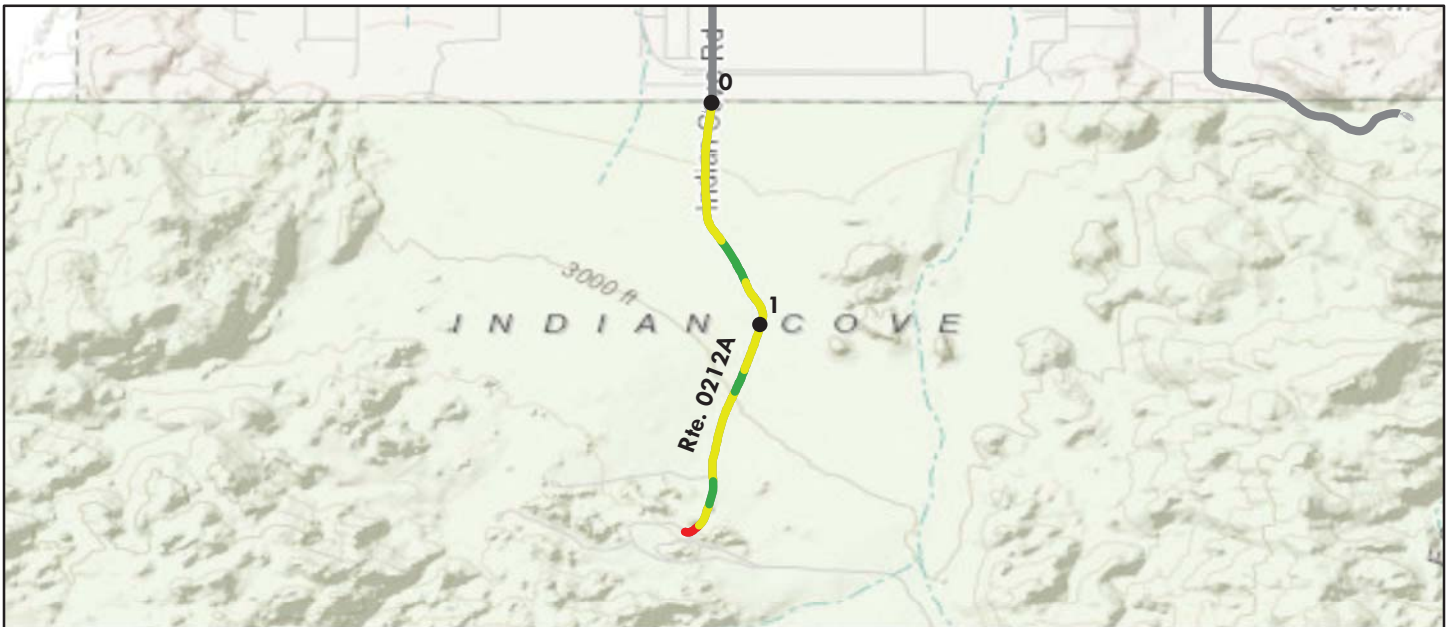
ROUTE 0212A: INDIAN COVE CAMPGROUND ROAD A

Route Condition Legend – Pavement Condition Rating (PCR)						
Poor (0 - 60)	Fair (61- 84)	Good (85 - 94)	Excellent (95 - 100)	Not Rated		
See Appendix for definitions and formulas						
Inspection Date: 5/18/2015	Beginning Section MP	0	1			
Paved Length (Miles): 1.96	Section Length (MI)	1	0.96			
Surface Type: ASPHALT	Route Summary					
Roadway Condition Information						
Pavement Condition Rating (PCR)	80	80	81			
Surface Condition Rating (SCR)	86	87	85			
Roughness Condition Index (RCI)	72	70	74			
Distress Index Values						
Structural Crack Index	86	87	85			
Alligator Crack Index	100	100	100			
Longitudinal Crack Index	86	87	85			
Transverse Cracking Index	89	90	88			
Patching Index	100	100	100			
Rutting Index	90	90	89			
International Roughness Index (IRI)	194	201	187			
Lane & Width Information						
Number of Lanes	2	2	2			
Paved Width (ft)	21.6	21.5	21.8			
Lane Width (ft)	9.8	9.9	9.7

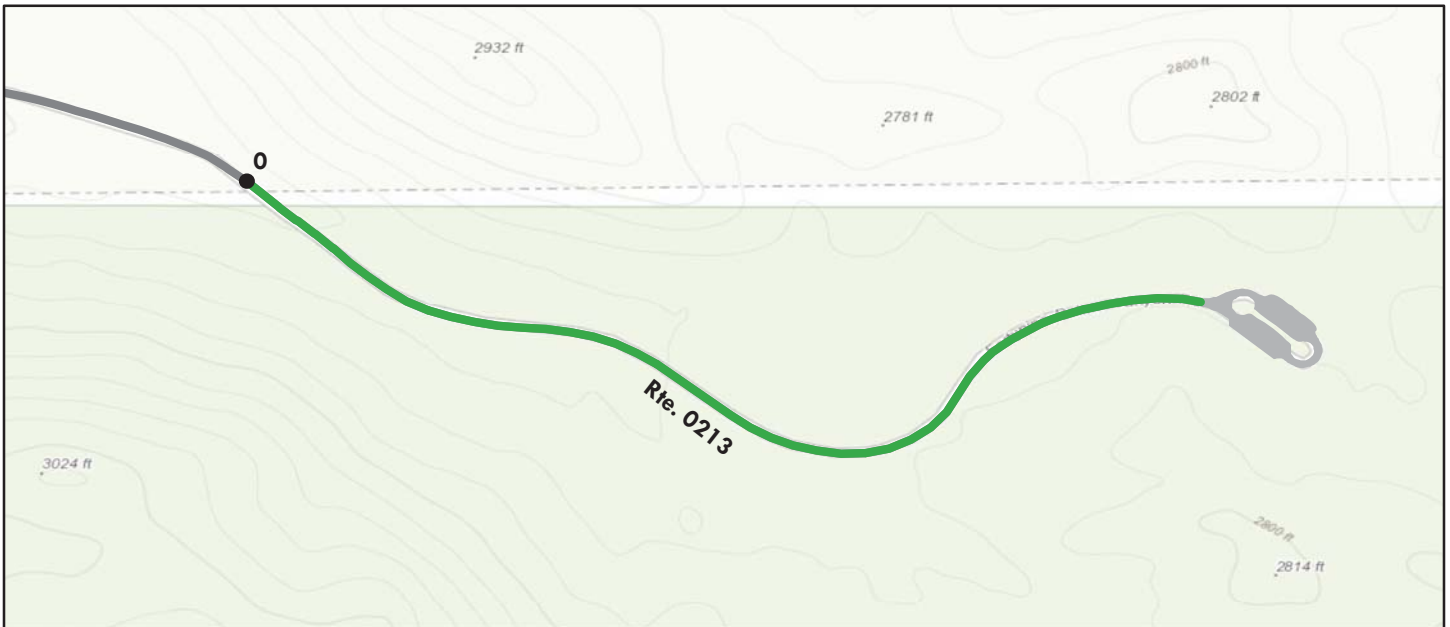
ROUTE 0213: 49 PALMS OASIS ACCESS ROAD

Route Condition Legend – Pavement Condition Rating (PCR)						
Poor (0 - 60)	Fair (61- 84)	Good (85 - 94)	Excellent (95 - 100)	Not Rated		
See Appendix for definitions and formulas						
Inspection Date: 5/18/2015	Beginning Section MP	0				
Paved Length (Miles): 0.47	Section Length (MI)	0.47				
Surface Type: ASPHALT	Route Summary					
Roadway Condition Information						
Pavement Condition Rating (PCR)	90	90				
Surface Condition Rating (SCR)	90	90				
Roughness Condition Index (RCI)	N/A	N/A				
Distress Index Values						
Structural Crack Index	90	90				
Alligator Crack Index	100	100				
Longitudinal Crack Index	90	90				
Transverse Cracking Index	91	91				
Patching Index	100	100				
Rutting Index	93	93				
International Roughness Index (IRI)	N/A	N/A				
Lane & Width Information						
Number of Lanes	2	2				
Paved Width (ft)	19.5	19.5				
Lane Width (ft)	9.8	9.8

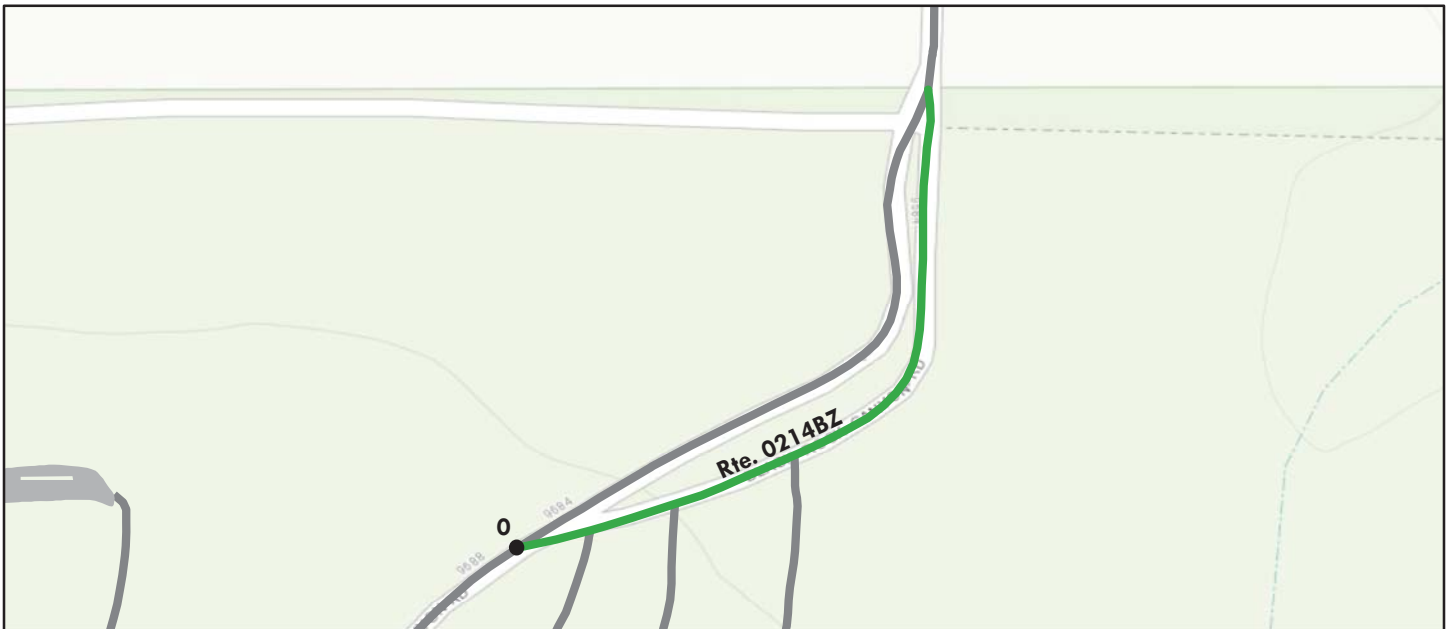
ROUTE 0214BZ: BLACK ROCK CAMPGROUND ROAD B

Route Condition Legend – Pavement Condition Rating (PCR)						
Poor (0 - 60)	Fair (61- 84)	Good (85 - 94)	Excellent (95 - 100)	Not Rated		
See Appendix for definitions and formulas						
Inspection Date: 2/25/2015	Beginning Section MP	0.00				
Paved Length (Miles): 0.16	Section Length (MI)	0.16				
Surface Type: ASPHALT	Route Summary					
Roadway Condition Information						
Pavement Condition Rating (PCR)	90	90				
Surface Condition Rating (SCR)	90	90				
Roughness Condition Index (RCI)	N/A	N/A				
Distress Index Values						
Structural Crack Index	N/A	N/A				
Alligator Crack Index	90	90				
Longitudinal Crack Index	90	90				
Transverse Cracking Index	90	90				
Patching Index	90	90				
Rutting Index	90	90				
International Roughness Index (IRI)	N/A	N/A				
Lane & Width Information						
Number of Lanes	2	2				
Paved Width (ft)	16	16				
Lane Width (ft)	8	8

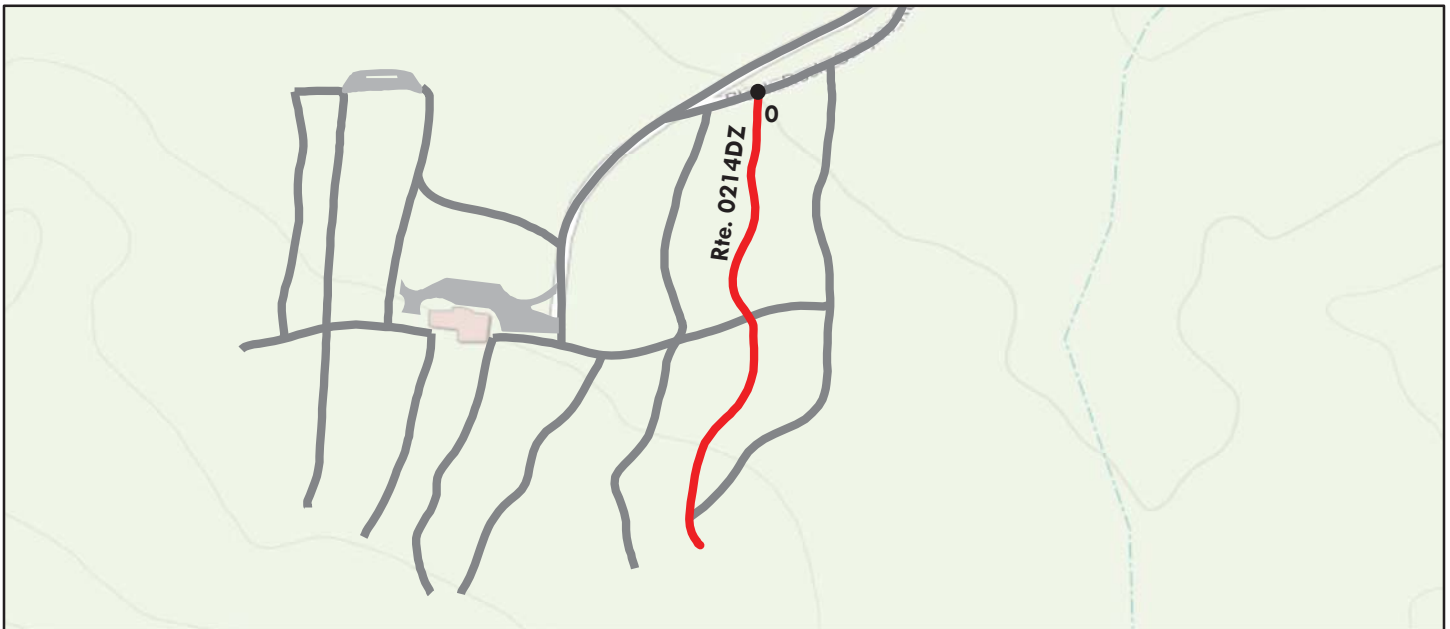
ROUTE 0214DZ: BLACK ROCK CAMPGROUND ROAD D

Route Condition Legend – Pavement Condition Rating (PCR)						
Poor (0 - 60)	Fair (61- 84)	Good (85 - 94)	Excellent (95 - 100)	Not Rated		
See Appendix for definitions and formulas						
Inspection Date: 2/25/2015	Beginning Section MP	0.00				
Paved Length (Miles): 0.20	Section Length (MI)	0.20				
Surface Type: ASPHALT	Route Summary					
Roadway Condition Information						
Pavement Condition Rating (PCR)	30	30				
Surface Condition Rating (SCR)	30	30				
Roughness Condition Index (RCI)	N/A	N/A				
Distress Index Values						
Structural Crack Index	N/A	N/A				
Alligator Crack Index	30	30				
Longitudinal Crack Index	30	30				
Transverse Cracking Index	53	53				
Patching Index	30	30				
Rutting Index	53	53				
International Roughness Index (IRI)	N/A	N/A				
Lane & Width Information						
Number of Lanes	1	1				
Paved Width (ft)	10	10				
Lane Width (ft)	10	10

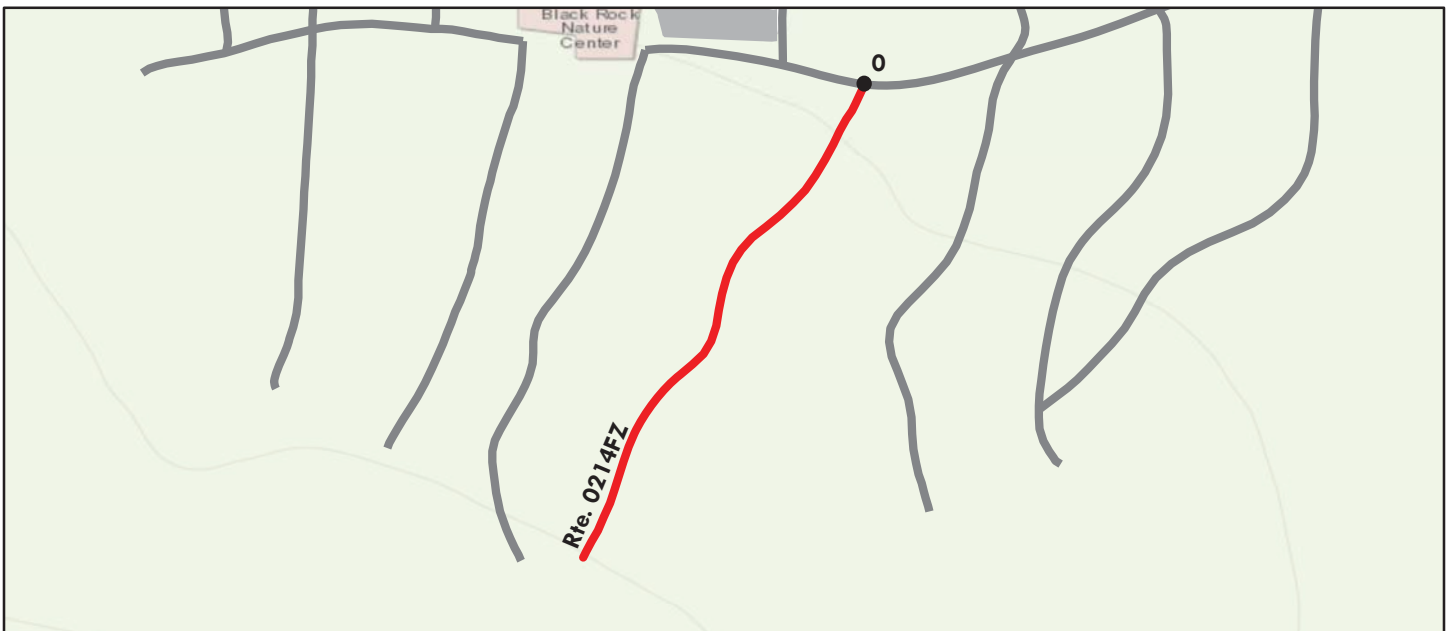
Subcomponent of Route JOTR-0214ZZ

Route Condition Legend – Pavement Condition Rating (PCR)						
Poor (0 - 60)	Fair (61- 84)	Good (85 - 94)	Excellent (95 - 100)	Not Rated		
See Appendix for definitions and formulas						
Inspection Date: 2/25/2015	Beginning Section MP	0.00				
Paved Length (Miles): 0.11	Section Length (MI)	0.11				
Surface Type: ASPHALT	Route Summary					
Roadway Condition Information						
Pavement Condition Rating (PCR)	30	30				
Surface Condition Rating (SCR)	30	30				
Roughness Condition Index (RCI)	N/A	N/A				
Distress Index Values						
Structural Crack Index	N/A	N/A				
Alligator Crack Index	30	30				
Longitudinal Crack Index	30	30				
Transverse Cracking Index	53	53				
Patching Index	30	30				
Rutting Index	53	53				
International Roughness Index (IRI)	N/A	N/A				
Lane & Width Information						
Number of Lanes	1	1				
Paved Width (ft)	10	10				
Lane Width (ft)	10	10

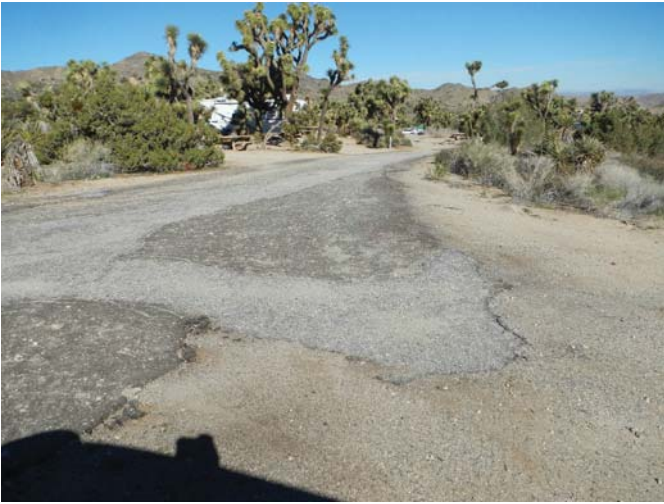
JOTR_0214GZ_0486.JPG

Route Condition Legend – Pavement Condition Rating (PCR)						
Poor (0 - 60)	Fair (61- 84)	Good (85 - 94)	Excellent (95 - 100)	Not Rated		
See Appendix for definitions and formulas						
Inspection Date: 2/25/2015	Beginning Section MP	0.00				
Paved Length (Miles): 0.11	Section Length (MI)	0.11				
Surface Type: ASPHALT	Route Summary					
Roadway Condition Information						
Pavement Condition Rating (PCR)	30	30				
Surface Condition Rating (SCR)	30	30				
Roughness Condition Index (RCI)	N/A	N/A				
Distress Index Values						
Structural Crack Index	N/A	N/A				
Alligator Crack Index	30	30				
Longitudinal Crack Index	30	30				
Transverse Cracking Index	53	53				
Patching Index	30	30				
Rutting Index	53	53				
International Roughness Index (IRI)	N/A	N/A				
Lane & Width Information						
Number of Lanes	1	1				
Paved Width (ft)	10	10				
Lane Width (ft)	10	10

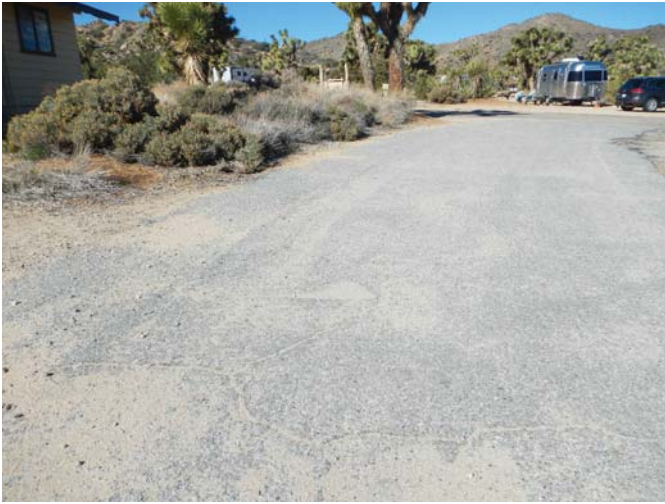
JOTR_0214JZ_0508.JPG

Route Condition Legend – Pavement Condition Rating (PCR)						
Poor (0 - 60)	Fair (61- 84)	Good (85 - 94)	Excellent (95 - 100)	Not Rated		
See Appendix for definitions and formulas						
Inspection Date: 2/25/2015	Beginning Section MP	0.00				
Paved Length (Miles): 0.10	Section Length (MI)	0.10				
Surface Type: ASPHALT	Route Summary					
Roadway Condition Information						
Pavement Condition Rating (PCR)	53	53				
Surface Condition Rating (SCR)	53	53				
Roughness Condition Index (RCI)	N/A	N/A				
Distress Index Values						
Structural Crack Index	N/A	N/A				
Alligator Crack Index	53	53				
Longitudinal Crack Index	73	73				
Transverse Cracking Index	73	73				
Patching Index	97	97				
Rutting Index	53	53				
International Roughness Index (IRI)	N/A	N/A				
Lane & Width Information						
Number of Lanes	1	1				
Paved Width (ft)	12	12				
Lane Width (ft)	12	12

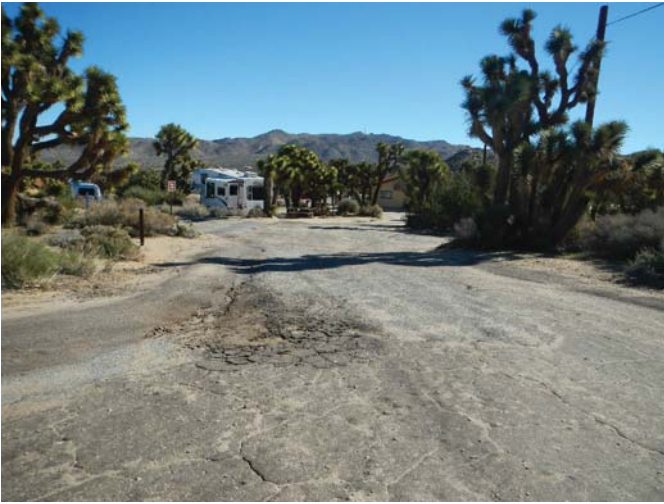
JOTR_0214MZ_0499.JPG

Route Condition Legend – Pavement Condition Rating (PCR)						
Poor (0 - 60)	Fair (61- 84)	Good (85 - 94)	Excellent (95 - 100)	Not Rated		
See Appendix for definitions and formulas						
Inspection Date: 2/25/2015	Beginning Section MP	0.00				
Paved Length (Miles): 0.07	Section Length (MI)	0.07				
Surface Type: ASPHALT	Route Summary					
Roadway Condition Information						
Pavement Condition Rating (PCR)	30	30				
Surface Condition Rating (SCR)	30	30				
Roughness Condition Index (RCI)	N/A	N/A				
Distress Index Values						
Structural Crack Index	N/A	N/A				
Alligator Crack Index	30	30				
Longitudinal Crack Index	30	30				
Transverse Cracking Index	53	53				
Patching Index	30	30				
Rutting Index	53	53				
International Roughness Index (IRI)	N/A	N/A				
Lane & Width Information						
Number of Lanes	2	2				
Paved Width (ft)	16	16				
Lane Width (ft)	8	8

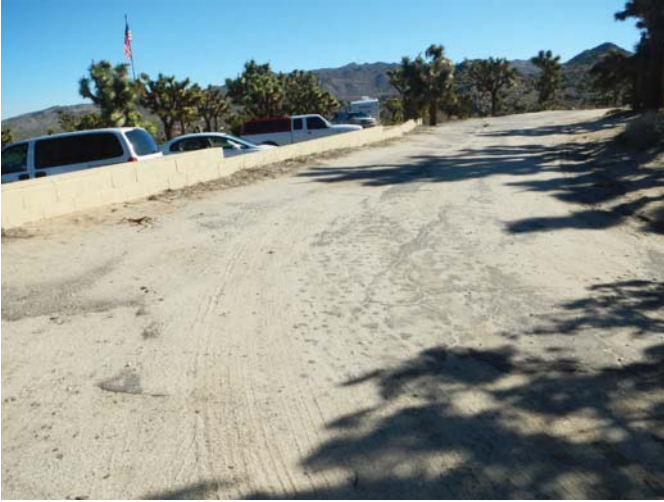
JOTR_0214NZ_0502.JPG

Inspection Date: 2/25/2015	Beginning Section MP	0.00				
Paved Length (Miles): 0.12	Section Length (MI)	0.12				
Surface Type: ASPHALT	Route Summary					
Roadway Condition Information						
Pavement Condition Rating (PCR)	30	30				
Surface Condition Rating (SCR)	30	30				
Roughness Condition Index (RCI)	N/A	N/A				
Distress Index Values						
Structural Crack Index	N/A	N/A				
Alligator Crack Index	30	30				
Longitudinal Crack Index	30	30				
Transverse Cracking Index	53	53				
Patching Index	30	30				
Rutting Index	53	53				
International Roughness Index (IRI)	N/A	N/A				
Lane & Width Information						
Number of Lanes	2	2				
Paved Width (ft)	16	16				
Lane Width (ft)	8	8

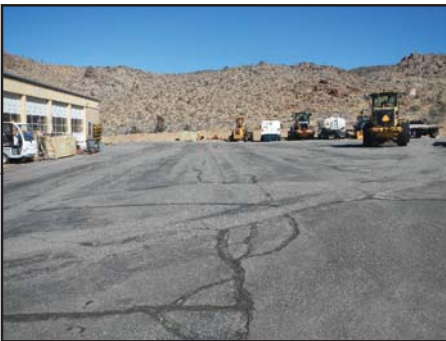
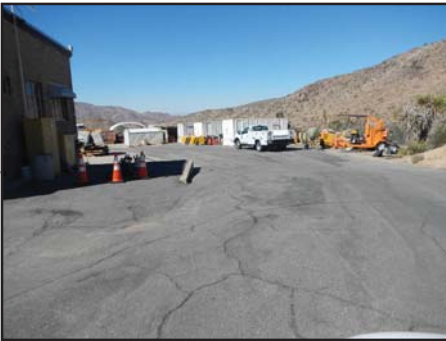
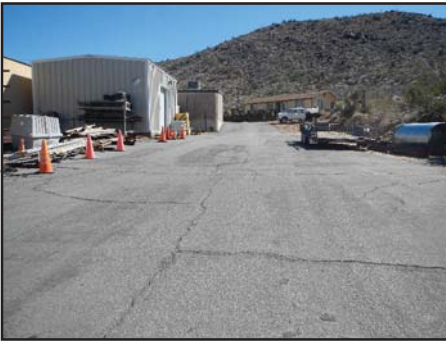
ROUTE 0902: TWIN TANKS BACKCOUNTRY PARKING

Inspection Date	FMSS Number	User Access	Surface Type
2/24/2015	38993	PUBLIC	ASPHALT
Area (Sq. Ft.)	Lane Miles (11' Widths)	Curb Reveal (Inches)	Curb Recommendation
23,562	0.406	NOT APPLICABLE	NOT APPLICABLE
Curb Type		Curb & Gutter Type	
NO CURB		NO CURB AND GUTTER	
Pavement Recommendation		Condition Rating / PCR	
HEAVY 3R TREATMENTS		POOR / 53

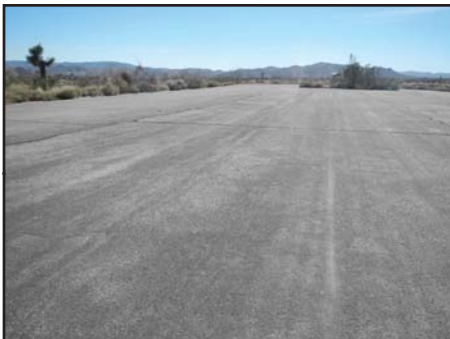
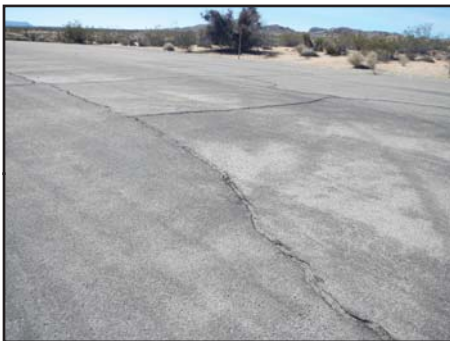
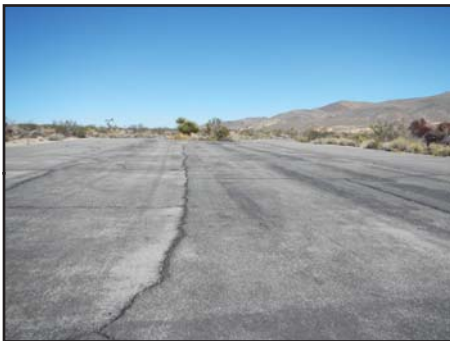
ROUTE 0903: STIRRUP TANK PARKING

Inspection Date	FMSS Number	User Access	Surface Type
2/24/2015	38994	PUBLIC	ASPHALT
Area (Sq. Ft.)	Lane Miles (11' Widths)	Curb Reveal (Inches)	Curb Recommendation
6,267	0.108	NOT APPLICABLE	NOT APPLICABLE
Curb Type		Curb & Gutter Type	
NO CURB		NO CURB AND GUTTER	
Pavement Recommendation		Condition Rating / PCR	
HEAVY 3R TREATMENTS		POOR / 53

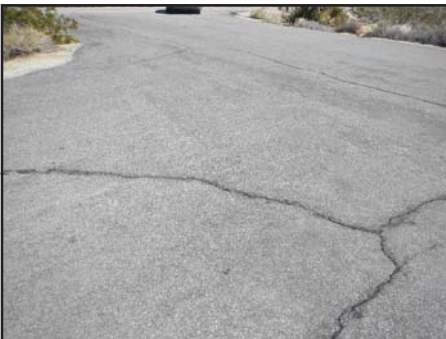
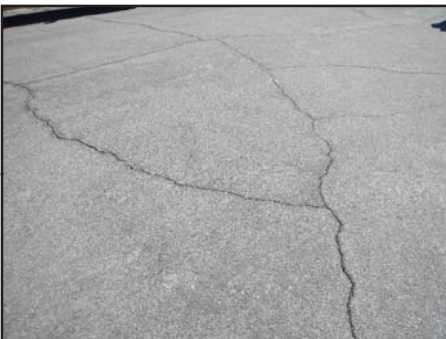
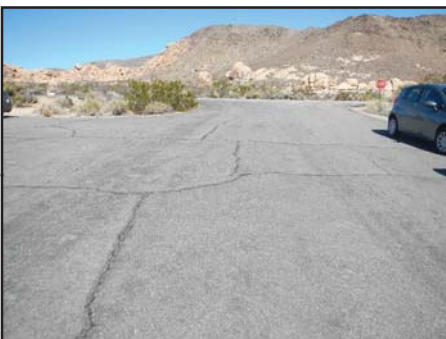
ROUTE 0904: COTTONWOOD VISITOR CENTER

Inspection Date	FMSS Number	User Access	Surface Type
2/24/2015	38995	PUBLIC	ASPHALT
Area (Sq. Ft.)	Lane Miles (11' Widths)	Curb Reveal (Inches)	Curb Recommendation
17,080	0.294	6	DO NOTHING
Curb Type		Curb & Gutter Type	
CONCRETE		CONCRETE	
Pavement Recommendation		Condition Rating / PCR	
PREVENTIVE MAINTENANCE		GOOD / 90

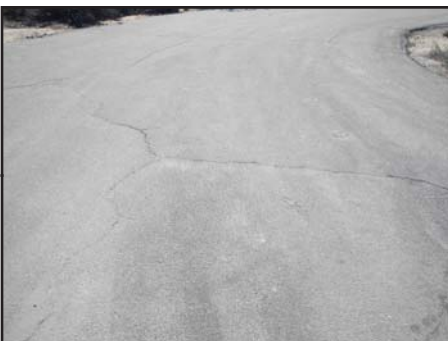
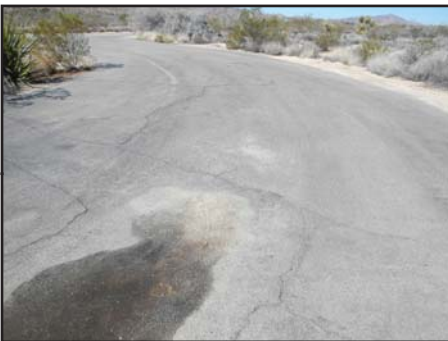
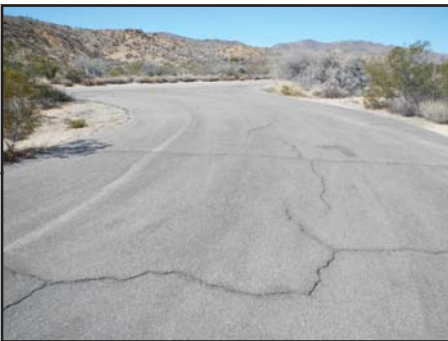
ROUTE 0907A: COTTONWOOD CAMPGROUND PARKING A

Inspection Date	FMSS Number	User Access	Surface Type
2/24/2015	98211	PUBLIC	ASPHALT
Area (Sq. Ft.)	Lane Miles (11' Widths)	Curb Reveal (Inches)	Curb Recommendation
8,024	0.138	NOT APPLICABLE	DO NOTHING
Curb Type		Curb & Gutter Type	
NO CURB		CONCRETE	
Pavement Recommendation		Condition Rating / PCR	
HEAVY 3R TREATMENTS		POOR / 53

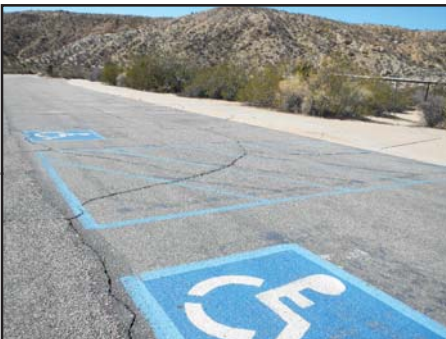
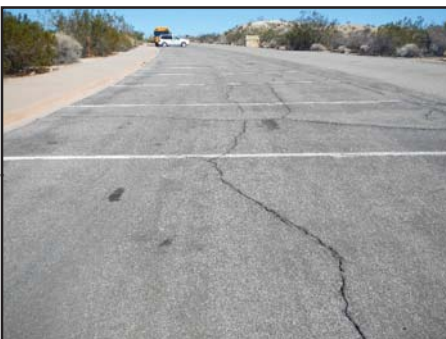
ROUTE 0907B: COTTONWOOD CAMPGROUND PARKING B

Inspection Date	FMSS Number	User Access	Surface Type
2/24/2015	98212	PUBLIC	ASPHALT
Area (Sq. Ft.)	Lane Miles (11' Widths)	Curb Reveal (Inches)	Curb Recommendation
884	0.015	NOT APPLICABLE	DO NOTHING
Curb Type		Curb & Gutter Type	
NO CURB		CONCRETE	
Pavement Recommendation		Condition Rating / PCR	
HEAVY 3R TREATMENTS		POOR / 53

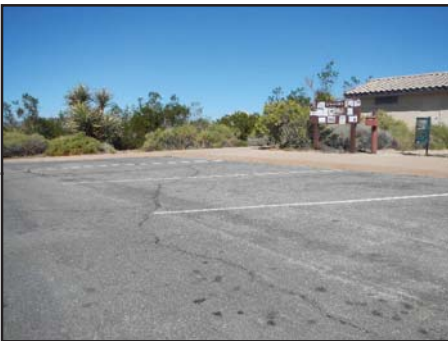
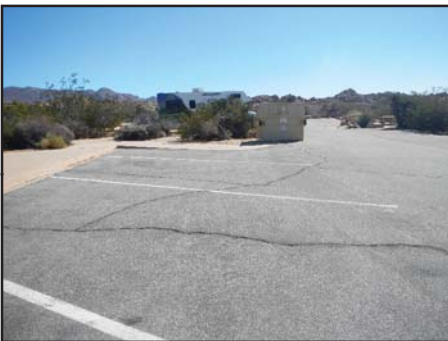
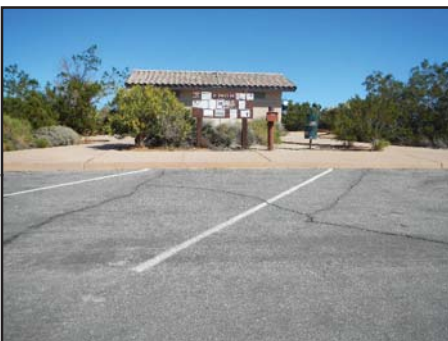
ROUTE 0907C: COTTONWOOD CAMPGROUND PARKING C

Inspection Date	FMSS Number	User Access	Surface Type
2/24/2015	98213	PUBLIC	ASPHALT
Area (Sq. Ft.)	Lane Miles (11' Widths)	Curb Reveal (Inches)	Curb Recommendation
953	0.016	NOT APPLICABLE	DO NOTHING
Curb Type		Curb & Gutter Type	
NO CURB		CONCRETE	
Pavement Recommendation		Condition Rating / PCR	
LIGHT 3R TREATMENTS		FAIR / 73

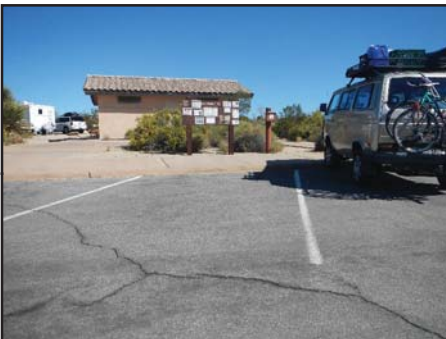
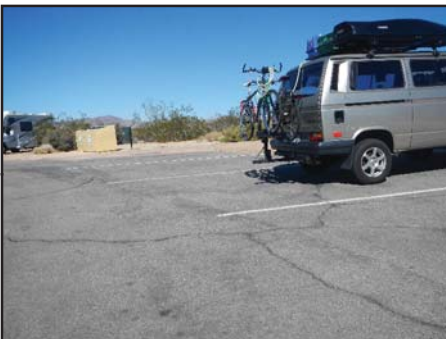
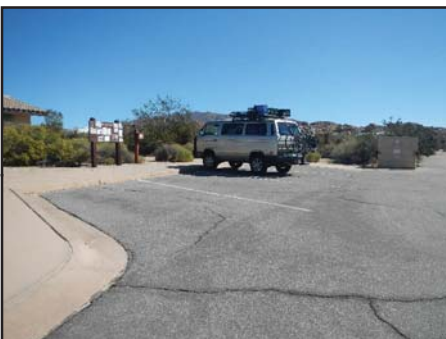
ROUTE 0907D: COTTONWOOD CAMPGROUND PICNIC PARKING D

Inspection Date	FMSS Number	User Access	Surface Type
2/24/2015	98208	PUBLIC	ASPHALT
Area (Sq. Ft.)	Lane Miles (11' Widths)	Curb Reveal (Inches)	Curb Recommendation
757	0.013	NOT APPLICABLE	NOT APPLICABLE
Curb Type		Curb & Gutter Type	
NO CURB		NO CURB AND GUTTER	
Pavement Recommendation		Condition Rating / PCR	
LIGHT 3R TREATMENTS		FAIR / 73

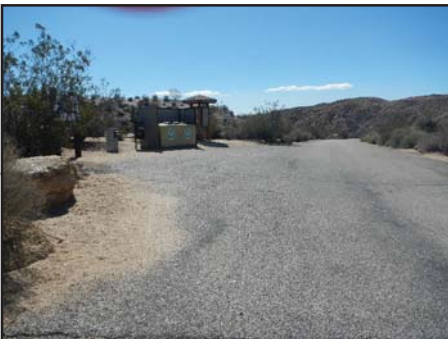
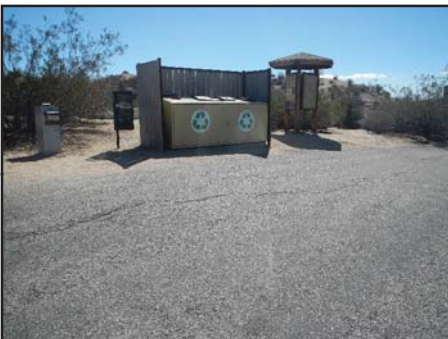
ROUTE 0908: COTTONWOOD SPRINGS OASIS PARKING

Inspection Date	FMSS Number	User Access	Surface Type
2/24/2015	38998	PUBLIC	ASPHALT
Area (Sq. Ft.)	Lane Miles (11' Widths)	Curb Reveal (Inches)	Curb Recommendation
16,087	0.277	NOT APPLICABLE	DO NOTHING
Curb Type		Curb & Gutter Type	
NO CURB		CONCRETE	
Pavement Recommendation		Condition Rating / PCR	
PREVENTIVE MAINTENANCE		GOOD / 90

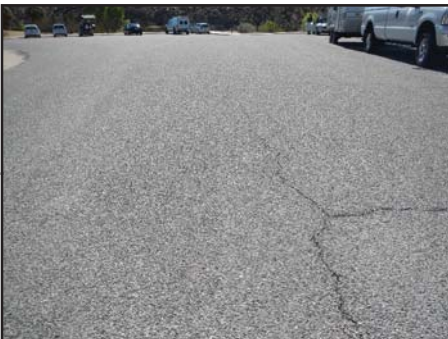
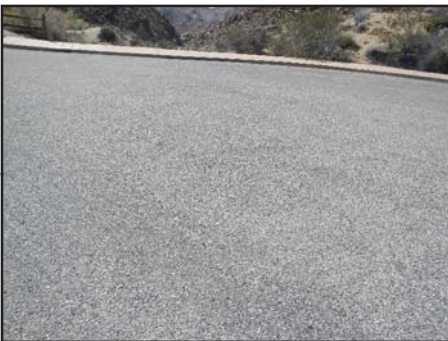
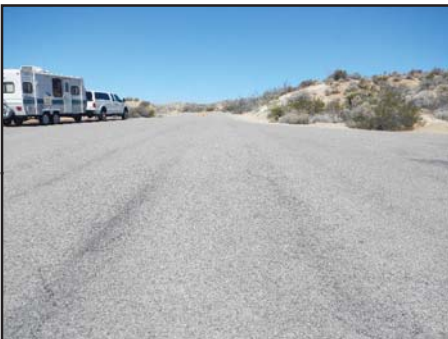
ROUTE 0909: BAJADA ALL TRAIL PARKING

Inspection Date	FMSS Number	User Access	Surface Type
2/24/2015	38999	PUBLIC	ASPHALT
Area (Sq. Ft.)	Lane Miles (11' Widths)	Curb Reveal (Inches)	Curb Recommendation
10,748	0.185	NOT APPLICABLE	DO NOTHING
Curb Type		Curb & Gutter Type	
NO CURB		CONCRETE	
Pavement Recommendation		Condition Rating / PCR	
HEAVY 3R TREATMENTS		POOR / 53

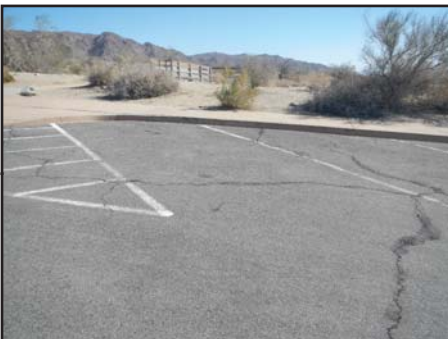
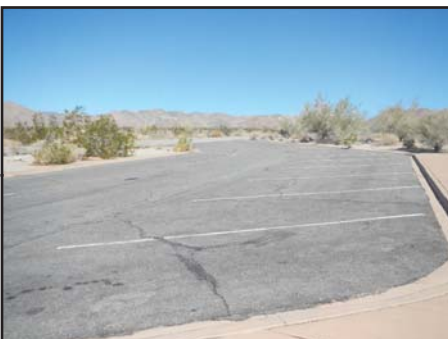
ROUTE 0911: OYSTER BAR TRAILHEAD PARKING

Inspection Date	FMSS Number	User Access	Surface Type
2/25/2015	39001	PUBLIC	ASPHALT
Area (Sq. Ft.)	Lane Miles (11' Widths)	Curb Reveal (Inches)	Curb Recommendation
12,755	0.22	8	DO NOTHING
Curb Type		Curb & Gutter Type	
CONCRETE		NO CURB AND GUTTER	
Pavement Recommendation		Condition Rating / PCR	
PREVENTIVE MAINTENANCE		GOOD / 90

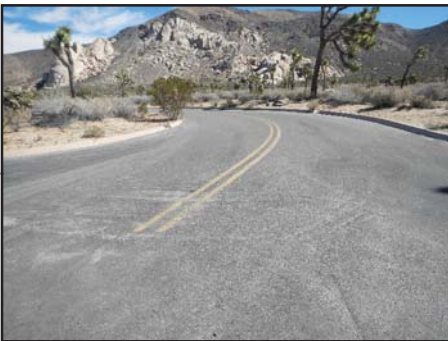
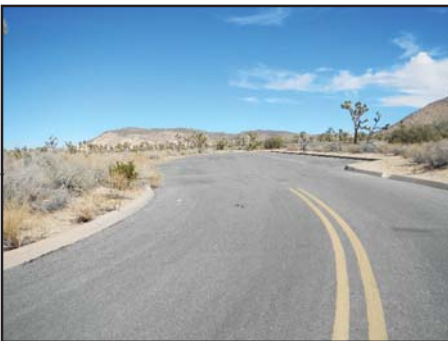
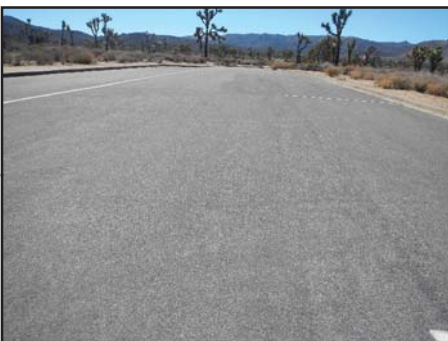
ROUTE 0912: RYAN MOUNTAIN TRAILHEAD PARKING

Inspection Date	FMSS Number	User Access	Surface Type
2/25/2015	19493	PUBLIC	ASPHALT
Area (Sq. Ft.)	Lane Miles (11' Widths)	Curb Reveal (Inches)	Curb Recommendation
33,875	0.583	6	DO NOTHING
Curb Type		Curb & Gutter Type	
CONCRETE		NO CURB AND GUTTER	
Pavement Recommendation		Condition Rating / PCR	
PREVENTIVE MAINTENANCE		GOOD / 90

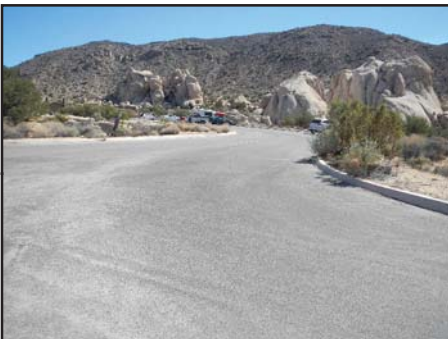
ROUTE 0913: QUAIL SPRINGS PARKING AREA

Inspection Date	FMSS Number	User Access	Surface Type
2/24/2015	39002	PUBLIC	ASPHALT
Area (Sq. Ft.)	Lane Miles (11' Widths)	Curb Reveal (Inches)	Curb Recommendation
41,172	0.709	6	DO NOTHING
Curb Type		Curb & Gutter Type	
CONCRETE		NO CURB AND GUTTER	
Pavement Recommendation		Condition Rating / PCR	
PREVENTIVE MAINTENANCE		GOOD / 90

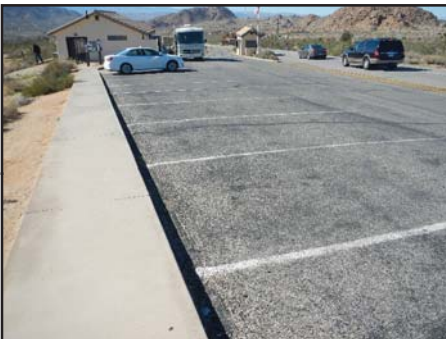
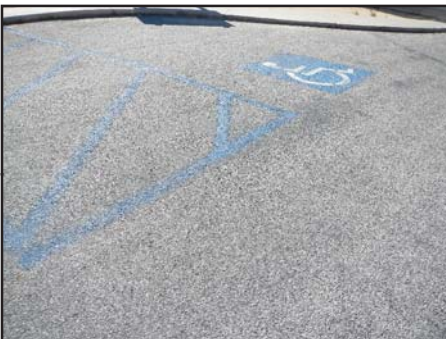
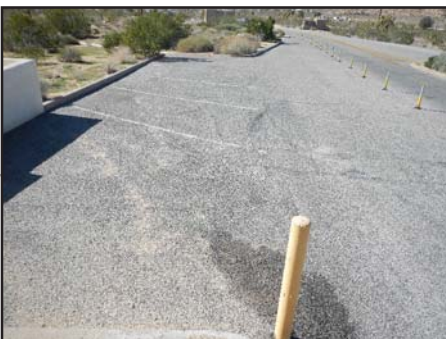
ROUTE 0915A: KEYS VIEW PARKING A

Inspection Date	FMSS Number	User Access	Surface Type
2/24/2015	231794	PUBLIC	ASPHALT
Area (Sq. Ft.)	Lane Miles (11' Widths)	Curb Reveal (Inches)	Curb Recommendation
1,649	0.028	8	DO NOTHING
Curb Type		Curb & Gutter Type	
CONCRETE		NO CURB AND GUTTER	
Pavement Recommendation		Condition Rating / PCR	
DO NOTHING		EXCELLENT / 97

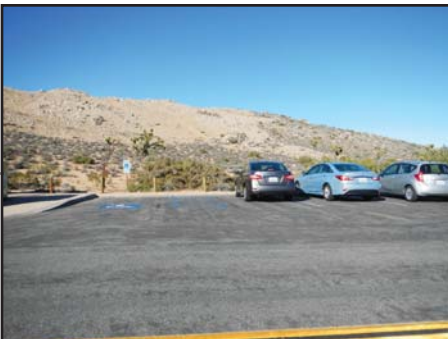
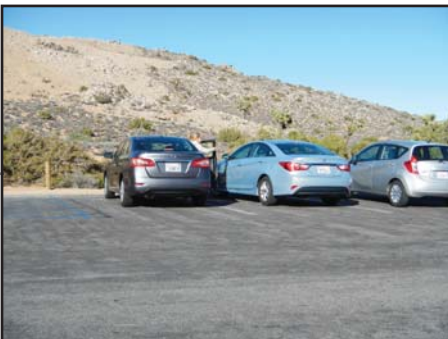
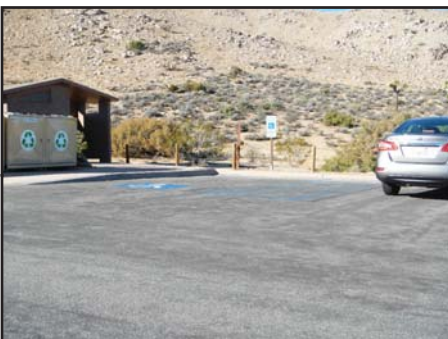
ROUTE 0915B: KEYS VIEW PARKING B

Inspection Date	FMSS Number	User Access	Surface Type
2/24/2015	55566	PUBLIC	ASPHALT
Area (Sq. Ft.)	Lane Miles (11' Widths)	Curb Reveal (Inches)	Curb Recommendation
23,000	0.396	8	DO NOTHING
Curb Type		Curb & Gutter Type	
CONCRETE		NO CURB AND GUTTER	
Pavement Recommendation		Condition Rating / PCR	
DO NOTHING		EXCELLENT / 97
