JOTR Cycle 6

Final Report

Road Inventory and Condition Assessment of Paved Routes Joshua Tree National Park

Report Date: December 2015

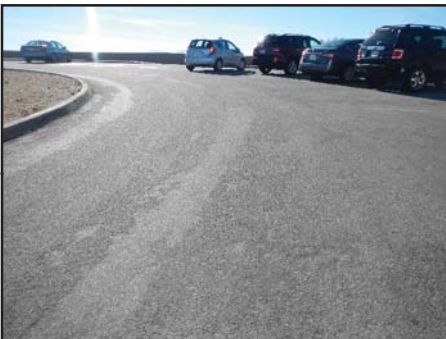
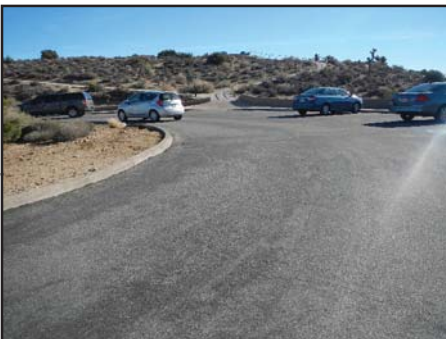
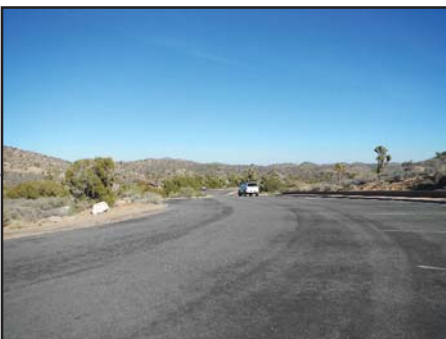
ROUTE 0916: INDIAN COVE CONTACT STATION

Inspection Date	FMSS Number	User Access	Surface Type
2/25/2015	39005	PUBLIC	ASPHALT
Area (Sq. Ft.)	Lane Miles (11' Widths)	Curb Reveal (Inches)	Curb Recommendation
13,155	0.226	NOT APPLICABLE	DO NOTHING
Curb Type		Curb & Gutter Type	
NO CURB		CONCRETE	
Pavement Recommendation		Condition Rating / PCR	
LIGHT 3R TREATMENTS		FAIR / 73

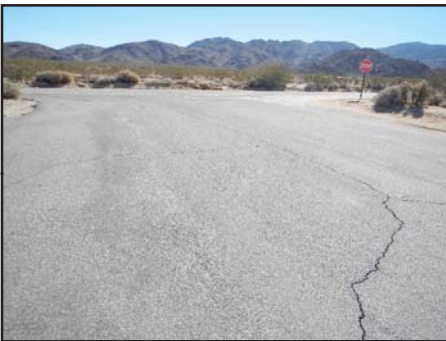
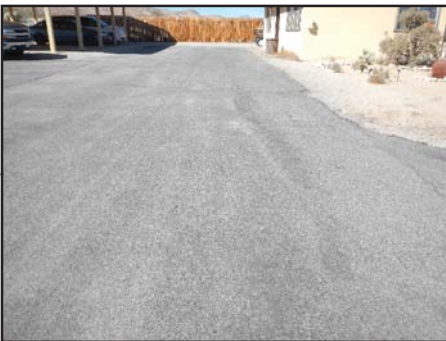
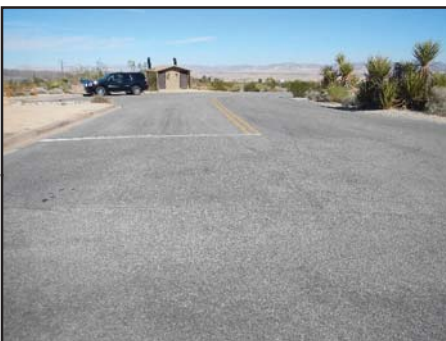
ROUTE 0917: 49 PALMS OASIS PARKING

Inspection Date	FMSS Number	User Access	Surface Type
2/25/2015	19730	PUBLIC	ASPHALT
Area (Sq. Ft.)	Lane Miles (11' Widths)	Curb Reveal (Inches)	Curb Recommendation
23,513	0.405	8	DO NOTHING
Curb Type		Curb & Gutter Type	
ASPHALT		NO CURB AND GUTTER	
Pavement Recommendation		Condition Rating / PCR	
LIGHT 3R TREATMENTS		FAIR / 73

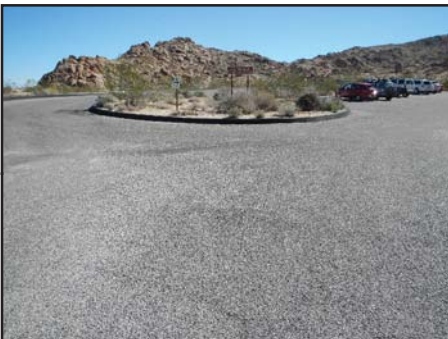
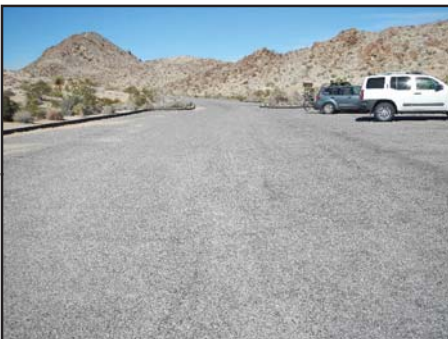
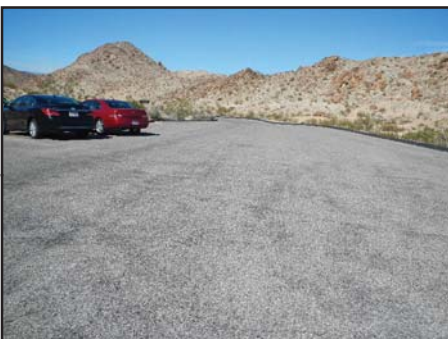
ROUTE 0918: HIDDEN VALLEY PICNIC PARKING

Inspection Date	FMSS Number	User Access	Surface Type
2/25/2015	39006	PUBLIC	ASPHALT
Area (Sq. Ft.)	Lane Miles (11' Widths)	Curb Reveal (Inches)	Curb Recommendation
101,532	1.748	6	DO NOTHING
Curb Type		Curb & Gutter Type	
CONCRETE		NO CURB AND GUTTER	
Pavement Recommendation		Condition Rating / PCR	
PREVENTIVE MAINTENANCE		GOOD / 90

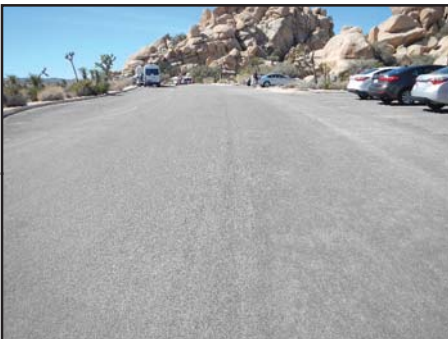
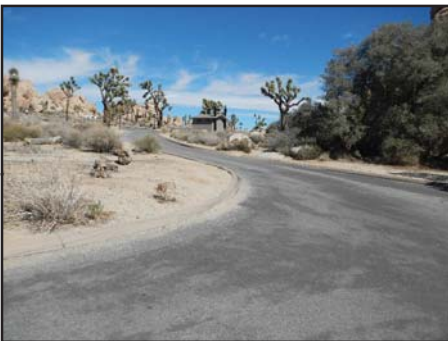
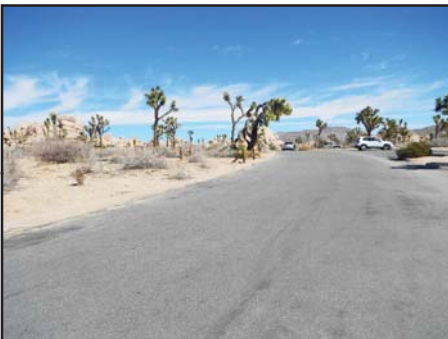
ROUTE 0919: NORTH ENTRANCE CONTACT STATION PARKING

Inspection Date	FMSS Number	User Access	Surface Type
2/25/2015	98214	PUBLIC	ASPHALT
Area (Sq. Ft.)	Lane Miles (11' Widths)	Curb Reveal (Inches)	Curb Recommendation
3,117	0.054	6	DO NOTHING
Curb Type		Curb & Gutter Type	
CONCRETE		NO CURB AND GUTTER	
Pavement Recommendation		Condition Rating / PCR	
PREVENTIVE MAINTENANCE		GOOD / 90

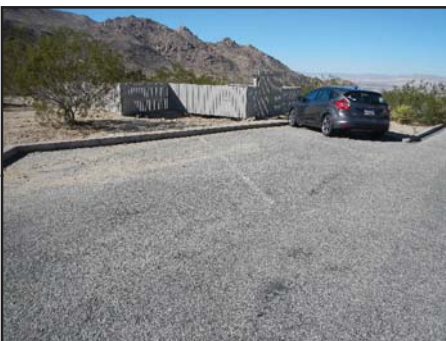
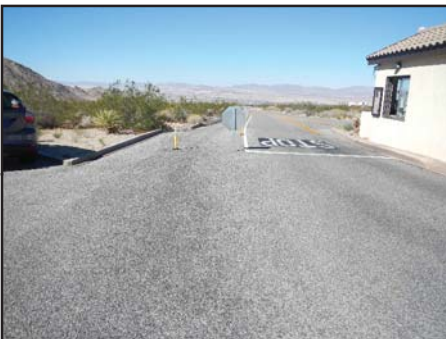
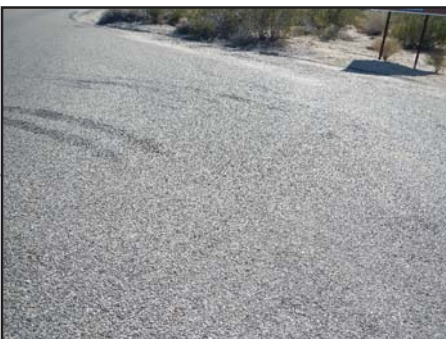
ROUTE 0920: MOJAVE PLANTS PARKING

Inspection Date	FMSS Number	User Access	Surface Type
2/25/2015	57151	PUBLIC	ASPHALT
Area (Sq. Ft.)	Lane Miles (11' Widths)	Curb Reveal (Inches)	Curb Recommendation
13,748	0.237	6	DO NOTHING
Curb Type		Curb & Gutter Type	
CONCRETE		NO CURB AND GUTTER	
Pavement Recommendation		Condition Rating / PCR	
PREVENTIVE MAINTENANCE		GOOD / 90

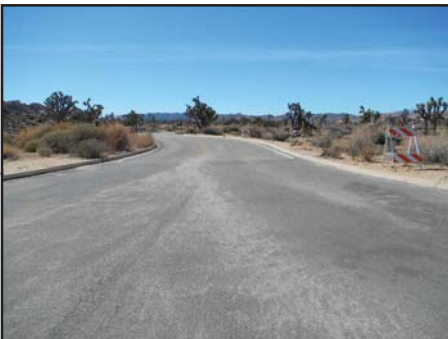
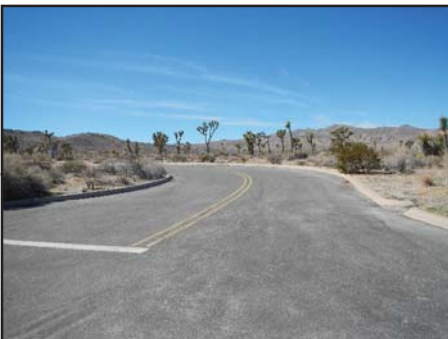
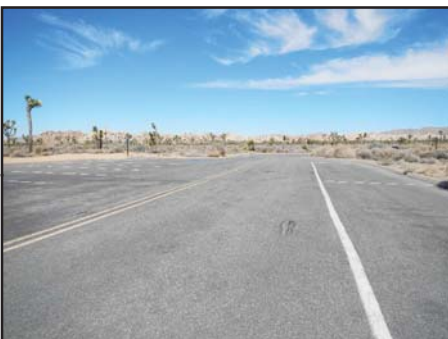
ROUTE 0921: HEMMINGWAY PARKING

Inspection Date	FMSS Number	User Access	Surface Type
2/24/2015	16847	PUBLIC	ASPHALT
Area (Sq. Ft.)	Lane Miles (11' Widths)	Curb Reveal (Inches)	Curb Recommendation
17,941	0.309	6	DO NOTHING
Curb Type		Curb & Gutter Type	
CONCRETE		NO CURB AND GUTTER	
Pavement Recommendation		Condition Rating / PCR	
PREVENTIVE MAINTENANCE		GOOD / 90

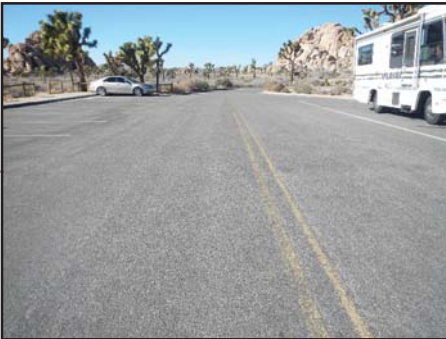
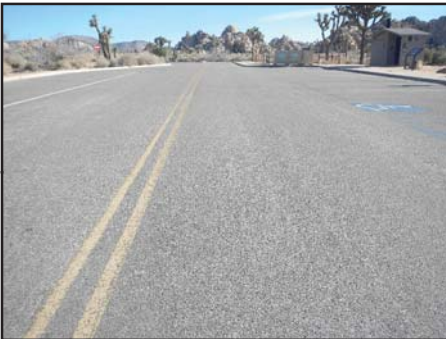
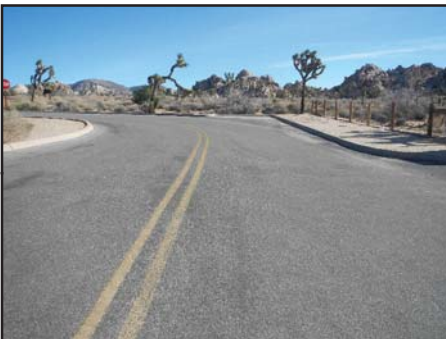
ROUTE 0922: INTERSECTION ROCK PARKING

Inspection Date	FMSS Number	User Access	Surface Type
2/25/2015	39012	PUBLIC	ASPHALT
Area (Sq. Ft.)	Lane Miles (11' Widths)	Curb Reveal (Inches)	Curb Recommendation
48,820	0.841	6	DO NOTHING
Curb Type		Curb & Gutter Type	
CONCRETE		NO CURB AND GUTTER	
Pavement Recommendation		Condition Rating / PCR	
PREVENTIVE MAINTENANCE		GOOD / 90

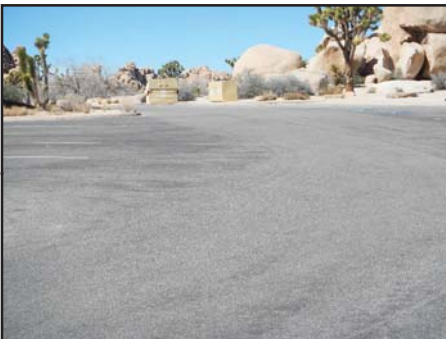
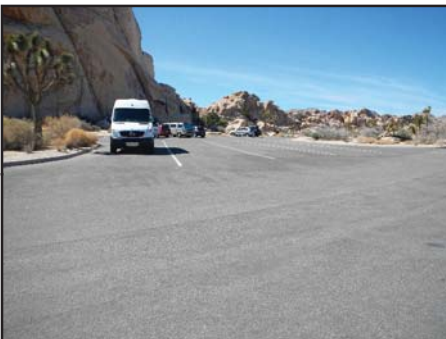
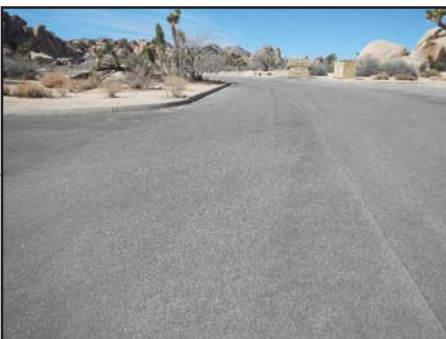
ROUTE 0923: BARKER DAM PARKING

Inspection Date	FMSS Number	User Access	Surface Type
2/25/2015	19904	PUBLIC	ASPHALT
Area (Sq. Ft.)	Lane Miles (11' Widths)	Curb Reveal (Inches)	Curb Recommendation
40,595	0.699	6	DO NOTHING
Curb Type		Curb & Gutter Type	
CONCRETE		NO CURB AND GUTTER	
Pavement Recommendation		Condition Rating / PCR	
PREVENTIVE MAINTENANCE		GOOD / 90

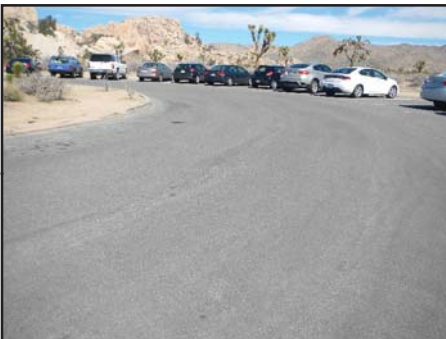
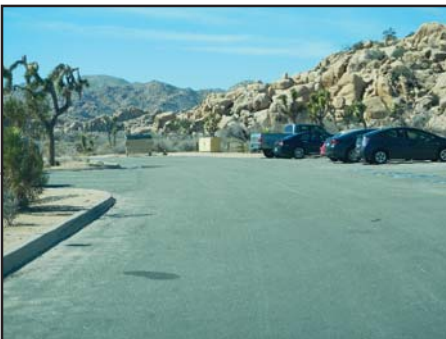
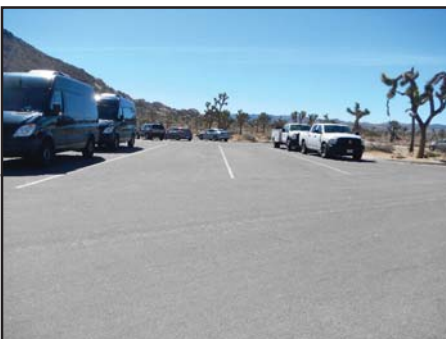
ROUTE 0925: BLACK ROCK CAMPGROUND DUMPSTATION

Inspection Date	FMSS Number	User Access	Surface Type
2/25/2015	98215	PUBLIC	ASPHALT
Area (Sq. Ft.)	Lane Miles (11' Widths)	Curb Reveal (Inches)	Curb Recommendation
5,609	0.097	NOT APPLICABLE	NOT APPLICABLE
Curb Type		Curb & Gutter Type	
NO CURB		NO CURB AND GUTTER	
Pavement Recommendation		Condition Rating / PCR	
LIGHT 3R TREATMENTS		FAIR / 73

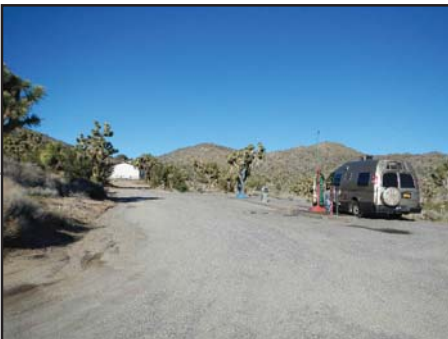
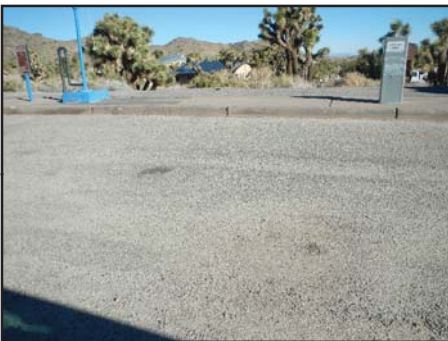
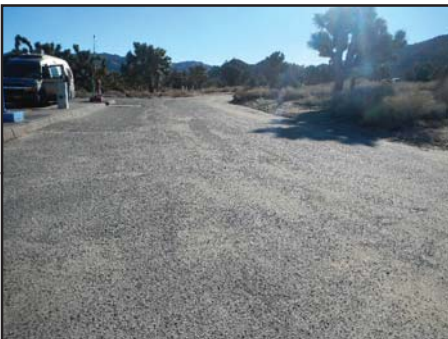
ROUTE 0926: BLACK ROCK NATURE CENTER PARKING

Inspection Date	FMSS Number	User Access	Surface Type
2/25/2015	98216	PUBLIC	ASPHALT
Area (Sq. Ft.)	Lane Miles (11' Widths)	Curb Reveal (Inches)	Curb Recommendation
16,073	0.277	NOT APPLICABLE	NOT APPLICABLE
Curb Type		Curb & Gutter Type	
NO CURB		NO CURB AND GUTTER	
Pavement Recommendation		Condition Rating / PCR	
HEAVY 3R TREATMENTS		POOR / 53

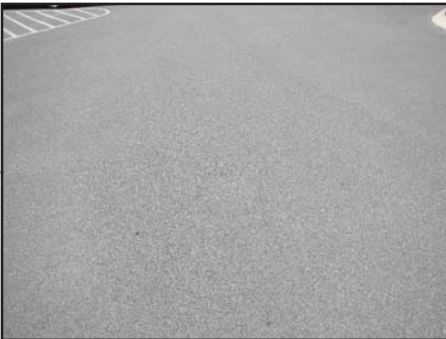
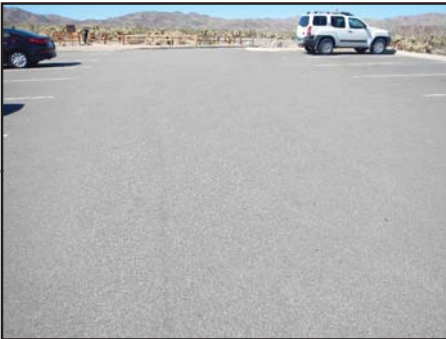
ROUTE 0937: OCOTILLO PATCH PARKING

Inspection Date	FMSS Number	User Access	Surface Type
2/24/2015	98191	PUBLIC	ASPHALT
Area (Sq. Ft.)	Lane Miles (11' Widths)	Curb Reveal (Inches)	Curb Recommendation
7,722	0.133	10	DO NOTHING
Curb Type		Curb & Gutter Type	
CONCRETE		NO CURB AND GUTTER	
Pavement Recommendation		Condition Rating / PCR	
PREVENTIVE MAINTENANCE		GOOD / 90

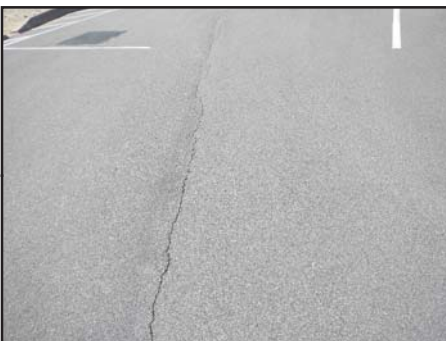
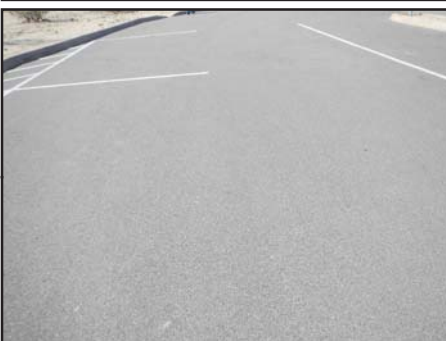
ROUTE 0938: TURKEY FLATS BACKCOUNTRY BOARD PARKING

Inspection Date	FMSS Number	User Access	Surface Type
2/24/2015	98193	PUBLIC	ASPHALT
Area (Sq. Ft.)	Lane Miles (11' Widths)	Curb Reveal (Inches)	Curb Recommendation
8,575	0.148	8	DO NOTHING
Curb Type		Curb & Gutter Type	
CONCRETE		NO CURB AND GUTTER	
Pavement Recommendation		Condition Rating / PCR	
PREVENTIVE MAINTENANCE		GOOD / 90

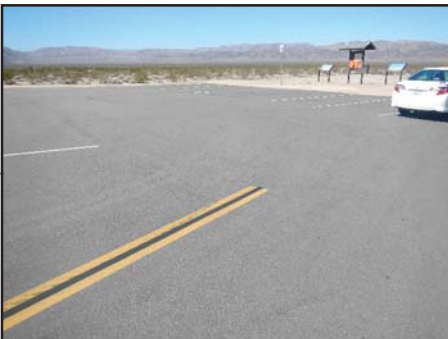
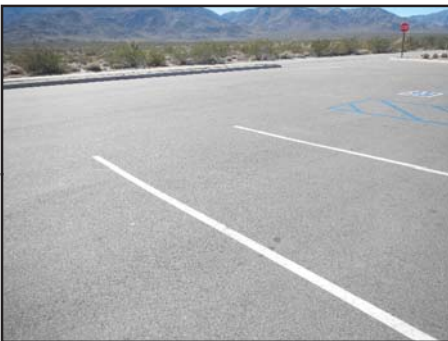
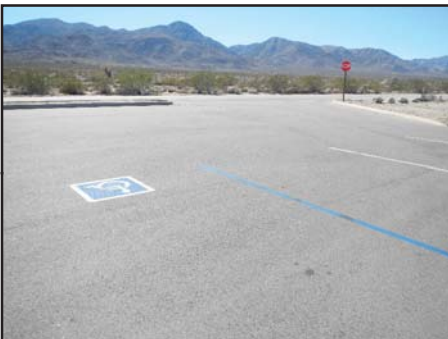
ROUTE 0939: PORCUPINE WASH BACKCOUNTRY BOARD PARKING

Inspection Date	FMSS Number	User Access	Surface Type
2/24/2015	98194	PUBLIC	ASPHALT
Area (Sq. Ft.)	Lane Miles (11' Widths)	Curb Reveal (Inches)	Curb Recommendation
4,259	0.073	6	DO NOTHING
Curb Type		Curb & Gutter Type	
CONCRETE		NO CURB AND GUTTER	
Pavement Recommendation		Condition Rating / PCR	
DO NOTHING		EXCELLENT / 97

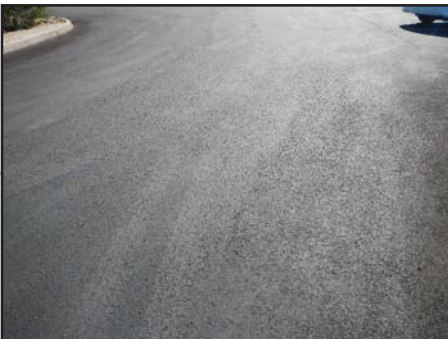
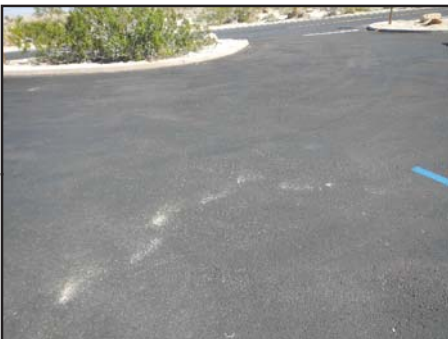
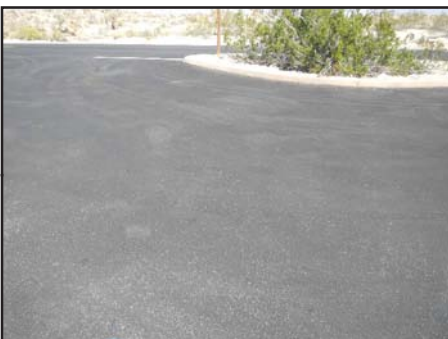
ROUTE 0953: CAP ROCK PARKING

Inspection Date	FMSS Number	User Access	Surface Type
2/24/2015	19898	PUBLIC	ASPHALT
Area (Sq. Ft.)	Lane Miles (11' Widths)	Curb Reveal (Inches)	Curb Recommendation
33,688	0.58	6	DO NOTHING
Curb Type		Curb & Gutter Type	
CONCRETE		NO CURB AND GUTTER	
Pavement Recommendation		Condition Rating / PCR	
PREVENTIVE MAINTENANCE		GOOD / 90

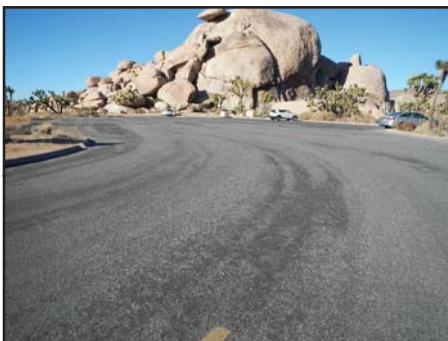
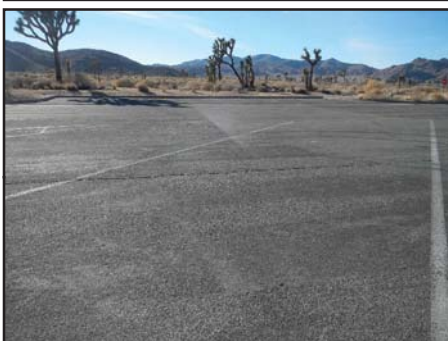
ROUTE 0956: NORTH ENTRANCE SIGN PARKING

Inspection Date	FMSS Number	User Access	Surface Type
2/25/2015	98200	PUBLIC	ASPHALT
Area (Sq. Ft.)	Lane Miles (11' Widths)	Curb Reveal (Inches)	Curb Recommendation
2,913	0.05	NOT APPLICABLE	NOT APPLICABLE
Curb Type		Curb & Gutter Type	
NO CURB		NO CURB AND GUTTER	
Pavement Recommendation		Condition Rating / PCR	
PREVENTIVE MAINTENANCE		GOOD / 90

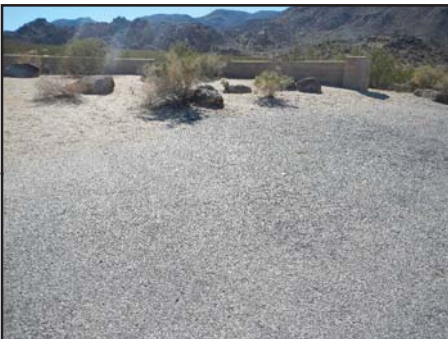
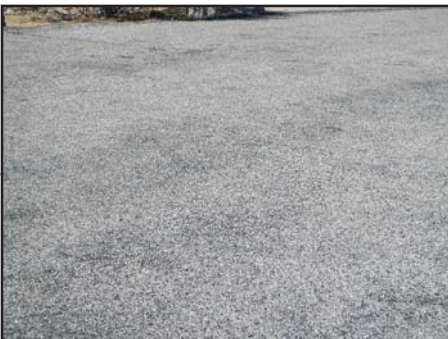
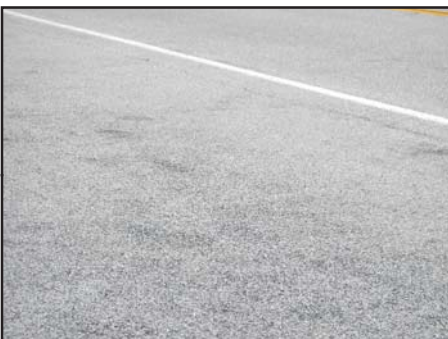
ROUTE 0957: BARREN OR BOUNTIFUL PARKING

Inspection Date	FMSS Number	User Access	Surface Type
2/24/2015	232183	PUBLIC	ASPHALT
Area (Sq. Ft.)	Lane Miles (11' Widths)	Curb Reveal (Inches)	Curb Recommendation
4,158	0.072	NOT APPLICABLE	DO NOTHING
Curb Type		Curb & Gutter Type	
NO CURB		CONCRETE	
Pavement Recommendation		Condition Rating / PCR	
PREVENTIVE MAINTENANCE		GOOD / 90

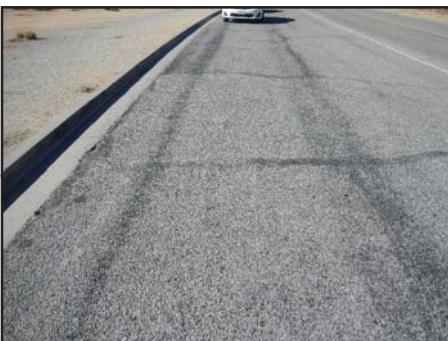
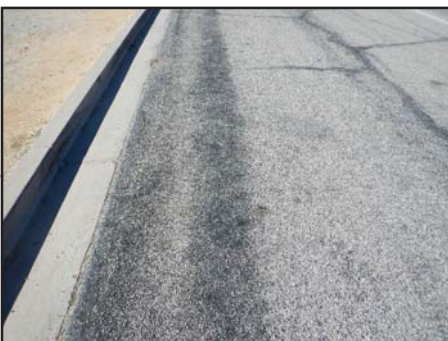
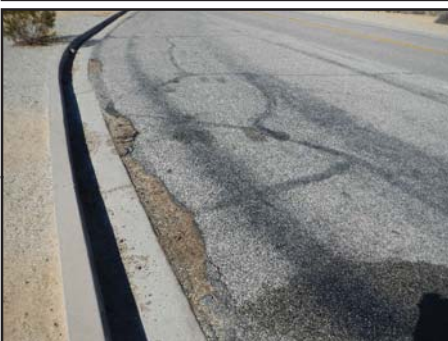
ROUTE 0958: RYAN RANCH PARKING

Inspection Date	FMSS Number	User Access	Surface Type
2/25/2015	231788	PUBLIC	ASPHALT
Area (Sq. Ft.)	Lane Miles (11' Widths)	Curb Reveal (Inches)	Curb Recommendation
6,292	0.108	8	DO NOTHING
Curb Type		Curb & Gutter Type	
CONCRETE		NO CURB AND GUTTER	
Pavement Recommendation		Condition Rating / PCR	
LIGHT 3R TREATMENTS		FAIR / 73

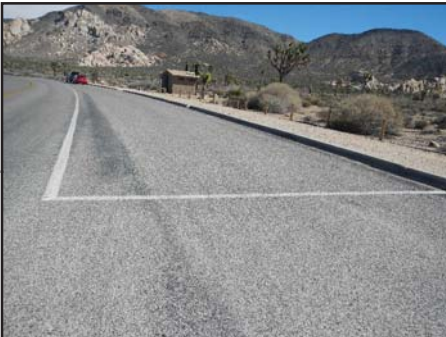
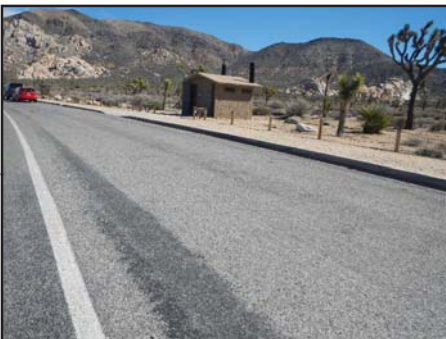
ROUTE 0959: HALL OF HORRORS PARKING

Inspection Date	FMSS Number	User Access	Surface Type
2/25/2015	19839	PUBLIC	ASPHALT
Area (Sq. Ft.)	Lane Miles (11' Widths)	Curb Reveal (Inches)	Curb Recommendation
17,755	0.306	6	DO NOTHING
Curb Type		Curb & Gutter Type	
CONCRETE		NO CURB AND GUTTER	
Pavement Recommendation		Condition Rating / PCR	
PREVENTIVE MAINTENANCE		GOOD / 90

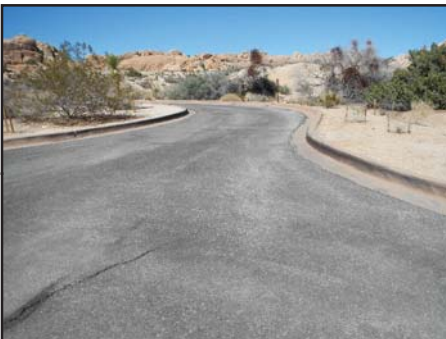
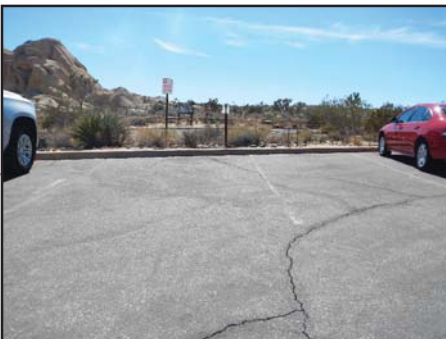
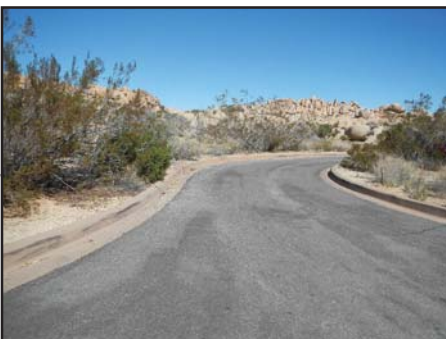
ROUTE 0960BZ: SKULL ROCK TRAIL AND AMPHITHEATER PARKING

Inspection Date	FMSS Number	User Access	Surface Type
2/25/2015	98224	PUBLIC	ASPHALT
Area (Sq. Ft.)	Lane Miles (11' Widths)	Curb Reveal (Inches)	Curb Recommendation
1,058	0.018	NOT APPLICABLE	NOT APPLICABLE
Curb Type		Curb & Gutter Type	
NO CURB		NO CURB AND GUTTER	
Pavement Recommendation		Condition Rating / PCR	
LIGHT 3R TREATMENTS		FAIR / 73

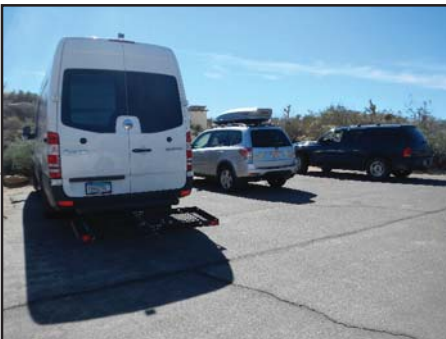
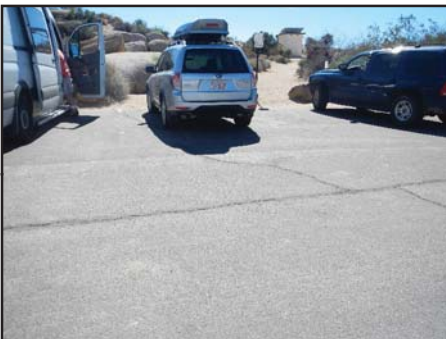
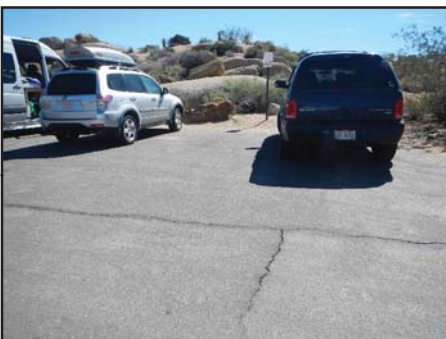
ROUTE 0960CZ: SITES 72 THROUGH 76 PARKING

Inspection Date	FMSS Number	User Access	Surface Type
2/25/2015	98224	PUBLIC	ASPHALT
Area (Sq. Ft.)	Lane Miles (11' Widths)	Curb Reveal (Inches)	Curb Recommendation
3,844	0.066	NOT APPLICABLE	NOT APPLICABLE
Curb Type		Curb & Gutter Type	
NO CURB		NO CURB AND GUTTER	
Pavement Recommendation		Condition Rating / PCR	
HEAVY 3R TREATMENTS		POOR / 53

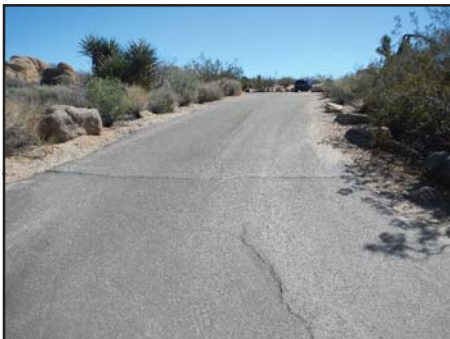
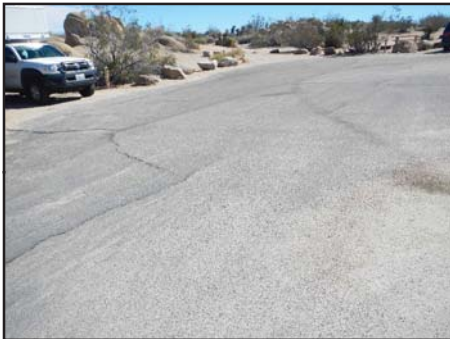
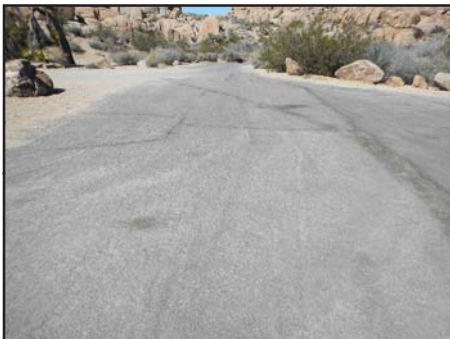
ROUTE 0961: KEYS VIEW HANDICAPPED PARKING

Inspection Date	FMSS Number	User Access	Surface Type
2/24/2015	231792	PUBLIC	ASPHALT
Area (Sq. Ft.)	Lane Miles (11' Widths)	Curb Reveal (Inches)	Curb Recommendation
1,331	0.023	6	DO NOTHING
Curb Type		Curb & Gutter Type	
CONCRETE		NO CURB AND GUTTER	
Pavement Recommendation		Condition Rating / PCR	
PREVENTIVE MAINTENANCE		GOOD / 90

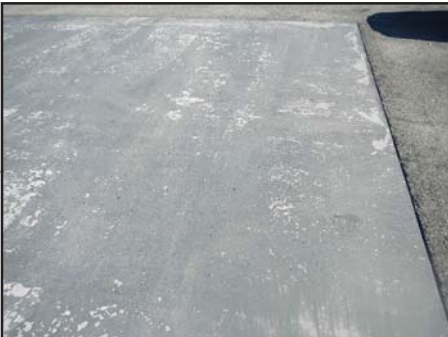
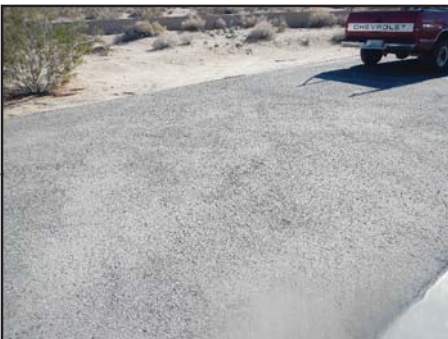
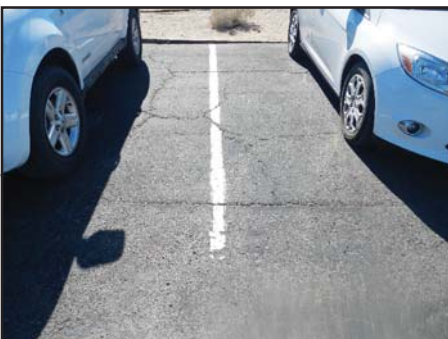
ROUTE 0967: SILVER BELL MINE WAYSIDE #75 PARKING

Inspection Date	FMSS Number	User Access	Surface Type
2/24/2015	232185	PUBLIC	ASPHALT
Area (Sq. Ft.)	Lane Miles (11' Widths)	Curb Reveal (Inches)	Curb Recommendation
2,235	0.038	8	DO NOTHING
Curb Type		Curb & Gutter Type	
CONCRETE		NO CURB AND GUTTER	
Pavement Recommendation		Condition Rating / PCR	
DO NOTHING		EXCELLENT / 97

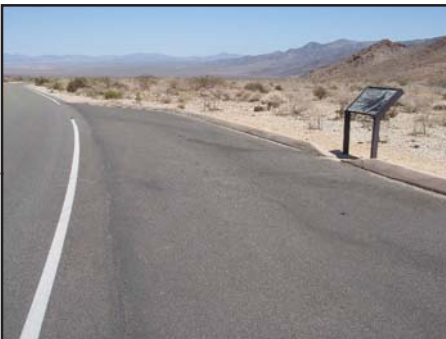
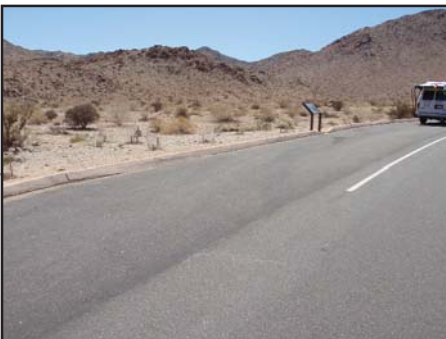
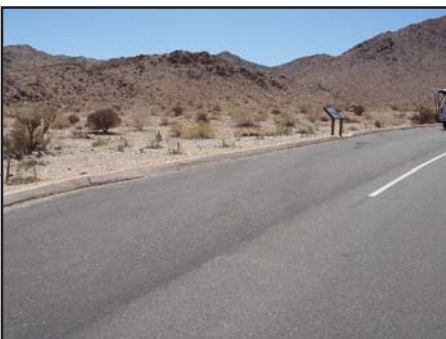
ROUTE 0969: DESERT GOVERNOR WAYSIDE #79 PARKING

Inspection Date	FMSS Number	User Access	Surface Type
2/24/2015	232200	PUBLIC	ASPHALT
Area (Sq. Ft.)	Lane Miles (11' Widths)	Curb Reveal (Inches)	Curb Recommendation
6,137	0.106	6	DO NOTHING
Curb Type		Curb & Gutter Type	
CONCRETE		NO CURB AND GUTTER	
Pavement Recommendation		Condition Rating / PCR	
DO NOTHING		EXCELLENT / 97

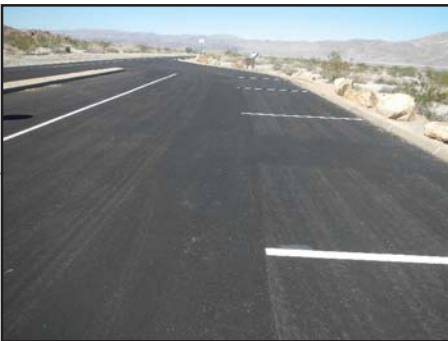
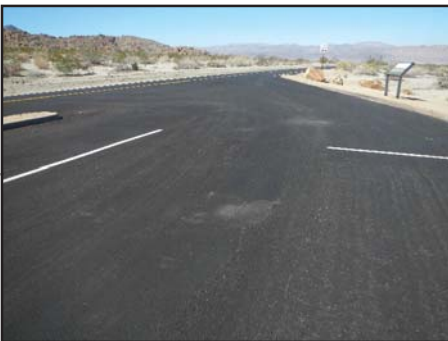
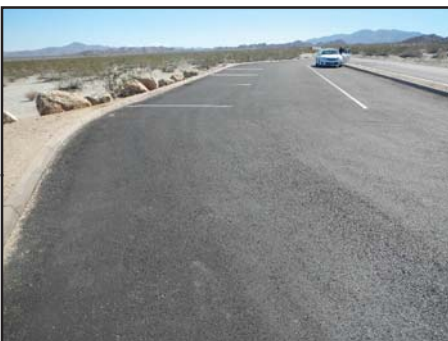
ROUTE 0972: SMOKE TREE WASH PARKING

Inspection Date	FMSS Number	User Access	Surface Type
2/24/2015	232215	PUBLIC	ASPHALT
Area (Sq. Ft.)	Lane Miles (11' Widths)	Curb Reveal (Inches)	Curb Recommendation
7,461	0.128	7	DO NOTHING
Curb Type		Curb & Gutter Type	
CONCRETE		NO CURB AND GUTTER	
Pavement Recommendation		Condition Rating / PCR	
DO NOTHING		EXCELLENT / 97

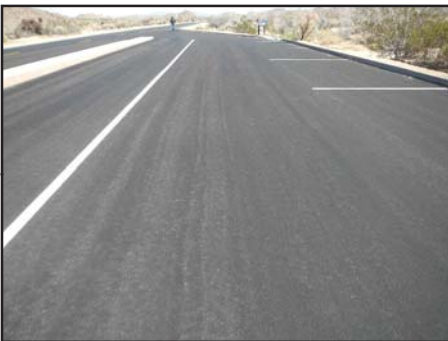
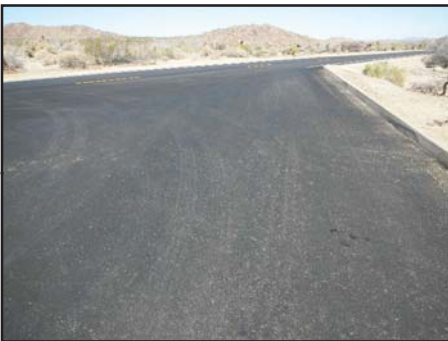
ROUTE 0973: WOODLAND BOUNTY EXHIBIT PARKING

Inspection Date	FMSS Number	User Access	Surface Type
2/24/2015	232221	PUBLIC	ASPHALT
Area (Sq. Ft.)	Lane Miles (11' Widths)	Curb Reveal (Inches)	Curb Recommendation
2,597	0.045	6	DO NOTHING
Curb Type		Curb & Gutter Type	
CONCRETE		NO CURB AND GUTTER	
Pavement Recommendation		Condition Rating / PCR	
DO NOTHING		EXCELLENT / 97

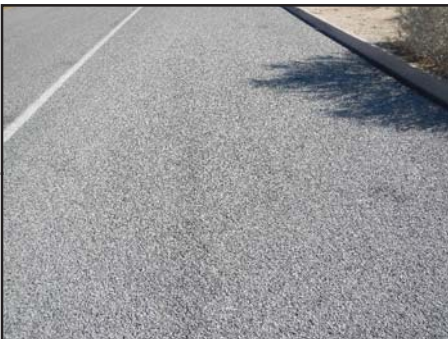
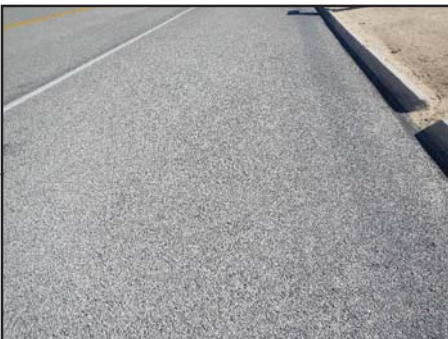
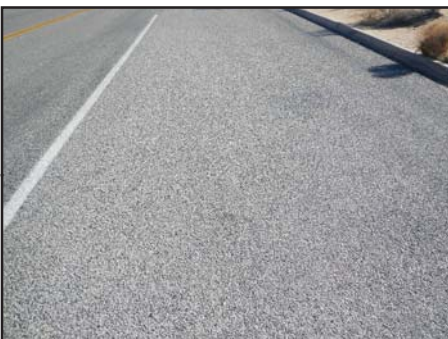
ROUTE 0974: A DISTINGUISHED YUCCA WAYSIDE PARKING

Inspection Date	FMSS Number	User Access	Surface Type
2/25/2015	232225	PUBLIC	ASPHALT
Area (Sq. Ft.)	Lane Miles (11' Widths)	Curb Reveal (Inches)	Curb Recommendation
2,058	0.035	NOT APPLICABLE	DO NOTHING
Curb Type		Curb & Gutter Type	
NO CURB		CONCRETE	
Pavement Recommendation		Condition Rating / PCR	
LIGHT 3R TREATMENTS		FAIR / 73

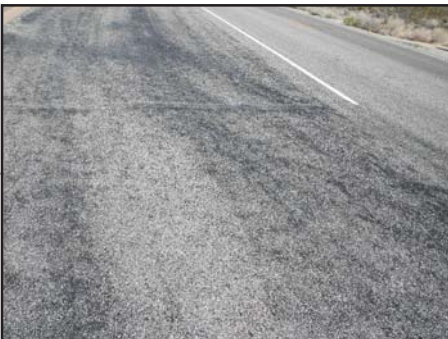
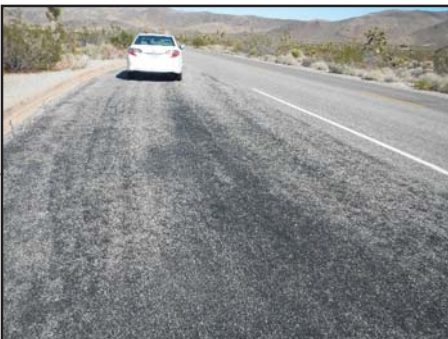
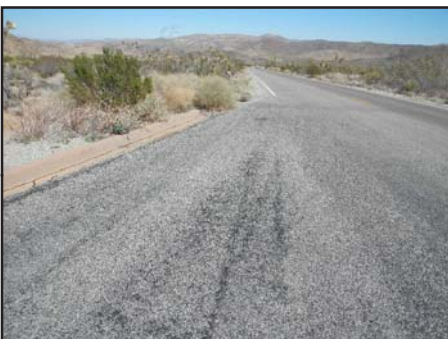
ROUTE 0976: COLORADO DESERT WAYSIDE PARKING, N COTTONWOOD CYN E SIDE

Inspection Date	FMSS Number	User Access	Surface Type
2/24/2015	232232	PUBLIC	ASPHALT
Area (Sq. Ft.)	Lane Miles (11' Widths)	Curb Reveal (Inches)	Curb Recommendation
2,445	0.042	NOT APPLICABLE	DO NOTHING
Curb Type		Curb & Gutter Type	
NO CURB		CONCRETE	
Pavement Recommendation		Condition Rating / PCR	
LIGHT 3R TREATMENTS		FAIR / 73

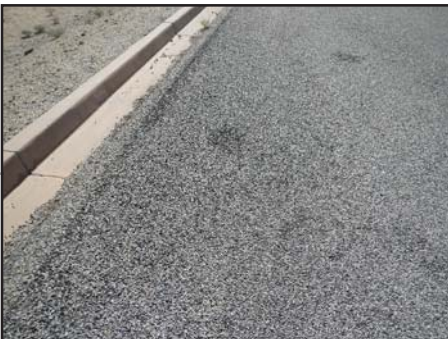
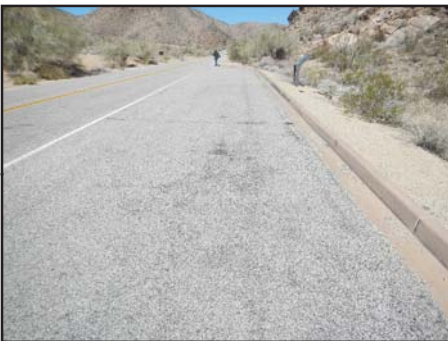
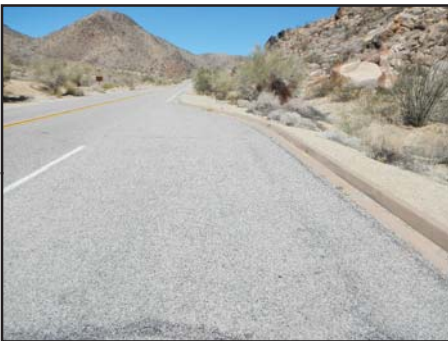
ROUTE 0977: SOUTH COLORADO DESERT WAYSIDE PARKING

Inspection Date	FMSS Number	User Access	Surface Type
2/24/2015	232233	PUBLIC	ASPHALT
Area (Sq. Ft.)	Lane Miles (11' Widths)	Curb Reveal (Inches)	Curb Recommendation
3,615	0.062	NOT APPLICABLE	DO NOTHING
Curb Type		Curb & Gutter Type	
NO CURB		CONCRETE	
Pavement Recommendation		Condition Rating / PCR	
LIGHT 3R TREATMENTS		FAIR / 73

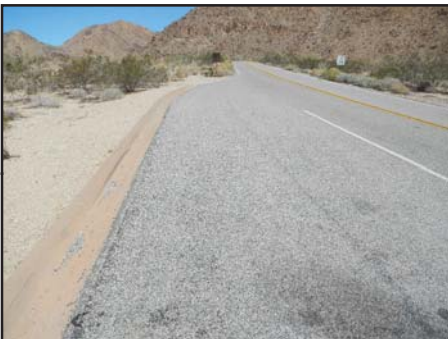
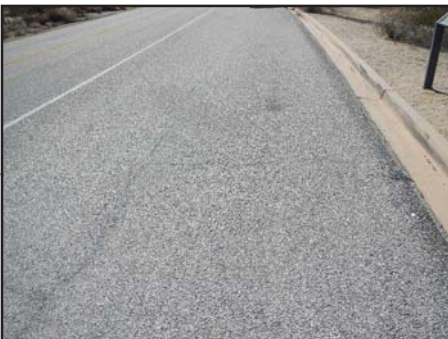
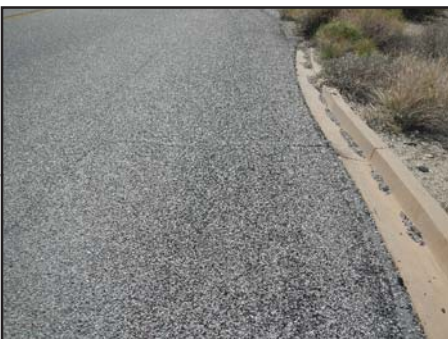
ROUTE 0978: THE ADVENTUROUS YUCCA WAYSIDE PARKING, #54

Inspection Date	FMSS Number	User Access	Surface Type
2/25/2015	232236	PUBLIC	ASPHALT
Area (Sq. Ft.)	Lane Miles (11' Widths)	Curb Reveal (Inches)	Curb Recommendation
1,423	0.025	6	DO NOTHING
Curb Type		Curb & Gutter Type	
CONCRETE		NO CURB AND GUTTER	
Pavement Recommendation		Condition Rating / PCR	
PREVENTIVE MAINTENANCE		GOOD / 90

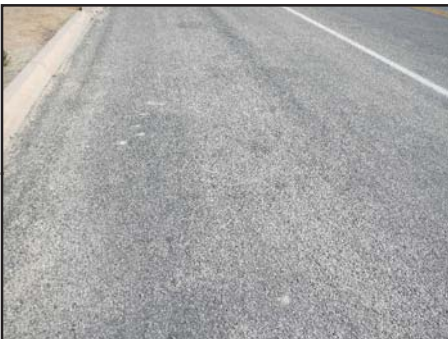
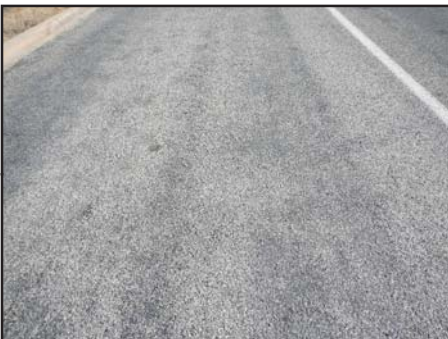
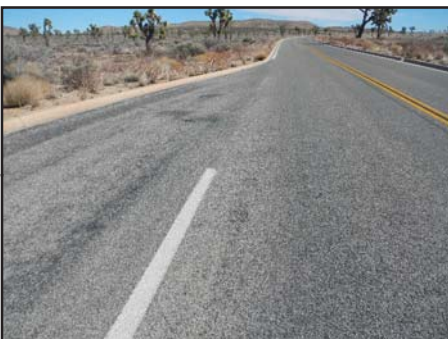
ROUTE 0980: MOJAVE DESERT WAYSIDE EXHIBIT #47 PARKING

Inspection Date	FMSS Number	User Access	Surface Type
2/24/2015	232451	PUBLIC	ASPHALT
Area (Sq. Ft.)	Lane Miles (11' Widths)	Curb Reveal (Inches)	Curb Recommendation
964	0.017	6	DO NOTHING
Curb Type		Curb & Gutter Type	
CONCRETE		NO CURB AND GUTTER	
Pavement Recommendation		Condition Rating / PCR	
PREVENTIVE MAINTENANCE		GOOD / 90

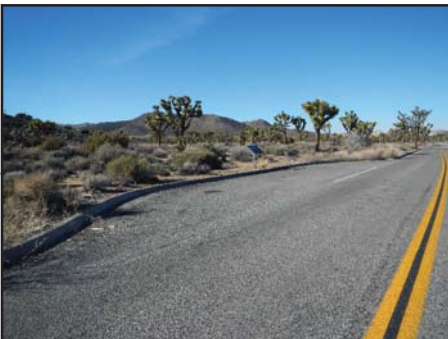
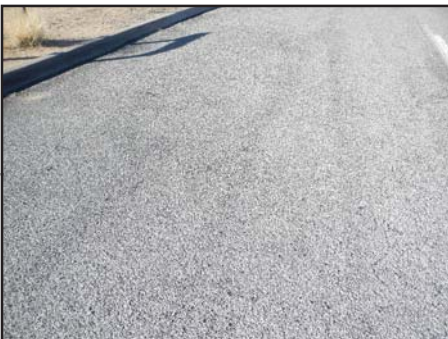
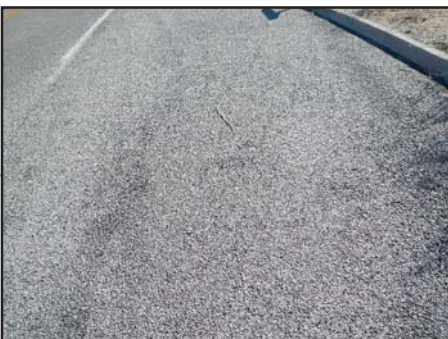
ROUTE 0981: MOJAVE SYMBOL WAYSIDE PARKING, #51

Inspection Date	FMSS Number	User Access	Surface Type
2/25/2015	232482	PUBLIC	ASPHALT
Area (Sq. Ft.)	Lane Miles (11' Widths)	Curb Reveal (Inches)	Curb Recommendation
3,397	0.058	NOT APPLICABLE	DO NOTHING
Curb Type		Curb & Gutter Type	
NO CURB		CONCRETE	
Pavement Recommendation		Condition Rating / PCR	
PREVENTIVE MAINTENANCE		GOOD / 90

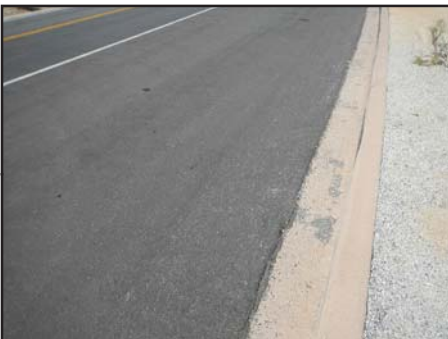
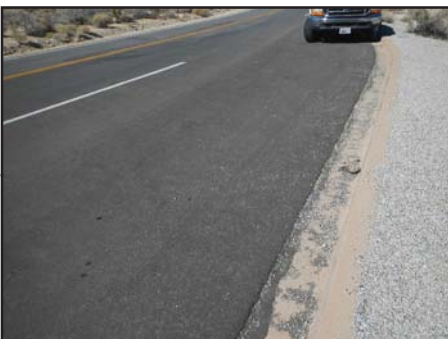
ROUTE 0982: RAPID FIRE WAYSIDE PARKING

Inspection Date	FMSS Number	User Access	Surface Type
2/24/2015	232483	PUBLIC	ASPHALT
Area (Sq. Ft.)	Lane Miles (11' Widths)	Curb Reveal (Inches)	Curb Recommendation
985	0.017	6	DO NOTHING
Curb Type		Curb & Gutter Type	
CONCRETE		NO CURB AND GUTTER	
Pavement Recommendation		Condition Rating / PCR	
PREVENTIVE MAINTENANCE		GOOD / 90

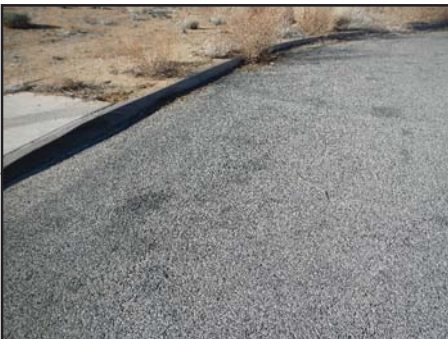
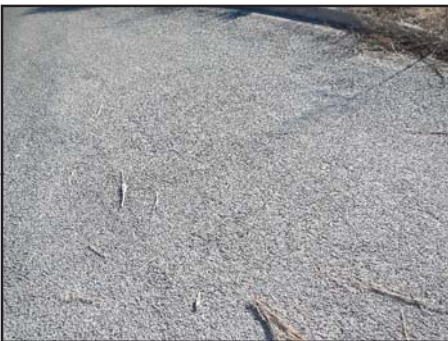
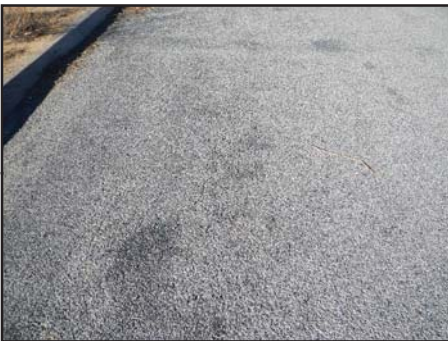
ROUTE 0983: BIGHORNS DOMAIN WAYSIDE PARKING, #55

Inspection Date	FMSS Number	User Access	Surface Type
2/25/2015	232492	PUBLIC	ASPHALT
Area (Sq. Ft.)	Lane Miles (11' Widths)	Curb Reveal (Inches)	Curb Recommendation
1,911	0.033	6	DO NOTHING
Curb Type		Curb & Gutter Type	
CONCRETE		NO CURB AND GUTTER	
Pavement Recommendation		Condition Rating / PCR	
PREVENTIVE MAINTENANCE		GOOD / 90

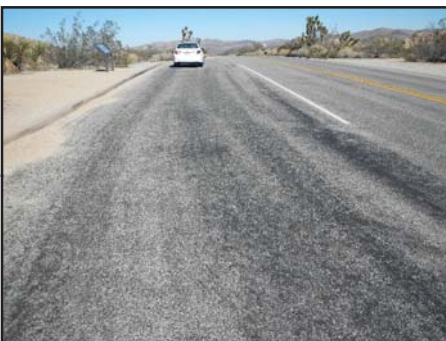
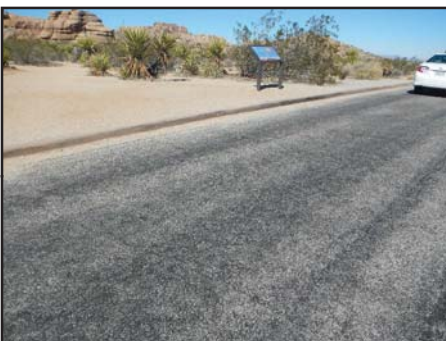
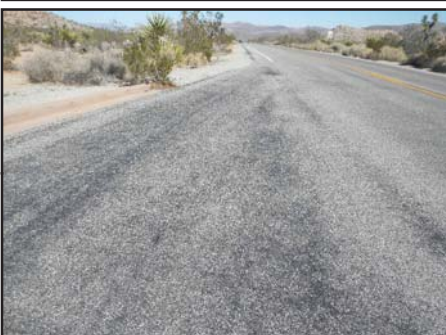
Inspection Date	FMSS Number	User Access	Surface Type
2/25/2015	232496	PUBLIC	ASPHALT
Area (Sq. Ft.)	Lane Miles (11' Widths)	Curb Reveal (Inches)	Curb Recommendation
1,931	0.033	NOT APPLICABLE	DO NOTHING
Curb Type		Curb & Gutter Type	
NO CURB		CONCRETE	
Pavement Recommendation		Condition Rating / PCR	
PREVENTIVE MAINTENANCE		GOOD / 90

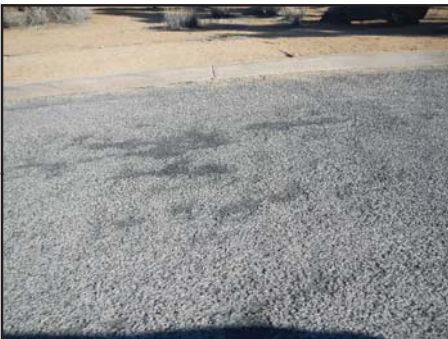
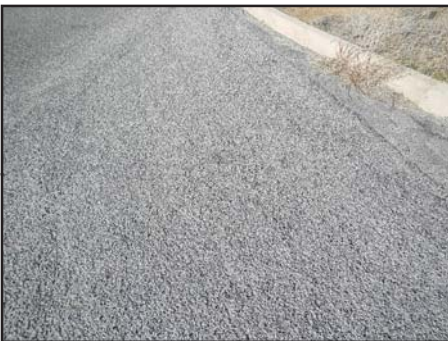
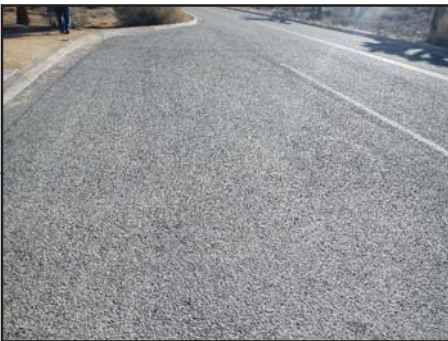
ROUTE 0985: TREE OF LIFE WAYSIDE PARKING #58

Inspection Date	FMSS Number	User Access	Surface Type
2/24/2015	232496	PUBLIC	ASPHALT
Area (Sq. Ft.)	Lane Miles (11' Widths)	Curb Reveal (Inches)	Curb Recommendation
931	0.016	NOT APPLICABLE	DO NOTHING
Curb Type		Curb & Gutter Type	
NO CURB		CONCRETE	
Pavement Recommendation		Condition Rating / PCR	
PREVENTIVE MAINTENANCE		GOOD / 90

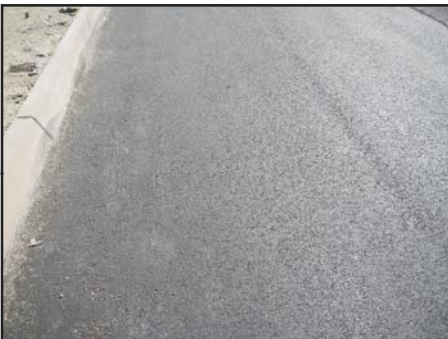
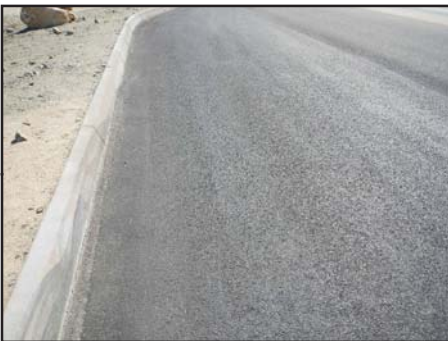
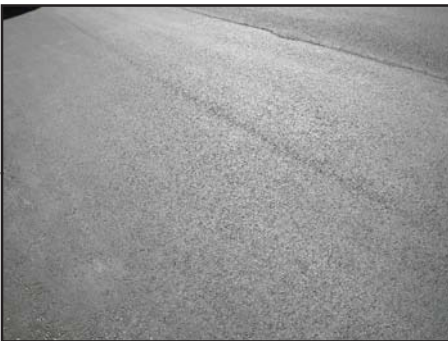
ROUTE 0988: PINTO PEOPLE WAYSIDE PARKING, #81

Inspection Date	FMSS Number	User Access	Surface Type
2/24/2015	N/A	PUBLIC	ASPHALT
Area (Sq. Ft.)	Lane Miles (11' Widths)	Curb Reveal (Inches)	Curb Recommendation
1,526	0.026	8	DO NOTHING
Curb Type		Curb & Gutter Type	
CONCRETE		NO CURB AND GUTTER	
Pavement Recommendation		Condition Rating / PCR	
DO NOTHING		EXCELLENT / 97

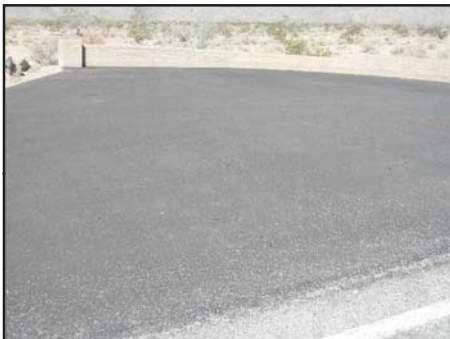
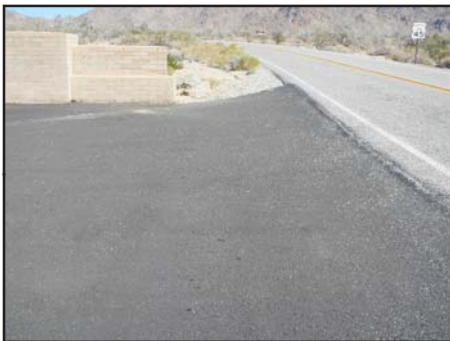
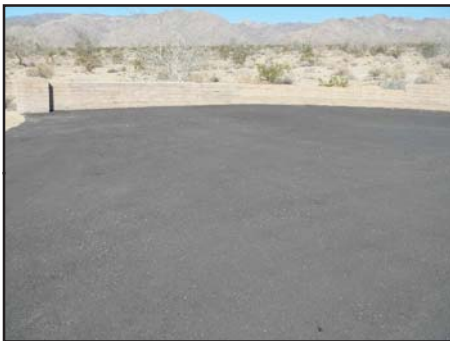
ROUTE 0989A: SOUTH ENTRANCE SIGN PARKING A

Inspection Date	FMSS Number	User Access	Surface Type
2/24/2015	N/A	PUBLIC	ASPHALT
Area (Sq. Ft.)	Lane Miles (11' Widths)	Curb Reveal (Inches)	Curb Recommendation
2,341	0.04	NOT APPLICABLE	NOT APPLICABLE
Curb Type		Curb & Gutter Type	
NO CURB		NO CURB AND GUTTER	
Pavement Recommendation		Condition Rating / PCR	
DO NOTHING		EXCELLENT / 97

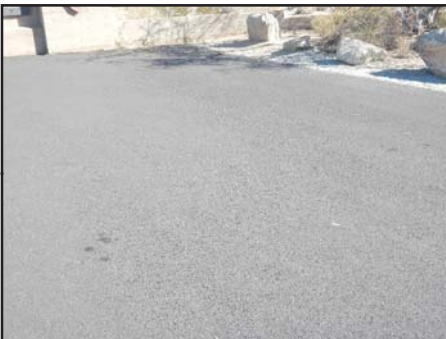
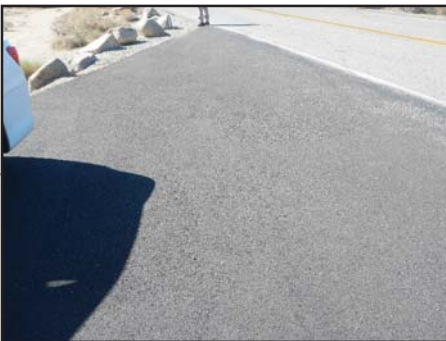
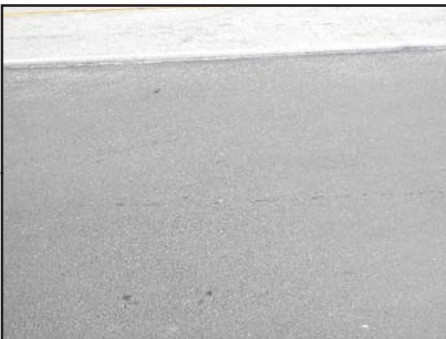
ROUTE 0989B: SOUTH ENTRANCE SIGN PARKING B

Inspection Date	FMSS Number	User Access	Surface Type
2/24/2015	N/A	PUBLIC	ASPHALT
Area (Sq. Ft.)	Lane Miles (11' Widths)	Curb Reveal (Inches)	Curb Recommendation
2,171	0.037	NOT APPLICABLE	NOT APPLICABLE
Curb Type		Curb & Gutter Type	
NO CURB		NO CURB AND GUTTER	
Pavement Recommendation		Condition Rating / PCR	
DO NOTHING		EXCELLENT / 97
