KEMO Cycle 6

Final Report

Road Inventory and Condition Assessment of Paved Routes Kennesaw Mountain National Battlefield Park

Report Date: March 2022

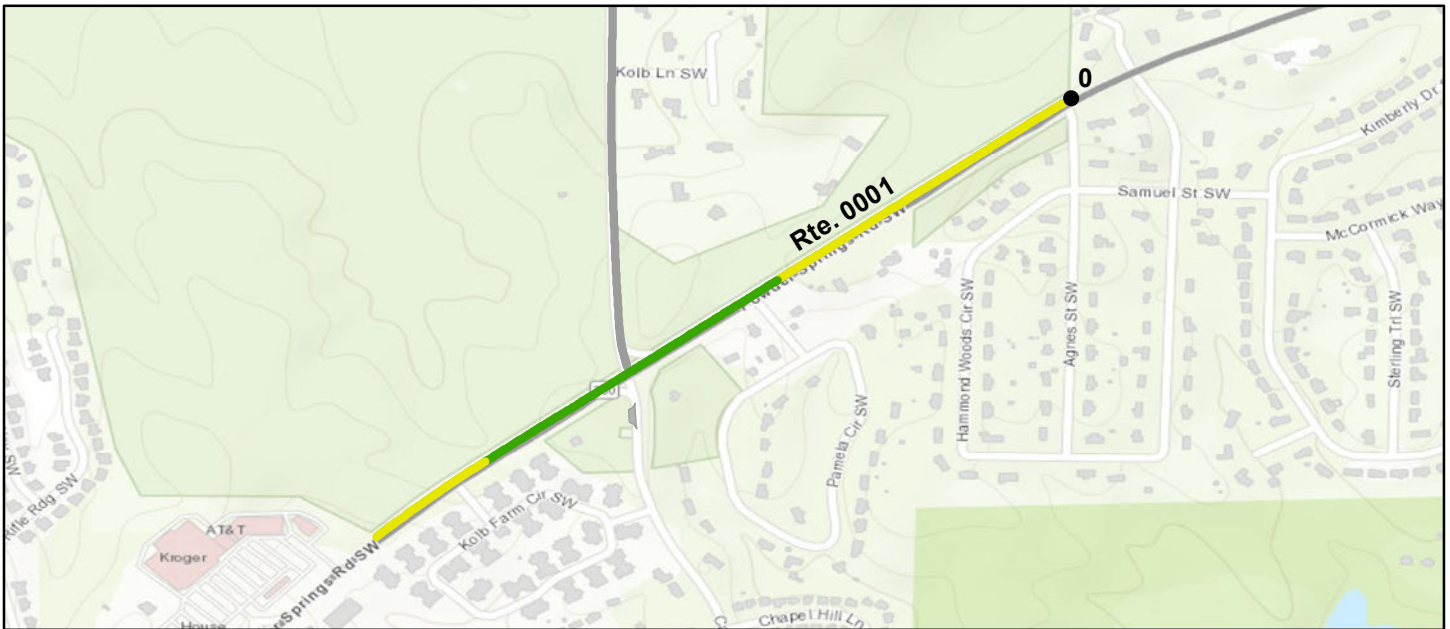
Data Collection Vehicle (DCV) Rating

Inspection Date:	7/24/2021	Beginning Section MP	0				
Paved Length (Miles):	0.72	Section Length (MI)	0.72				
Surface Type:	ASPHALT	Route Summary					
Roadway Condition Information							
Pavement Condition Rating (PCR)	83	83					
Surface Condition Rating (SCR)	72	72					
Roughness Condition Index (RCI)	100	100					
Distress Index Values							
Structural Crack Index	72	72					
Alligator Crack Index	100	100					
Longitudinal Crack Index	72	72					
Transverse Cracking Index	87	87					
Patching Index	100	100					
Rutting Index	98	98					
International Roughness Index (IRI)	77	77					
Lane & Width Information							
Number of Lanes	5	5					
Paved Width (ft)	61.8	61.8					
Lane Width (ft)	11.2	11.2

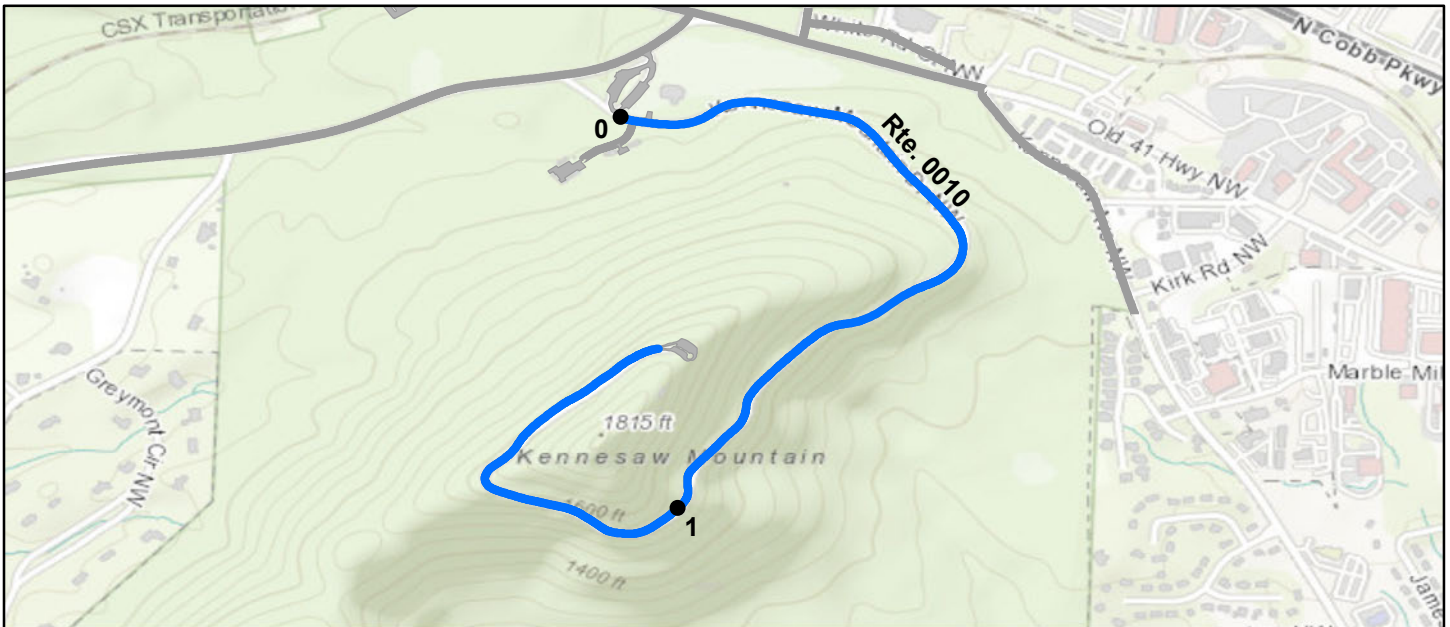
Data Collection Vehicle (DCV) Rating

Inspection Date:	7/24/2021	Beginning Section MP	0	1			
Paved Length (Miles):	1.53	Section Length (MI)	1	0.53			
Surface Type:	ASPHALT	Route Summary					
Roadway Condition Information							
Pavement Condition Rating (PCR)	100	100	99				
Surface Condition Rating (SCR)	100	100	99				
Roughness Condition Index (RCI)	N/A	N/A	N/A				
Distress Index Values							
Structural Crack Index	100	100	100				
Alligator Crack Index	100	100	100				
Longitudinal Crack Index	100	100	100				
Transverse Cracking Index	100	100	100				
Patching Index	100	100	100				
Rutting Index	100	100	99				
International Roughness Index (IRI)	N/A	N/A	N/A				
Lane & Width Information							
Number of Lanes	2	2	2				
Paved Width (ft)	20.4	20.3	20.7				
Lane Width (ft)	10.1	10.1	10

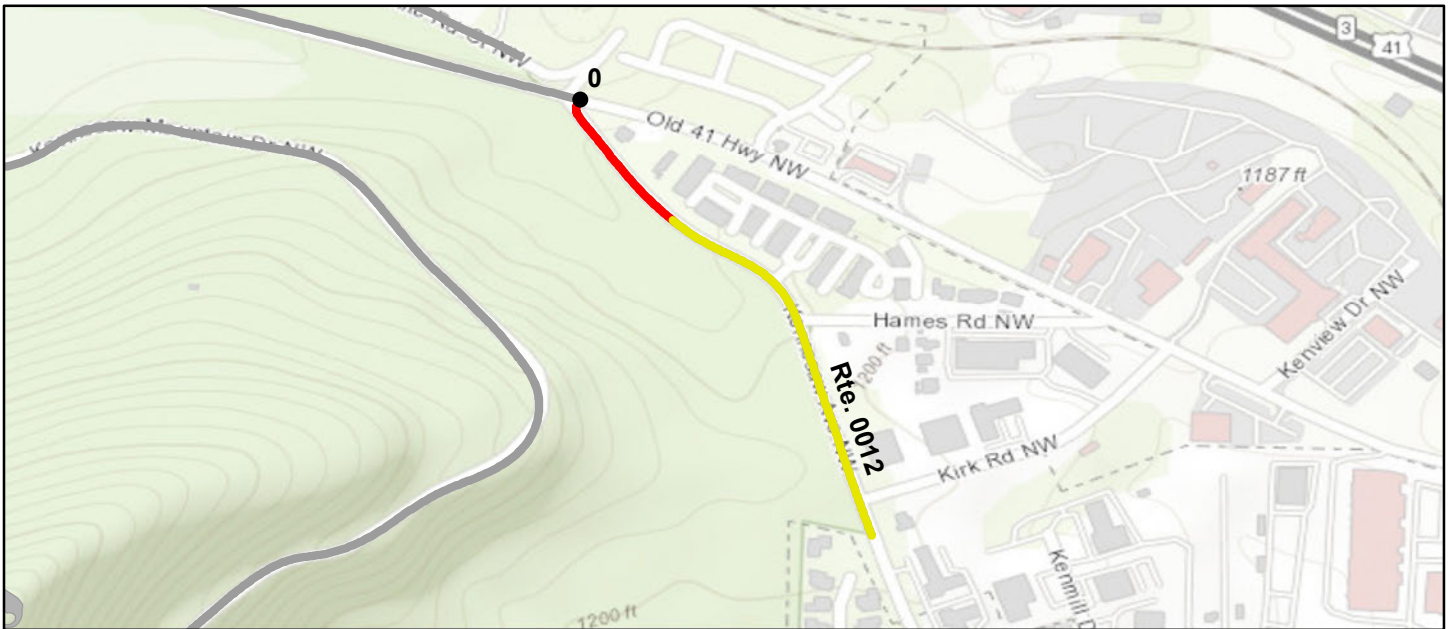
Data Collection Vehicle (DCV) Rating

Inspection Date: 7/24/2021	Beginning Section MP	0				
Paved Length (Miles): 0.36	Section Length (MI)	0.36				
Surface Type: ASPHALT	Route Summary					
Roadway Condition Information						
Pavement Condition Rating (PCR)	69	69				
Surface Condition Rating (SCR)	69	69				
Roughness Condition Index (RCI)	N/A	N/A				
Distress Index Values						
Structural Crack Index	69	69				
Alligator Crack Index	100	100				
Longitudinal Crack Index	69	69				
Transverse Cracking Index	74	74				
Patching Index	100	100				
Rutting Index	94	94				
International Roughness Index (IRI)	N/A	N/A				
Lane & Width Information						
Number of Lanes	2	2				
Paved Width (ft)	23.5	23.5				
Lane Width (ft)	10.6	10.6

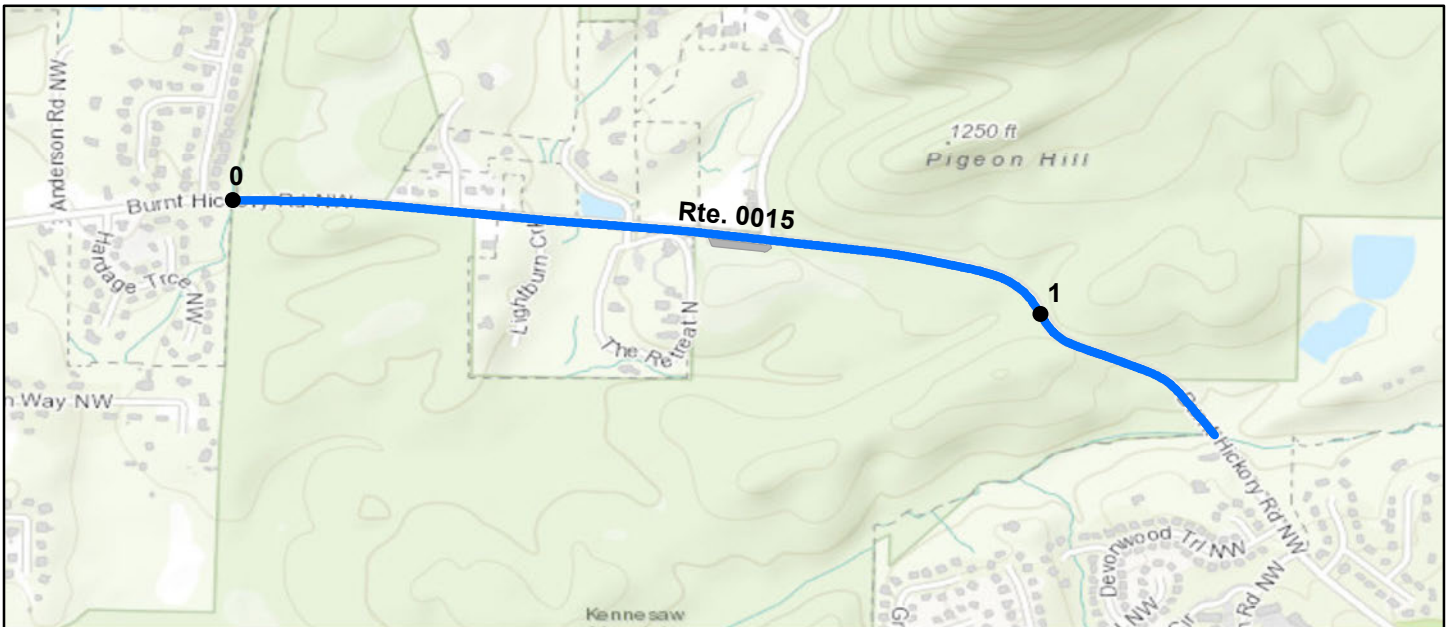
ROUTE 0015: BURNT HICKORY ROAD

Inspection Date:	7/24/2021	Beginning Section MP	0	1			
Paved Length (Miles):	1.28	Section Length (MI)	1	0.28			
Surface Type:	ASPHALT	Route Summary					
Roadway Condition Information							
Pavement Condition Rating (PCR)	100	99	100				
Surface Condition Rating (SCR)	100	99	100				
Roughness Condition Index (RCI)	100	100	100				
Distress Index Values							
Structural Crack Index	100	100	100				
Alligator Crack Index	100	100	100				
Longitudinal Crack Index	100	100	100				
Transverse Cracking Index	100	100	100				
Patching Index	100	100	100				
Rutting Index	100	99	100				
International Roughness Index (IRI)	81	74	107				
Lane & Width Information							
Number of Lanes	2	2	2				
Paved Width (ft)	22.8	22.6	23.6				
Lane Width (ft)	10.9	10.9	10.7

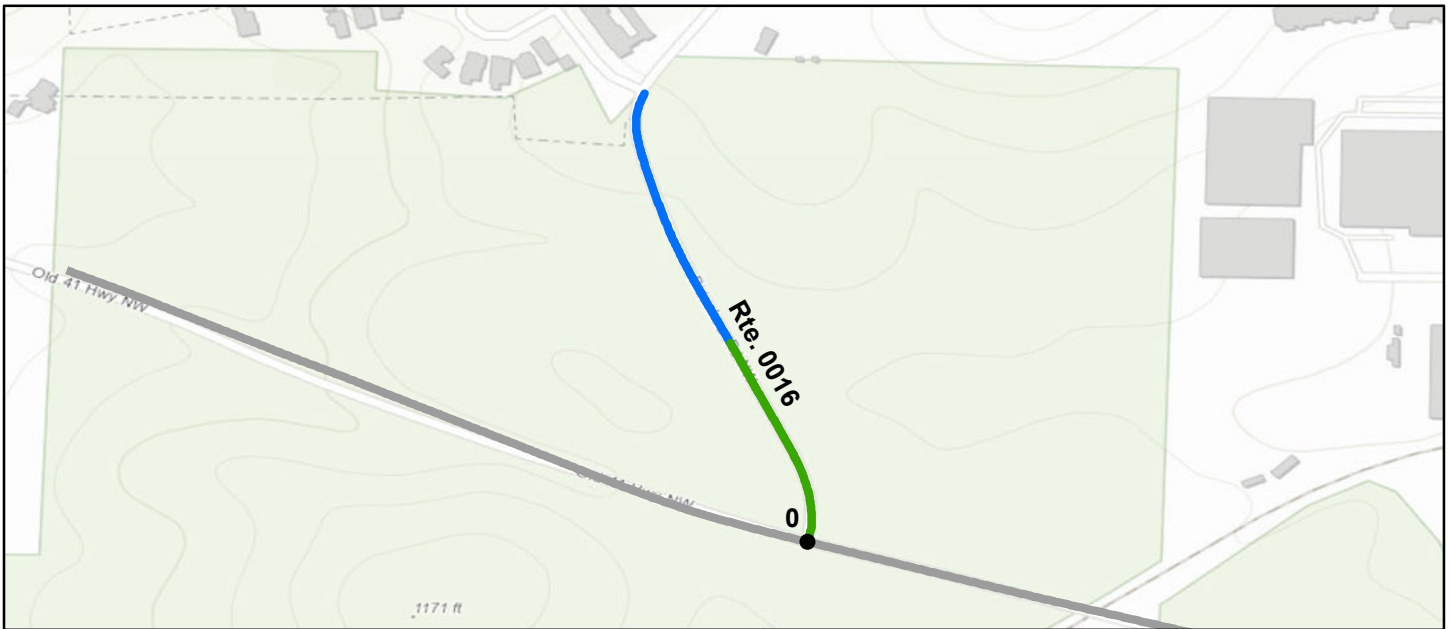
Data Collection Vehicle (DCV) Rating

Route Condition Legend – Pavement Condition Rating (PCR)						
Poor (0 - 60)	Fair (61- 84)	Good (85 - 94)	Excellent (95 - 100)	Not Rated		
Colors on map represent condition scores at 0.10-mile intervals. See Appendix for definitions and formulas.						
Inspection Date: 7/24/2021	Beginning Section MP	0				
Paved Length (Miles): 0.23	Section Length (MI)	0.23				
Surface Type: ASPHALT	Route Summary					
Roadway Condition Information						
Pavement Condition Rating (PCR)	97	97				
Surface Condition Rating (SCR)	97	97				
Roughness Condition Index (RCI)	N/A	N/A				
Distress Index Values						
Structural Crack Index	97	97				
Alligator Crack Index	100	100				
Longitudinal Crack Index	97	97				
Transverse Cracking Index	97	97				
Patching Index	100	100				
Rutting Index	100	100				
International Roughness Index (IRI)	N/A	N/A				
Lane & Width Information						
Number of Lanes	2	2				
Paved Width (ft)	19.8	19.8				
Lane Width (ft)	9.3	9.3
