KLGO Cycle 6

Final Report

Road Inventory and Condition Assessments Klondike Gold Rush National Historical Park

Report Date: December 2019

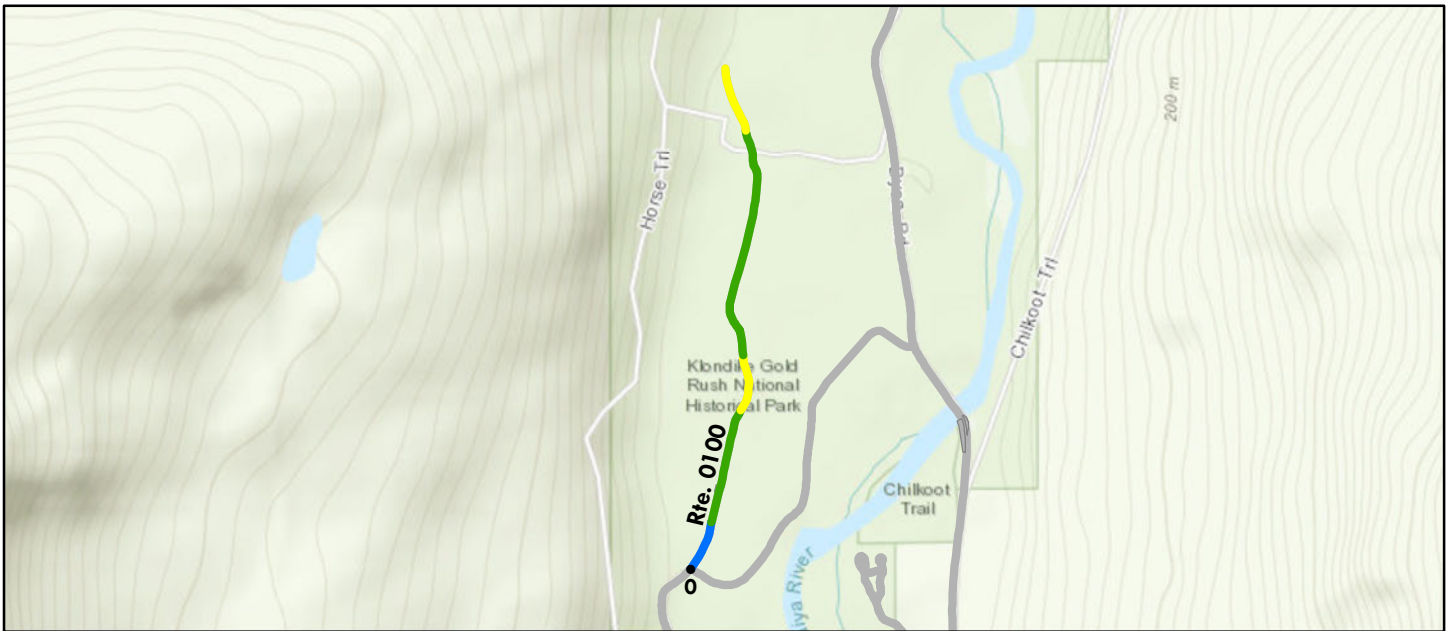
ROUTE 0100: LOST LAKE ROAD

Route Condition Legend					
Poor (1)	Poor (2)	Fair (3)	Good (4)	Excellent (5)	Not Rated
See Appendix for definitions and formulas					
Inspection Date: 7/11/2019		Unpaved Length (Miles): 0.92		Surface Type: GRAVEL

Begin MP	End MP	Section Length	# of Lanes	Lane Width	Road Width	Treatment Recommendation	Treatment Cost	Unpaved Rating (Paser +)	Crown Severity	Drainage Severity	Rutting, Washboard Severity	Potholes / Loose Aggregate Severity
0.00	0.92	0.92	1	10.4	12.7	Routine Maintenance	\$9,190	4	Med	Low	Low	Med
Route Level Data:		0.92	1	10.4	12.7	Routine Maintenance	\$9,190	4	Med	Low	Low	Med

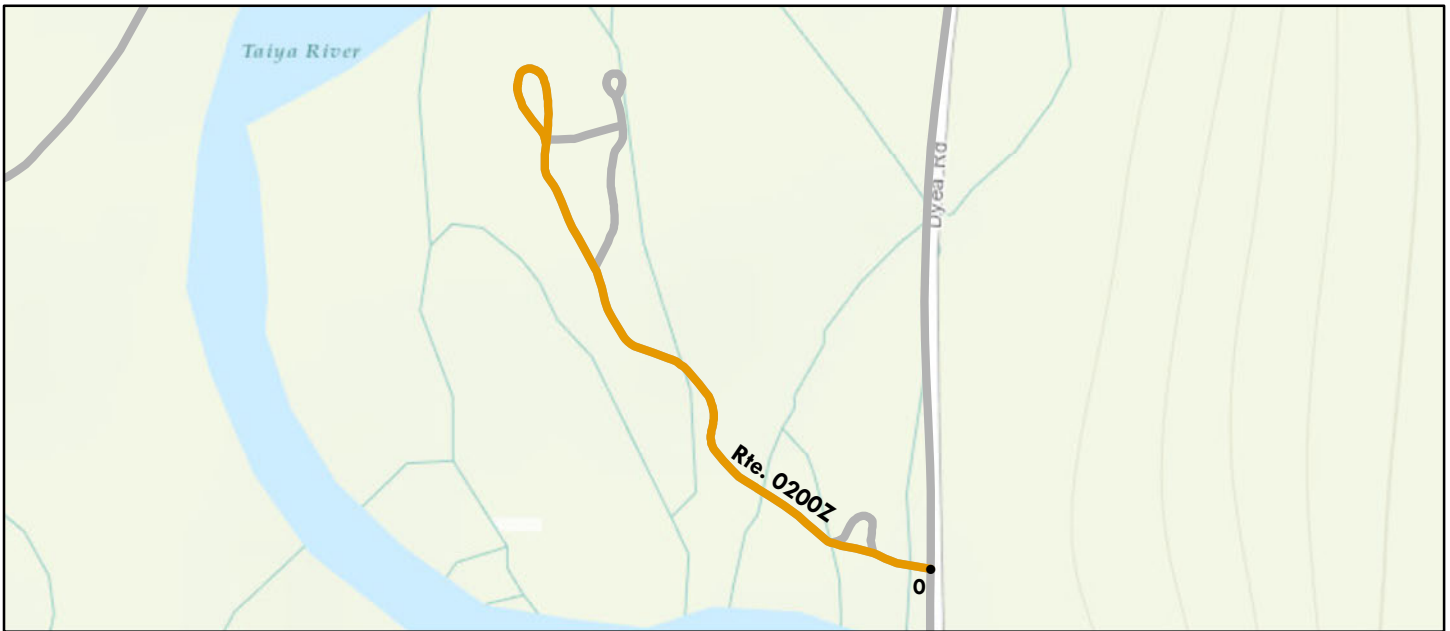
ROUTE 0200Z: DYEA CAMPGROUND MAIN ROAD

Route Condition Legend					
Poor (1)	Poor (2)	Fair (3)	Good (4)	Excellent (5)	Not Rated
See Appendix for definitions and formulas					
Inspection Date: 7/11/2019	Unpaved Length (Miles): 0.32		Surface Type: GRAVEL

Begin MP	End MP	Section Length	# of Lanes	Lane Width	Road Width	Treatment Recommendation	Treatment Cost	Unpaved Rating (Paser +)	Crown Severity	Drainage Severity	Rutting, Washboard Severity	Potholes / Loose Aggregate Severity
0.00	0.32	0.32	1	12.0	12.0	Heavy Rehabilitation	\$51,840	2	Med	Med	High	High
Route Level Data:		0.32	1	12.0	12.0	Heavy Rehabilitation	\$51,840	2	Med	Med	High	High
