LEWI Cycle 6

Final Report

Road Inventory and Condition Assessment of Paved Routes Lewis and Clark National Historical Park

Report Date: February 2016

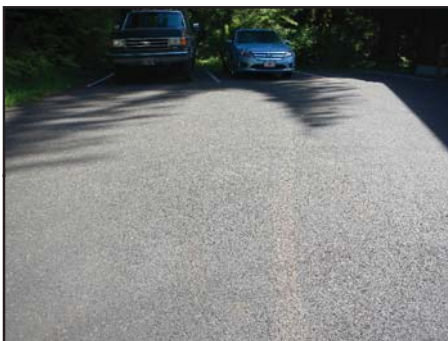
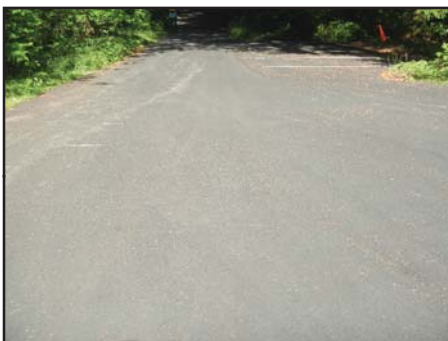
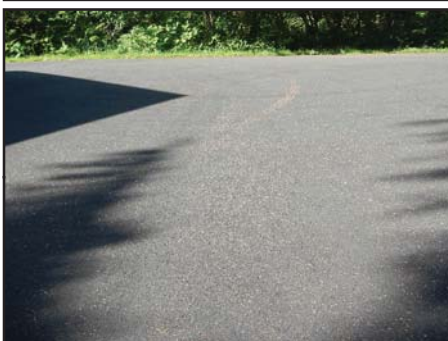
Inspection Date	FMSS Number	User Access	Surface Type
6/9/2015	106382	NONPUBLIC	ASPHALT
Area (Sq. Ft.)	Lane Miles (11' Widths)	Curb Reveal (Inches)	Curb Recommendation
8,257	0.142	NOT APPLICABLE	NOT APPLICABLE
Curb Type		Curb & Gutter Type	
NO CURB		NO CURB AND GUTTER	
Pavement Recommendation		Condition Rating / PCR	
PREVENTIVE MAINTENANCE		GOOD / 90

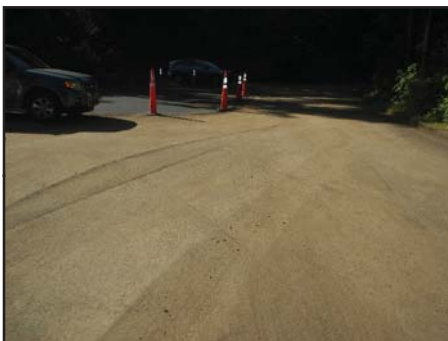
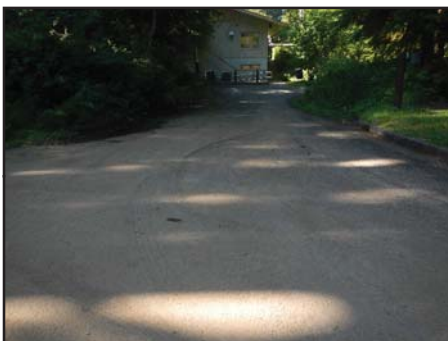
ROUTE 0901: VISITOR CENTER EMPLOYEE PARKING

Inspection Date	FMSS Number	User Access	Surface Type
6/9/2015	106397	NONPUBLIC	ASPHALT
Area (Sq. Ft.)	Lane Miles (11' Widths)	Curb Reveal (Inches)	Curb Recommendation
9,583	0.165	NOT APPLICABLE	DO NOTHING
Curb Type		Curb & Gutter Type	
NO CURB		CONCRETE	
Pavement Recommendation		Condition Rating / PCR	
PREVENTIVE MAINTENANCE		GOOD / 90

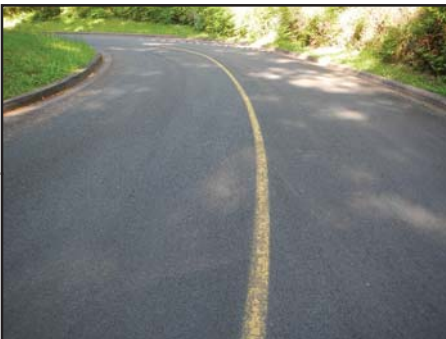
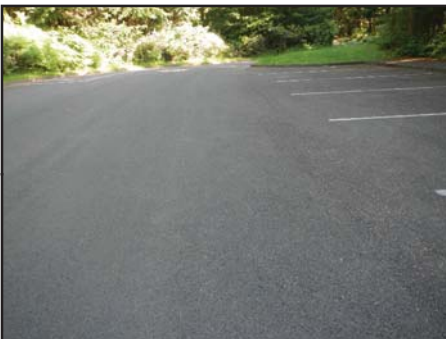
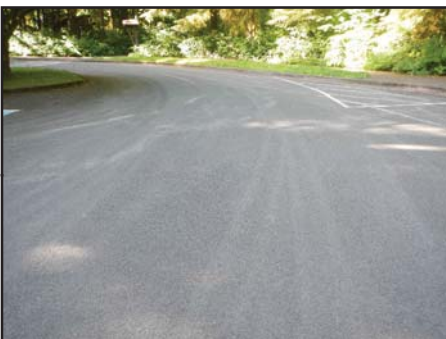
ROUTE 0902Z: OVERFLOW PARKING

Inspection Date	FMSS Number	User Access	Surface Type
6/9/2015	231273	PUBLIC	ASPHALT
Area (Sq. Ft.)	Lane Miles (11' Widths)	Curb Reveal (Inches)	Curb Recommendation
22,951	0.395	NOT APPLICABLE	DO NOTHING
Curb Type		Curb & Gutter Type	
NO CURB		CONCRETE	
Pavement Recommendation		Condition Rating / PCR	
PREVENTIVE MAINTENANCE		GOOD / 90

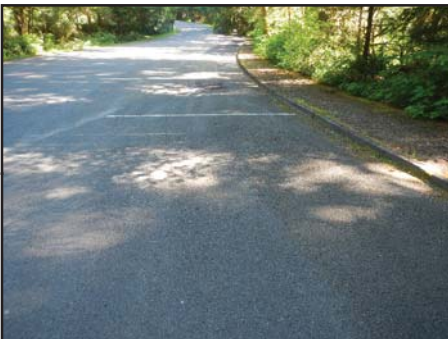
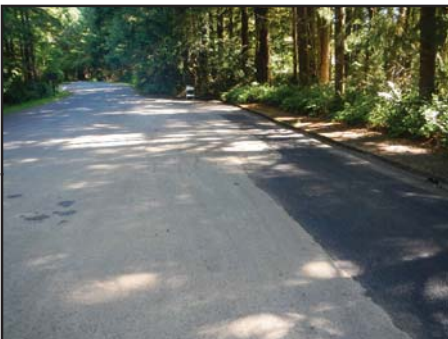
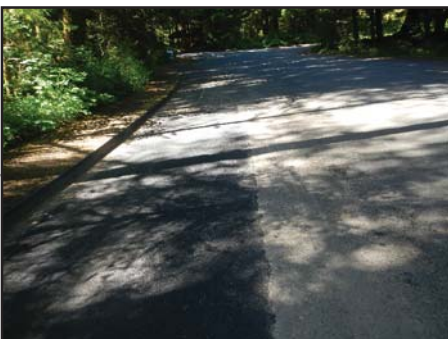
ROUTE 0908Z: BUS AND RV PARKING

Inspection Date	FMSS Number	User Access	Surface Type
6/9/2015	231273	PUBLIC	ASPHALT
Area (Sq. Ft.)	Lane Miles (11' Widths)	Curb Reveal (Inches)	Curb Recommendation
4,048	0.07	NOT APPLICABLE	DO NOTHING
Curb Type		Curb & Gutter Type	
NO CURB		CONCRETE	
Pavement Recommendation		Condition Rating / PCR	
LIGHT 3R TREATMENTS		FAIR / 73

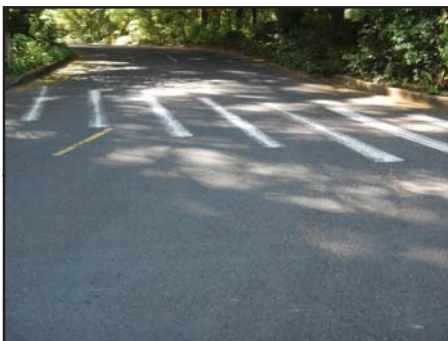
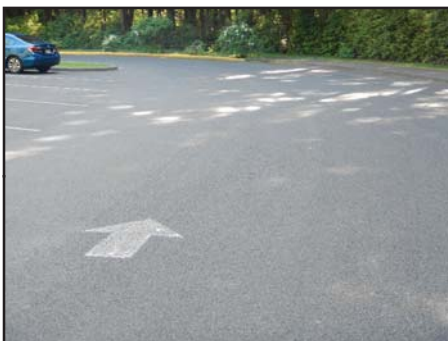
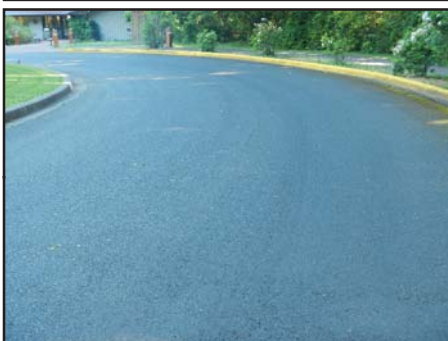
ROUTE 0903: VISITOR CENTER PARKING

Inspection Date	FMSS Number	User Access	Surface Type
6/9/2015	106381	PUBLIC	ASPHALT
Area (Sq. Ft.)	Lane Miles (11' Widths)	Curb Reveal (Inches)	Curb Recommendation
18,187	0.313	6	DO NOTHING
Curb Type		Curb & Gutter Type	
CONCRETE		CONCRETE	
Pavement Recommendation		Condition Rating / PCR	
PREVENTIVE MAINTENANCE		GOOD / 90

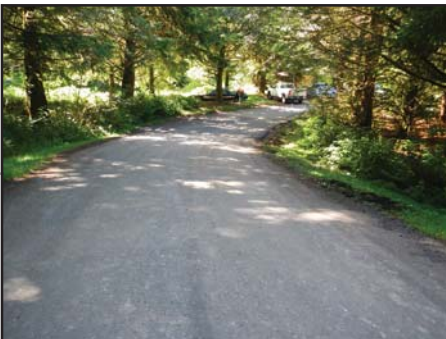
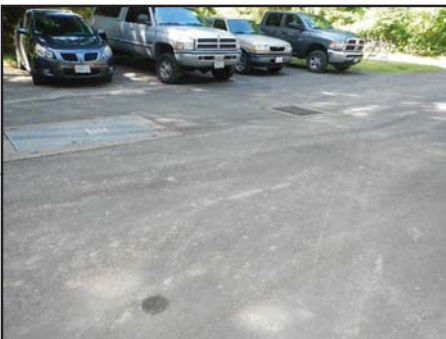
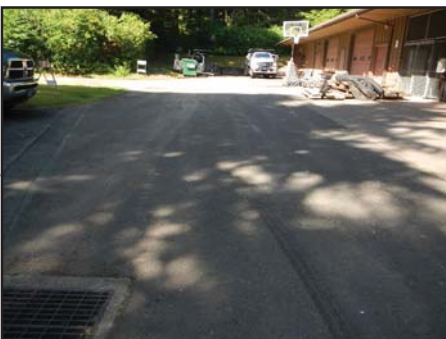
ROUTE 0904Z: MAINTENANCE SHOP PARKING

Inspection Date	FMSS Number	User Access	Surface Type
6/9/2015	106380	NONPUBLIC	ASPHALT
Area (Sq. Ft.)	Lane Miles (11' Widths)	Curb Reveal (Inches)	Curb Recommendation
9,339	0.161	NOT APPLICABLE	NOT APPLICABLE
Curb Type		Curb & Gutter Type	
NO CURB		NO CURB AND GUTTER	
Pavement Recommendation		Condition Rating / PCR	
LIGHT 3R TREATMENTS		FAIR / 73

Parking area consists of multiple surface types: 1 part Asphalt at 8,258 square feet; 1 part Concrete at 1,081 square feet.

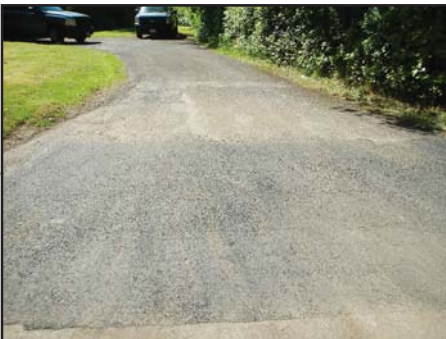
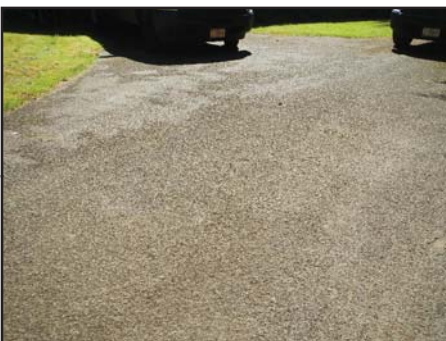
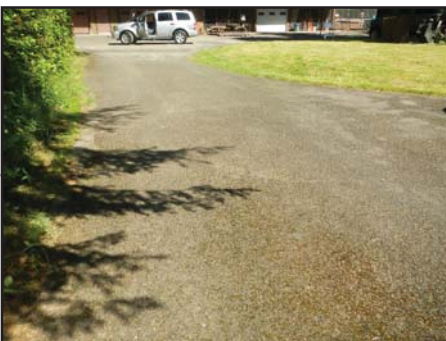
ROUTE 0905Z: RESIDENCE PARKING

Inspection Date	FMSS Number	User Access	Surface Type
6/9/2015	106380	NONPUBLIC	ASPHALT
Area (Sq. Ft.)	Lane Miles (11' Widths)	Curb Reveal (Inches)	Curb Recommendation
1,887	0.032	NOT APPLICABLE	NOT APPLICABLE
Curb Type		Curb & Gutter Type	
NO CURB		NO CURB AND GUTTER	
Pavement Recommendation		Condition Rating / PCR	
LIGHT 3R TREATMENTS		FAIR / 73

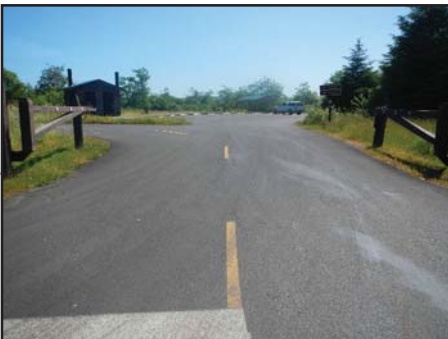
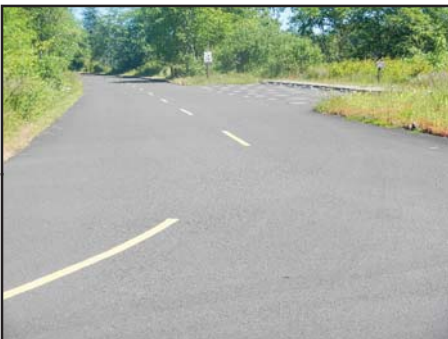
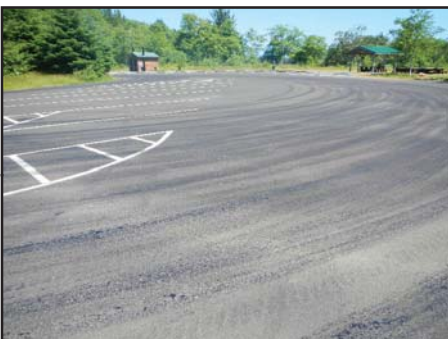
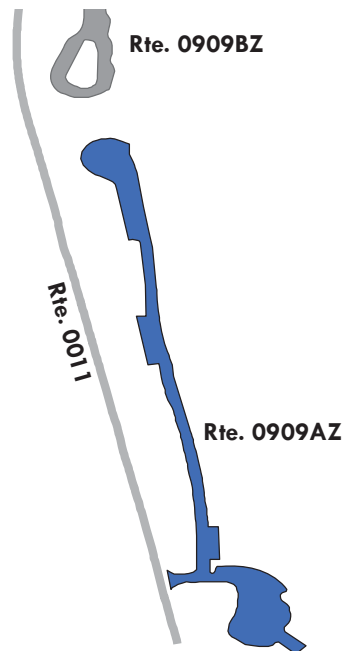
ROUTE 0909AZ: NETUL LANDING VISITOR AND RV PARKING

Inspection Date	FMSS Number	User Access	Surface Type
6/9/2015	88811	PUBLIC	ASPHALT
Area (Sq. Ft.)	Lane Miles (11' Widths)	Curb Reveal (Inches)	Curb Recommendation
71,708	1.235	NOT APPLICABLE	NOT APPLICABLE
Curb Type		Curb & Gutter Type	
NO CURB		NO CURB AND GUTTER	
Pavement Recommendation		Condition Rating / PCR	
DO NOTHING		EXCELLENT / 97

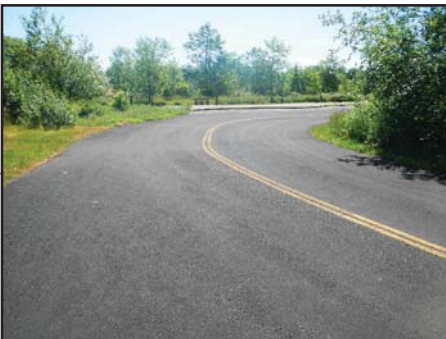
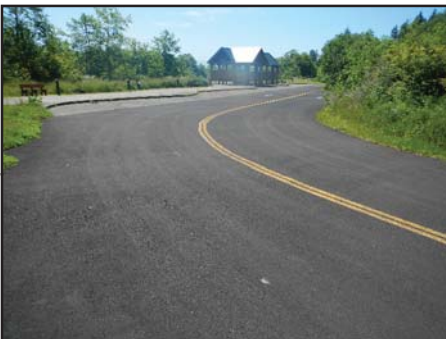
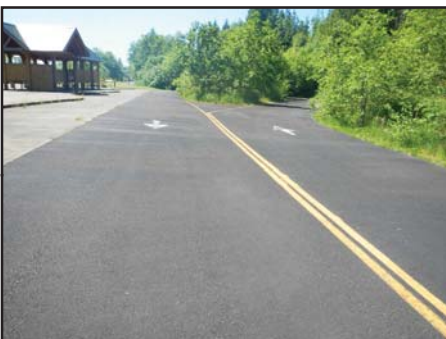
ROUTE 0909BZ: NETUL LANDING BUS LOOP

Inspection Date	FMSS Number	User Access	Surface Type
6/9/2015	88811	PUBLIC	ASPHALT
Area (Sq. Ft.)	Lane Miles (11' Widths)	Curb Reveal (Inches)	Curb Recommendation
22,089	0.38	NOT APPLICABLE	NOT APPLICABLE
Curb Type		Curb & Gutter Type	
NO CURB		NO CURB AND GUTTER	
Pavement Recommendation		Condition Rating / PCR	
DO NOTHING		EXCELLENT / 97

The parking area consists of multiple surface types, 1 part asphalt at 17,259 square feet; 2 parts concrete at 4,830 square feet.

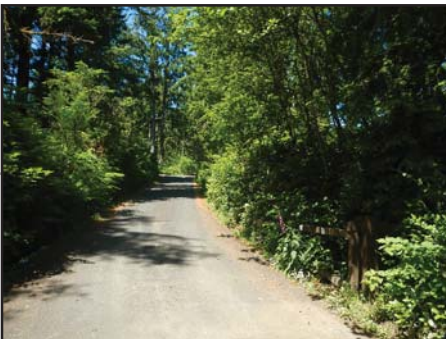
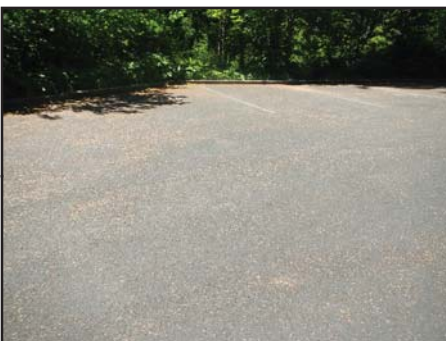
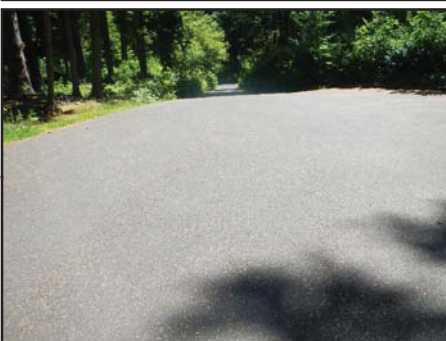
ROUTE 0910: FORT TO SEA TRAIL PARKING LOT

Inspection Date	FMSS Number	User Access	Surface Type
6/9/2015	228259	PUBLIC	ASPHALT
Area (Sq. Ft.)	Lane Miles (11' Widths)	Curb Reveal (Inches)	Curb Recommendation
7,037	0.121	3	DO NOTHING
Curb Type		Curb & Gutter Type	
CONCRETE		NO CURB AND GUTTER	
Pavement Recommendation		Condition Rating / PCR	
PREVENTIVE MAINTENANCE		GOOD / 90
