Road Inventory and Condition Assessment of Paved Routes Little Bighorn Battlefield National Monument

**Federal Lands Highway
Road Inventory Program**

Federal Highway Administration
Eastern Federal Lands Highway Division
Road Inventory Program (RIP)

Report Date: February 2018

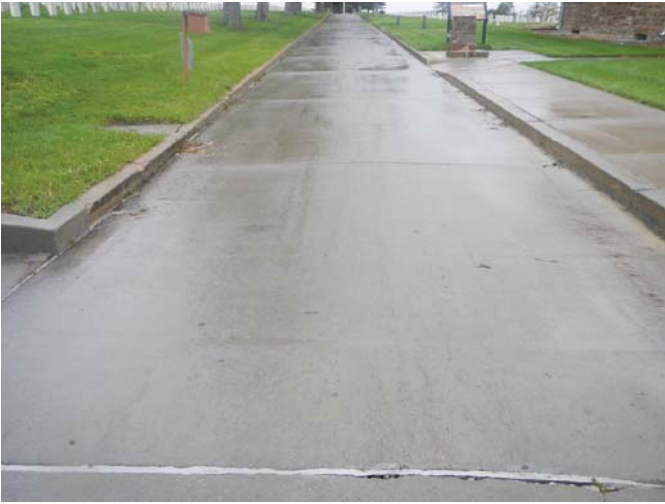
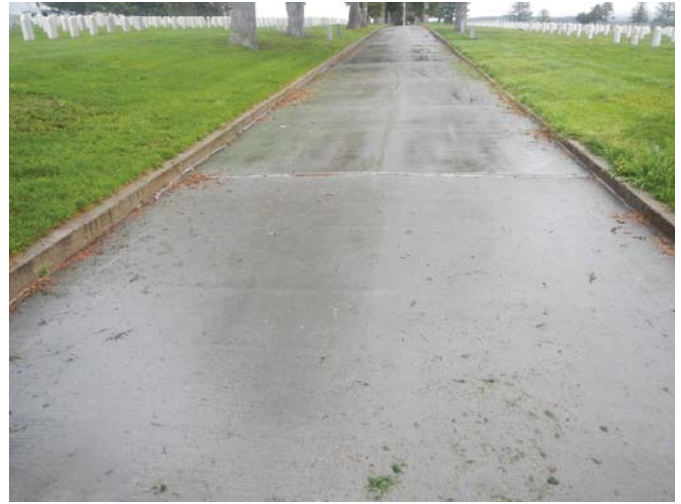
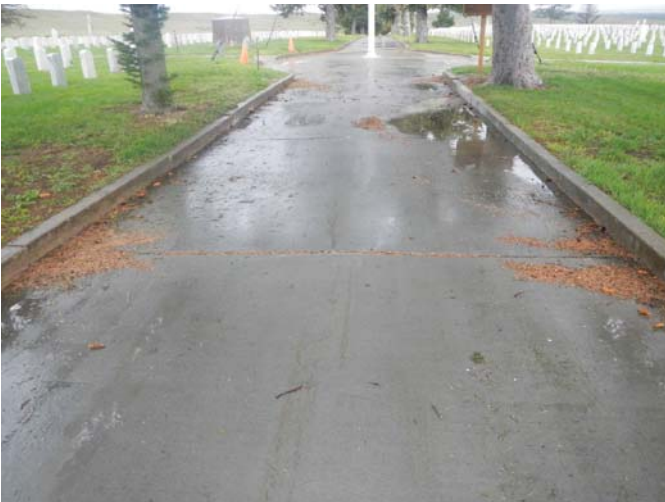
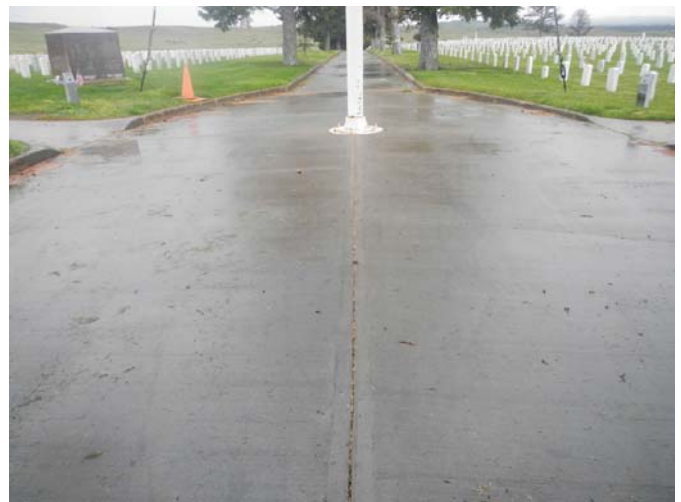
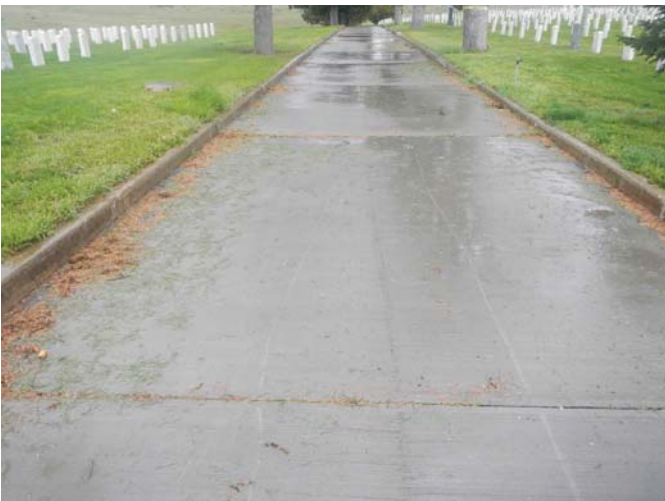
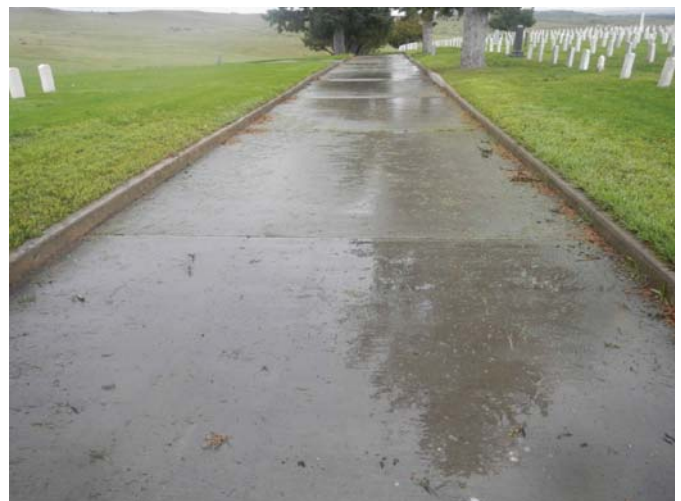
ROUTE 0200: NATIONAL CEMETERY ROAD

Inspection Date: 4/27/2017	Beginning Section MP	0.00				
Paved Length (Miles): 0.14	Section Length (MI)	0.14				
Surface Type: CONCRETE	Route Summary					
Roadway Condition Information						
Pavement Condition Rating (PCR)	90	90				
Surface Condition Rating (SCR)	90	90				
Roughness Condition Index (RCI)	N/A	N/A				
Distress Index Values						
Structural Crack Index	N/A	N/A				
Alligator Crack Index	N/A	N/A				
Longitudinal Crack Index	N/A	N/A				
Transverse Cracking Index	N/A	N/A				
Patching Index	N/A	N/A				
Rutting Index	N/A	N/A				
International Roughness Index (IRI)	N/A	N/A				
Lane & Width Information						
Number of Lanes	1	1				
Paved Width (ft)	15	15				
Lane Width (ft)	15	15

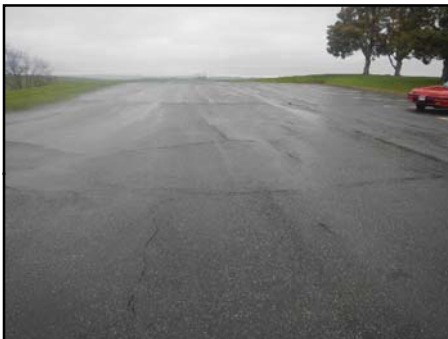
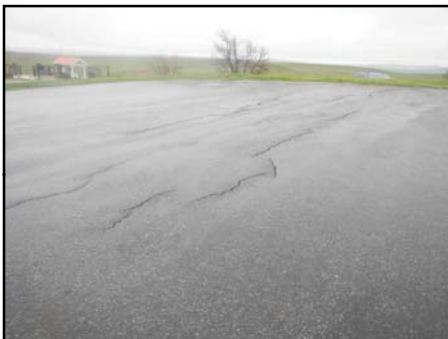
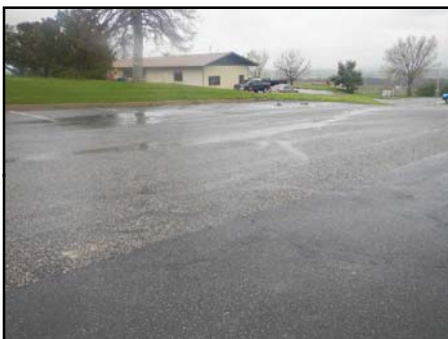
Inspection Date	FMSS Number	User Access	Surface Type
4/27/2017	51753	PUBLIC	ASPHALT
Area (Sq. Ft.)	Lane Miles (11' Widths)	Curb Reveal (Inches)	Curb Recommendation
23,373	0.402	NOT APPLICABLE	DO NOTHING
Curb Type		Curb & Gutter Type	
NO CURB		CONCRETE	
Pavement Recommendation		Condition Rating / PCR	
LIGHT 3R TREATMENTS		FAIR / 73

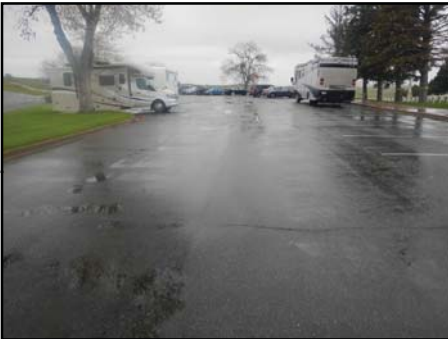
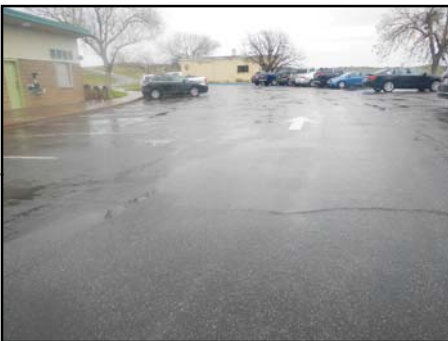
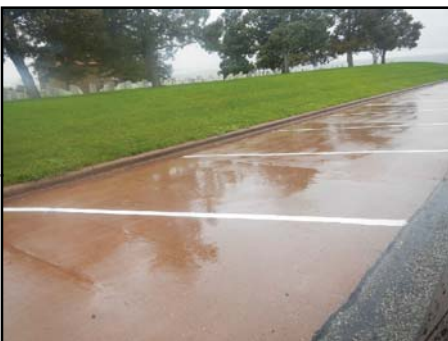
ROUTE 0901: VISITOR CENTER PARKING

Inspection Date	FMSS Number	User Access	Surface Type
4/27/2017	51763	PUBLIC	ASPHALT
Area (Sq. Ft.)	Lane Miles (11' Widths)	Curb Reveal (Inches)	Curb Recommendation
72,899	1.255	NOT APPLICABLE	DO NOTHING
Curb Type		Curb & Gutter Type	
NO CURB		CONCRETE	
Pavement Recommendation		Condition Rating / PCR	
PREVENTIVE MAINTENANCE		GOOD / 90

Note: Parking area consists of multiple surface types: 1 part Asphalt at 66,542 square feet; 3 parts Concrete at 6,357 square feet.

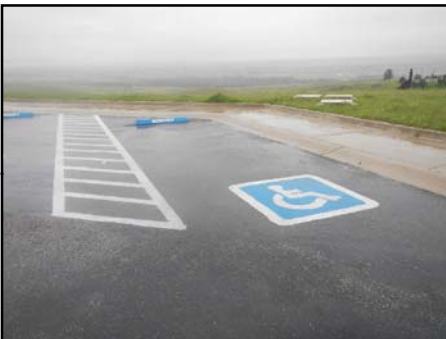
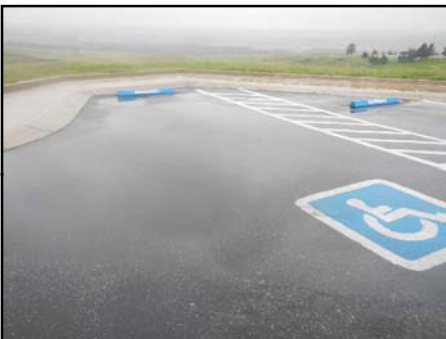
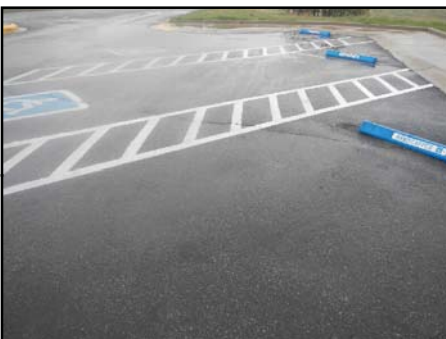
ROUTE 0902: CUSTER MONUMENT PARKING

Inspection Date	FMSS Number	User Access	Surface Type
4/27/2017	104205	PUBLIC	ASPHALT
Area (Sq. Ft.)	Lane Miles (11' Widths)	Curb Reveal (Inches)	Curb Recommendation
1,169	0.02	3	NOT APPLICABLE
Curb Type		Curb & Gutter Type	
CONCRETE		NO CURB AND GUTTER	
Pavement Recommendation		Condition Rating / PCR	
PREVENTIVE MAINTENANCE		GOOD / 90

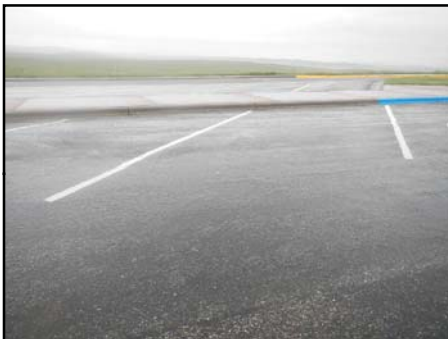
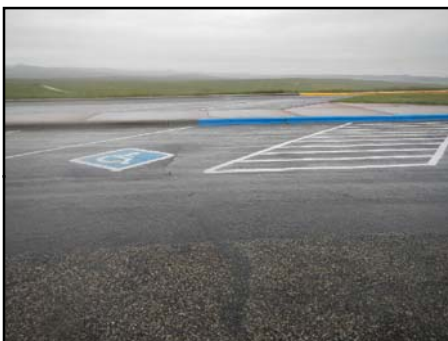
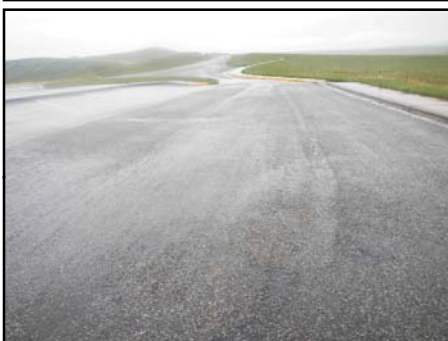
ROUTE 0904: RENO-BENTEEN MONUMENT PARKING

Inspection Date	FMSS Number	User Access	Surface Type
4/27/2017	51793	PUBLIC	ASPHALT
Area (Sq. Ft.)	Lane Miles (11' Widths)	Curb Reveal (Inches)	Curb Recommendation
16,763	0.289	NOT APPLICABLE	DO NOTHING
Curb Type		Curb & Gutter Type	
NO CURB		CONCRETE	
Pavement Recommendation		Condition Rating / PCR	
PREVENTIVE MAINTENANCE		GOOD / 90

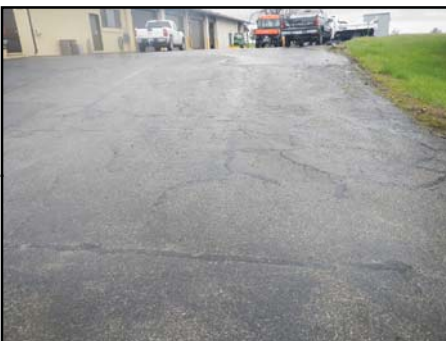
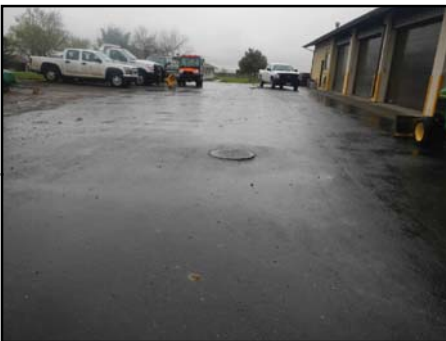
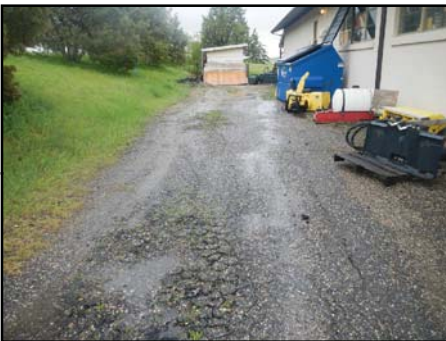
ROUTE 0905: MAINTENANCE PARKING

Inspection Date	FMSS Number	User Access	Surface Type
4/27/2017	51754	NONPUBLIC	ASPHALT
Area (Sq. Ft.)	Lane Miles (11' Widths)	Curb Reveal (Inches)	Curb Recommendation
10,974	0.189	NOT APPLICABLE	NOT APPLICABLE
Curb Type		Curb & Gutter Type	
NO CURB		NO CURB AND GUTTER	
Pavement Recommendation		Condition Rating / PCR	
LIGHT 3R TREATMENTS		FAIR / 73

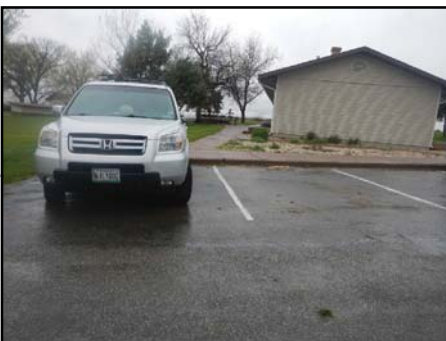
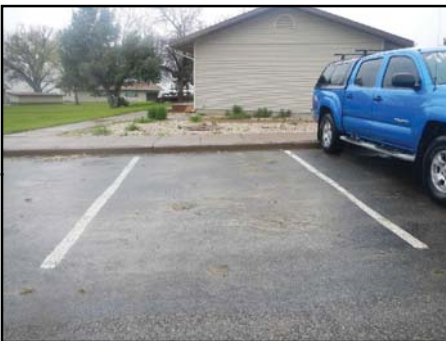
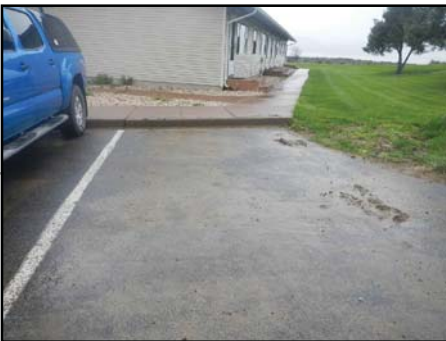
ROUTE 0915: RESIDENCE PARKING

Inspection Date	FMSS Number	User Access	Surface Type
4/27/2017	76288	NONPUBLIC	ASPHALT
Area (Sq. Ft.)	Lane Miles (11' Widths)	Curb Reveal (Inches)	Curb Recommendation
1,088	0.019	NOT APPLICABLE	DO NOTHING
Curb Type		Curb & Gutter Type	
NO CURB		CONCRETE	
Pavement Recommendation		Condition Rating / PCR	
PREVENTIVE MAINTENANCE		GOOD / 90

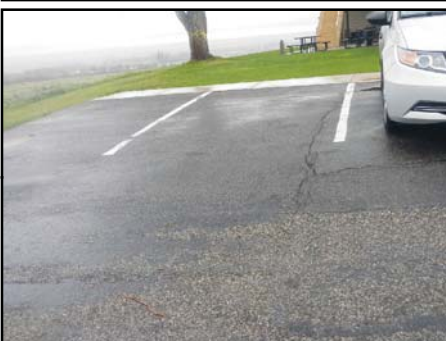
ROUTE 0916: ADMINISTRATIVE / EMPLOYEE PARKING

Inspection Date	FMSS Number	User Access	Surface Type
4/27/2017	236892	NONPUBLIC	ASPHALT
Area (Sq. Ft.)	Lane Miles (11' Widths)	Curb Reveal (Inches)	Curb Recommendation
2,471	0.043	NOT APPLICABLE	NOT APPLICABLE
Curb Type		Curb & Gutter Type	
NO CURB		NO CURB AND GUTTER	
Pavement Recommendation		Condition Rating / PCR	
PREVENTIVE MAINTENANCE		GOOD / 90

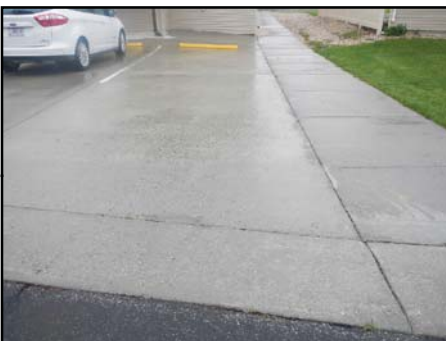
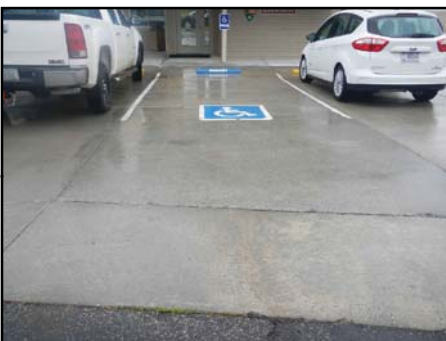
ROUTE 0918: ADMINISTRATIVE VISITOR PARKING

Inspection Date	FMSS Number	User Access	Surface Type
4/27/2017	236896	PUBLIC	CONCRETE
Area (Sq. Ft.)	Lane Miles (11' Widths)	Curb Reveal (Inches)	Curb Recommendation
1,781	0.031	NOT APPLICABLE	NOT APPLICABLE
Curb Type		Curb & Gutter Type	
NO CURB		NO CURB AND GUTTER	
Pavement Recommendation		Condition Rating / PCR	
PREVENTIVE MAINTENANCE		GOOD / 90
