# MABI Cycle 6

# Road Inventory and Condition Assessments for Marsh-Billings-Rockefeller National Historical Park

**Report Date: October 2020**

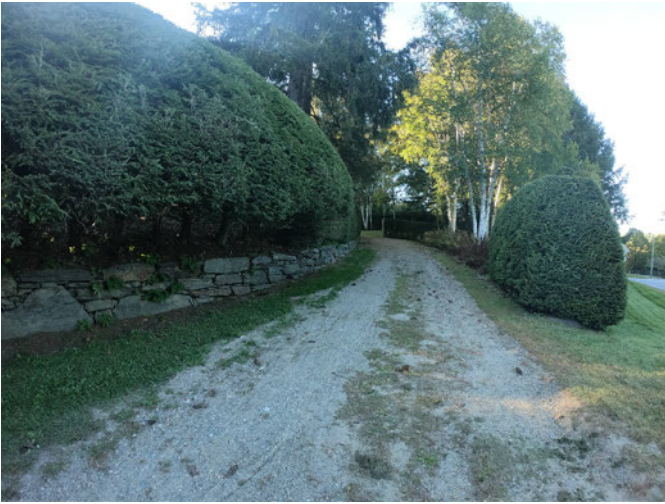
MABI\_0400AZ\_0.001

Begin MP	End MP	Section Length	# of Lanes	Lane Width	Road Width	Treatment Recommendation	Treatment Cost	Unpaved Rating (Paser +)	Crown Severity	Drainage Severity	Rutting, Washboard Severity	Potholes / Loose Aggregate Severity
0.00	0.12	0.12	1	10.0	10.0	Routine Maintenance	\$1,160	4	Low	Med	Med	Med
<b>Route Level Data:</b>		0.12	1	10.0	10.00	Routine Maintenance	\$1,160	4	Low	Med	Med	Med

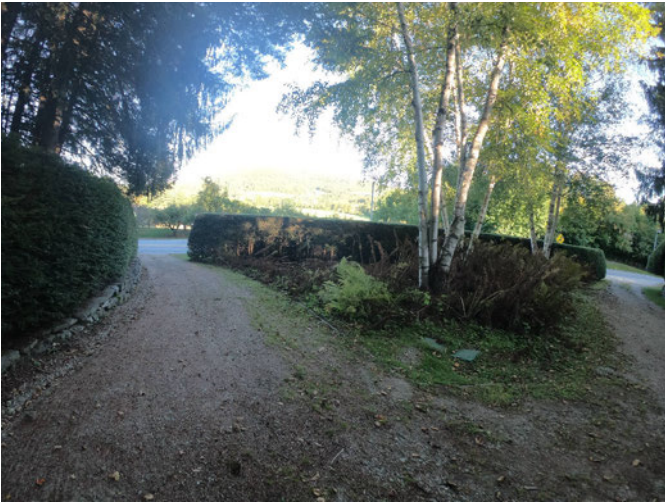
MABI\_0400BZ\_0.001

Begin MP	End MP	Section Length	# of Lanes	Lane Width	Road Width	Treatment Recommendation	Treatment Cost	Unpaved Rating (Paser +)	Crown Severity	Drainage Severity	Rutting, Washboard Severity	Potholes / Loose Aggregate Severity	
0.00	0.02	0.02	1	10.0	10.0	Light Rehabilitation	\$1,700	3	Med	Med	Med	Low	
<b>Route Level Data:</b>			0.02	1	10.0	10.00	Light Rehabilitation	\$1,700	3	Med	Med	Med	Low

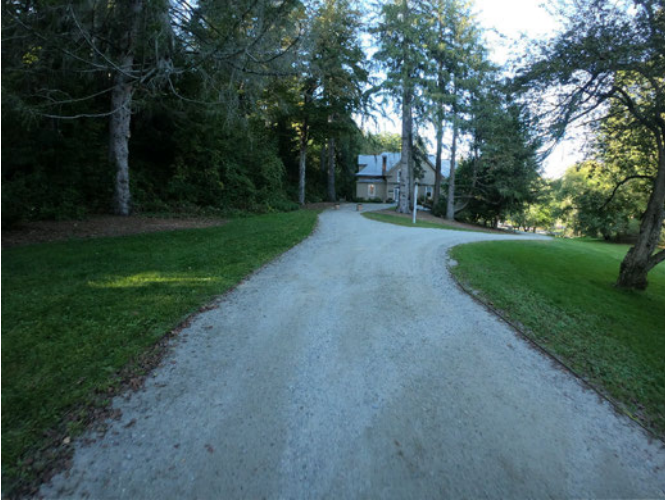
MABI\_0401\_0.006

Begin MP	End MP	Section Length	# of Lanes	Lane Width	Road Width	Treatment Recommendation	Treatment Cost	Unpaved Rating (Paser +)	Crown Severity	Drainage Severity	Rutting, Washboard Severity	Potholes / Loose Aggregate Severity	
0.00	0.09	0.09	1	10.0	10.0	Routine Maintenance	\$910	4	Low	Med	Med	Med	
<b>Route Level Data:</b>			0.09	1	10.0	10.00	Routine Maintenance	\$910	4	Low	Med	Med	Med

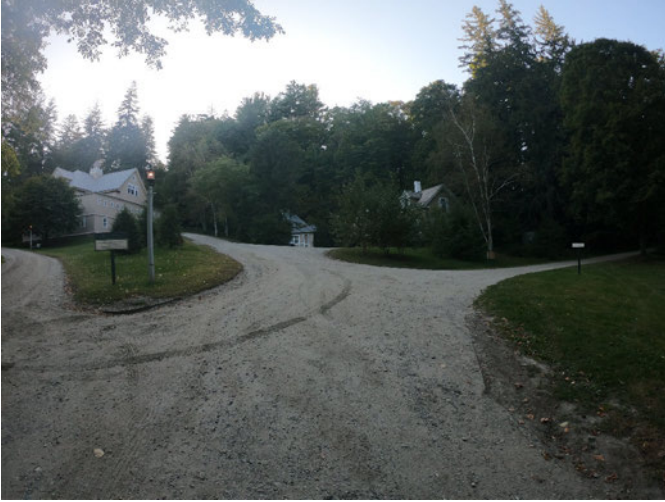
MABI\_0402\_0.007

Begin MP	End MP	Section Length	# of Lanes	Lane Width	Road Width	Treatment Recommendation	Treatment Cost	Unpaved Rating (Paser +)	Crown Severity	Drainage Severity	Rutting, Washboard Severity	Potholes / Loose Aggregate Severity
0.00	0.03	0.03	1	10.0	10.0	Routine Maintenance	\$340	4	Low	Med	Med	Med
<b>Route Level Data:</b>		0.03	1	10.0	10.00	Routine Maintenance	\$340	4	Low	Med	Med	Med

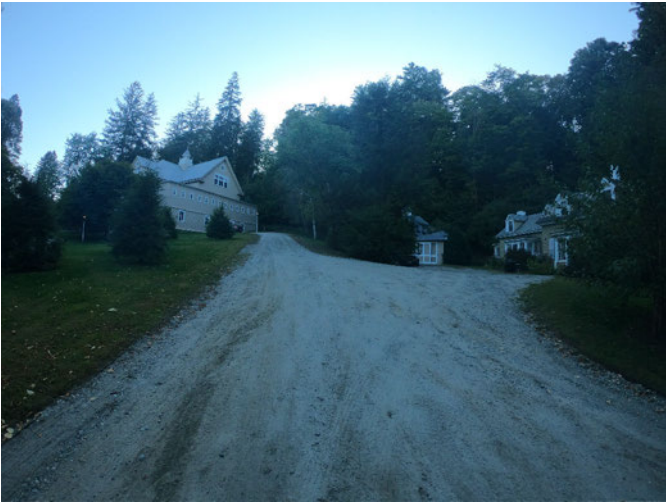
MABI\_0403\_0.000

Begin MP	End MP	Section Length	# of Lanes	Lane Width	Road Width	Treatment Recommendation	Treatment Cost	Unpaved Rating (Paser +)	Crown Severity	Drainage Severity	Rutting, Washboard Severity	Potholes / Loose Aggregate Severity	
0.00	0.04	0.04	1	10.0	10.0	Light Rehabilitation	\$3,500	3	Med	Med	Low	Med	
<b>Route Level Data:</b>			0.04	1	10.0	10.00	Light Rehabilitation	\$3,500	3	Med	Med	Low	Med

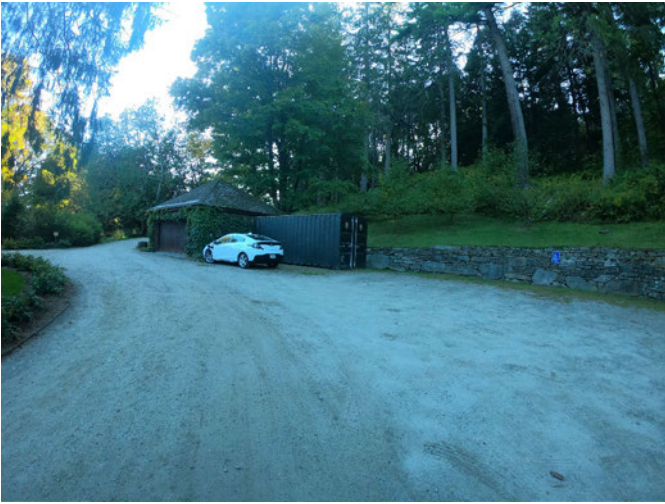
MABI\_0404\_0.005

Begin MP	End MP	Section Length	# of Lanes	Lane Width	Road Width	Treatment Recommendation	Treatment Cost	Unpaved Rating (Paser +)	Crown Severity	Drainage Severity	Rutting, Washboard Severity	Potholes / Loose Aggregate Severity	
0.00	0.11	0.11	1	10.0	10.0	Light Rehabilitation	\$10,600	3	Med	Med	Low	Med	
<b>Route Level Data:</b>			0.11	1	10.0	10.00	Light Rehabilitation	\$10,600	3	Med	Med	Low	Med

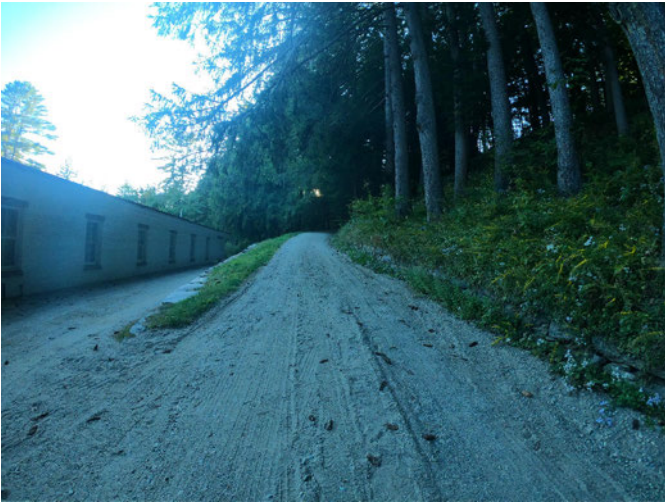
MABI\_0405\_0.003

Begin MP	End MP	Section Length	# of Lanes	Lane Width	Road Width	Treatment Recommendation	Treatment Cost	Unpaved Rating (Paser +)	Crown Severity	Drainage Severity	Rutting, Washboard Severity	Potholes / Loose Aggregate Severity	
0.00	0.10	0.10	1	10.0	10.0	Heavy Rehabilitation	\$16,480	2	Med	Med	Med	Med	
<b>Route Level Data:</b>			0.10	1	10.0	10.00	Heavy Rehabilitation	\$16,480	2	Med	Med	Med	Med

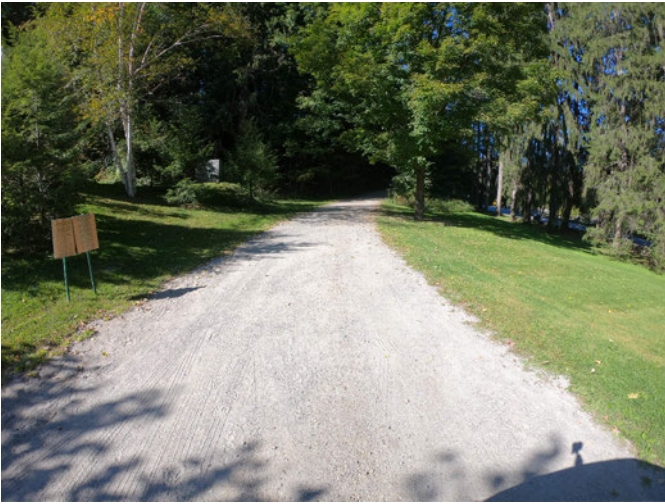
MABI\_0406AZ\_0.009

Begin MP	End MP	Section Length	# of Lanes	Lane Width	Road Width	Treatment Recommendation	Treatment Cost	Unpaved Rating (Paser +)	Crown Severity	Drainage Severity	Rutting, Washboard Severity	Potholes / Loose Aggregate Severity	
0.00	1.00	1.00	1	10.0	10.0	Routine Maintenance	\$10,000	4	Med	Low	Low	Med	
1.00	1.22	0.22	1	10.0	10.0	Reconstruction	\$55,250	1	High	High	High	High	
<b>Route Level Data:</b>			1.22	1	10.0	10.00	Routine Maintenance	\$65,250	4	Med	Low	Low	Med

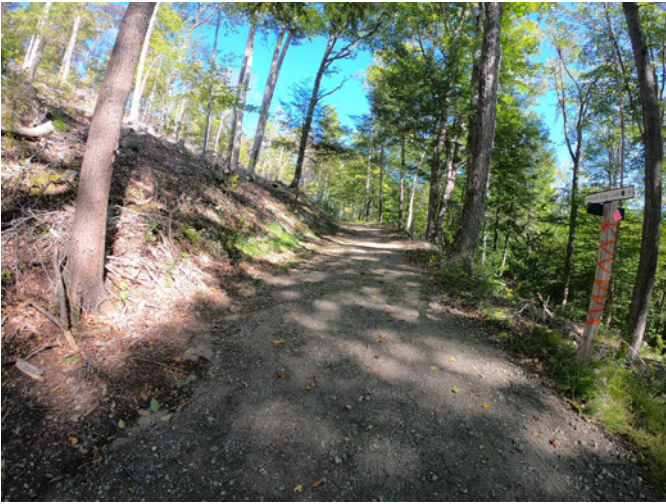
MABI\_0406BZ\_0.009

Begin MP	End MP	Section Length	# of Lanes	Lane Width	Road Width	Treatment Recommendation	Treatment Cost	Unpaved Rating (Paser +)	Crown Severity	Drainage Severity	Rutting, Washboard Severity	Potholes / Loose Aggregate Severity	
0.00	0.79	0.79	1	10.0	10.0	Heavy Rehabilitation	\$126,880	2	Med	High	High	Med	
<b>Route Level Data:</b>			0.79	1	10.0	10.00	Heavy Rehabilitation	\$126,880	2	Med	High	High	Med

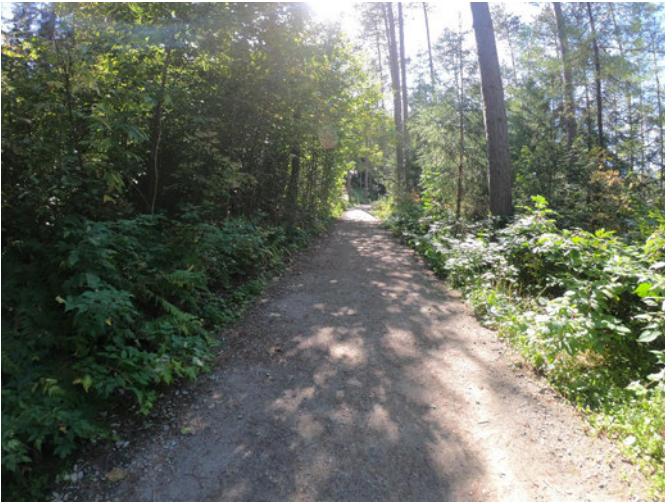
MABI\_0406CZ\_0.004

Begin MP	End MP	Section Length	# of Lanes	Lane Width	Road Width	Treatment Recommendation	Treatment Cost	Unpaved Rating (Paser +)	Crown Severity	Drainage Severity	Rutting, Washboard Severity	Potholes / Loose Aggregate Severity	
0.00	0.58	0.58	1	10.0	10.0	Light Rehabilitation	\$58,000	3	Med	Med	Low	Low	
<b>Route Level Data:</b>			0.58	1	10.0	10.00	Light Rehabilitation	\$58,000	3	Med	Med	Low	Low

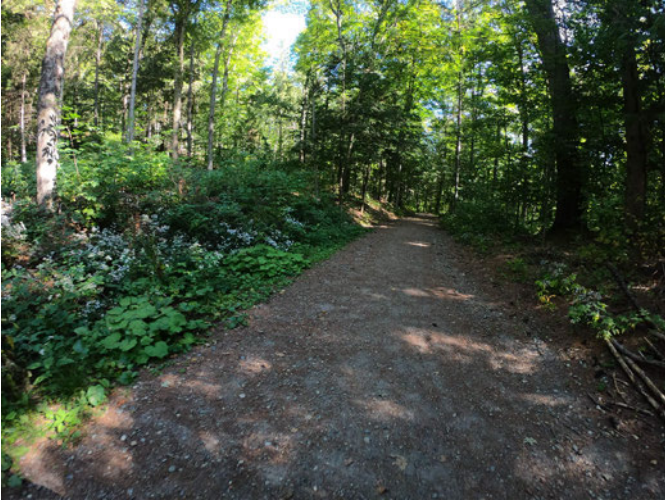
MABI\_0406DZ\_0.010

Begin MP	End MP	Section Length	# of Lanes	Lane Width	Road Width	Treatment Recommendation	Treatment Cost	Unpaved Rating (Paser +)	Crown Severity	Drainage Severity	Rutting, Washboard Severity	Potholes / Loose Aggregate Severity	
0.00	0.96	0.96	1	10.0	10.0	Heavy Rehabilitation	\$153,760	2	High	Med	Med	Low	
<b>Route Level Data:</b>			0.96	1	10.0	10.00	Heavy Rehabilitation	\$153,760	2	High	Med	Med	Low

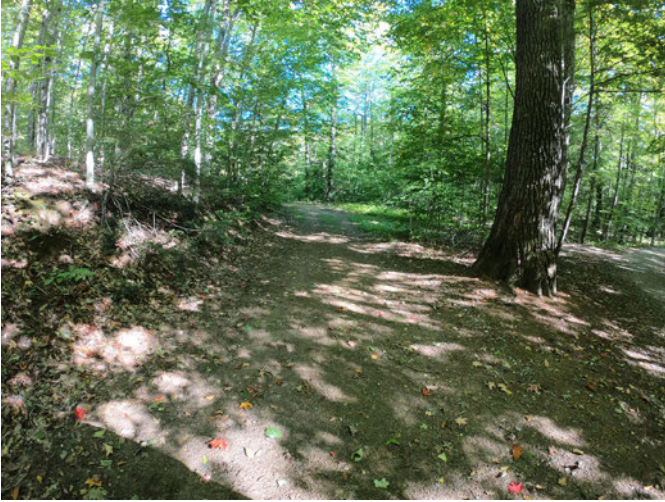
MABI\_0406EZ\_0.001

Begin MP	End MP	Section Length	# of Lanes	Lane Width	Road Width	Treatment Recommendation	Treatment Cost	Unpaved Rating (Paser +)	Crown Severity	Drainage Severity	Rutting, Washboard Severity	Potholes / Loose Aggregate Severity	
0.00	0.20	0.20	1	10.0	10.0	Light Rehabilitation	\$19,900	3	Med	Med	Med	Low	
<b>Route Level Data:</b>			0.20	1	10.0	10.00	Light Rehabilitation	\$19,900	3	Med	Med	Med	Low

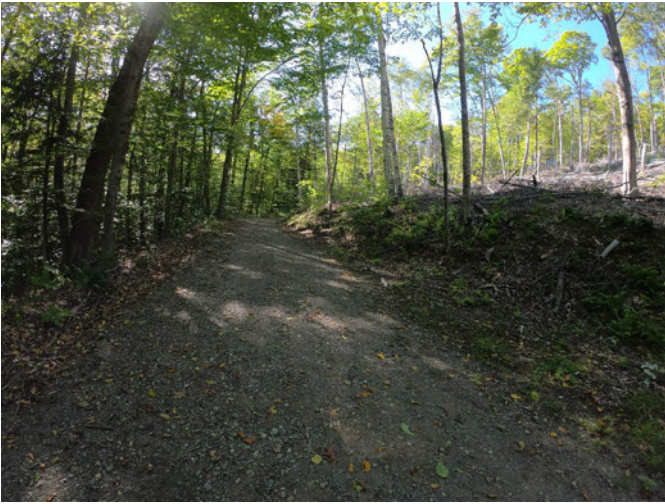
MABI\_0406FZ\_0.000

Begin MP	End MP	Section Length	# of Lanes	Lane Width	Road Width	Treatment Recommendation	Treatment Cost	Unpaved Rating (Paser +)	Crown Severity	Drainage Severity	Rutting, Washboard Severity	Potholes / Loose Aggregate Severity	
0.00	0.37	0.37	1	10.0	10.0	Light Rehabilitation	\$37,100	3	Med	Med	Low	Med	
<b>Route Level Data:</b>			0.37	1	10.0	10.00	Light Rehabilitation	\$37,100	3	Med	Med	Low	Med

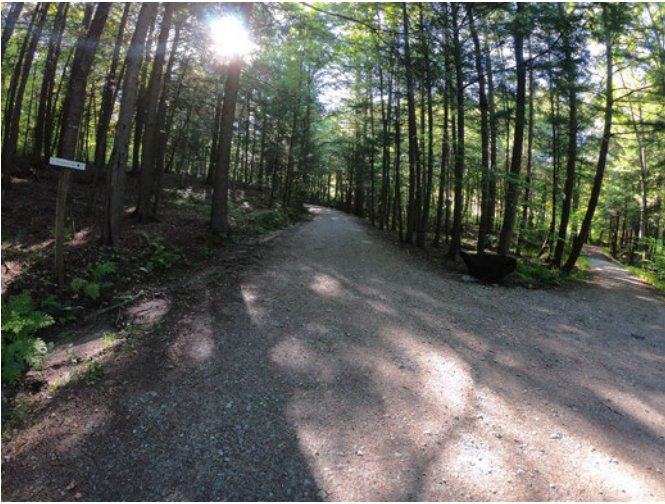
MABI\_0406GZ\_0.001

Begin MP	End MP	Section Length	# of Lanes	Lane Width	Road Width	Treatment Recommendation	Treatment Cost	Unpaved Rating (Paser +)	Crown Severity	Drainage Severity	Rutting, Washboard Severity	Potholes / Loose Aggregate Severity
0.00	0.39	0.39	1	10.0	10.0	Routine Maintenance	\$3,910	4	Med	Low	Low	Med
<b>Route Level Data:</b>		0.39	1	10.0	10.00	Routine Maintenance	\$3,910	4	Med	Low	Low	Med

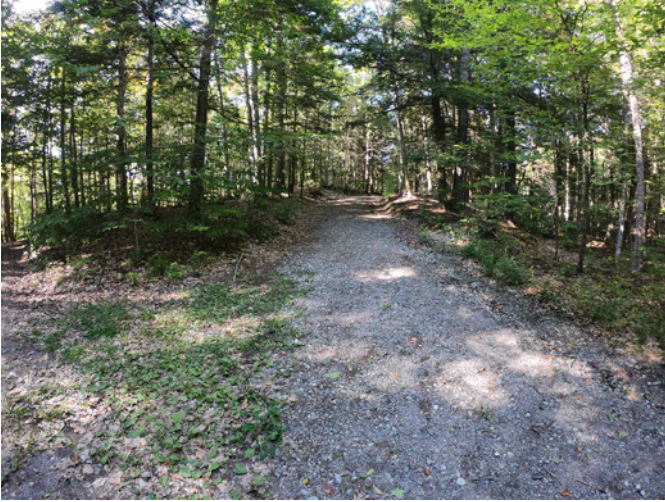
MABI\_0406HZ\_0.003

Begin MP	End MP	Section Length	# of Lanes	Lane Width	Road Width	Treatment Recommendation	Treatment Cost	Unpaved Rating (Paser +)	Crown Severity	Drainage Severity	Rutting, Washboard Severity	Potholes / Loose Aggregate Severity	
0.00	0.27	0.27	1	10.0	10.0	Heavy Rehabilitation	\$43,200	2	Med	Med	Med	Med	
<b>Route Level Data:</b>			0.27	1	10.0	10.00	Heavy Rehabilitation	\$43,200	2	Med	Med	Med	Med
