MACA Cycle 6

Final Report

Road Inventory and Condition Assessment of Paved Routes Mammoth Cave National Park

Report Date: May 2022

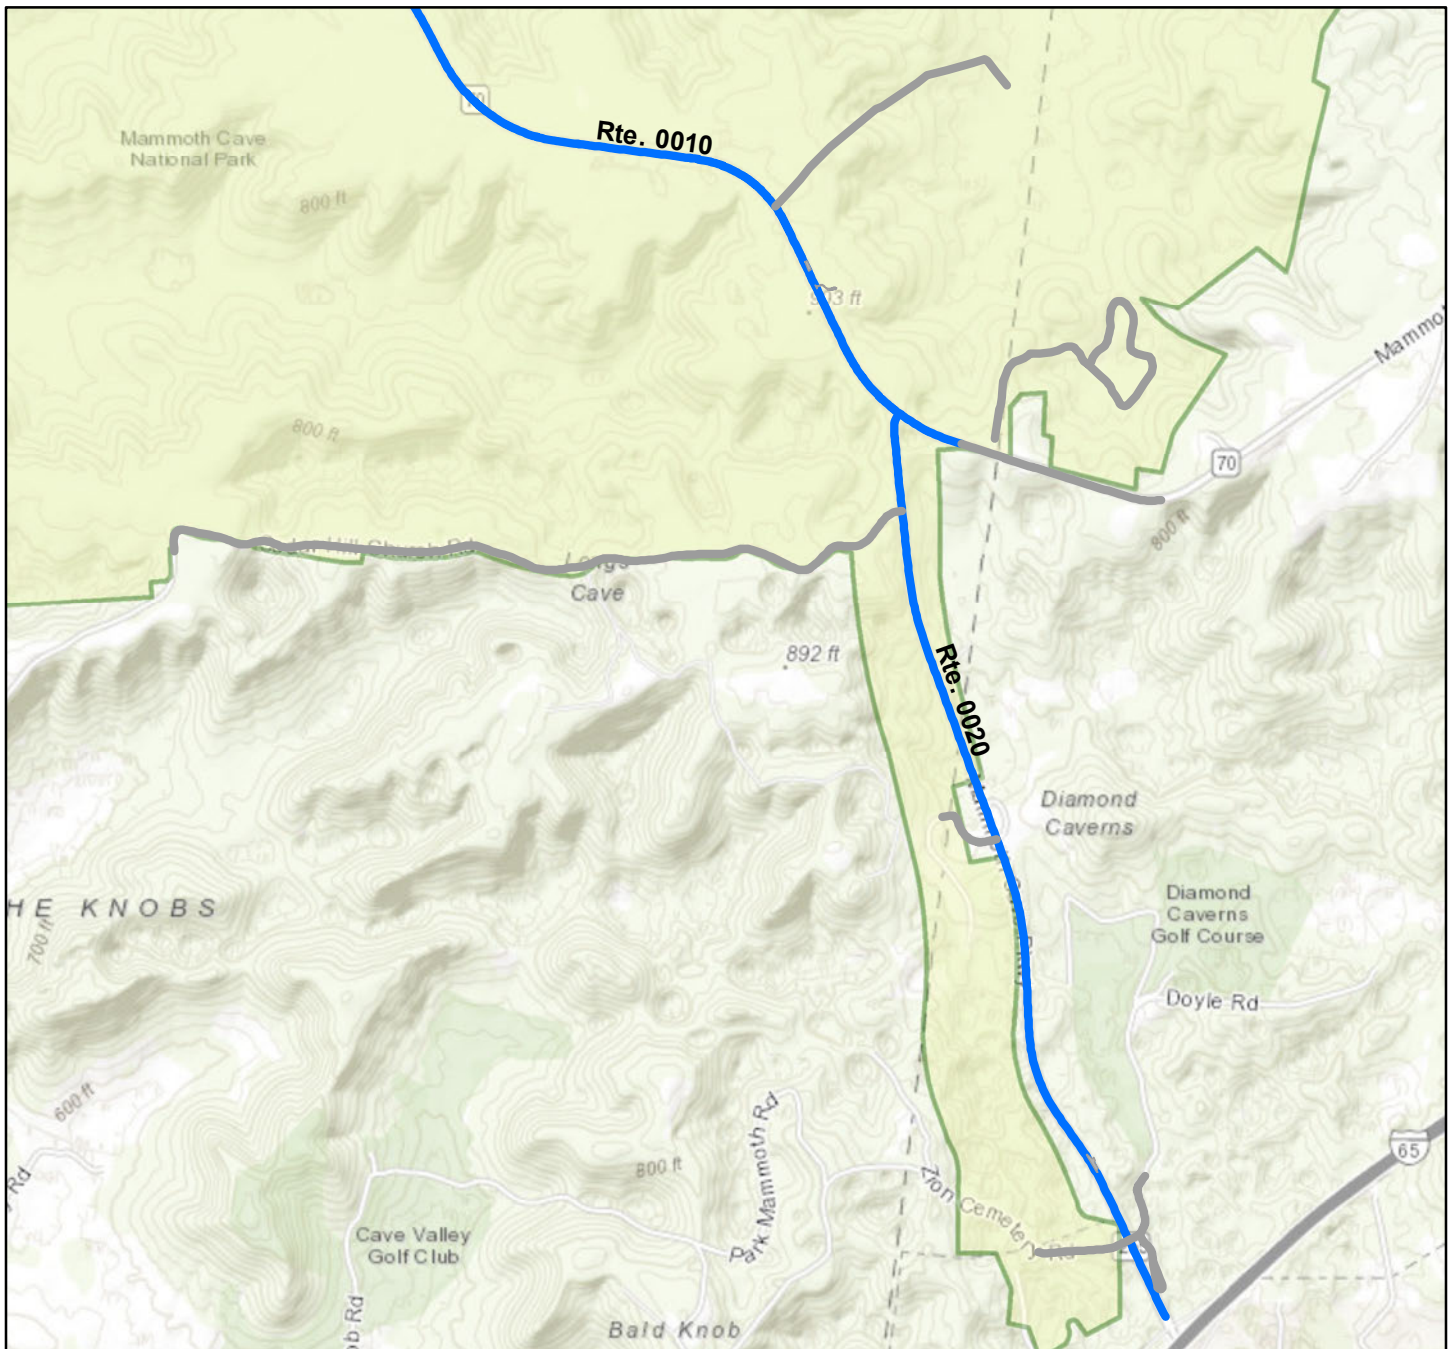
MAP 1C

Colors on map represent condition scores at 1-mile intervals. See Appendix for definitions and formulas

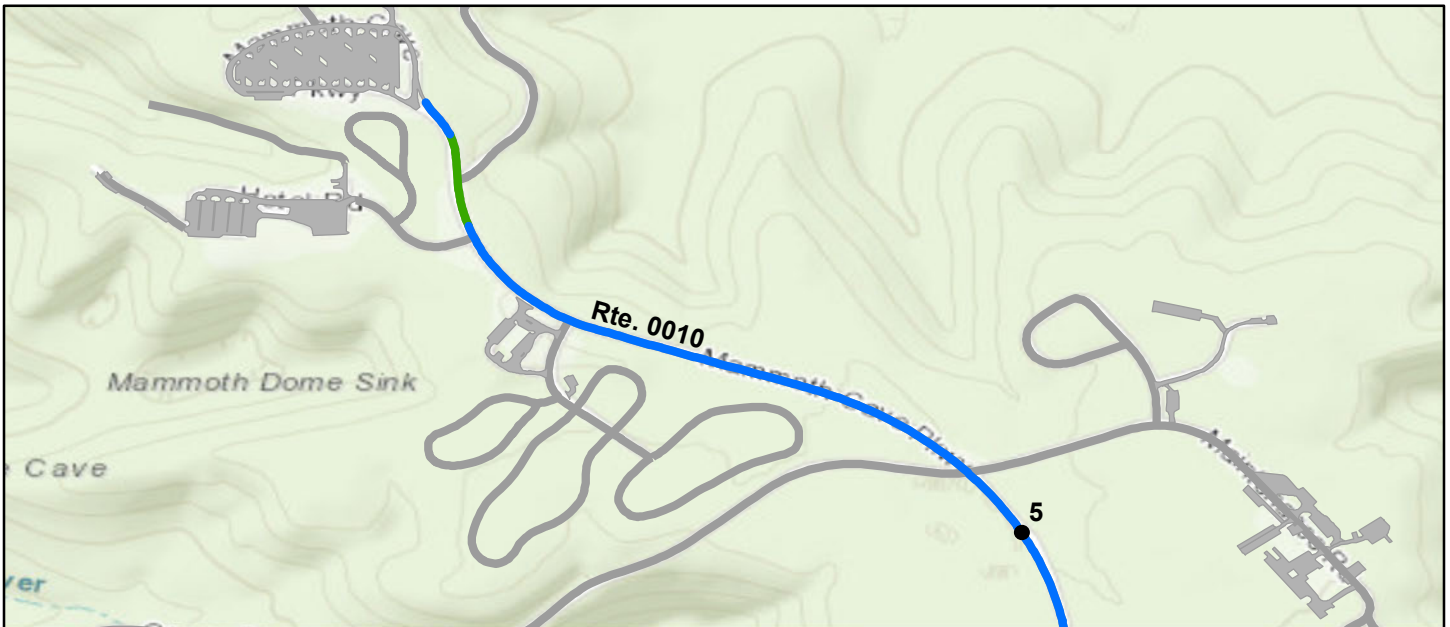
ROUTE 0010: MAMMOTH CAVE PARKWAY

Route Condition Legend – Pavement Condition Rating (PCR)						
Poor (0 - 60)	Fair (61- 84)	Good (85 - 94)	Excellent (95 - 100)	Not Rated		
Colors on map represent condition scores at 0.10-mile intervals. See Appendix for definitions and formulas.						
Inspection Date: 7/21/2021	Beginning Section MP	5				
Paved Length (Miles): 5.74	Section Length (MI)	0.74				
Surface Type: ASPHALT	Route Summary					
Roadway Condition Information						
Pavement Condition Rating (PCR)	100	100				
Surface Condition Rating (SCR)	100	100				
Roughness Condition Index (RCI)	100	100				
Distress Index Values						
Structural Crack Index	100	100				
Alligator Crack Index	100	100				
Longitudinal Crack Index	100	100				
Transverse Cracking Index	100	100				
Patching Index	100	100				
Rutting Index	100	100				
International Roughness Index (IRI)	73	101				
Lane & Width Information						
Number of Lanes	2	2				
Paved Width (ft)	23.6	26.6

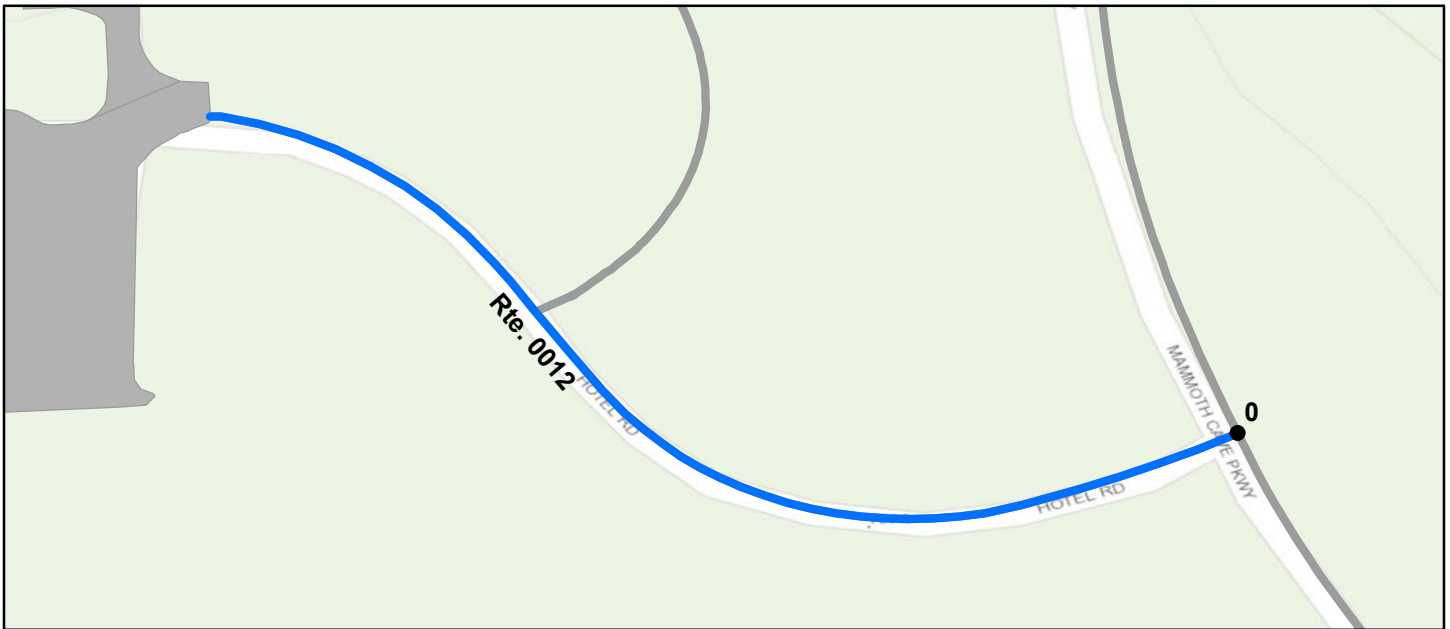
Colors on map represent condition scores at 0.10-mile intervals. See Appendix for definitions and formulas.

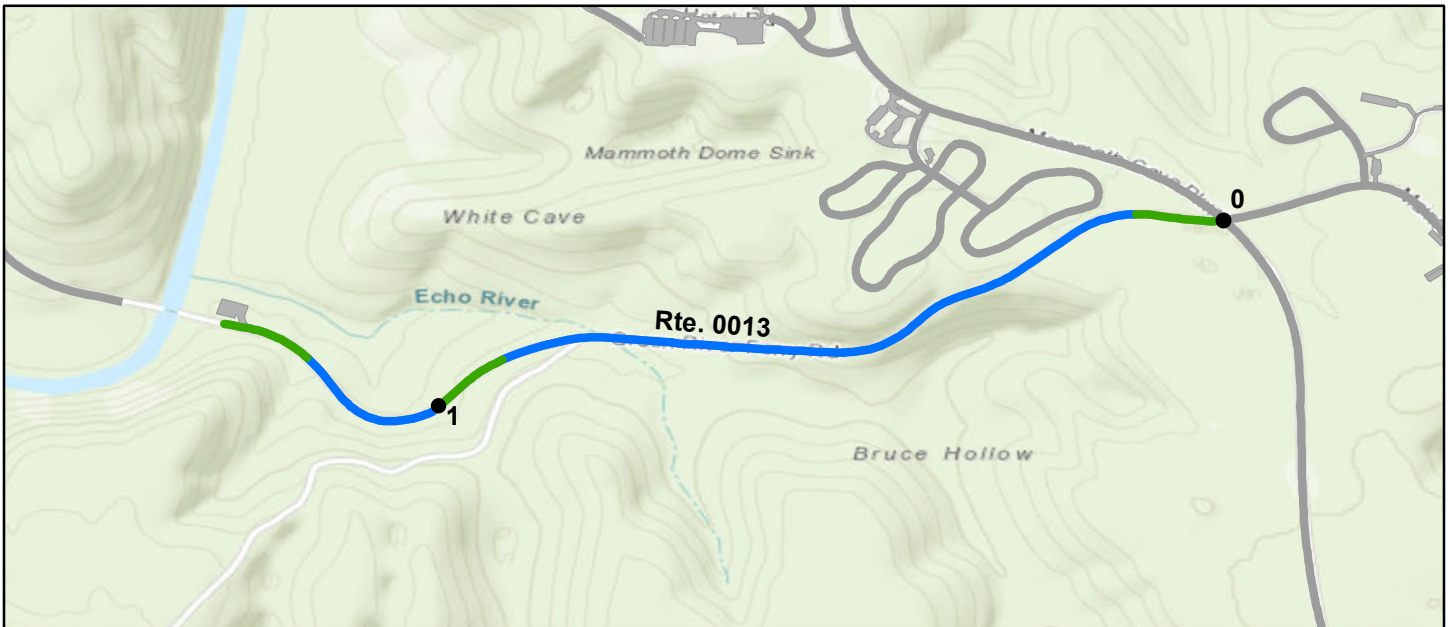
ROUTE 0013: GREEN RIVER FERRY ROAD SOUTH

Route Condition Legend – Pavement Condition Rating (PCR)						
Poor (0 - 60)	Fair (61- 84)	Good (85 - 94)	Excellent (95 - 100)	Not Rated		
Colors on map represent condition scores at 0.10-mile intervals. See Appendix for definitions and formulas.						
Inspection Date: 7/21/2021	Beginning Section MP	0	1			
Paved Length (Miles): 1.31	Section Length (MI)	1	0.31			
Surface Type: ASPHALT	Route Summary					
Roadway Condition Information						
Pavement Condition Rating (PCR)	100	99	99			
Surface Condition Rating (SCR)	100	99	99			
Roughness Condition Index (RCI)	100	100	100			
Distress Index Values						
Structural Crack Index	100	100	100			
Alligator Crack Index	100	100	100			
Longitudinal Crack Index	100	100	100			
Transverse Cracking Index	100	100	100			
Patching Index	100	100	100			
Rutting Index	100	99	99			
International Roughness Index (IRI)	91	88	103			
Lane & Width Information						
Number of Lanes	2	2	2

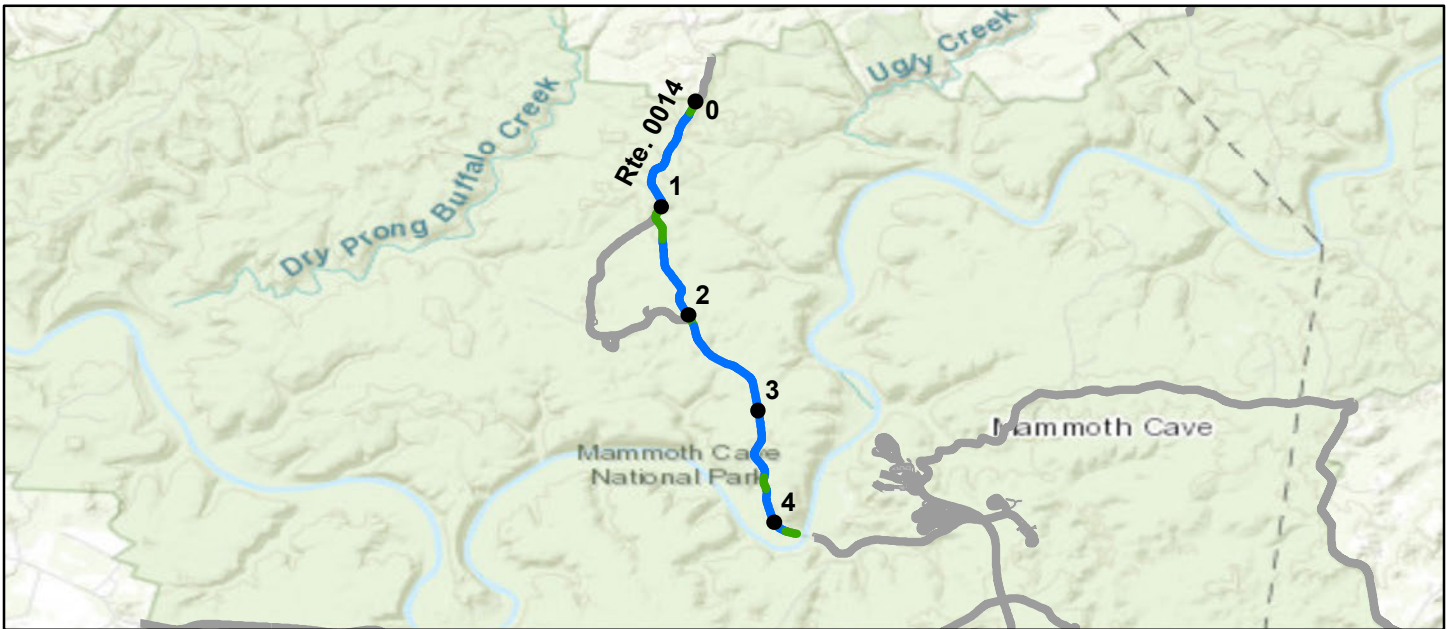
ROUTE 0014: GREEN RIVER FERRY ROAD NORTH

Route Condition Legend – Pavement Condition Rating (PCR)						
Poor (0 - 60)	Fair (61- 84)	Good (85 - 94)	Excellent (95 - 100)	Not Rated		
Colors on map represent condition scores at 0.10-mile intervals. See Appendix for definitions and formulas.						
Inspection Date: 7/21/2021	Beginning Section MP	0	1	2	3	4
Paved Length (Miles): 4.18	Section Length (MI)	1	1	1	1	0.18
Surface Type: ASPHALT	Route Summary					
Roadway Condition Information						
Pavement Condition Rating (PCR)	100	100	99	99	99	99
Surface Condition Rating (SCR)	100	100	100	99	99	100
Roughness Condition Index (RCI)	100	100	97	100	100	98
Distress Index Values						
Structural Crack Index	100	100	100	100	100	100
Alligator Crack Index	100	100	100	100	100	100
Longitudinal Crack Index	100	100	100	100	100	100
Transverse Cracking Index	100	100	100	100	100	100
Patching Index	100	100	100	100	100	100
Rutting Index	100	100	100	99	99	100
International Roughness Index (IRI)	106	104	122	98	98	121

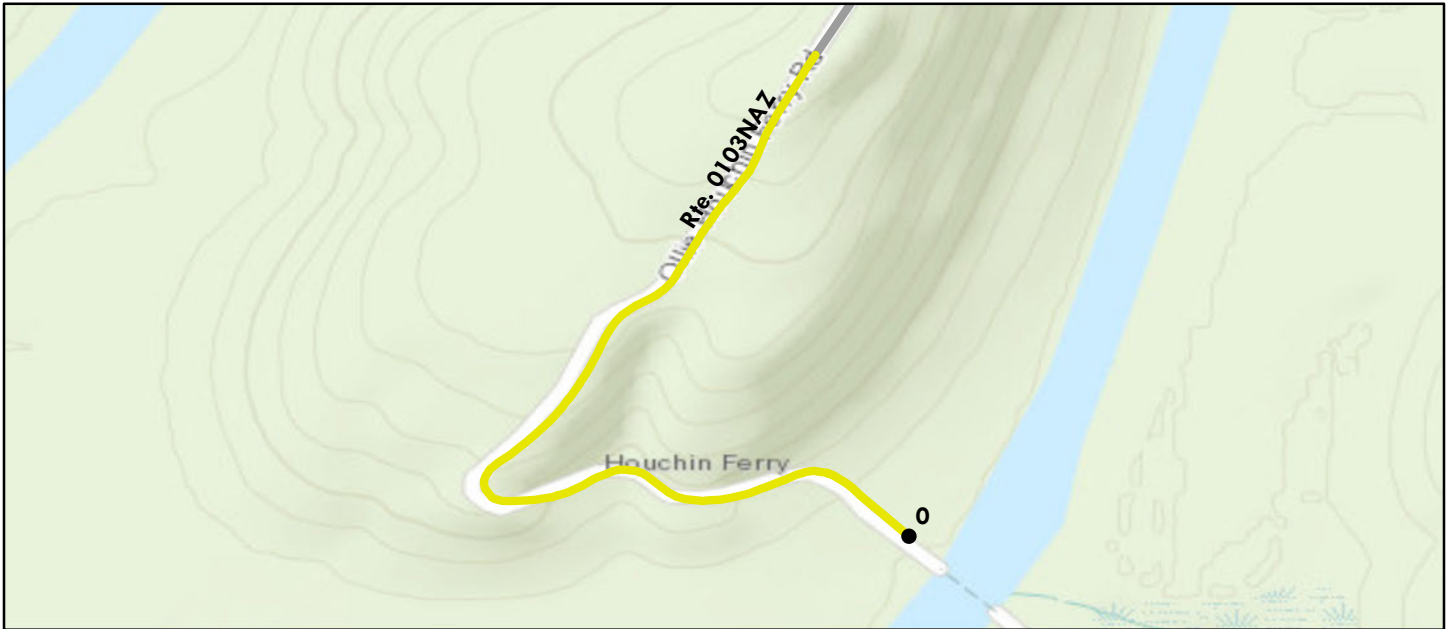
ROUTE 0103NAZ: HOUCHINS FERRY ROAD NORTH PAVED

Route Condition Legend – Pavement Condition Rating (PCR)						
Poor (0 - 60)	Fair (61- 84)	Good (85 - 94)	Excellent (95 - 100)	Not Rated		
See Appendix for definitions and formulas						
Inspection Date: 6/14/2021	Beginning Section MP	0.00				
Paved Length (Miles): 0.50	Section Length (MI)	0.50				
Surface Type: ASPHALT	Route Summary					
Roadway Condition Information						
Pavement Condition Rating (PCR)	81	81				
Surface Condition Rating (SCR)	81	81				
Roughness Condition Index (RCI)	N/A	N/A				
Distress Index Values						
Structural Crack Index	81	81				
Alligator Crack Index	90	90				
Longitudinal Crack Index	91	91				
Transverse Cracking Index	97	97				
Patching Index	100	100				
Rutting Index	99	99				
International Roughness Index (IRI)	N/A	N/A				
Lane & Width Information						
Number of Lanes	2	2				
Paved Width (ft)	16	16				
Lane Width (ft)	8	8

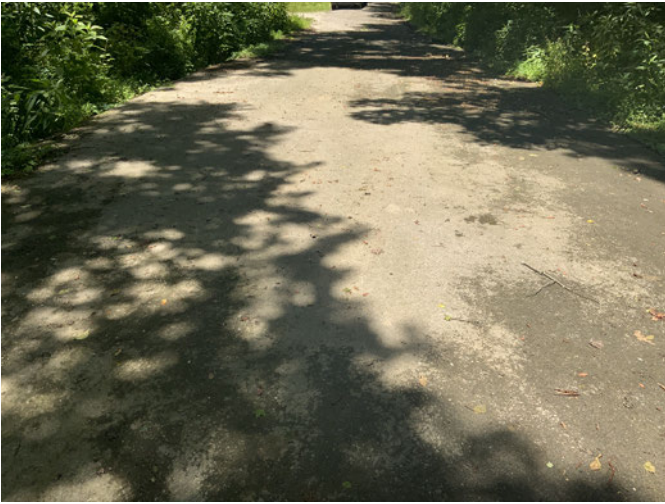
MACA_0103NAZ_1.jpg

Condition Photos

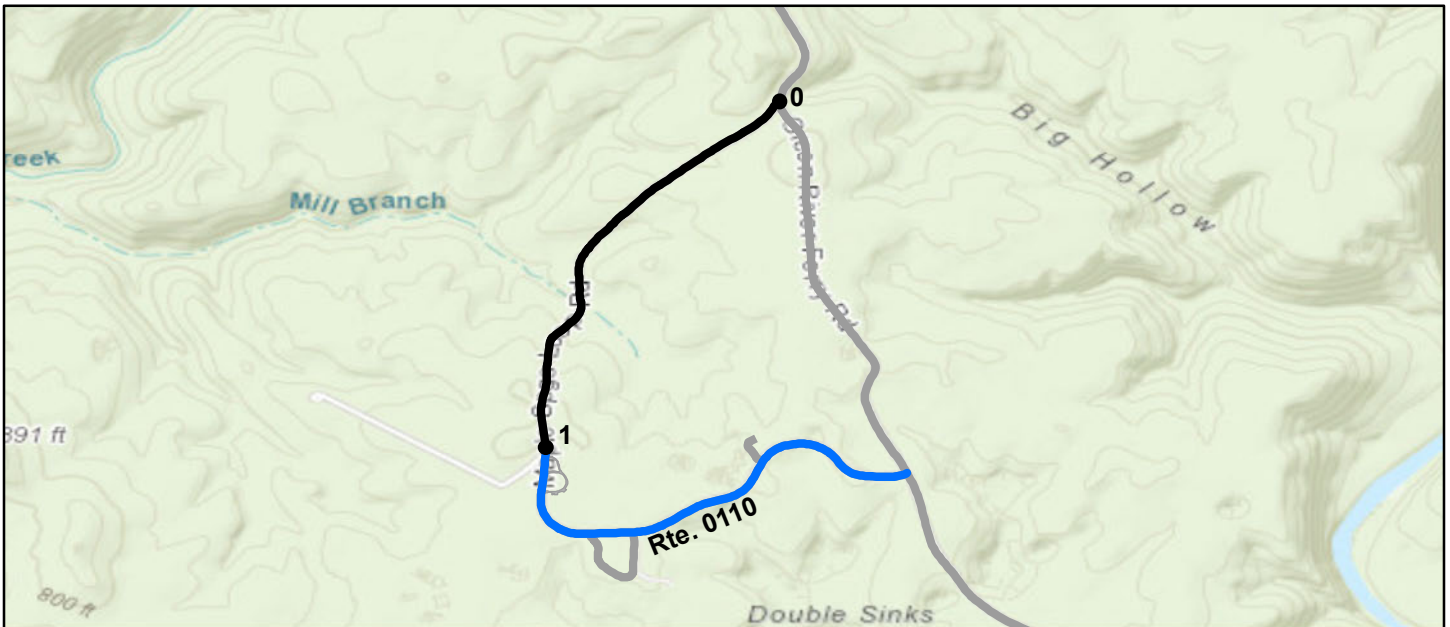
ROUTE 0110: MAPLE SPRINGS LOOP

Route Condition Legend – Pavement Condition Rating (PCR)						
Poor (0 - 60)	Fair (61- 84)	Good (85 - 94)	Excellent (95 - 100)	Not Rated		
Colors on map represent condition scores at 0.10-mile intervals. See Appendix for definitions and formulas.						
Inspection Date: 7/21/2021	Beginning Section MP	0	1			
Paved Length (Miles): 1.96	Section Length (MI)	1	0.96			
Surface Type: ASPHALT	Route Summary					
Roadway Condition Information						
Pavement Condition Rating (PCR)	100	N/A	100			
Surface Condition Rating (SCR)	100	N/A	100			
Roughness Condition Index (RCI)	N/A	N/A	100			
Distress Index Values						
Structural Crack Index	100	N/A	100			
Alligator Crack Index	100	N/A	100			
Longitudinal Crack Index	100	N/A	100			
Transverse Cracking Index	100	N/A	100			
Patching Index	100	N/A	100			
Rutting Index	100	N/A	100			
International Roughness Index (IRI)	N/A	N/A	102			
Lane & Width Information						
Number of Lanes	1	1	2

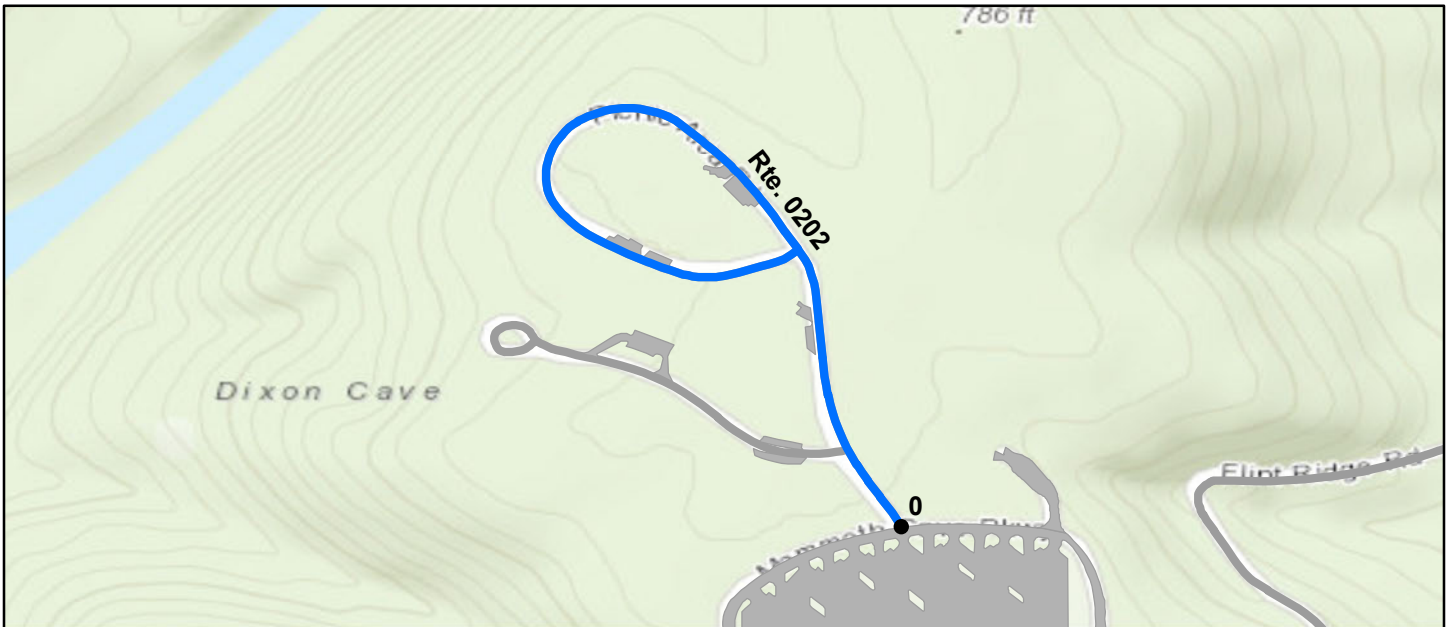
ROUTE 0202: VISITOR CENTER PICNIC GROUNDS ROAD

Route Condition Legend – Pavement Condition Rating (PCR)						
Poor (0 - 60)	Fair (61- 84)	Good (85 - 94)	Excellent (95 - 100)	Not Rated		
Colors on map represent condition scores at 0.10-mile intervals. See Appendix for definitions and formulas.						
Inspection Date: 7/21/2021	Beginning Section MP	0				
Paved Length (Miles): 0.45	Section Length (MI)	0.45				
Surface Type: ASPHALT	Route Summary					
Roadway Condition Information						
Pavement Condition Rating (PCR)	100	100				
Surface Condition Rating (SCR)	100	100				
Roughness Condition Index (RCI)	N/A	N/A				
Distress Index Values						
Structural Crack Index	100	100				
Alligator Crack Index	100	100				
Longitudinal Crack Index	100	100				
Transverse Cracking Index	100	100				
Patching Index	100	100				
Rutting Index	100	100				
International Roughness Index (IRI)	N/A	N/A				
Lane & Width Information						
Number of Lanes	1	1				
Paved Width (ft)	14.6	14.6

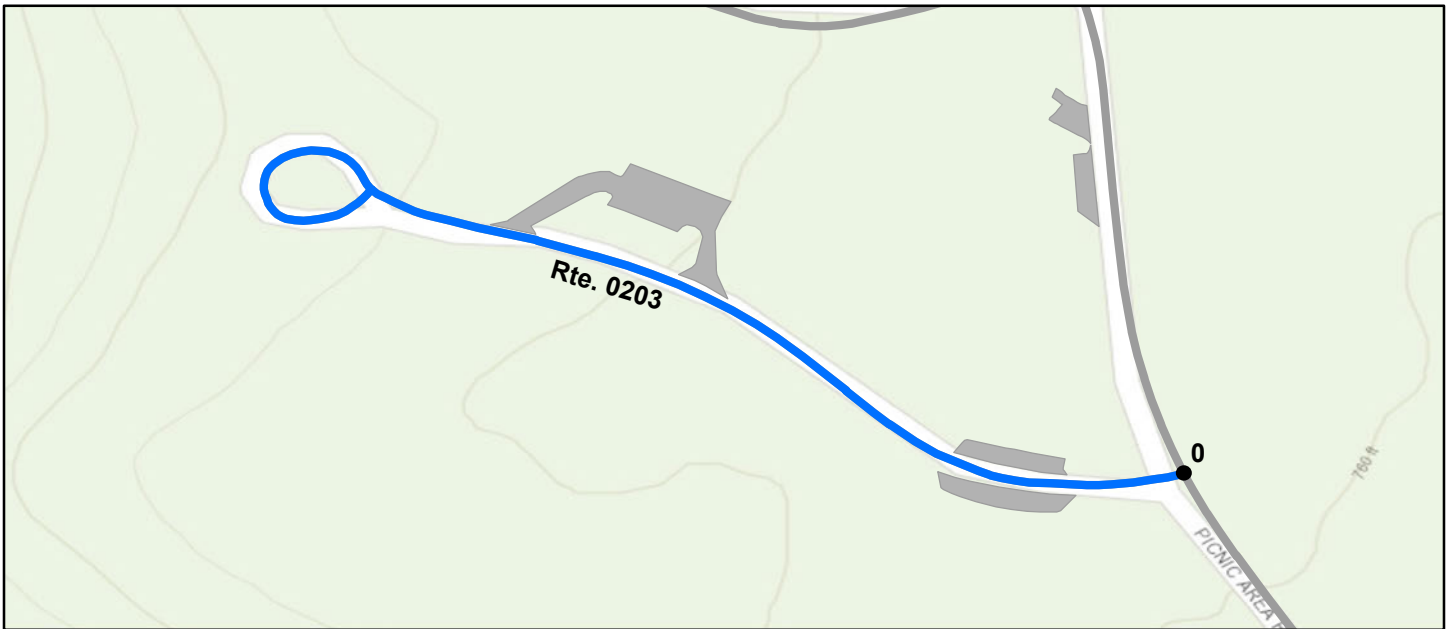
ROUTE 0203: VISITOR CENTER PICNIC SHELTER ROAD

Route Condition Legend – Pavement Condition Rating (PCR)						
Poor (0 - 60)	Fair (61- 84)	Good (85 - 94)	Excellent (95 - 100)	Not Rated		
Colors on map represent condition scores at 0.10-mile intervals. See Appendix for definitions and formulas.						
Inspection Date: 7/21/2021	Beginning Section MP	0				
Paved Length (Miles): 0.19	Section Length (MI)	0.19				
Surface Type: ASPHALT	Route Summary					
Roadway Condition Information						
Pavement Condition Rating (PCR)	99	99				
Surface Condition Rating (SCR)	99	99				
Roughness Condition Index (RCI)	N/A	N/A				
Distress Index Values						
Structural Crack Index	100	100				
Alligator Crack Index	100	100				
Longitudinal Crack Index	100	100				
Transverse Cracking Index	100	100				
Patching Index	100	100				
Rutting Index	99	99				
International Roughness Index (IRI)	N/A	N/A				
Lane & Width Information						
Number of Lanes	2	2				
Paved Width (ft)	17.4	17.4

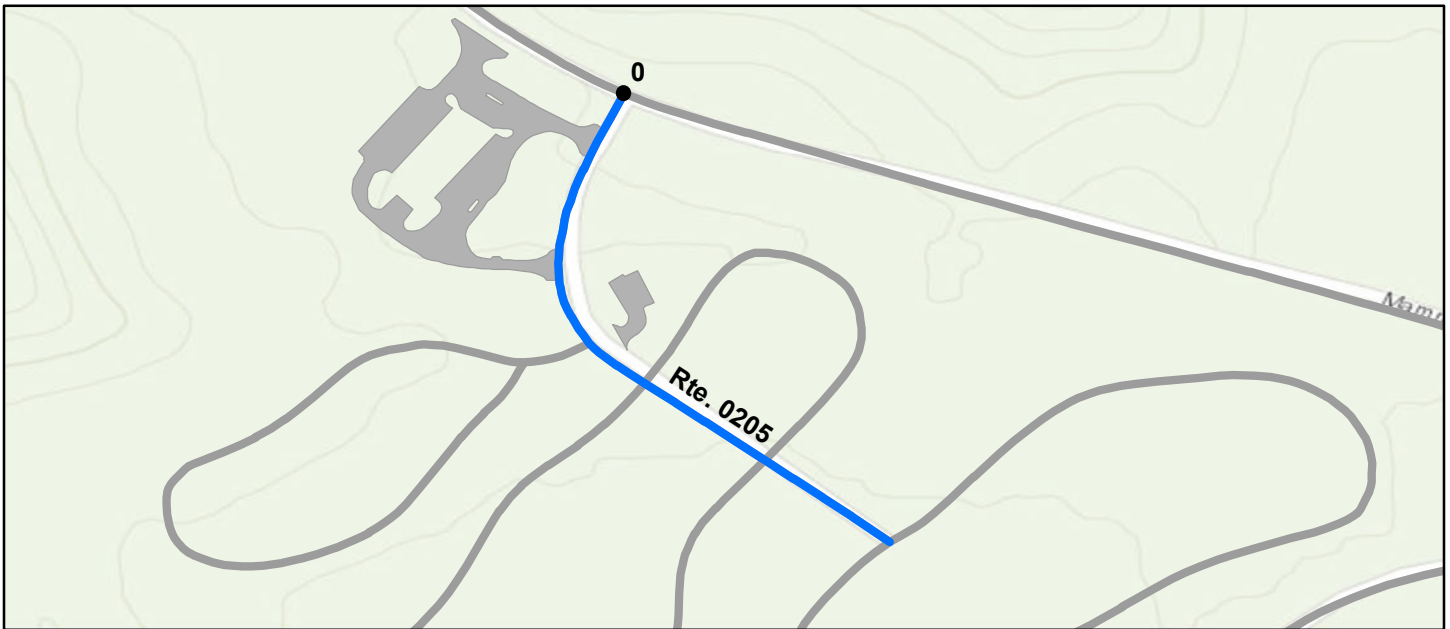
ROUTE 0205: HQ CAMPGROUND ACCESS ROAD

Route Condition Legend – Pavement Condition Rating (PCR)						
Poor (0 - 60)	Fair (61- 84)	Good (85 - 94)	Excellent (95 - 100)	Not Rated		
Colors on map represent condition scores at 0.10-mile intervals. See Appendix for definitions and formulas.						
Inspection Date: 7/21/2021	Beginning Section MP	0				
Paved Length (Miles): 0.18	Section Length (MI)	0.18				
Surface Type: ASPHALT	Route Summary					
Roadway Condition Information						
Pavement Condition Rating (PCR)	99	99				
Surface Condition Rating (SCR)	99	99				
Roughness Condition Index (RCI)	N/A	N/A				
Distress Index Values						
Structural Crack Index	100	100				
Alligator Crack Index	100	100				
Longitudinal Crack Index	100	100				
Transverse Cracking Index	100	100				
Patching Index	100	100				
Rutting Index	99	99				
International Roughness Index (IRI)	N/A	N/A				
Lane & Width Information						
Number of Lanes	2	2				
Paved Width (ft)	25	25				
Lane Width (ft)	10.4	10.4

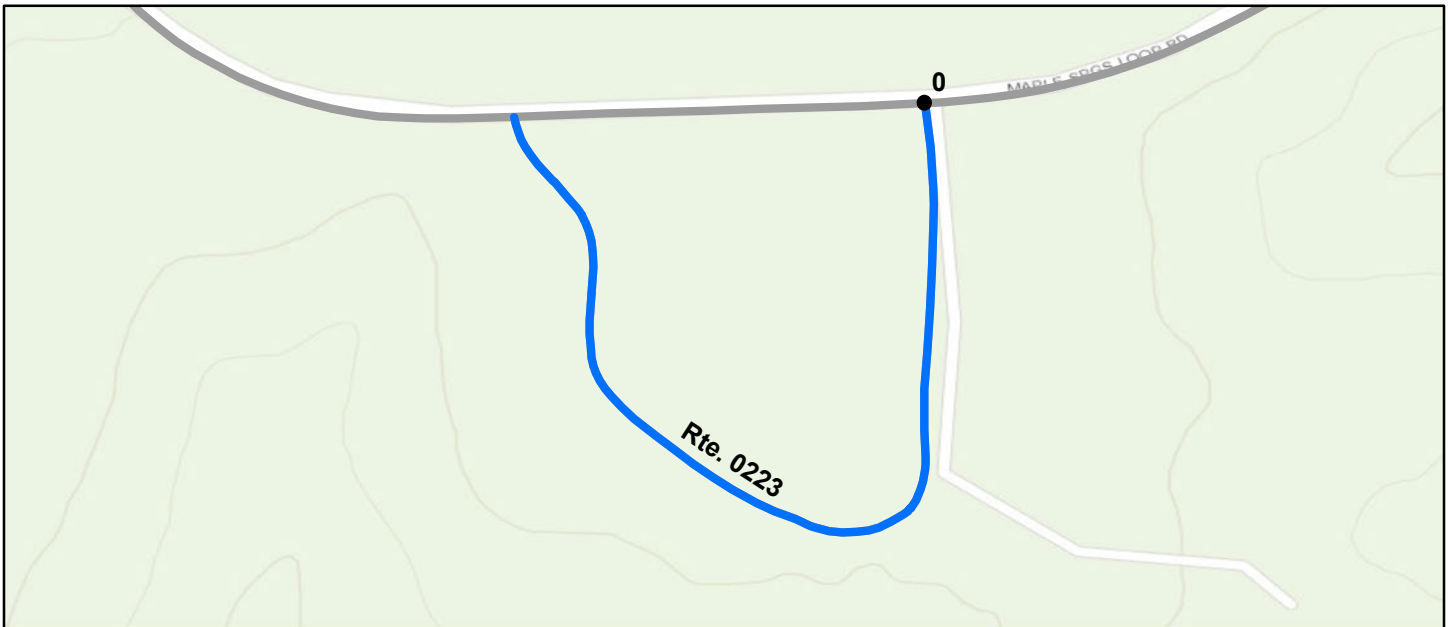
ROUTE 0223: MAPLE SPRINGS LOOP CAMPGROUND

Route Condition Legend – Pavement Condition Rating (PCR)						
Poor (0 - 60)	Fair (61- 84)	Good (85 - 94)	Excellent (95 - 100)	Not Rated		
Colors on map represent condition scores at 0.10-mile intervals. See Appendix for definitions and formulas.						
Inspection Date: 7/21/2021	Beginning Section MP	0				
Paved Length (Miles): 0.25	Section Length (MI)	0.25				
Surface Type: ASPHALT	Route Summary					
Roadway Condition Information						
Pavement Condition Rating (PCR)	98	98				
Surface Condition Rating (SCR)	98	98				
Roughness Condition Index (RCI)	N/A	N/A				
Distress Index Values						
Structural Crack Index	100	100				
Alligator Crack Index	100	100				
Longitudinal Crack Index	100	100				
Transverse Cracking Index	100	100				
Patching Index	100	100				
Rutting Index	98	98				
International Roughness Index (IRI)	N/A	N/A				
Lane & Width Information						
Number of Lanes	1	1				
Paved Width (ft)	12.2	12.2

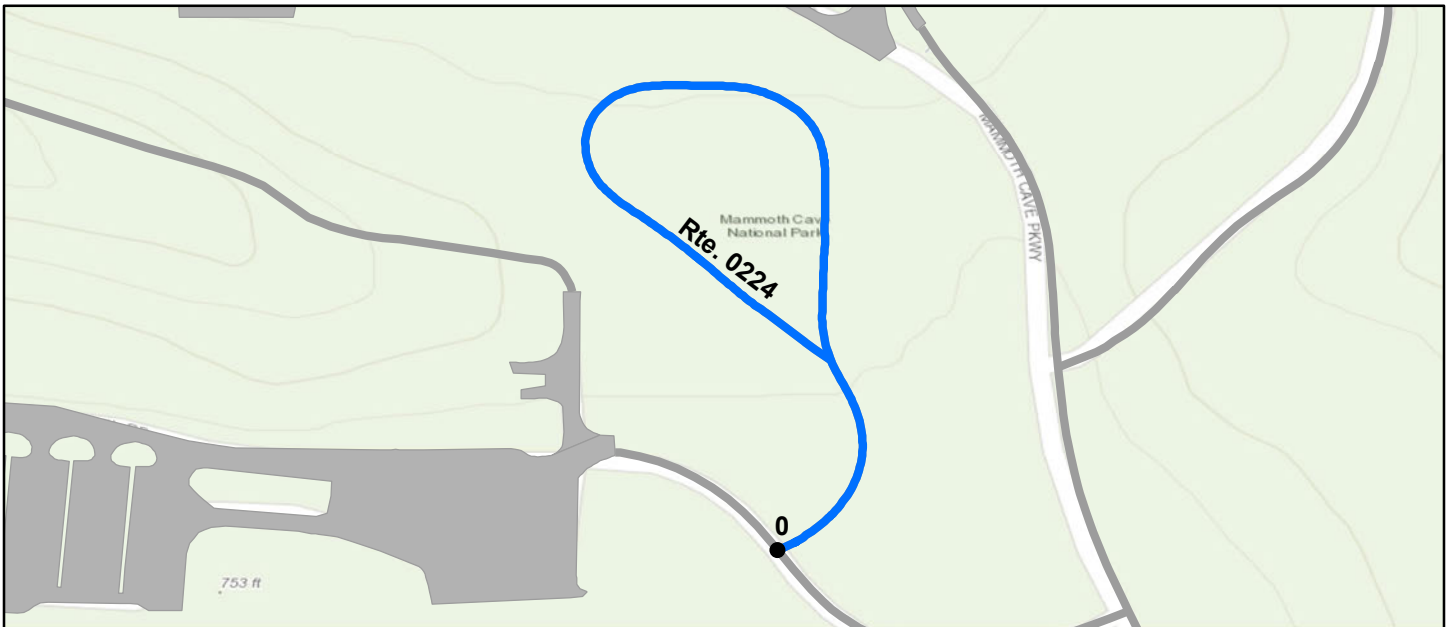
ROUTE 0224: VISITOR CENTER BUS LOOP

Route Condition Legend – Pavement Condition Rating (PCR)						
Poor (0 - 60)	Fair (61- 84)	Good (85 - 94)	Excellent (95 - 100)	Not Rated		
Colors on map represent condition scores at 0.10-mile intervals. See Appendix for definitions and formulas.						
Inspection Date: 7/21/2021	Beginning Section MP	0				
Paved Length (Miles): 0.23	Section Length (MI)	0.23				
Surface Type: ASPHALT	Route Summary					
Roadway Condition Information						
Pavement Condition Rating (PCR)	99	99				
Surface Condition Rating (SCR)	99	99				
Roughness Condition Index (RCI)	N/A	N/A				
Distress Index Values						
Structural Crack Index	100	100				
Alligator Crack Index	100	100				
Longitudinal Crack Index	100	100				
Transverse Cracking Index	100	100				
Patching Index	100	100				
Rutting Index	99	99				
International Roughness Index (IRI)	N/A	N/A				
Lane & Width Information						
Number of Lanes	1	1				
Paved Width (ft)	21.7	21.7

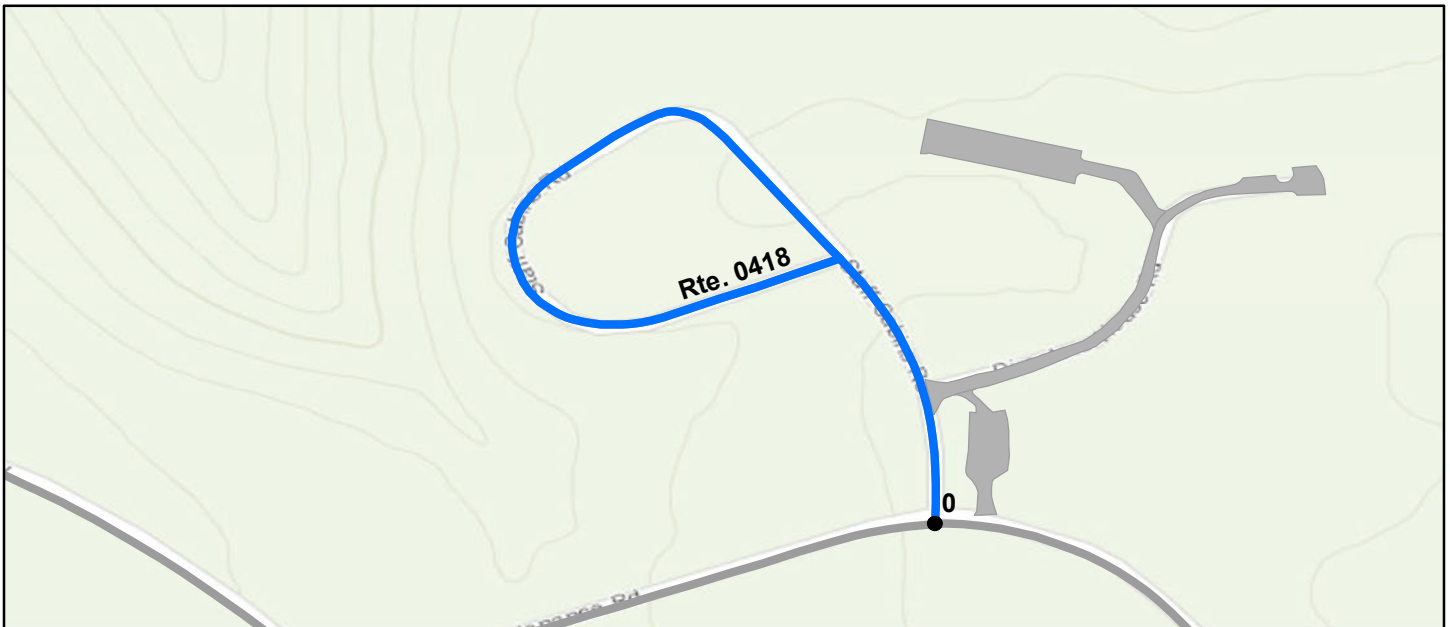
ROUTE 0418: RESIDENCE LOOP ROAD

Route Condition Legend – Pavement Condition Rating (PCR)						
Poor (0 - 60)	Fair (61- 84)	Good (85 - 94)	Excellent (95 - 100)	Not Rated		
Colors on map represent condition scores at 0.10-mile intervals. See Appendix for definitions and formulas.						
Inspection Date: 7/21/2021	Beginning Section MP	0				
Paved Length (Miles): 0.32	Section Length (MI)	0.32				
Surface Type: ASPHALT	Route Summary					
Roadway Condition Information						
Pavement Condition Rating (PCR)	100	100				
Surface Condition Rating (SCR)	100	100				
Roughness Condition Index (RCI)	N/A	N/A				
Distress Index Values						
Structural Crack Index	100	100				
Alligator Crack Index	100	100				
Longitudinal Crack Index	100	100				
Transverse Cracking Index	100	100				
Patching Index	100	100				
Rutting Index	100	100				
International Roughness Index (IRI)	N/A	N/A				
Lane & Width Information						
Number of Lanes	2	2				
Paved Width (ft)	17.4	17.4

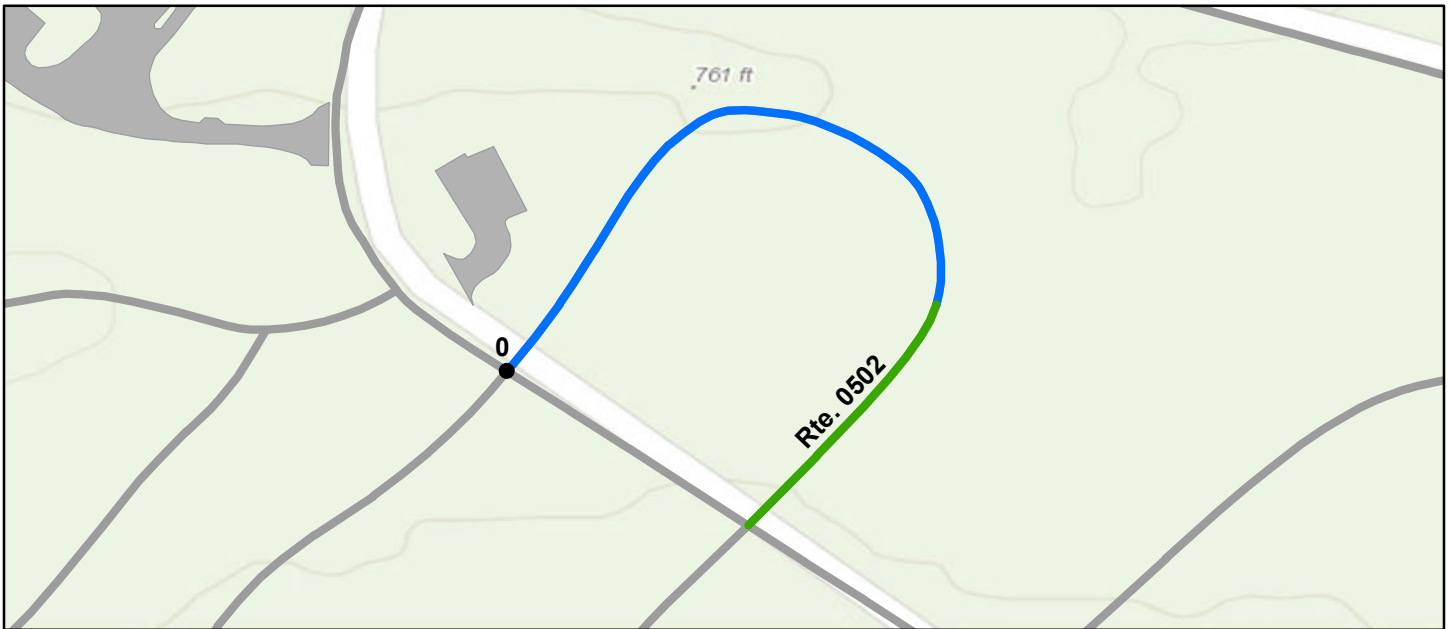
ROUTE 0502: VISITOR CENTER CAMPGROUND LOOP A

Route Condition Legend – Pavement Condition Rating (PCR)						
Poor (0 - 60)	Fair (61- 84)	Good (85 - 94)	Excellent (95 - 100)	Not Rated		
Colors on map represent condition scores at 0.10-mile intervals. See Appendix for definitions and formulas.						
Inspection Date: 7/21/2021	Beginning Section MP	0				
Paved Length (Miles): 0.14	Section Length (MI)	0.14				
Surface Type: ASPHALT	Route Summary					
Roadway Condition Information						
Pavement Condition Rating (PCR)	98	98				
Surface Condition Rating (SCR)	98	98				
Roughness Condition Index (RCI)	N/A	N/A				
Distress Index Values						
Structural Crack Index	100	100				
Alligator Crack Index	100	100				
Longitudinal Crack Index	100	100				
Transverse Cracking Index	100	100				
Patching Index	100	100				
Rutting Index	98	98				
International Roughness Index (IRI)	N/A	N/A				
Lane & Width Information						
Number of Lanes	1	1				
Paved Width (ft)	11.8	11.8

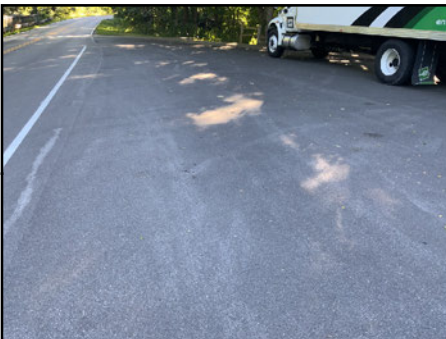
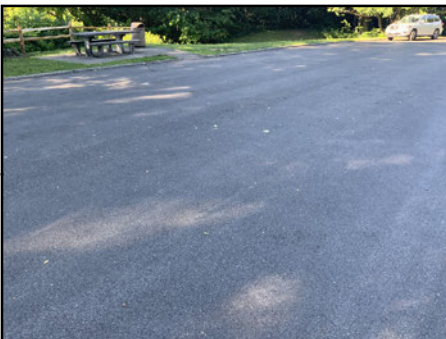
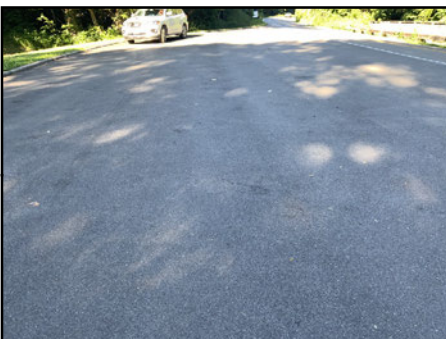
ROUTE 0901A: VISITOR CENTER PARKING

Inspection Date	FMSS Number	User Access	Surface Type
6/15/2021	50169	PUBLIC	ASPHALT
Area (Sq. Ft.)	Lane Miles (11' Widths)	Curb Reveal (Inches)	Curb Recommendation
247,079	4.254	0	MODERATE REPAIR
Curb Type		Curb & Gutter Type	
CONCRETE		CONCRETE	
Pavement Recommendation		Condition Rating / PCR	
PREVENTIVE MAINTENANCE		GOOD / 90

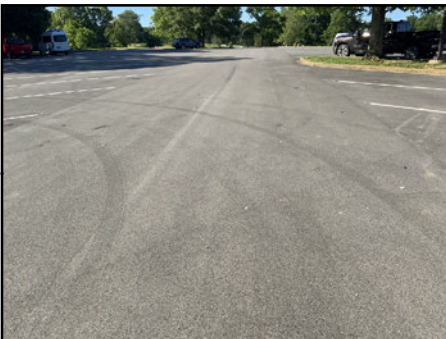
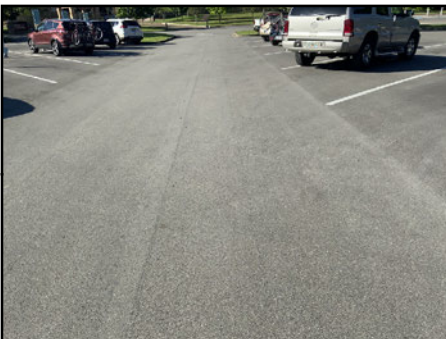
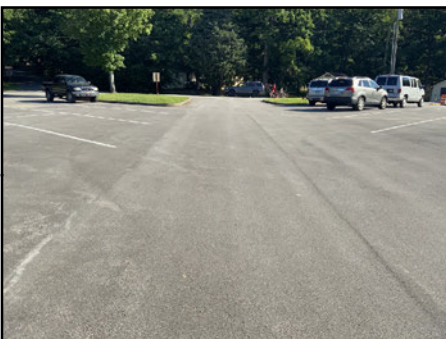
ROUTE 0901B: HOTEL SERVICES PARKING

Inspection Date	FMSS Number	User Access	Surface Type
6/15/2021	50165	PUBLIC	ASPHALT
Area (Sq. Ft.)	Lane Miles (11' Widths)	Curb Reveal (Inches)	Curb Recommendation
5,765	0.099	3	LIGHT REPAIR
Curb Type		Curb & Gutter Type	
CONCRETE		CONCRETE	
Pavement Recommendation		Condition Rating / PCR	
LIGHT 3R TREATMENTS		FAIR / 73

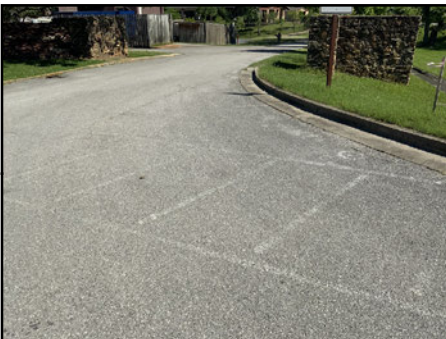
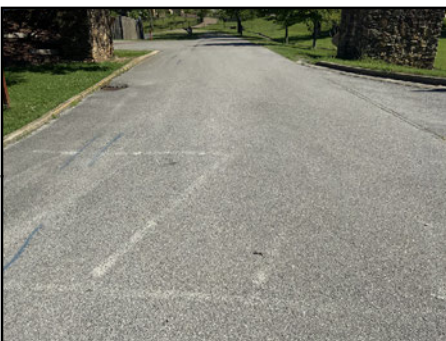
ROUTE 0902A: MAINTENANCE PARKING

Inspection Date	FMSS Number	User Access	Surface Type
6/15/2021	50172	NONPUBLIC	ASPHALT
Area (Sq. Ft.)	Lane Miles (11' Widths)	Curb Reveal (Inches)	Curb Recommendation
45,090	0.776	NOT APPLICABLE	NOT APPLICABLE
Curb Type		Curb & Gutter Type	
NO CURB		NO CURB AND GUTTER	
Pavement Recommendation		Condition Rating / PCR	
HEAVY 3R TREATMENTS		POOR / 53

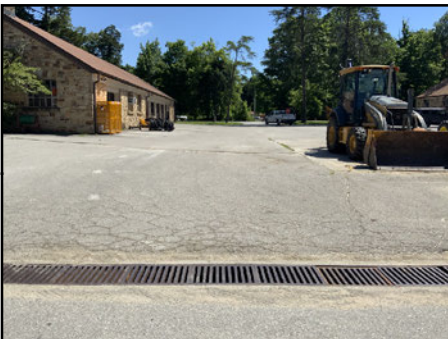
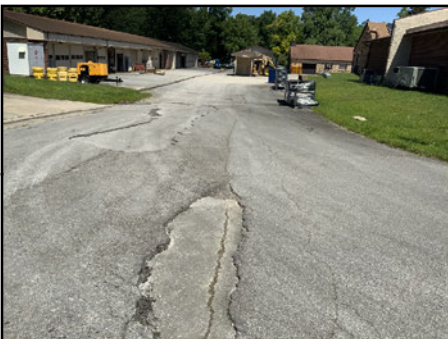
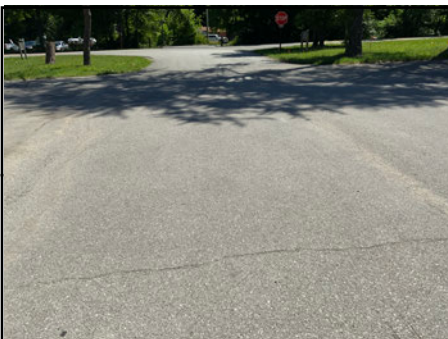
ROUTE 0902B: CONCESSION SERVICE PARKING

Inspection Date	FMSS Number	User Access	Surface Type
6/15/2021	50170	NONPUBLIC	ASPHALT
Area (Sq. Ft.)	Lane Miles (11' Widths)	Curb Reveal (Inches)	Curb Recommendation
16,232	0.279	NOT APPLICABLE	NOT APPLICABLE
Curb Type		Curb & Gutter Type	
NO CURB		NO CURB AND GUTTER	
Pavement Recommendation		Condition Rating / PCR	
PREVENTIVE MAINTENANCE		GOOD / 90

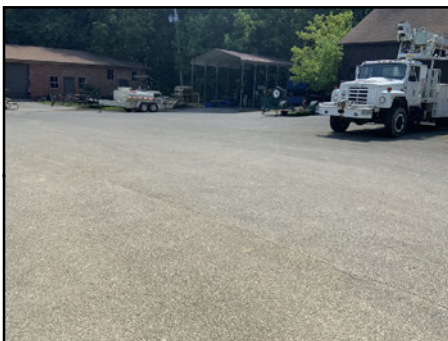
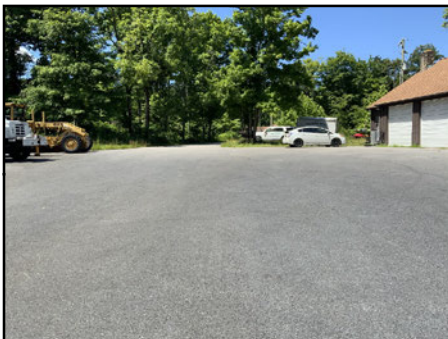
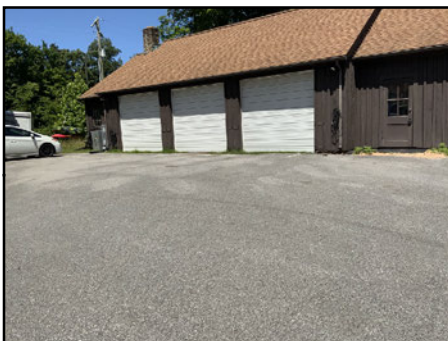
ROUTE 0903ZZ: RANGER TRAINING CENTER PARKING

Inspection Date	FMSS Number	User Access	Surface Type
6/15/2021	50184	PUBLIC	ASPHALT
Area (Sq. Ft.)	Lane Miles (11' Widths)	Condition Rating / PCR	
13,932	0.24	SUMMARY / 85

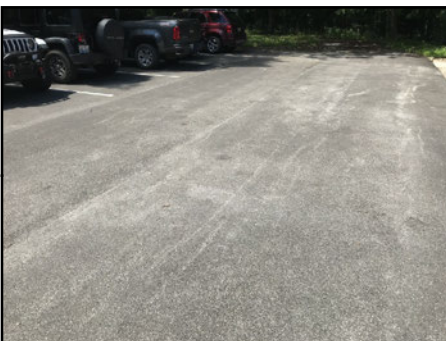
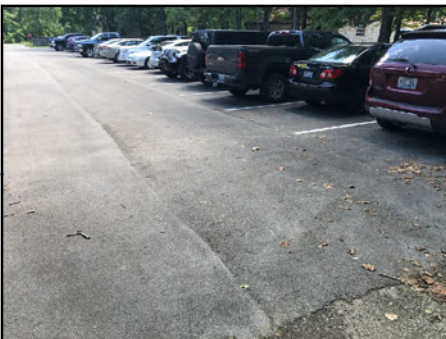
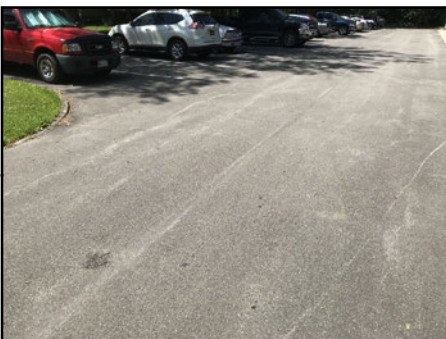
ROUTE 0903BZ: RANGER TRAINING CENTER B PARKING

Inspection Date	FMSS Number	User Access	Surface Type
6/15/2021	50184	PUBLIC	CONCRETE
Area (Sq. Ft.)	Lane Miles (11' Widths)	Curb Reveal (Inches)	Curb Recommendation
3,950	0.068	5	MODERATE REPAIR
Curb Type		Curb & Gutter Type	
CONCRETE		NO CURB AND GUTTER	
Pavement Recommendation		Condition Rating / PCR	
LIGHT 3R TREATMENTS		FAIR / 73

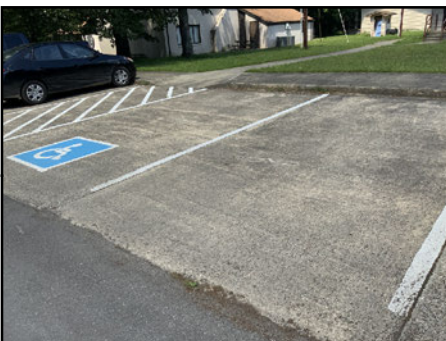
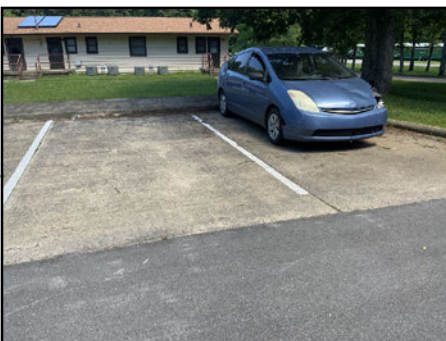
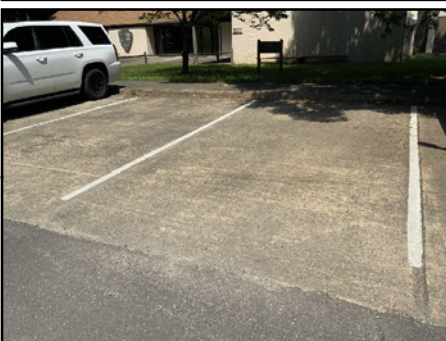
ROUTE 0904A: HOUCHINS FERRY ROAD SOUTH PARKING

Inspection Date	FMSS Number	User Access	Surface Type
6/14/2021	50167	PUBLIC	ASPHALT
Area (Sq. Ft.)	Lane Miles (11' Widths)	Curb Reveal (Inches)	Curb Recommendation
1,606	0.028	4	LIGHT REPAIR
Curb Type		Curb & Gutter Type	
CONCRETE		NO CURB AND GUTTER	
Pavement Recommendation		Condition Rating / PCR	
PREVENTIVE MAINTENANCE		GOOD / 90

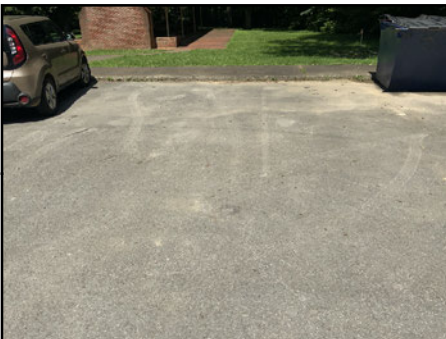
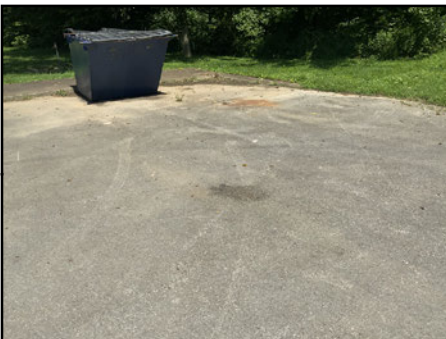
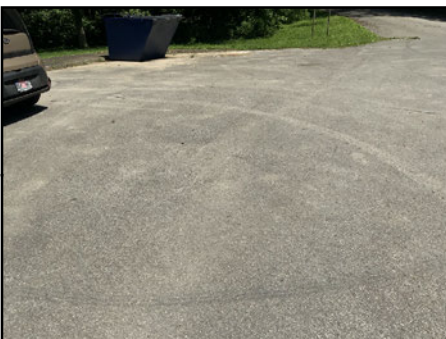
ROUTE 0904B: HOUCHINS FERRY ROAD SOUTH BOAT TRAILER PARKING

Inspection Date	FMSS Number	User Access	Surface Type
6/14/2021	86327	PUBLIC	ASPHALT
Area (Sq. Ft.)	Lane Miles (11' Widths)	Curb Reveal (Inches)	Curb Recommendation
3,172	0.055	4	LIGHT REPAIR
Curb Type		Curb & Gutter Type	
CONCRETE		NO CURB AND GUTTER	
Pavement Recommendation		Condition Rating / PCR	
LIGHT 3R TREATMENTS		FAIR / 73

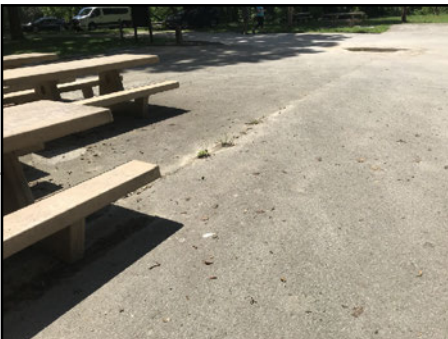
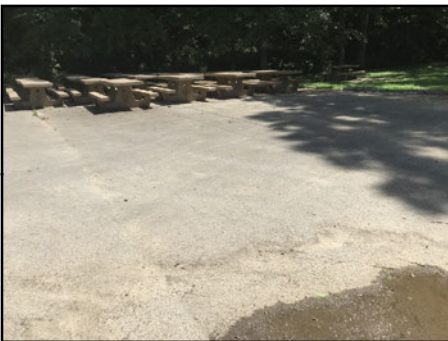
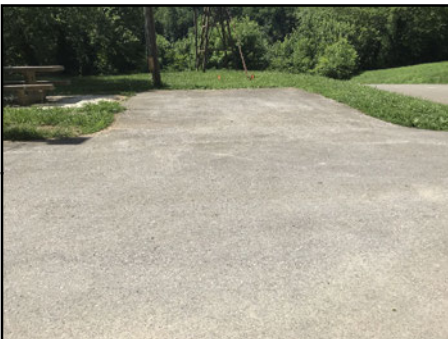
ROUTE 0905: RECYCLING AREA PARKING

Inspection Date	FMSS Number	User Access	Surface Type
6/15/2021	50185	NONPUBLIC	ASPHALT
Area (Sq. Ft.)	Lane Miles (11' Widths)	Curb Reveal (Inches)	Curb Recommendation
8,324	0.143	NOT APPLICABLE	NOT APPLICABLE
Curb Type		Curb & Gutter Type	
NO CURB		NO CURB AND GUTTER	
Pavement Recommendation		Condition Rating / PCR	
PREVENTIVE MAINTENANCE		GOOD / 90

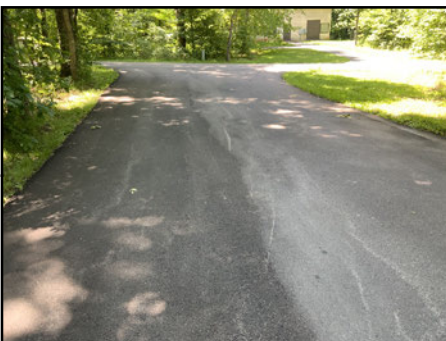
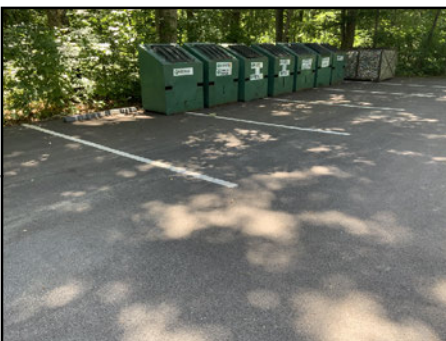
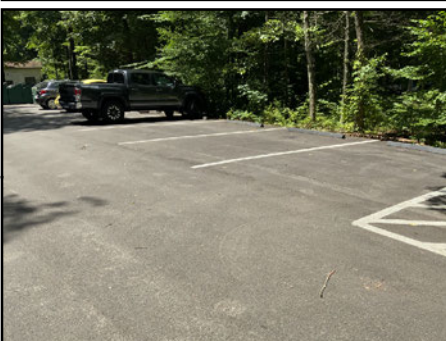
ROUTE 0906A: SUNSET LODGE A PARKING

Inspection Date	FMSS Number	User Access	Surface Type
6/15/2021	50175	PUBLIC	ASPHALT
Area (Sq. Ft.)	Lane Miles (11' Widths)	Curb Reveal (Inches)	Curb Recommendation
2,380	0.041	2	LIGHT REPAIR
Curb Type		Curb & Gutter Type	
CONCRETE		NO CURB AND GUTTER	
Pavement Recommendation		Condition Rating / PCR	
PREVENTIVE MAINTENANCE		GOOD / 90
