MACA Cycle 6

Final Report

Road Inventory and Condition Assessment of Paved Routes Mammoth Cave National Park

Report Date: May 2022

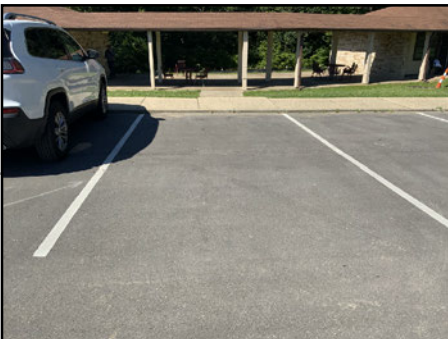
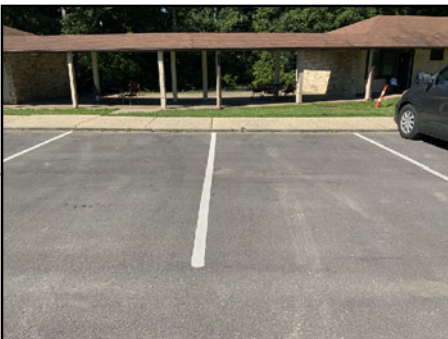
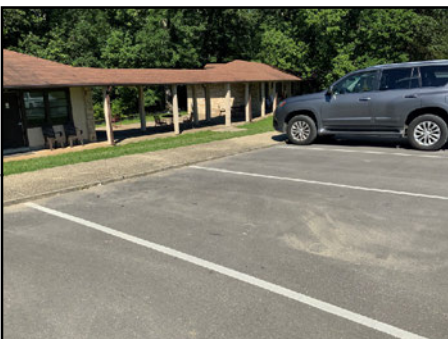
ROUTE 0906B: SUNSET LODGE B PARKING

Inspection Date	FMSS Number	User Access	Surface Type
6/15/2021	50176	PUBLIC	ASPHALT
Area (Sq. Ft.)	Lane Miles (11' Widths)	Curb Reveal (Inches)	Curb Recommendation
2,626	0.045	3	MODERATE REPAIR
Curb Type		Curb & Gutter Type	
CONCRETE		NO CURB AND GUTTER	
Pavement Recommendation		Condition Rating / PCR	
PREVENTIVE MAINTENANCE		GOOD / 90

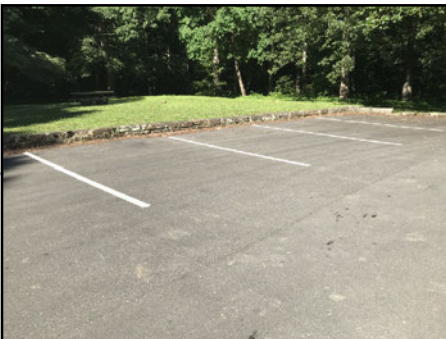
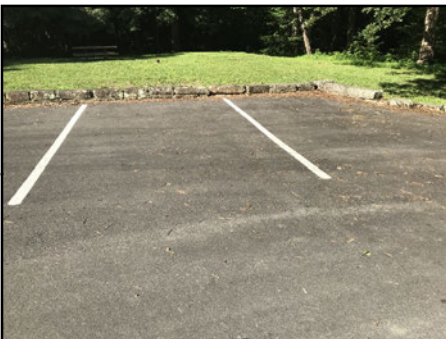
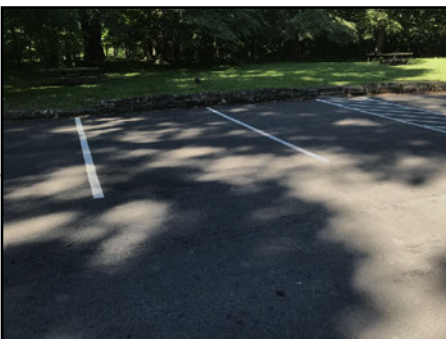
ROUTE 0907C: PICNIC SHELTER C PARKING

Inspection Date	FMSS Number	User Access	Surface Type
6/15/2021	86328	PUBLIC	ASPHALT
Area (Sq. Ft.)	Lane Miles (11' Widths)	Curb Reveal (Inches)	Curb Recommendation
1,682	0.029	1	MODERATE REPAIR
Curb Type		Curb & Gutter Type	
CONCRETE		NO CURB AND GUTTER	
Pavement Recommendation		Condition Rating / PCR	
DO NOTHING		EXCELLENT / 97

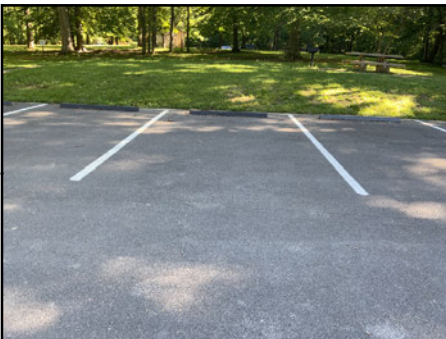
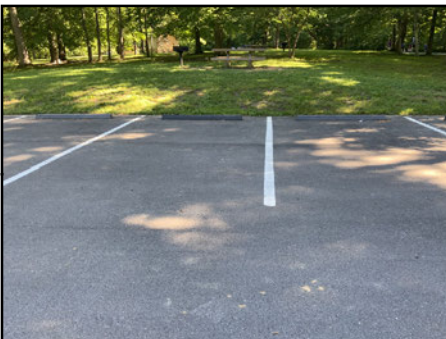
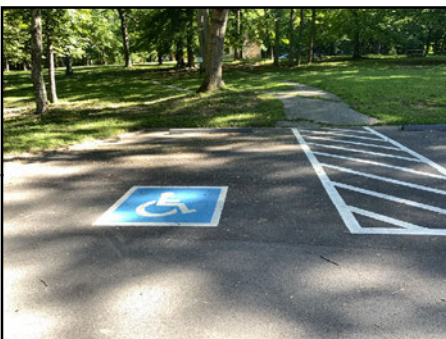
ROUTE 0908: MAMMOTH CAVE HOTEL PARKING

Inspection Date	FMSS Number	User Access	Surface Type
6/15/2021	50164	PUBLIC	ASPHALT
Area (Sq. Ft.)	Lane Miles (11' Widths)	Curb Reveal (Inches)	Curb Recommendation
123,003	2.118	6	MODERATE REPAIR
Curb Type		Curb & Gutter Type	
CONCRETE		CONCRETE	
Pavement Recommendation		Condition Rating / PCR	
LIGHT 3R TREATMENTS		FAIR / 73

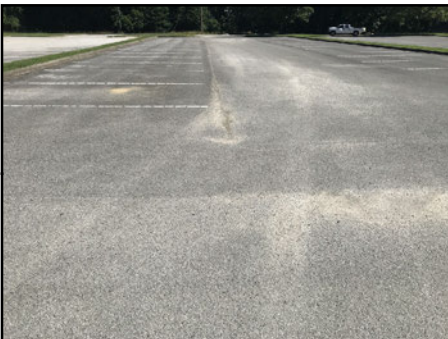
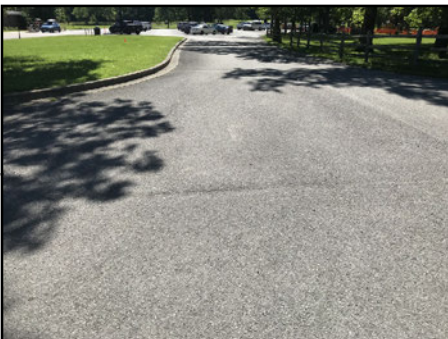
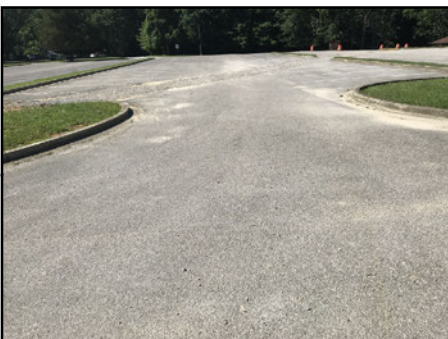
ROUTE 0909: SLOANS CROSSING PICNIC/POND PARKING

Inspection Date	FMSS Number	User Access	Surface Type
6/15/2021	50191	PUBLIC	ASPHALT
Area (Sq. Ft.)	Lane Miles (11' Widths)	Curb Reveal (Inches)	Curb Recommendation
9,355	0.161	NOT APPLICABLE	DO NOTHING
Curb Type		Curb & Gutter Type	
NO CURB		CONCRETE	
Pavement Recommendation		Condition Rating / PCR	
DO NOTHING		EXCELLENT / 97

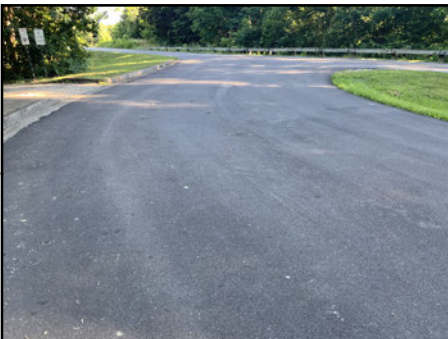
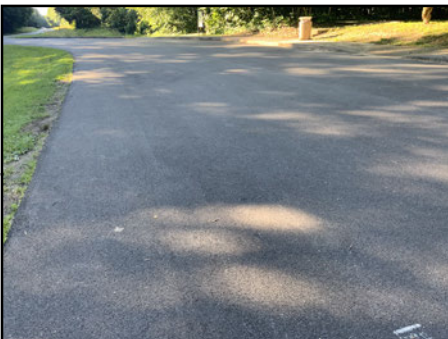
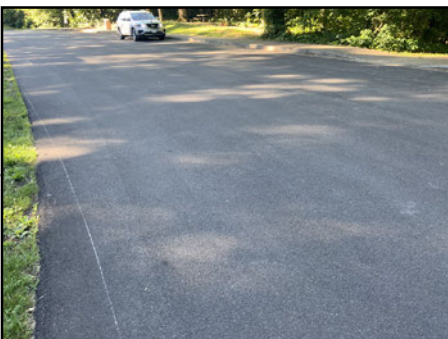
ROUTE 0911: PARK CITY ENTRANCE SIGN PARKING

Inspection Date	FMSS Number	User Access	Surface Type
6/15/2021	50179	PUBLIC	ASPHALT
Area (Sq. Ft.)	Lane Miles (11' Widths)	Curb Reveal (Inches)	Curb Recommendation
9,754	0.168	3	LIGHT REPAIR
Curb Type		Curb & Gutter Type	
CONCRETE		NO CURB AND GUTTER	
Pavement Recommendation		Condition Rating / PCR	
DO NOTHING		EXCELLENT / 97

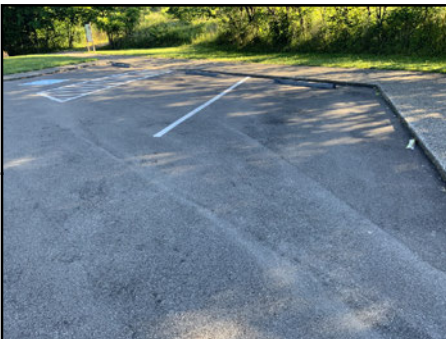
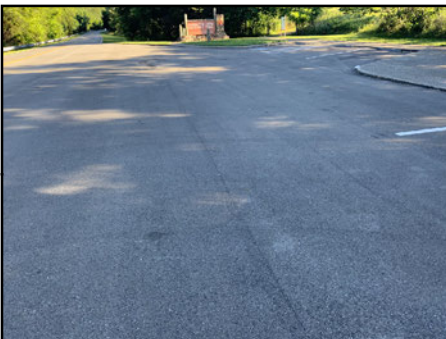
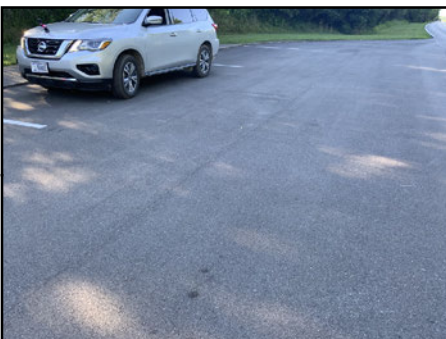
ROUTE 0912: TURNHOLE BEND NATURE TRAIL PARKING

Inspection Date	FMSS Number	User Access	Surface Type
6/14/2021	50193	PUBLIC	ASPHALT
Area (Sq. Ft.)	Lane Miles (11' Widths)	Curb Reveal (Inches)	Curb Recommendation
5,993	0.103	4	LIGHT REPAIR
Curb Type		Curb & Gutter Type	
CONCRETE		NO CURB AND GUTTER	
Pavement Recommendation		Condition Rating / PCR	
PREVENTIVE MAINTENANCE		GOOD / 90

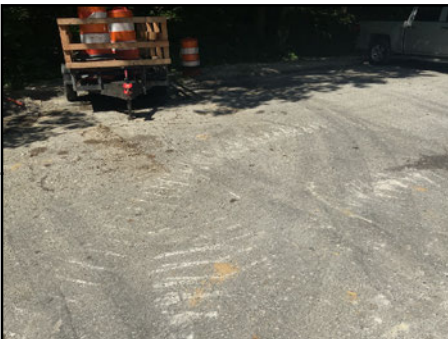
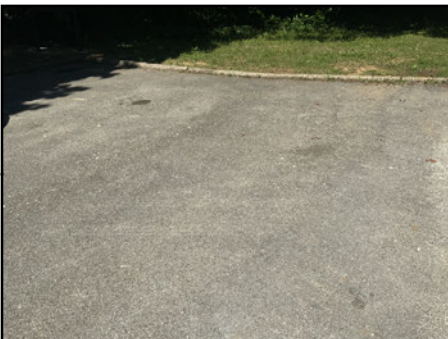
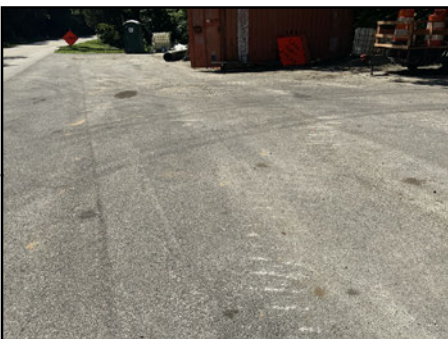
ROUTE 0913: SAND CAVE PARKING

Inspection Date	FMSS Number	User Access	Surface Type
6/15/2021	50189	PUBLIC	ASPHALT
Area (Sq. Ft.)	Lane Miles (11' Widths)	Curb Reveal (Inches)	Curb Recommendation
6,319	0.109	4	LIGHT REPAIR
Curb Type		Curb & Gutter Type	
CONCRETE		NO CURB AND GUTTER	
Pavement Recommendation		Condition Rating / PCR	
DO NOTHING		EXCELLENT / 97

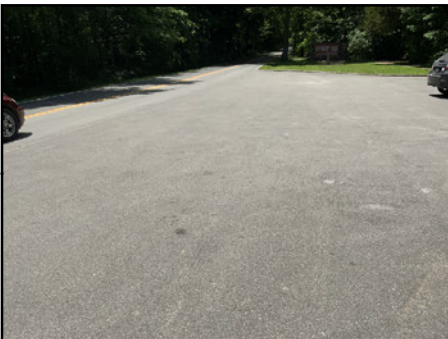
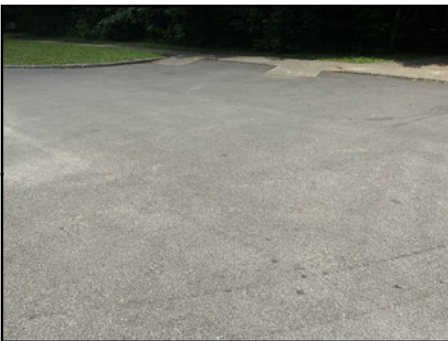
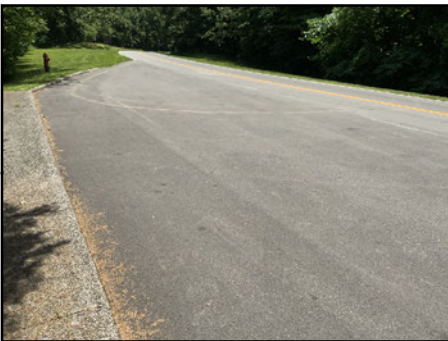
ROUTE 0915: GREEN RIVER PARKING

Inspection Date	FMSS Number	User Access	Surface Type
6/15/2021	50163	PUBLIC	ASPHALT
Area (Sq. Ft.)	Lane Miles (11' Widths)	Curb Reveal (Inches)	Curb Recommendation
21,033	0.362	6	DO NOTHING
Curb Type		Curb & Gutter Type	
CONCRETE AND STONE		NO CURB AND GUTTER	
Pavement Recommendation		Condition Rating / PCR	
LIGHT 3R TREATMENTS		FAIR / 73

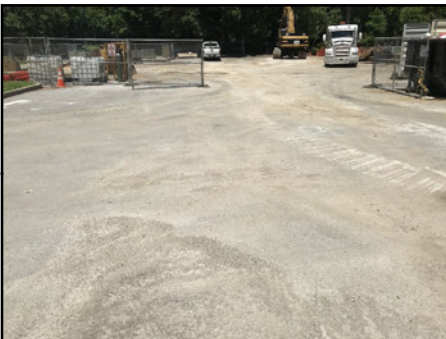
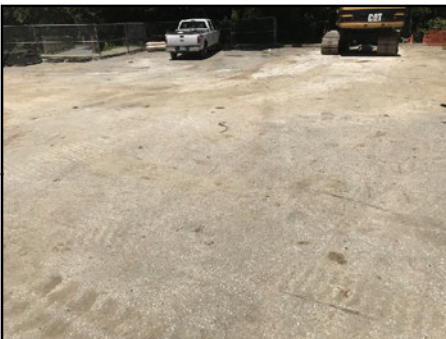
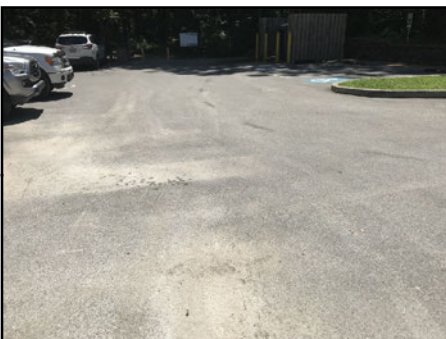
ROUTE 0916: LINCOLN TRAILHEAD PARKING

Inspection Date	FMSS Number	User Access	Surface Type
6/14/2021	50168	PUBLIC	ASPHALT
Area (Sq. Ft.)	Lane Miles (11' Widths)	Curb Reveal (Inches)	Curb Recommendation
12,943	0.223	NOT APPLICABLE	NOT APPLICABLE
Curb Type		Curb & Gutter Type	
NO CURB		NO CURB AND GUTTER	
Pavement Recommendation		Condition Rating / PCR	
HEAVY 3R TREATMENTS		POOR / 53

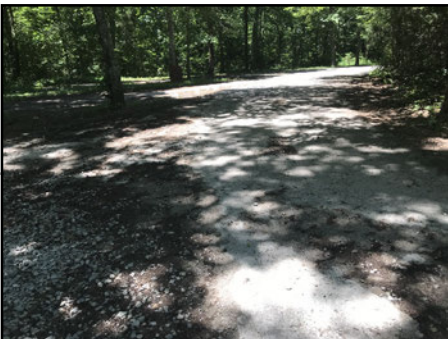
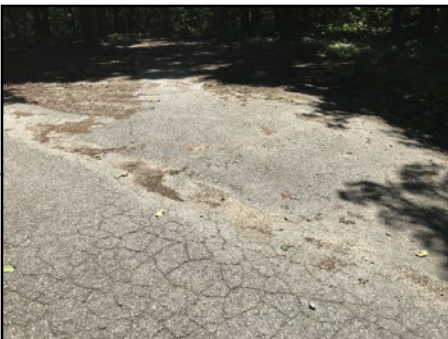
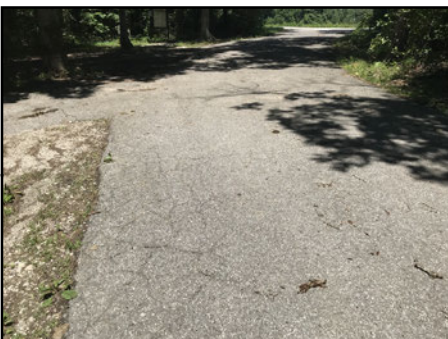
ROUTE 0919: CEDAR SINK TRAILHEAD PARKING

Inspection Date	FMSS Number	User Access	Surface Type
6/14/2021	50157	PUBLIC	ASPHALT
Area (Sq. Ft.)	Lane Miles (11' Widths)	Curb Reveal (Inches)	Curb Recommendation
5,796	0.1	6	DO NOTHING
Curb Type		Curb & Gutter Type	
CONCRETE		NO CURB AND GUTTER	
Pavement Recommendation		Condition Rating / PCR	
DO NOTHING		EXCELLENT / 97

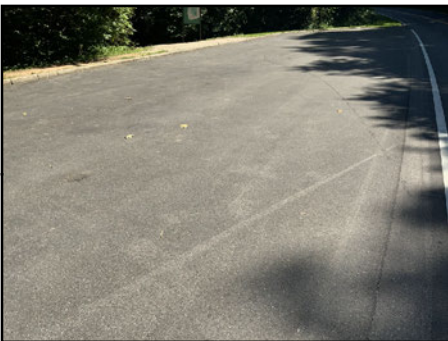
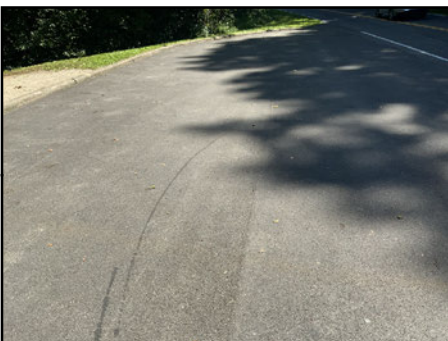
ROUTE 0920: WOODLAND COTTAGES PARKING

Inspection Date	FMSS Number	User Access	Surface Type
6/15/2021	50194	PUBLIC	ASPHALT
Area (Sq. Ft.)	Lane Miles (11' Widths)	Curb Reveal (Inches)	Curb Recommendation
9,711	0.167	NOT APPLICABLE	NOT APPLICABLE
Curb Type		Curb & Gutter Type	
NO CURB		NO CURB AND GUTTER	
Pavement Recommendation		Condition Rating / PCR	
PREVENTIVE MAINTENANCE		GOOD / 90

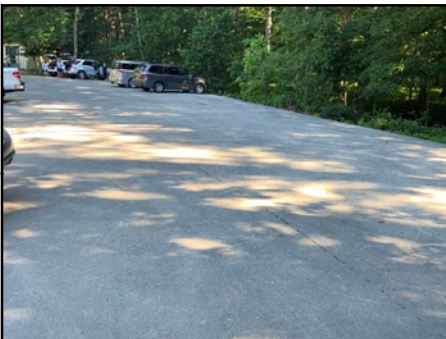
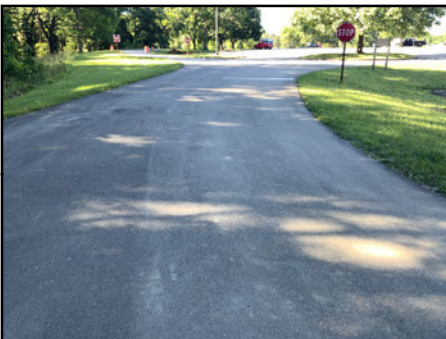
ROUTE 0922: SERVICES PARKING (POST OFFICE/DUMP STATION/GAS)

Inspection Date	FMSS Number	User Access	Surface Type
6/15/2021	50160	PUBLIC	ASPHALT
Area (Sq. Ft.)	Lane Miles (11' Widths)	Curb Reveal (Inches)	Curb Recommendation
45,911	0.79	4	LIGHT REPAIR
Curb Type		Curb & Gutter Type	
CONCRETE		NO CURB AND GUTTER	
Pavement Recommendation		Condition Rating / PCR	
PREVENTIVE MAINTENANCE		GOOD / 90

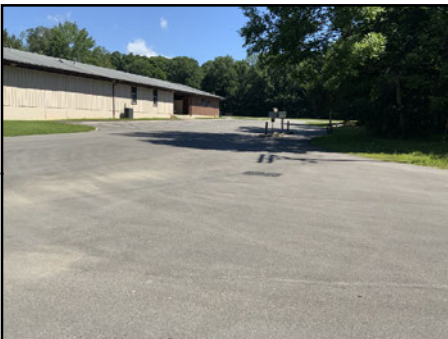
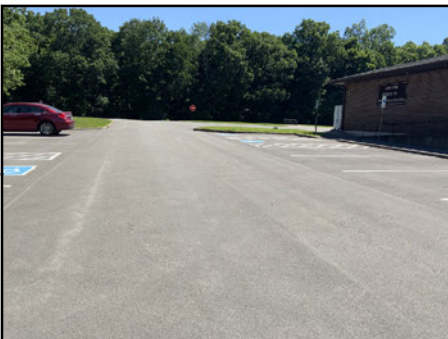
ROUTE 0923: ELEVATOR PARKING

Inspection Date	FMSS Number	User Access	Surface Type
6/15/2021	50162	NONPUBLIC	ASPHALT
Area (Sq. Ft.)	Lane Miles (11' Widths)	Curb Reveal (Inches)	Curb Recommendation
4,648	0.08	NOT APPLICABLE	NOT APPLICABLE
Curb Type		Curb & Gutter Type	
NO CURB		NO CURB AND GUTTER	
Pavement Recommendation		Condition Rating / PCR	
PREVENTIVE MAINTENANCE		GOOD / 90

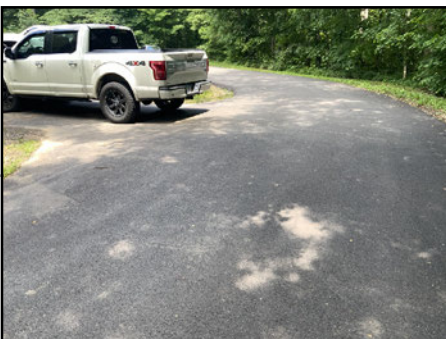
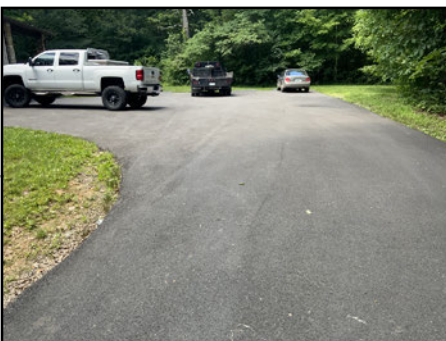
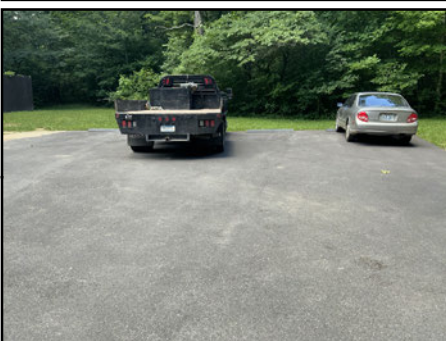
ROUTE 0931ZZ: PICNIC GROUNDS PARKING

Inspection Date	FMSS Number	User Access	Surface Type
6/15/2021	50180	PUBLIC	ASPHALT
Area (Sq. Ft.)	Lane Miles (11' Widths)	Condition Rating / PCR	
10,870	0.187	SUMMARY / 97

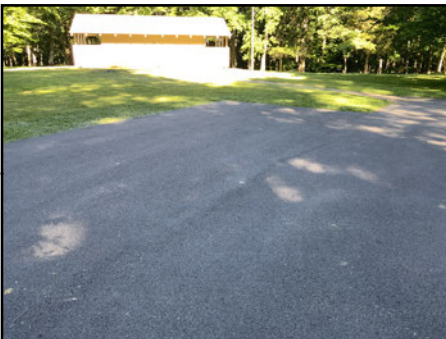
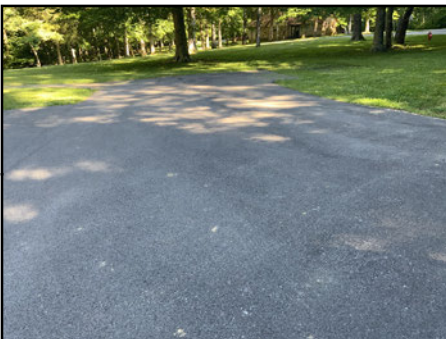
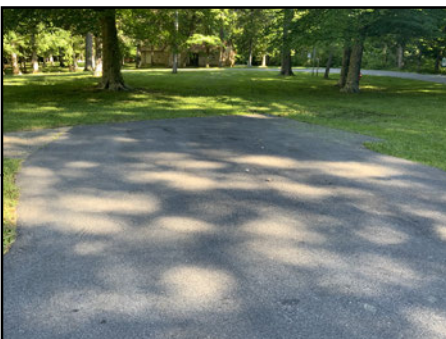
ROUTE 0931CZ: PICNIC GROUNDS C PARKING

Inspection Date	FMSS Number	User Access	Surface Type
6/15/2021	50180	PUBLIC	ASPHALT
Area (Sq. Ft.)	Lane Miles (11' Widths)	Curb Reveal (Inches)	Curb Recommendation
3,441	0.059	NOT APPLICABLE	NOT APPLICABLE
Curb Type		Curb & Gutter Type	
NO CURB		NO CURB AND GUTTER	
Pavement Recommendation		Condition Rating / PCR	
DO NOTHING		EXCELLENT / 97

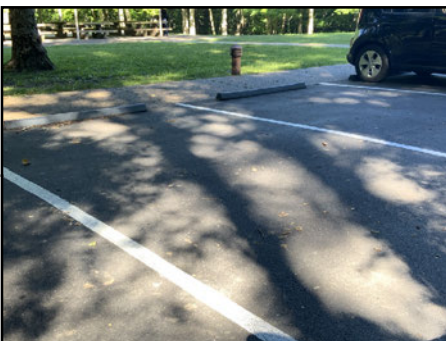
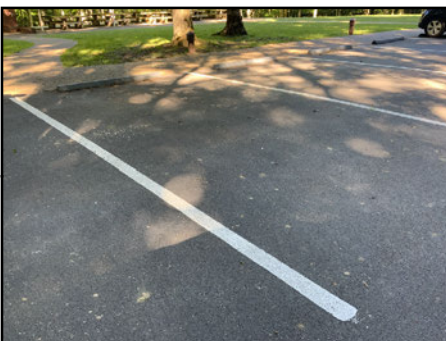
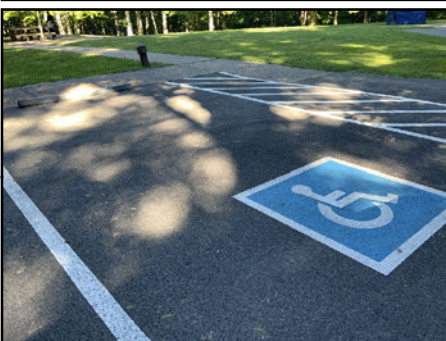
ROUTE 0931DZ: PICNIC GROUNDS D PARKING

Inspection Date	FMSS Number	User Access	Surface Type
6/15/2021	50180	PUBLIC	ASPHALT
Area (Sq. Ft.)	Lane Miles (11' Widths)	Curb Reveal (Inches)	Curb Recommendation
1,476	0.025	NOT APPLICABLE	NOT APPLICABLE
Curb Type		Curb & Gutter Type	
NO CURB		NO CURB AND GUTTER	
Pavement Recommendation		Condition Rating / PCR	
DO NOTHING		EXCELLENT / 97

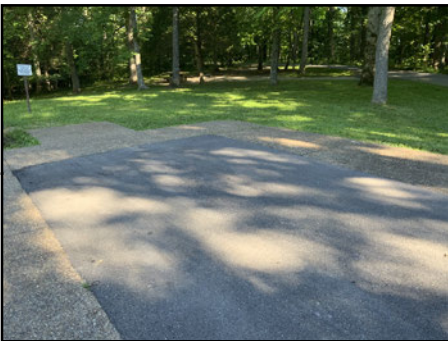
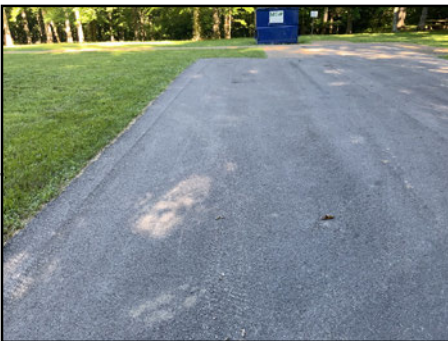
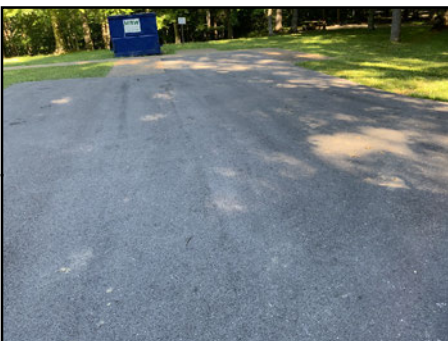
ROUTE 0931EZ: PICNIC GROUNDS E PARKING

Inspection Date	FMSS Number	User Access	Surface Type
6/15/2021	50180	PUBLIC	ASPHALT
Area (Sq. Ft.)	Lane Miles (11' Widths)	Curb Reveal (Inches)	Curb Recommendation
2,269	0.039	NOT APPLICABLE	NOT APPLICABLE
Curb Type		Curb & Gutter Type	
NO CURB		NO CURB AND GUTTER	
Pavement Recommendation		Condition Rating / PCR	
DO NOTHING		EXCELLENT / 97

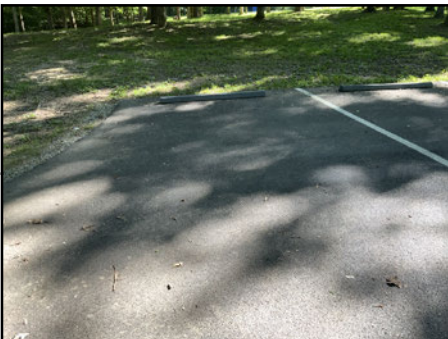
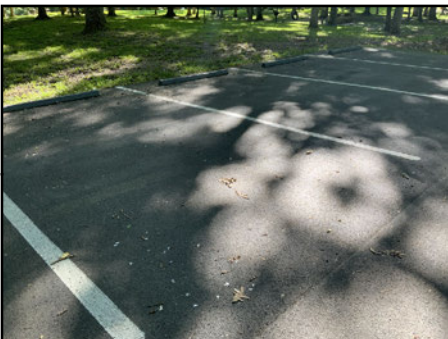
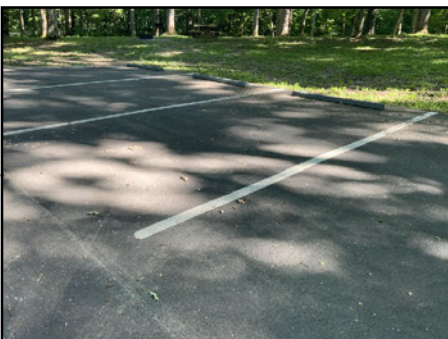
ROUTE 0931FZ: PICNIC GROUNDS F PARKING

Inspection Date	FMSS Number	User Access	Surface Type
6/15/2021	50180	PUBLIC	ASPHALT
Area (Sq. Ft.)	Lane Miles (11' Widths)	Curb Reveal (Inches)	Curb Recommendation
1,499	0.026	NOT APPLICABLE	NOT APPLICABLE
Curb Type		Curb & Gutter Type	
NO CURB		NO CURB AND GUTTER	
Pavement Recommendation		Condition Rating / PCR	
DO NOTHING		EXCELLENT / 97

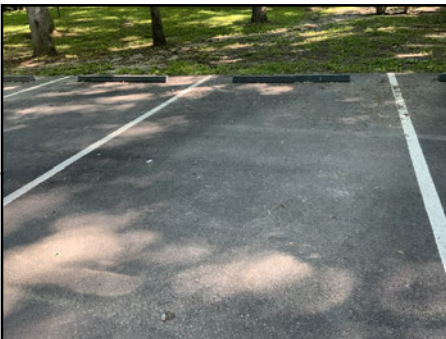
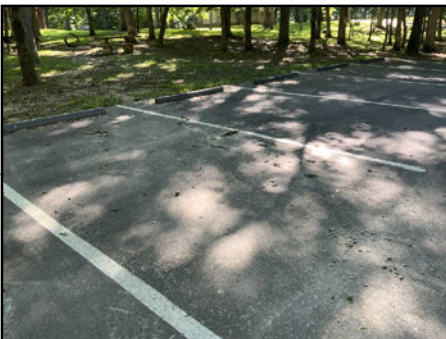
ROUTE 0946: ADMINISTRATION AREA EMPLOYEE PARKING

Inspection Date	FMSS Number	User Access	Surface Type
6/15/2021	61219	NONPUBLIC	ASPHALT
Area (Sq. Ft.)	Lane Miles (11' Widths)	Curb Reveal (Inches)	Curb Recommendation
16,220	0.279	NOT APPLICABLE	NOT APPLICABLE
Curb Type		Curb & Gutter Type	
NO CURB		NO CURB AND GUTTER	
Pavement Recommendation		Condition Rating / PCR	
LIGHT 3R TREATMENTS		FAIR / 73

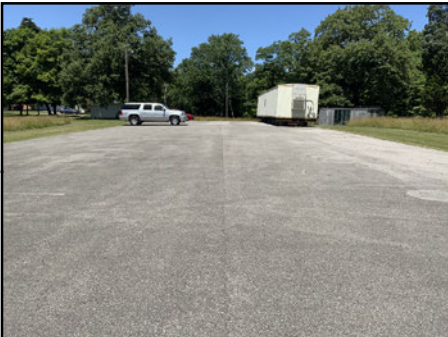
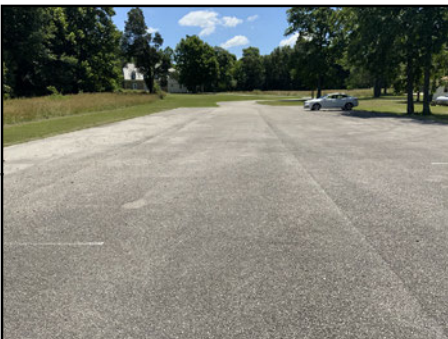
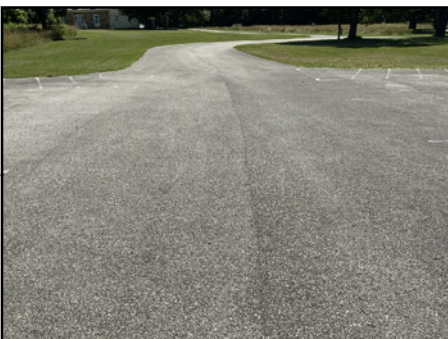
ROUTE 0947: S & RM #1 PARKING

Inspection Date	FMSS Number	User Access	Surface Type
6/15/2021	50205	NONPUBLIC	ASPHALT
Area (Sq. Ft.)	Lane Miles (11' Widths)	Curb Reveal (Inches)	Curb Recommendation
748	0.013	NOT APPLICABLE	NOT APPLICABLE
Curb Type		Curb & Gutter Type	
NO CURB		NO CURB AND GUTTER	
Pavement Recommendation		Condition Rating / PCR	
DO NOTHING		EXCELLENT / 97

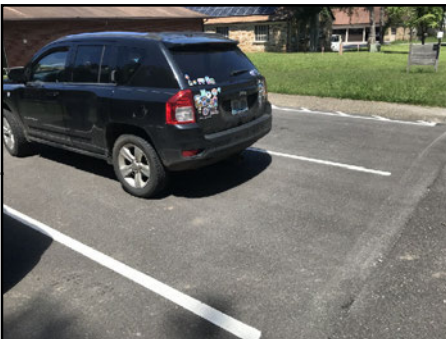
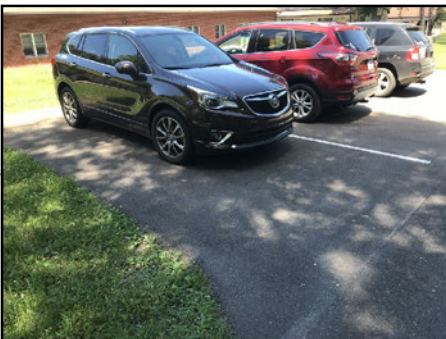
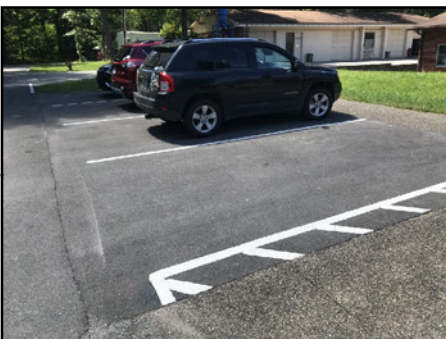
ROUTE 0948: S & RM EMPLOYEE #2 PARKING

Inspection Date	FMSS Number	User Access	Surface Type
6/15/2021	83608	NONPUBLIC	ASPHALT
Area (Sq. Ft.)	Lane Miles (11' Widths)	Curb Reveal (Inches)	Curb Recommendation
4,045	0.07	NOT APPLICABLE	NOT APPLICABLE
Curb Type		Curb & Gutter Type	
NO CURB		NO CURB AND GUTTER	
Pavement Recommendation		Condition Rating / PCR	
PREVENTIVE MAINTENANCE		GOOD / 90

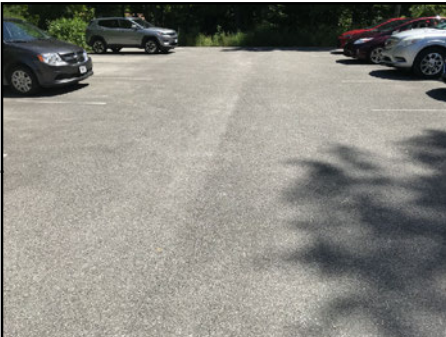
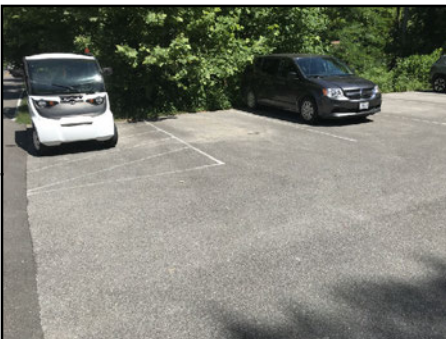
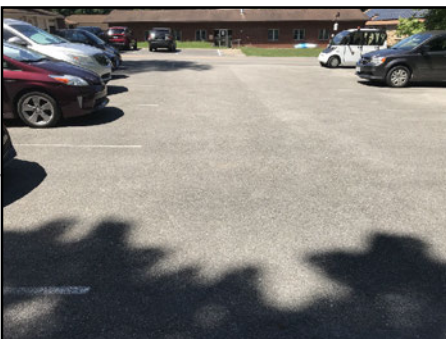
ROUTE 0949: HQ CAMPGROUND EMPLOYEE PARKING

Inspection Date	FMSS Number	User Access	Surface Type
6/15/2021	86331	NONPUBLIC	ASPHALT
Area (Sq. Ft.)	Lane Miles (11' Widths)	Curb Reveal (Inches)	Curb Recommendation
4,037	0.07	NOT APPLICABLE	NOT APPLICABLE
Curb Type		Curb & Gutter Type	
NO CURB		NO CURB AND GUTTER	
Pavement Recommendation		Condition Rating / PCR	
DO NOTHING		EXCELLENT / 97

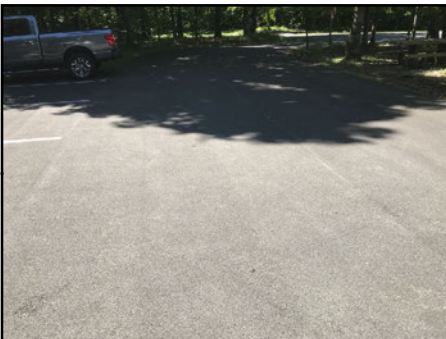
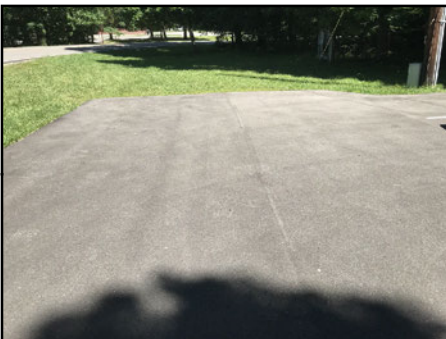
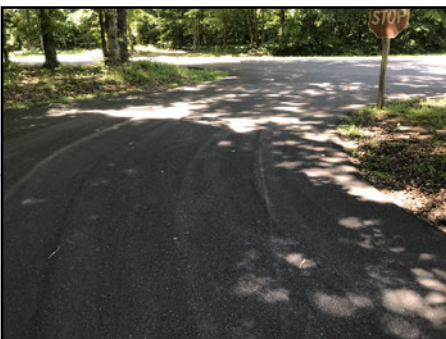
ROUTE 0951: LOCUST GROVE BIKE TRAIL PARKING

Inspection Date	FMSS Number	User Access	Surface Type
6/14/2021	113201	PUBLIC	ASPHALT
Area (Sq. Ft.)	Lane Miles (11' Widths)	Curb Reveal (Inches)	Curb Recommendation
4,554	0.078	NOT APPLICABLE	NOT APPLICABLE
Curb Type		Curb & Gutter Type	
NO CURB		NO CURB AND GUTTER	
Pavement Recommendation		Condition Rating / PCR	
DO NOTHING		EXCELLENT / 97

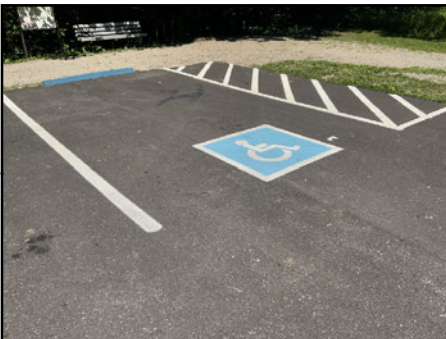
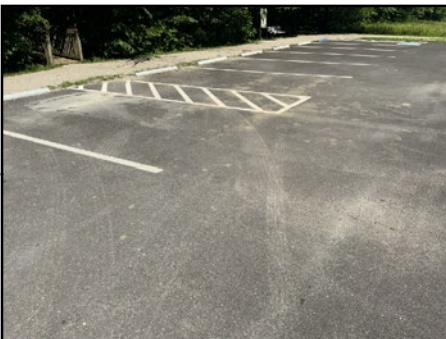
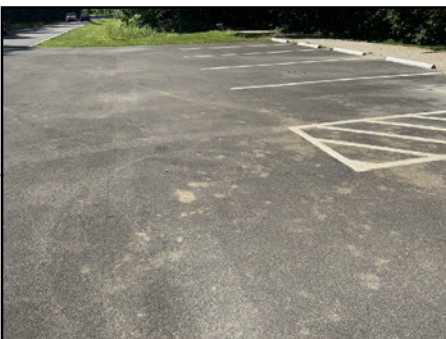
ROUTE 0955: SEASONAL QUARTERS PARKING

Inspection Date	FMSS Number	User Access	Surface Type
6/15/2021	231791	PUBLIC	CONCRETE
Area (Sq. Ft.)	Lane Miles (11' Widths)	Curb Reveal (Inches)	Curb Recommendation
6,502	0.112	4	MODERATE REPAIR
Curb Type		Curb & Gutter Type	
CONCRETE		NO CURB AND GUTTER	
Pavement Recommendation		Condition Rating / PCR	
LIGHT 3R TREATMENTS		FAIR / 73

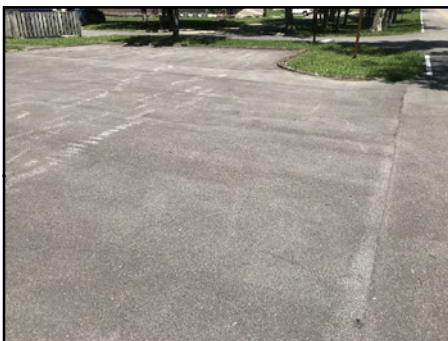
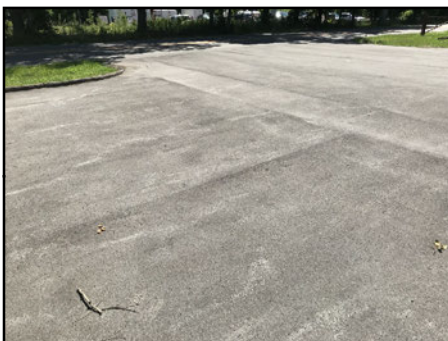
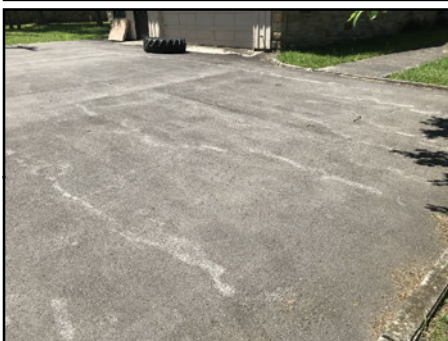
ROUTE 0957: HERITAGE TRAIL PARKING

Inspection Date	FMSS Number	User Access	Surface Type
6/15/2021	225462	PUBLIC	ASPHALT
Area (Sq. Ft.)	Lane Miles (11' Widths)	Curb Reveal (Inches)	Curb Recommendation
821	0.014	9	DO NOTHING
Curb Type		Curb & Gutter Type	
STONE		NO CURB AND GUTTER	
Pavement Recommendation		Condition Rating / PCR	
PREVENTIVE MAINTENANCE		GOOD / 90
