MANA Cycle 6

Final Report

Road Inventory and Condition Assessment of Paved Routes Manassas National Battlefield Park

Report Date: January 2019

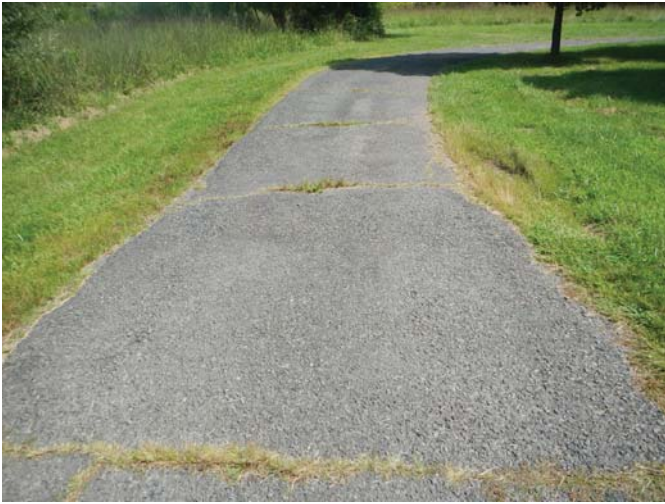
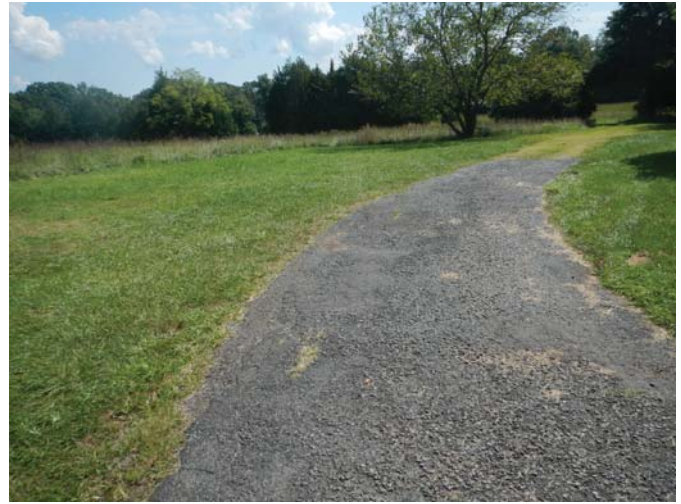
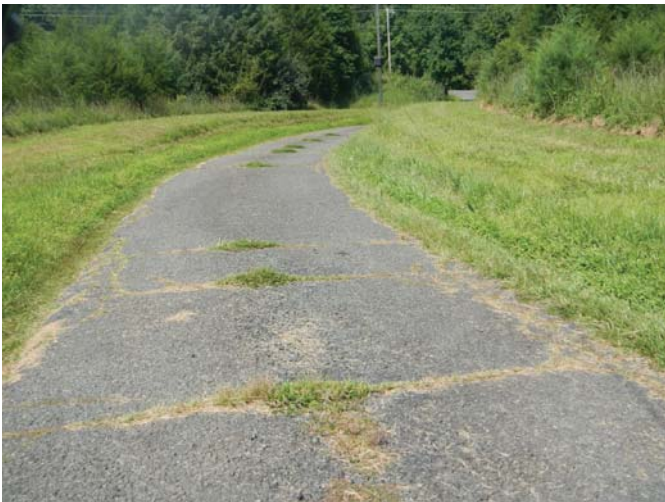
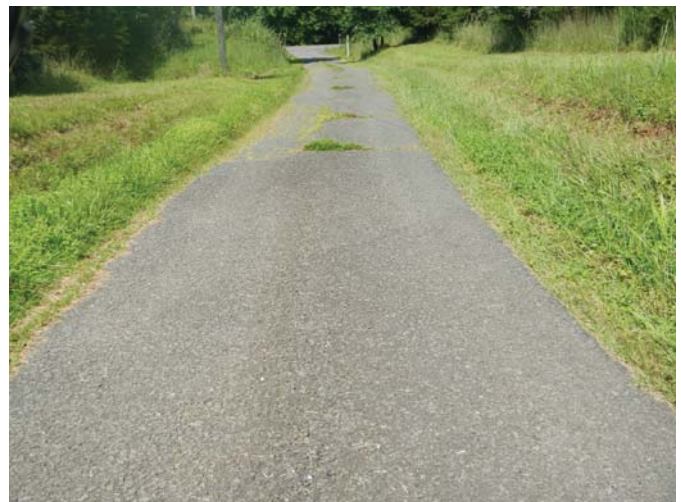
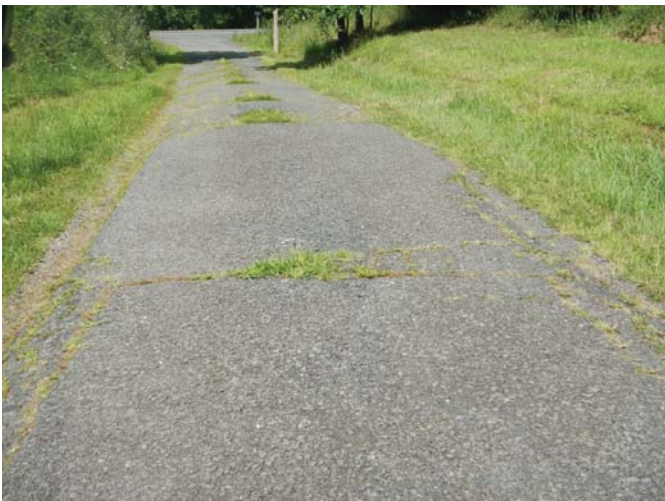
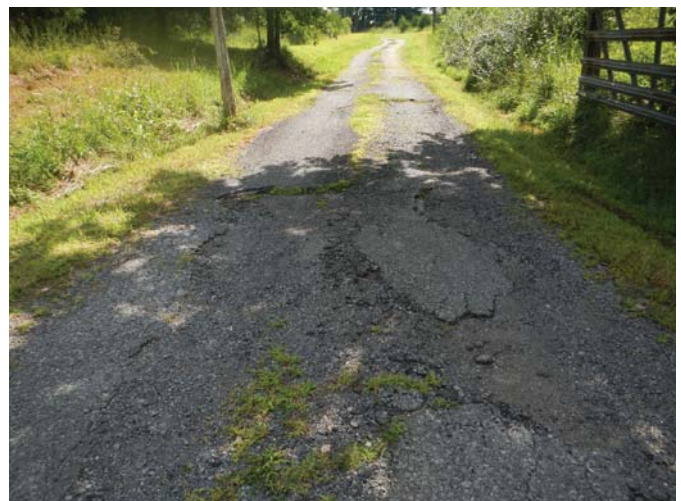
ROUTE 0200: QUARTERS 9 ACCESS ROAD

Route Condition Legend – Pavement Condition Rating (PCR)						
Poor (0 - 60)	Fair (61- 84)	Good (85 - 94)	Excellent (95 - 100)	Not Rated		
See Appendix for definitions and formulas						
Inspection Date:	8/10/2017	Beginning Section MP	0.00			
Paved Length (Miles):	0.11	Section Length (MI)	0.11			
Surface Type:	ASPHALT	Route Summary				
Roadway Condition Information						
Pavement Condition Rating (PCR)	53	53				
Surface Condition Rating (SCR)	53	53				
Roughness Condition Index (RCI)	N/A	N/A				
Distress Index Values						
Structural Crack Index	N/A	N/A				
Alligator Crack Index	53	53				
Longitudinal Crack Index	53	53				
Transverse Cracking Index	53	53				
Patching Index	53	53				
Rutting Index	53	53				
International Roughness Index (IRI)	N/A	N/A				
Lane & Width Information						
Number of Lanes	1	1				
Paved Width (ft)	9	9				
Lane Width (ft)	9	9

Condition photos are shown only for manually rated roads. Use the PathView program to see images of DCV rated roads.

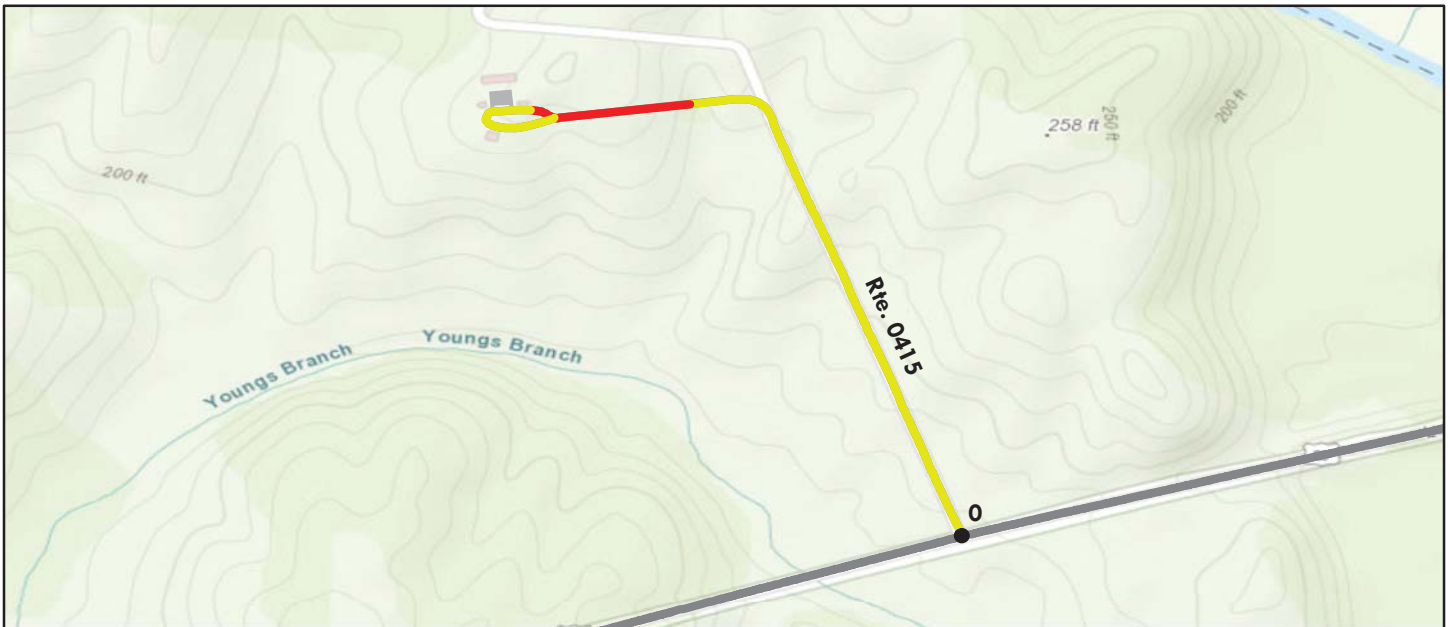
ROUTE 0415: VISITOR PROTECTION ACCESS ROAD

Inspection Date: 3/27/2018	Beginning Section MP	0				
Paved Length (Miles): 0.57	Section Length (MI)	0.57				
Surface Type: ASPHALT	Route Summary					
Roadway Condition Information						
Pavement Condition Rating (PCR)	69	69				
Surface Condition Rating (SCR)	69	69				
Roughness Condition Index (RCI)	N/A	N/A				
Distress Index Values						
Structural Crack Index	93	93				
Alligator Crack Index	100	100				
Longitudinal Crack Index	93	93				
Transverse Cracking Index	69	69				
Patching Index	100	100				
Rutting Index	97	97				
International Roughness Index (IRI)	N/A	N/A				
Lane & Width Information						
Number of Lanes	1	1				
Paved Width (ft)	10.9	10.9				
Lane Width (ft)	10.9	10.9
