# MANZ Cycle 6

## Final Report

### Road Inventory and Condition Assessment of Paved Routes Manzanar National Historic Site

**Report Date: August 2015**

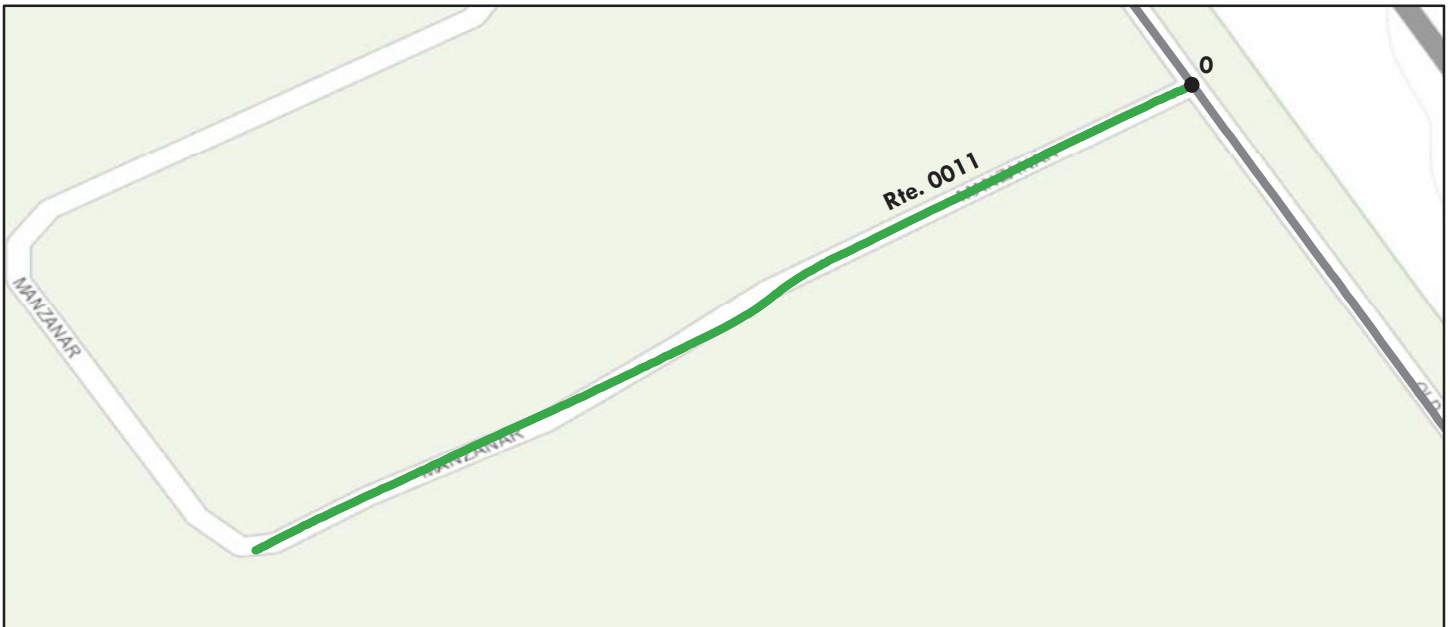
## ROUTE 0011: HISTORIC ENTRANCE ROAD

Route Condition Legend – Pavement Condition Rating (PCR)						
Poor (0 - 60)	Fair (61- 84)	Good (85 - 94)	Excellent (95 - 100)	Not Rated		
See Appendix for definitions and formulas						
<b>Inspection Date:</b> 3/8/2015	<b>Beginning Section MP</b>	0				
<b>Paved Length (Miles):</b> 0.18	<b>Section Length (MI)</b>	0.18				
<b>Surface Type:</b> ASPHALT	<b>Route Summary</b>					
<b>Roadway Condition Information</b>						
Pavement Condition Rating (PCR)	92	92				
Surface Condition Rating (SCR)	92	92				
Roughness Condition Index (RCI)	N/A	N/A				
<b>Distress Index Values</b>						
Structural Crack Index	99	99				
Alligator Crack Index	100	100				
Longitudinal Crack Index	99	99				
Transverse Cracking Index	92	92				
Patching Index	100	100				
Rutting Index	96	96				
International Roughness Index (IRI)	N/A	N/A				
<b>Lane &amp; Width Information</b>						
Number of Lanes	2	2				
Paved Width (ft)	36.2	36.2				
Lane Width (ft)	18.1	18.1

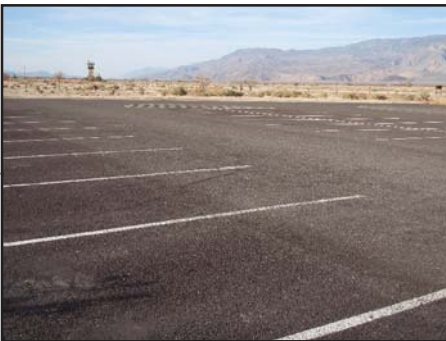
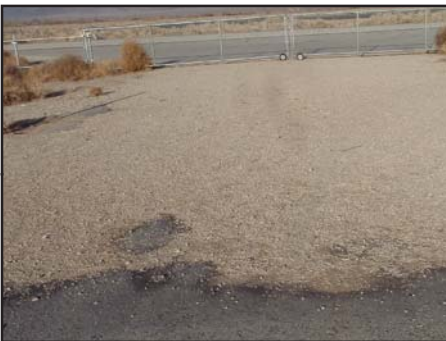
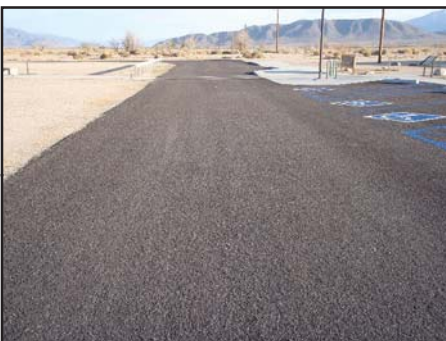
Inspection Date	FMSS Number	User Access	Surface Type
3/8/2015	77517	PUBLIC	ASPHALT
Area (Sq. Ft.)	Lane Miles (11' Widths)	Curb Reveal (Inches)	Curb Recommendation
120,003	2.066	6	DO NOTHING
Curb Type		Curb & Gutter Type	
CONCRETE		NO CURB AND GUTTER	
Pavement Recommendation		Condition Rating / PCR	
PREVENTIVE MAINTENANCE		GOOD / 90

The northern most portion of the parking lot (3,100 sq ft) was not chip-sealed when the parking lot was last treated. This portion will be demolished in the future according to the park.
