# MIMA Cycle 6

## Final Report

### Road Inventory and Condition Assessment of Paved Routes Minute Man National Historical Park

**Report Date: June 2021**

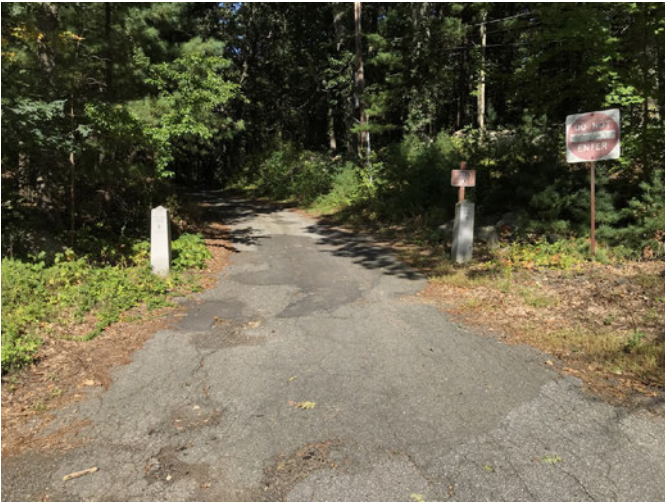
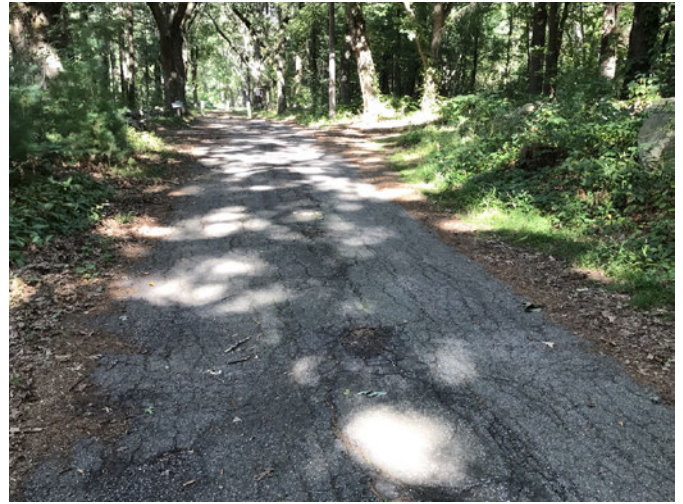
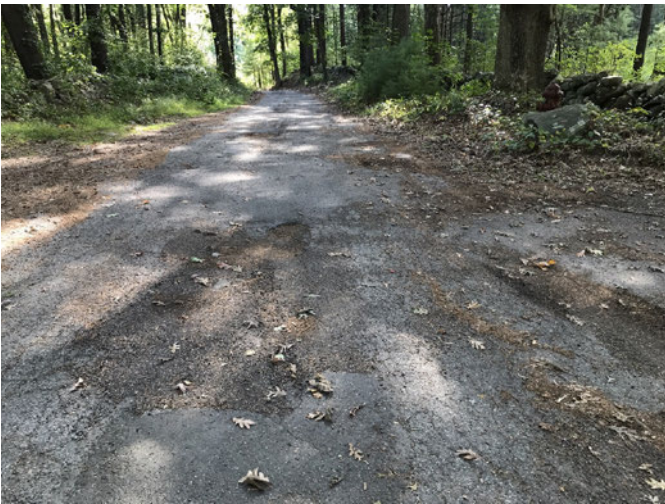
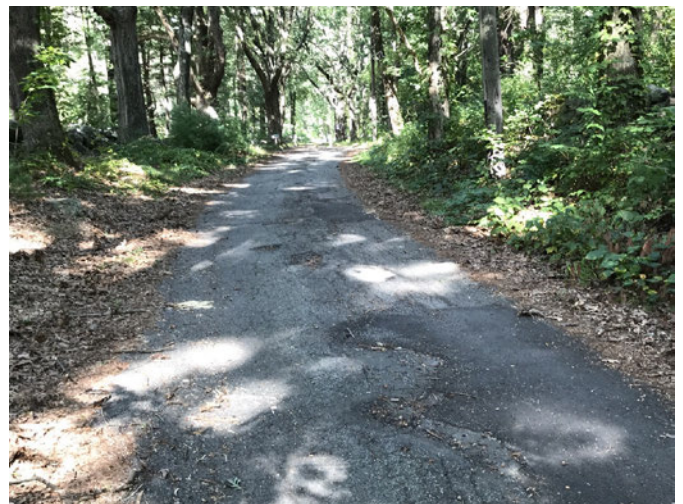
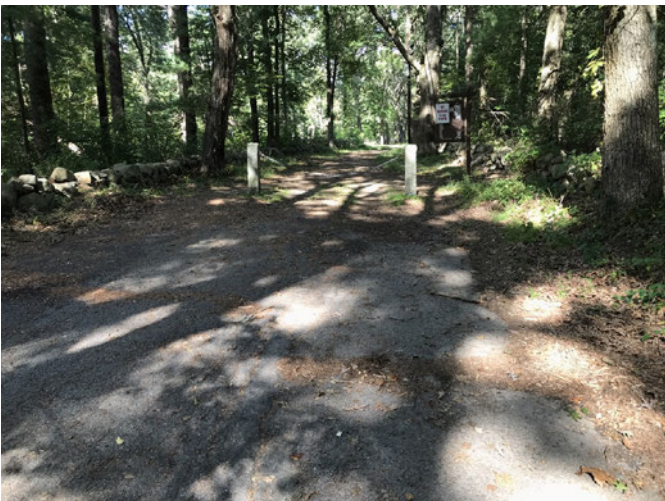
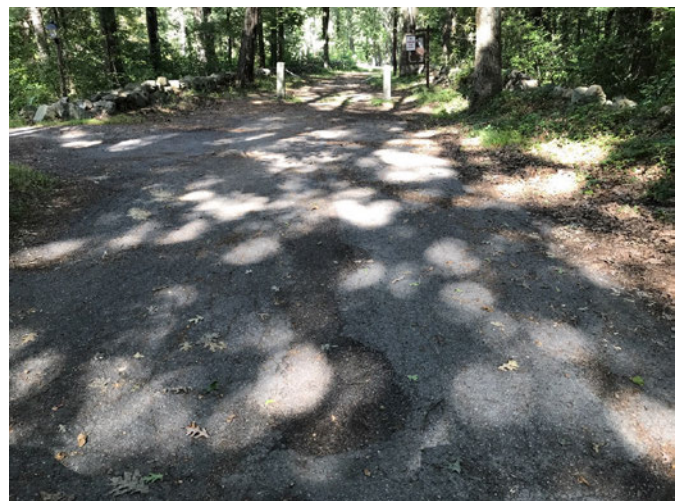
Route Condition Legend – Pavement Condition Rating (PCR)						
Poor (0 - 60)	Fair (61- 84)	Good (85 - 94)	Excellent (95 - 100)	Not Rated		
See Appendix for definitions and formulas						
<b>Inspection Date:</b>	9/17/2019	<b>Beginning Section MP</b>	0.00			
<b>Paved Length (Miles):</b>	0.09	<b>Section Length (MI)</b>	0.09			
<b>Surface Type:</b>	ASPHALT	<b>Route Summary</b>				
<b>Roadway Condition Information</b>						
Pavement Condition Rating (PCR)	30	30				
Surface Condition Rating (SCR)	30	30				
Roughness Condition Index (RCI)	N/A	N/A				
<b>Distress Index Values</b>						
Structural Crack Index	N/A	N/A				
Alligator Crack Index	30	30				
Longitudinal Crack Index	73	73				
Transverse Cracking Index	53	53				
Patching Index	30	30				
Rutting Index	53	53				
International Roughness Index (IRI)	N/A	N/A				
<b>Lane &amp; Width Information</b>						
Number of Lanes	1	1				
Paved Width (ft)	16	16				
Lane Width (ft)	16	16

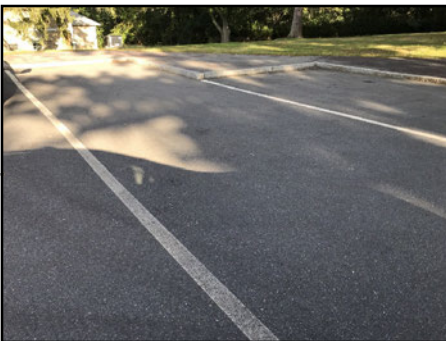
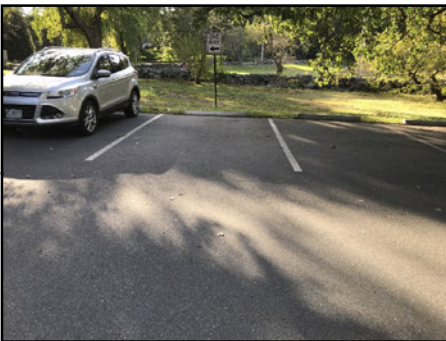
Inspection Date	FMSS Number	User Access	Surface Type
9/17/2019	63961	PUBLIC	ASPHALT
Area (Sq. Ft.)	Lane Miles (11' Widths)	Curb Reveal (Inches)	Curb Recommendation
22,905	0.394	5	DO NOTHING
Curb Type		Curb & Gutter Type	
STONE		NO CURB AND GUTTER	
Pavement Recommendation		Condition Rating / PCR	
PREVENTIVE MAINTENANCE		GOOD / 90

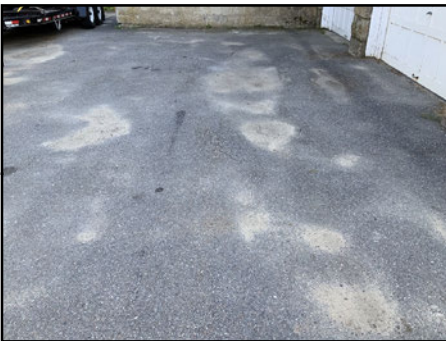
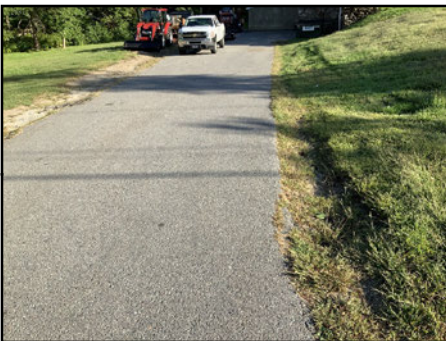
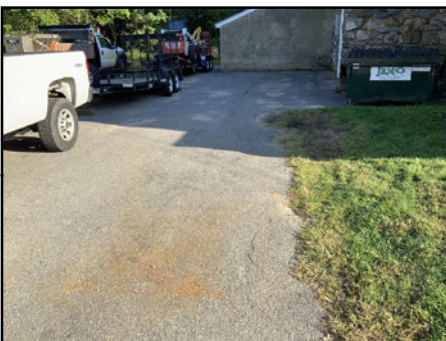
## ROUTE 0903: MAINTENANCE BARN PARKING

Inspection Date	FMSS Number	User Access	Surface Type
9/17/2019	104957	NONPUBLIC	ASPHALT
Area (Sq. Ft.)	Lane Miles (11' Widths)	Curb Reveal (Inches)	Curb Recommendation
2,900	0.05	NOT APPLICABLE	NOT APPLICABLE
Curb Type		Curb & Gutter Type	
NO CURB		NO CURB AND GUTTER	
Pavement Recommendation		Condition Rating / PCR	
HEAVY 3R TREATMENTS		POOR / 53

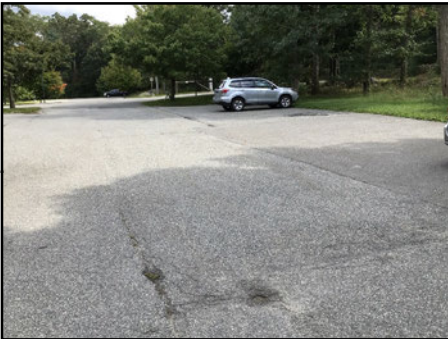
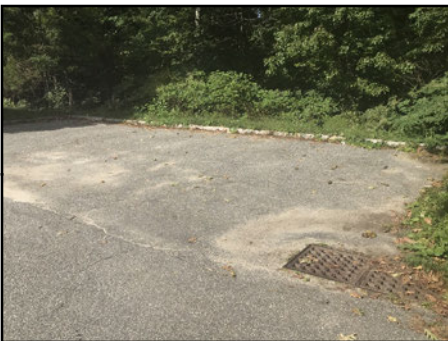
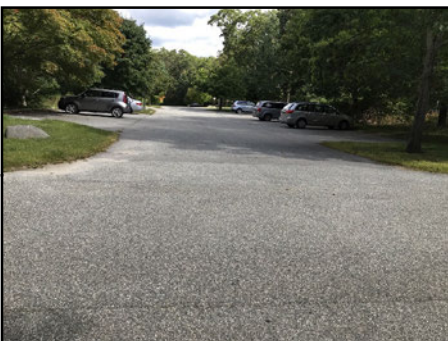
## ROUTE 0926AZ: HARTWELL PARKING A

Inspection Date	FMSS Number	User Access	Surface Type
9/17/2019	64172	PUBLIC	ASPHALT
Area (Sq. Ft.)	Lane Miles (11' Widths)	Curb Reveal (Inches)	Curb Recommendation
25,844	0.445	5	DO NOTHING
Curb Type		Curb & Gutter Type	
STONE		NO CURB AND GUTTER	
Pavement Recommendation		Condition Rating / PCR	
LIGHT 3R TREATMENTS		FAIR / 73

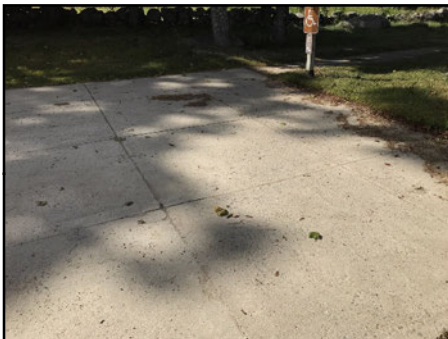
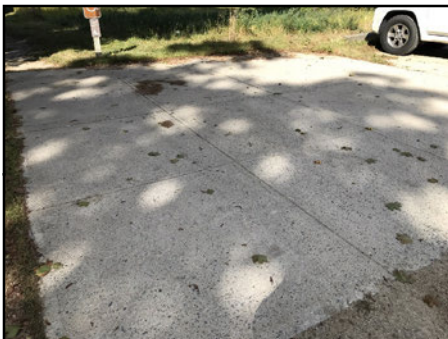
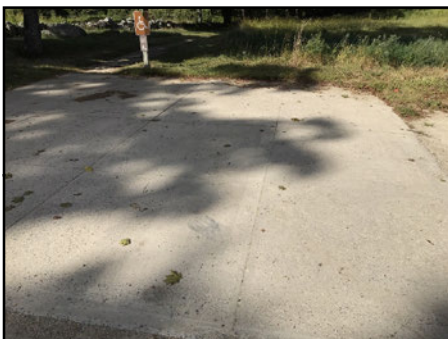
## ROUTE 0942: SAMUEL BROOKS ACCESSIBLE PARKING

Inspection Date	FMSS Number	User Access	Surface Type
9/17/2019	252944	PUBLIC	CONCRETE
Area (Sq. Ft.)	Lane Miles (11' Widths)	Curb Reveal (Inches)	Curb Recommendation
340	0.006	NOT APPLICABLE	NOT APPLICABLE
Curb Type		Curb & Gutter Type	
NO CURB		NO CURB AND GUTTER	
Pavement Recommendation		Condition Rating / PCR	
LIGHT 3R TREATMENTS		FAIR / 73
