MOCA Cycle 6

Final Report

Road Inventory and Condition Assessment of Paved Routes Montezuma Castle National Monument

**Federal Lands Highway
Road Inventory Program**

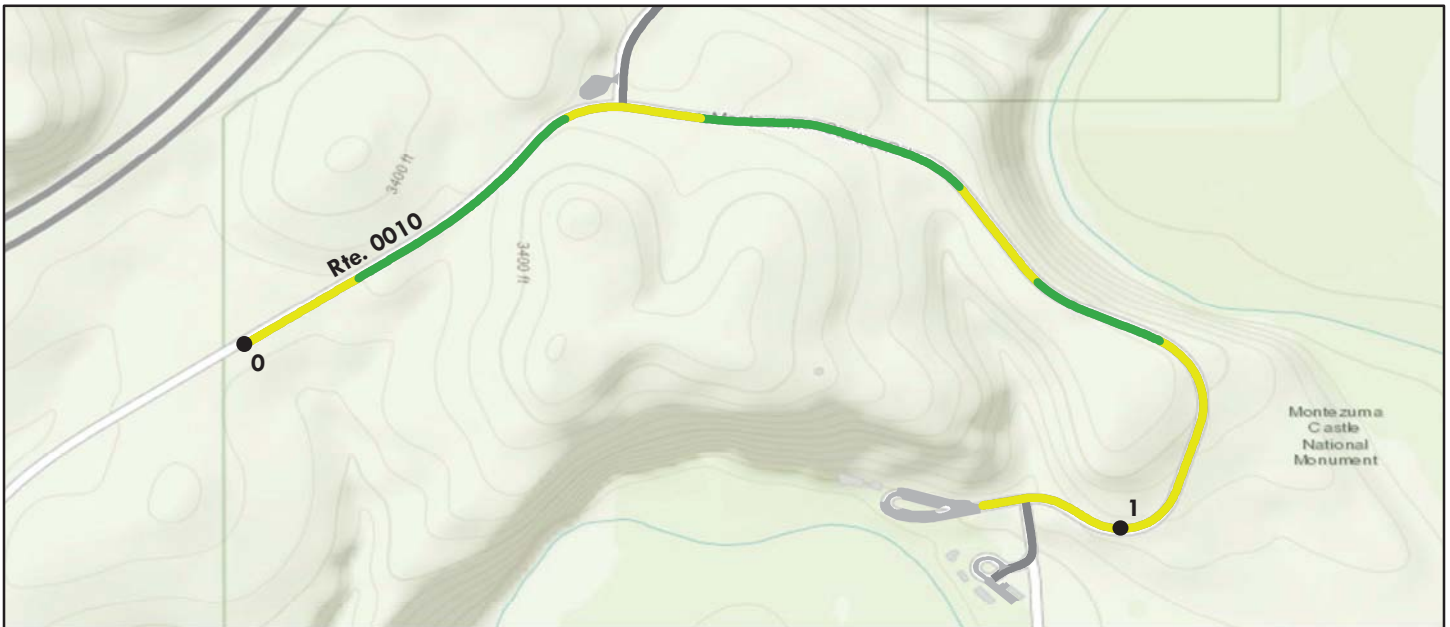
ROUTE 0010: MOCA CASTLE ACCESS ROAD

Route Condition Legend – Pavement Condition Rating (PCR)						
Poor (0 - 60)	Fair (61- 84)	Good (85 - 94)	Excellent (95 - 100)	Not Rated		
See Appendix for definitions and formulas						
Inspection Date: 7/11/2016	Beginning Section MP	0	1			
Paved Length (Miles): 1.11	Section Length (MI)	1	0.11			
Surface Type: ASPHALT	Route Summary					
Roadway Condition Information						
Pavement Condition Rating (PCR)	83	83	73			
Surface Condition Rating (SCR)	87	87	87			
Roughness Condition Index (RCI)	76	77	53			
Distress Index Values						
Structural Crack Index	93	93	87			
Alligator Crack Index	100	100	100			
Longitudinal Crack Index	93	93	87			
Transverse Cracking Index	87	87	90			
Patching Index	100	100	100			
Rutting Index	97	97	93			
International Roughness Index (IRI)	183	177	267			
Lane & Width Information						
Number of Lanes	2	2	2			
Paved Width (ft)	26.1	25.6	31.2			
Lane Width (ft)	10.1	10	10.8

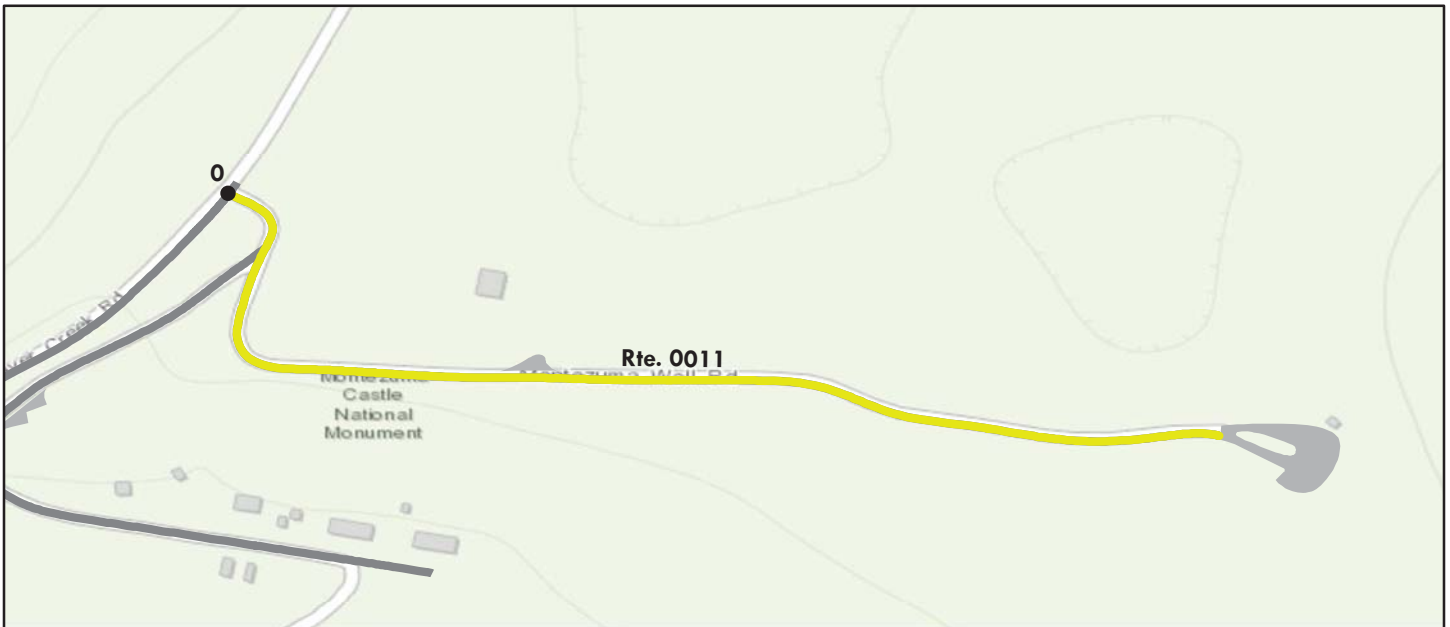
ROUTE 0011: MOWE WELL ACCESS ROAD

Route Condition Legend – Pavement Condition Rating (PCR)						
Poor (0 - 60)	Fair (61- 84)	Good (85 - 94)	Excellent (95 - 100)	Not Rated		
See Appendix for definitions and formulas						
Inspection Date: 7/11/2016	Beginning Section MP	0				
Paved Length (Miles): 0.37	Section Length (MI)	0.37				
Surface Type: ASPHALT	Route Summary					
Roadway Condition Information						
Pavement Condition Rating (PCR)	78	78				
Surface Condition Rating (SCR)	78	78				
Roughness Condition Index (RCI)	N/A	N/A				
Distress Index Values						
Structural Crack Index	92	92				
Alligator Crack Index	100	100				
Longitudinal Crack Index	92	92				
Transverse Cracking Index	78	78				
Patching Index	100	100				
Rutting Index	92	92				
International Roughness Index (IRI)	N/A	N/A				
Lane & Width Information						
Number of Lanes	2	2				
Paved Width (ft)	19.2	19.2				
Lane Width (ft)	9.2	9.2

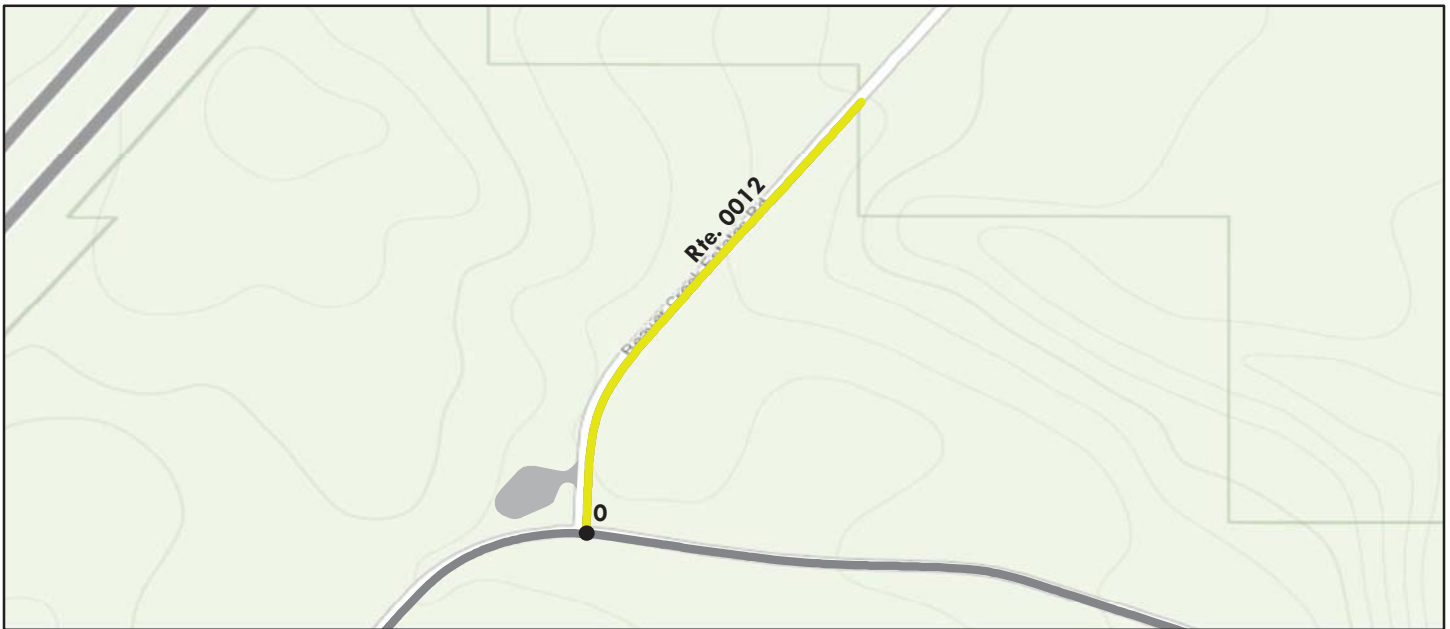
ROUTE 0012: MOCA BEAVER CREEK ESTATES ROAD

Route Condition Legend – Pavement Condition Rating (PCR)						
Poor (0 - 60)	Fair (61- 84)	Good (85 - 94)	Excellent (95 - 100)	Not Rated		
See Appendix for definitions and formulas						
Inspection Date: 7/11/2016	Beginning Section MP	0				
Paved Length (Miles): 0.21	Section Length (MI)	0.21				
Surface Type: ASPHALT	Route Summary					
Roadway Condition Information						
Pavement Condition Rating (PCR)	81	81				
Surface Condition Rating (SCR)	81	81				
Roughness Condition Index (RCI)	N/A	N/A				
Distress Index Values						
Structural Crack Index	91	91				
Alligator Crack Index	100	100				
Longitudinal Crack Index	91	91				
Transverse Cracking Index	81	81				
Patching Index	100	100				
Rutting Index	98	98				
International Roughness Index (IRI)	N/A	N/A				
Lane & Width Information						
Number of Lanes	2	2				
Paved Width (ft)	23.1	23.1				
Lane Width (ft)	11.5	11.5

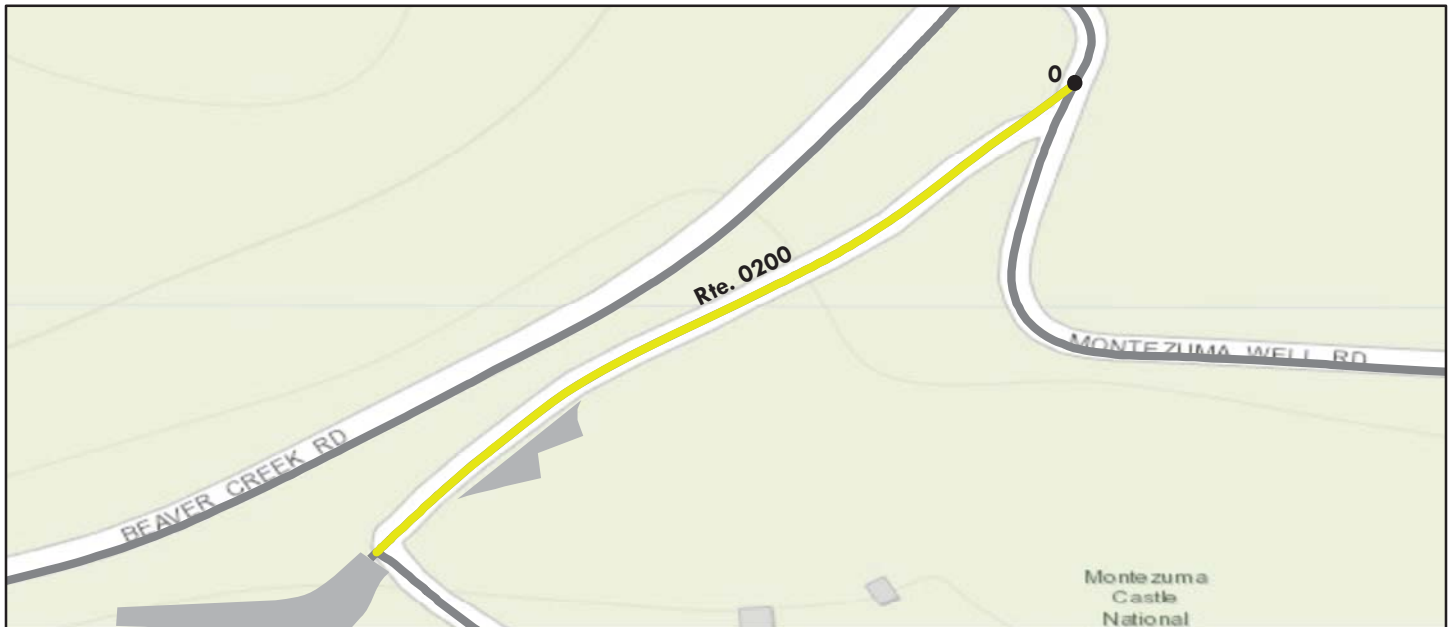
ROUTE 0200: MOWE PICNIC AREA ROAD

Route Condition Legend – Pavement Condition Rating (PCR)						
Poor (0 - 60)	Fair (61- 84)	Good (85 - 94)	Excellent (95 - 100)	Not Rated		
See Appendix for definitions and formulas						
Inspection Date: 7/11/2016	Beginning Section MP	0				
Paved Length (Miles): 0.12	Section Length (MI)	0.12				
Surface Type: ASPHALT	Route Summary					
Roadway Condition Information						
Pavement Condition Rating (PCR)	76	76				
Surface Condition Rating (SCR)	76	76				
Roughness Condition Index (RCI)	N/A	N/A				
Distress Index Values						
Structural Crack Index	89	89				
Alligator Crack Index	100	100				
Longitudinal Crack Index	89	89				
Transverse Cracking Index	76	76				
Patching Index	97	97				
Rutting Index	92	92				
International Roughness Index (IRI)	N/A	N/A				
Lane & Width Information						
Number of Lanes	2	2				
Paved Width (ft)	18.5	18.5				
Lane Width (ft)	9	9

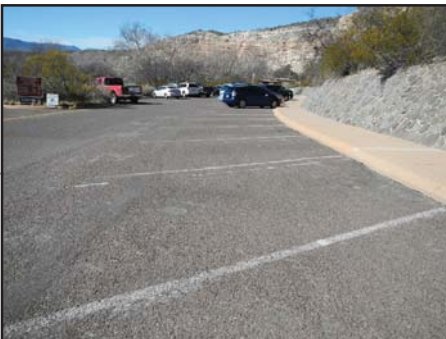
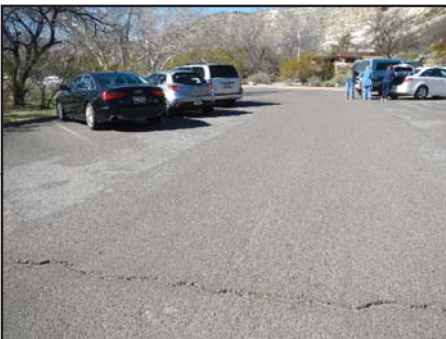
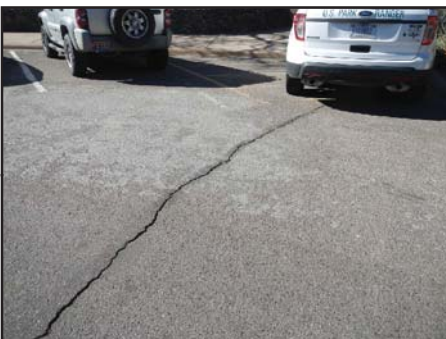
Inspection Date	FMSS Number	User Access	Surface Type
1/27/2016	58028	PUBLIC	ASPHALT
Area (Sq. Ft.)	Lane Miles (11' Widths)	Curb Reveal (Inches)	Curb Recommendation
32,410	0.558	NOT APPLICABLE	DO NOTHING
Curb Type		Curb & Gutter Type	
NO CURB		CONCRETE	
Pavement Recommendation		Condition Rating / PCR	
LIGHT 3R TREATMENTS		FAIR / 73

Parking area consists of multiple surface types: 1 part Asphalt at 30,383 square feet; 1 part Concrete at 2,027 square feet.

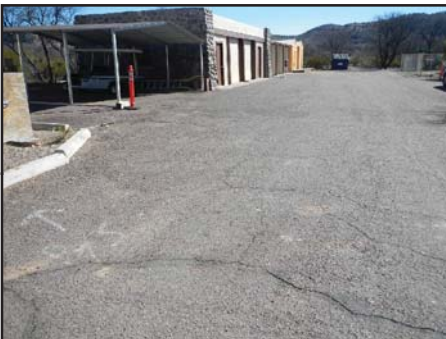
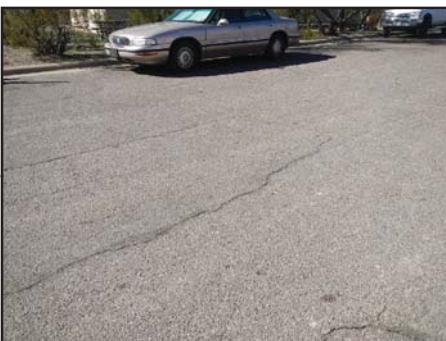
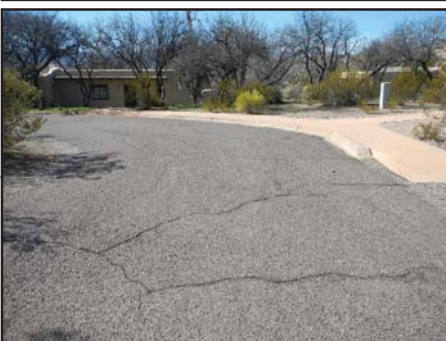
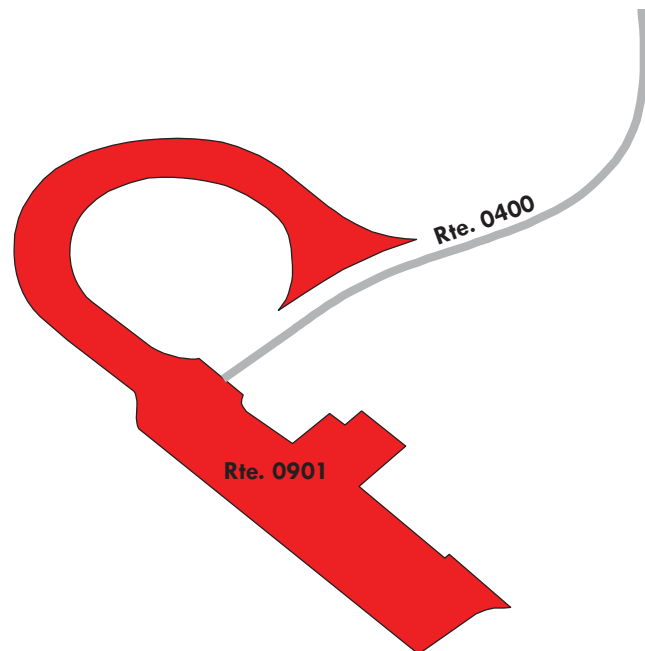
ROUTE 0901: MOCA RESIDENCE AREA PARKING

Inspection Date	FMSS Number	User Access	Surface Type
1/27/2016	58033	PUBLIC	ASPHALT
Area (Sq. Ft.)	Lane Miles (11' Widths)	Curb Reveal (Inches)	Curb Recommendation
10,346	0.178	NOT APPLICABLE	DO NOTHING
Curb Type		Curb & Gutter Type	
NO CURB		CONCRETE	
Pavement Recommendation		Condition Rating / PCR	
HEAVY 3R TREATMENTS		POOR / 53

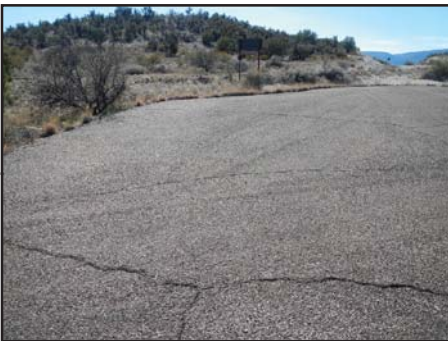
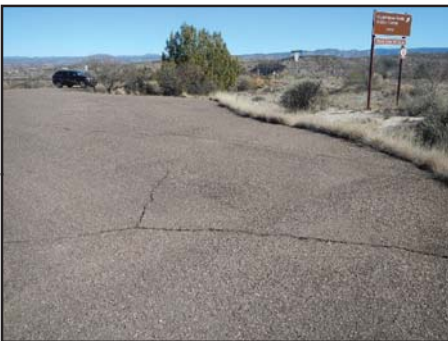
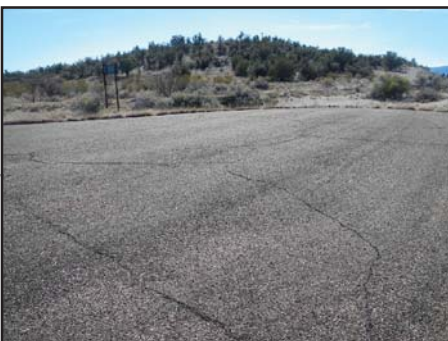
ROUTE 0902: MOCA ELEPHANT TRACKS PARKING

Inspection Date	FMSS Number	User Access	Surface Type
1/27/2016	58036	NONPUBLIC	ASPHALT
Area (Sq. Ft.)	Lane Miles (11' Widths)	Curb Reveal (Inches)	Curb Recommendation
10,582	0.182	NOT APPLICABLE	NOT APPLICABLE
Curb Type		Curb & Gutter Type	
NO CURB		NO CURB AND GUTTER	
Pavement Recommendation		Condition Rating / PCR	
PREVENTIVE MAINTENANCE		GOOD / 90

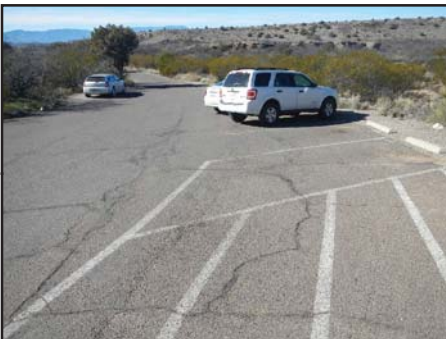
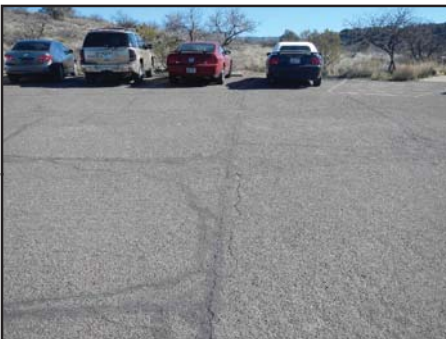
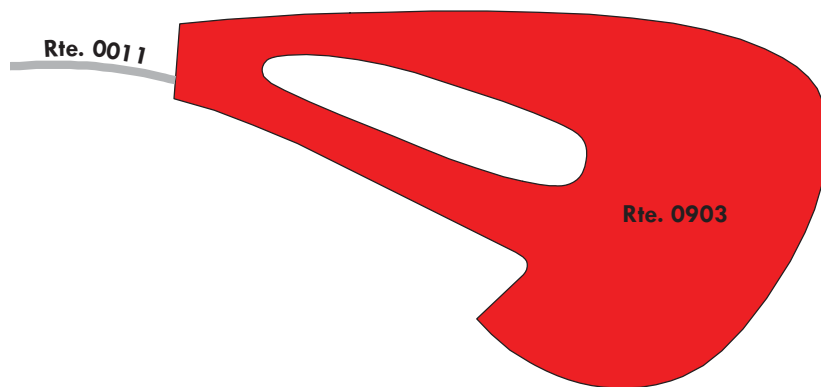
ROUTE 0903: MOWE WELL PARKING

Inspection Date	FMSS Number	User Access	Surface Type
1/27/2016	58041	PUBLIC	ASPHALT
Area (Sq. Ft.)	Lane Miles (11' Widths)	Curb Reveal (Inches)	Curb Recommendation
13,876	0.239	NOT APPLICABLE	NOT APPLICABLE
Curb Type		Curb & Gutter Type	
NO CURB		NO CURB AND GUTTER	
Pavement Recommendation		Condition Rating / PCR	
RECONSTRUCTION		POOR / 30

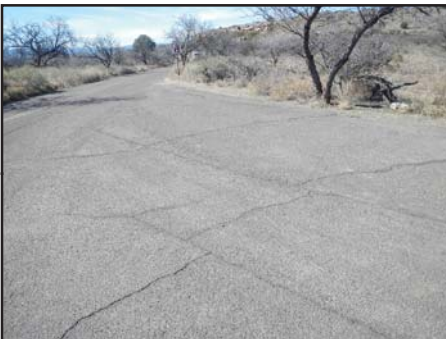
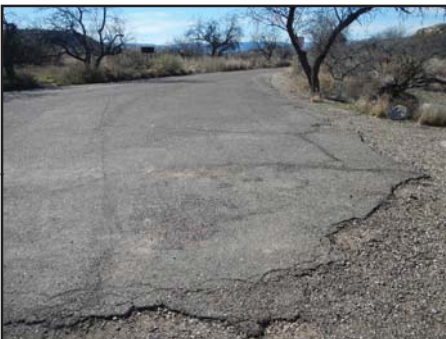
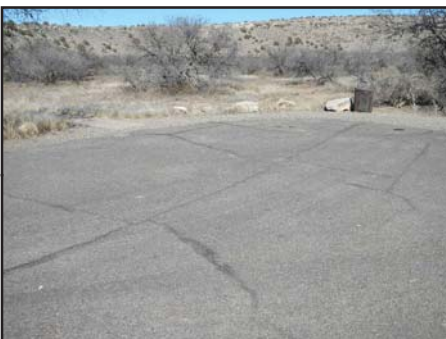
ROUTE 0904: MOWE PITHOUSE PARKING

Inspection Date	FMSS Number	User Access	Surface Type
1/27/2016	58044	PUBLIC	ASPHALT
Area (Sq. Ft.)	Lane Miles (11' Widths)	Curb Reveal (Inches)	Curb Recommendation
1,409	0.024	NOT APPLICABLE	NOT APPLICABLE
Curb Type		Curb & Gutter Type	
NO CURB		NO CURB AND GUTTER	
Pavement Recommendation		Condition Rating / PCR	
HEAVY 3R TREATMENTS		POOR / 53

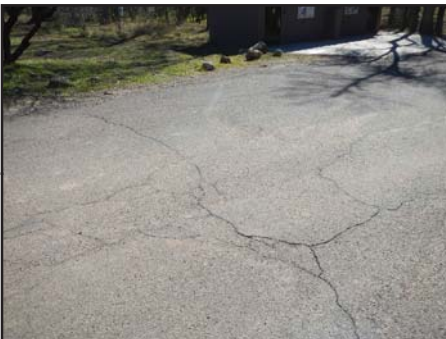
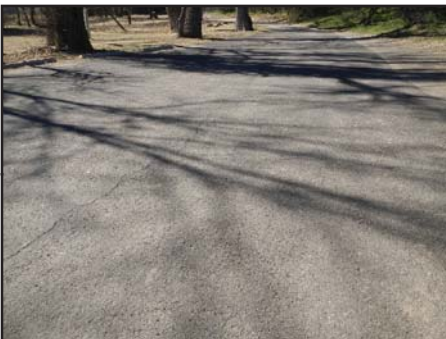
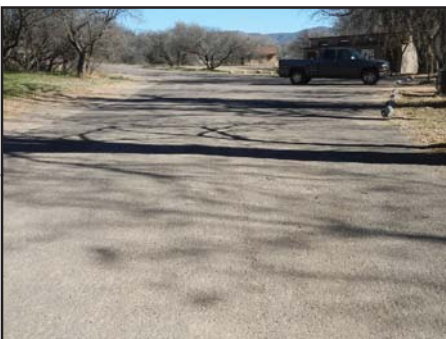
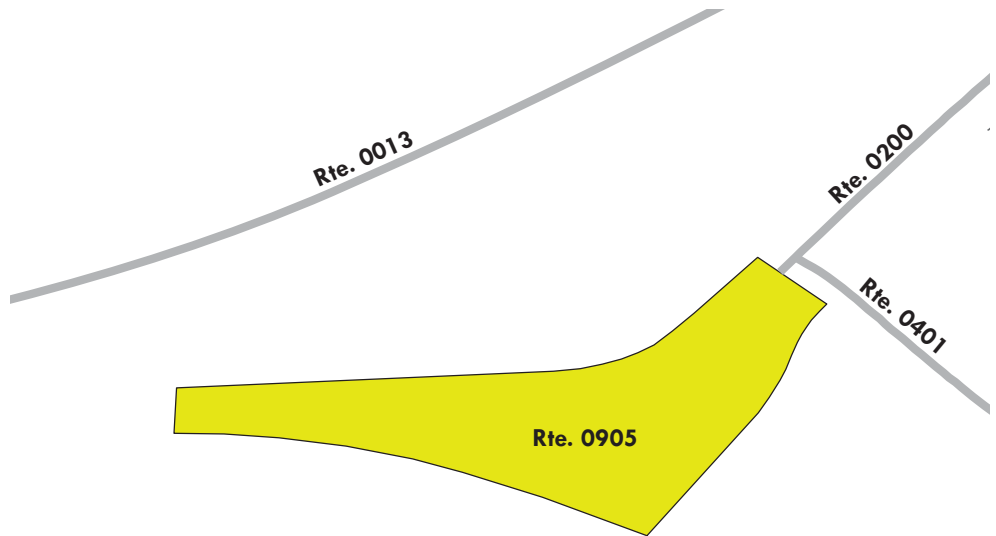
ROUTE 0905: MOWE PICNIC AREA PARKING

Inspection Date	FMSS Number	User Access	Surface Type
1/27/2016	58047	PUBLIC	ASPHALT
Area (Sq. Ft.)	Lane Miles (11' Widths)	Curb Reveal (Inches)	Curb Recommendation
7,292	0.126	NOT APPLICABLE	NOT APPLICABLE
Curb Type		Curb & Gutter Type	
NO CURB		NO CURB AND GUTTER	
Pavement Recommendation		Condition Rating / PCR	
LIGHT 3R TREATMENTS		FAIR / 73

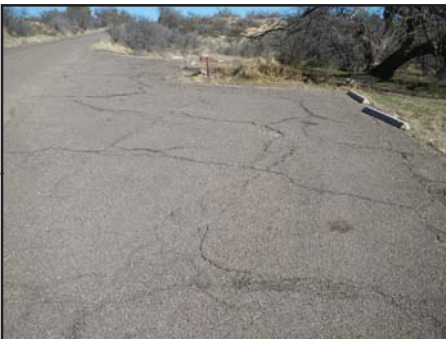
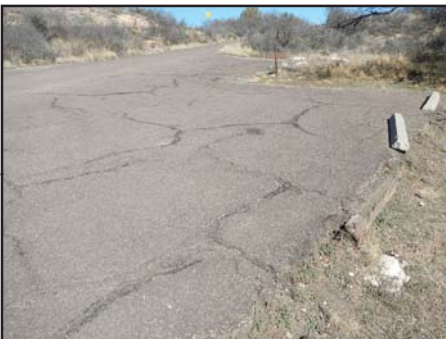
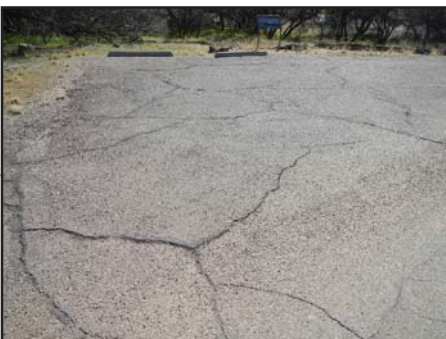
ROUTE 0906: MOWE PREHISTORIC DITCH PARKING

Inspection Date	FMSS Number	User Access	Surface Type
1/27/2016	58048	PUBLIC	ASPHALT
Area (Sq. Ft.)	Lane Miles (11' Widths)	Curb Reveal (Inches)	Curb Recommendation
1,811	0.031	NOT APPLICABLE	NOT APPLICABLE
Curb Type		Curb & Gutter Type	
NO CURB		NO CURB AND GUTTER	
Pavement Recommendation		Condition Rating / PCR	
HEAVY 3R TREATMENTS		POOR / 53
