MOJA Cycle 6

Road Inventory and Condition Assessment of Paved Routes Mojave National Preserve 2017 Condition Inspection Report

**Federal Lands Highway
Road Inventory Program**

Report Date: September 2018

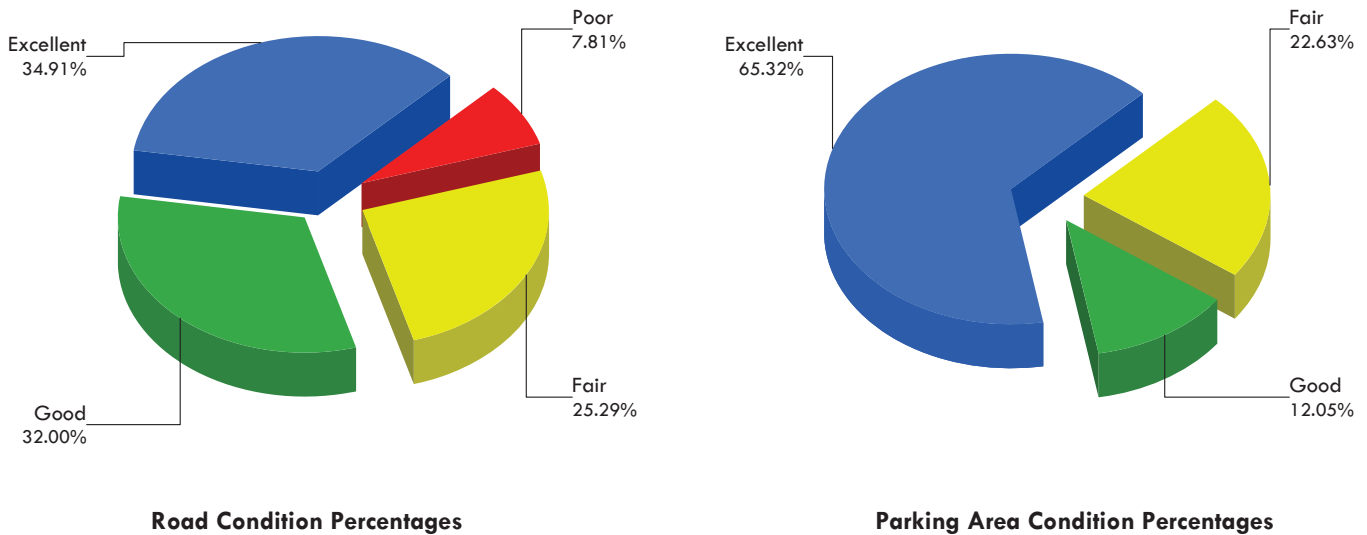
Figure 1: Pavement Condition Rating Breakdown for Paved Roads and Parking Areas

- Excellent / New: PCR of 95-100
 - o Pavements in this range will require only spot repairs
- Good: PCR of 85-94
 - o Pavements in this range will likely be candidates for Preventive Maintenance. Examples include Chip and Slurry Seals, Micro Surfacing and Thin Overlays.
- Fair: PCR of 61-84
 - o Pavements in this range will likely be candidates of Light Rehabilitation (L3R). Examples include singlelift overlays up to 2.5 inches in total thickness, milling and overlays.
- Poor: PCR of 0-60
 - o Pavements in this range will likely be candidates of Heavy Rehabilitation or Reconstruction (H3R or 4R). Examples include Pulverization, Multiple Lift Overlays, and Reconstruction.

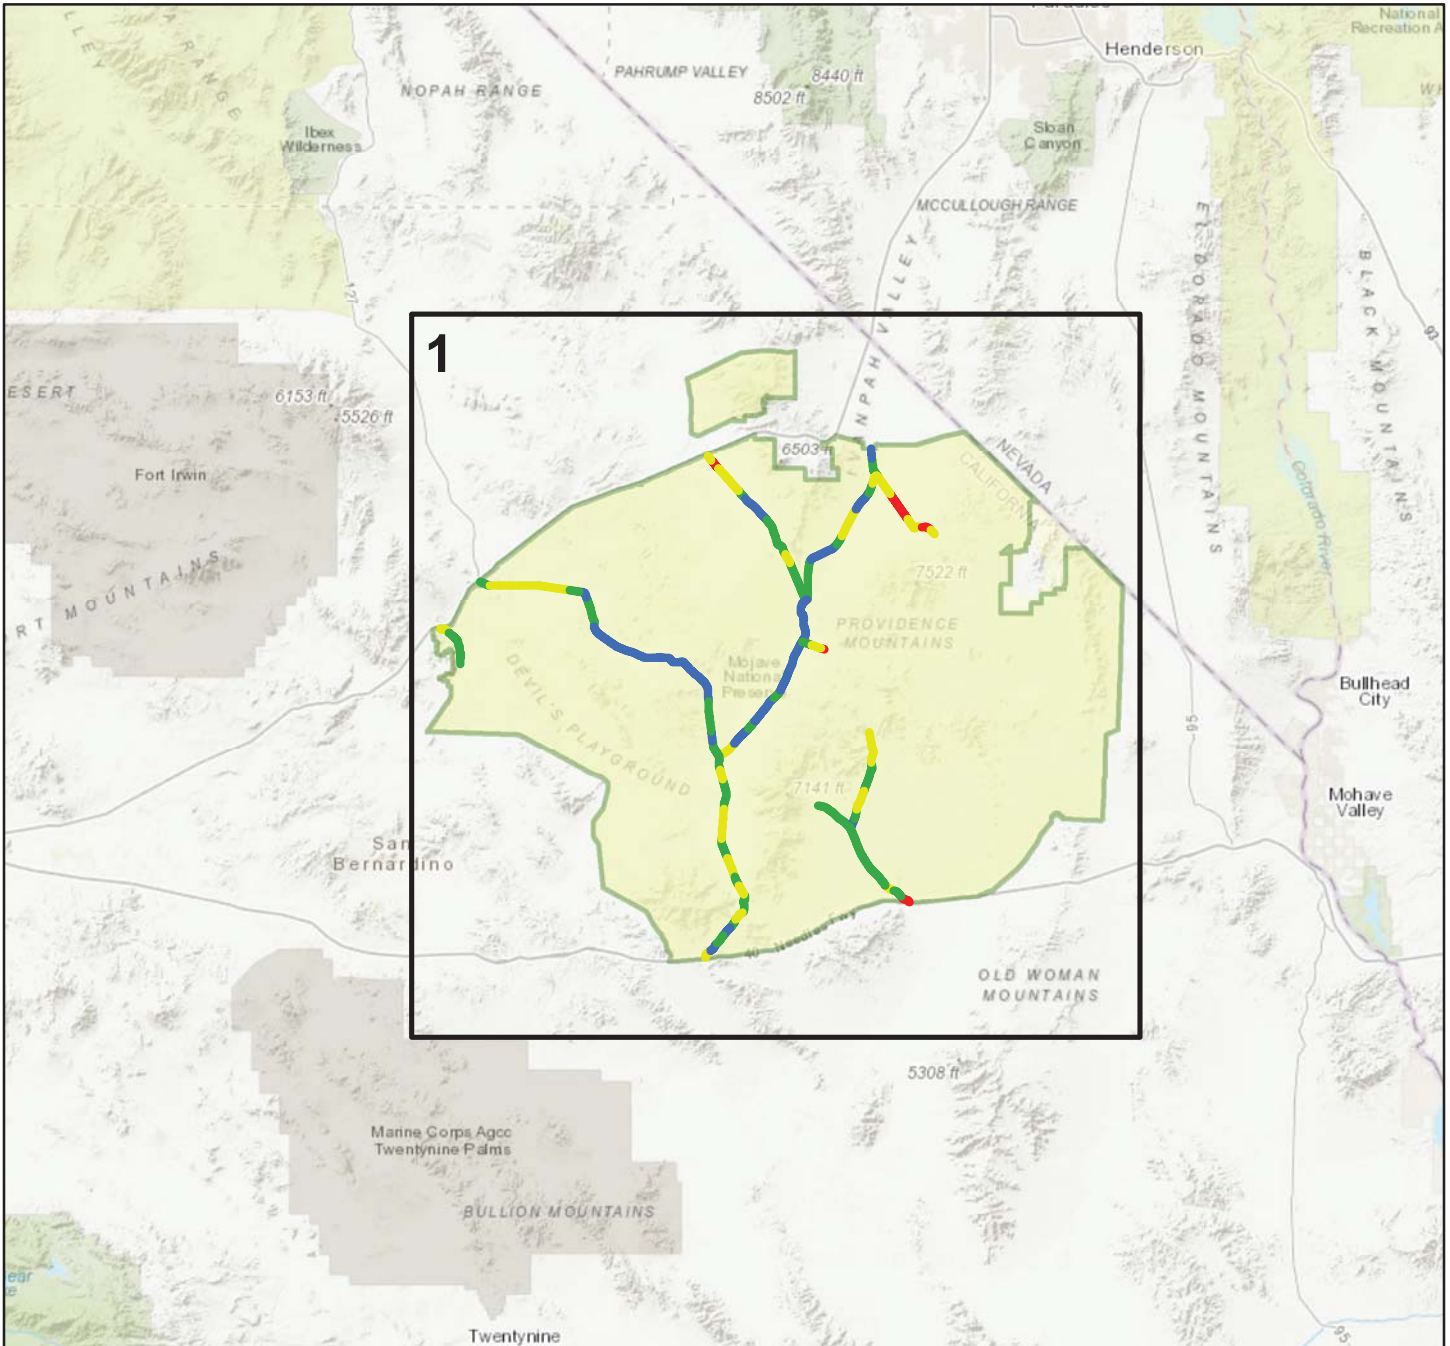
ROUTE CONDITION MAP

Colors on map represent condition scores at 1-mile intervals. See Appendix for definitions and formulas
 Only Data Collection Vehicle and Manually Rated Roads are displayed

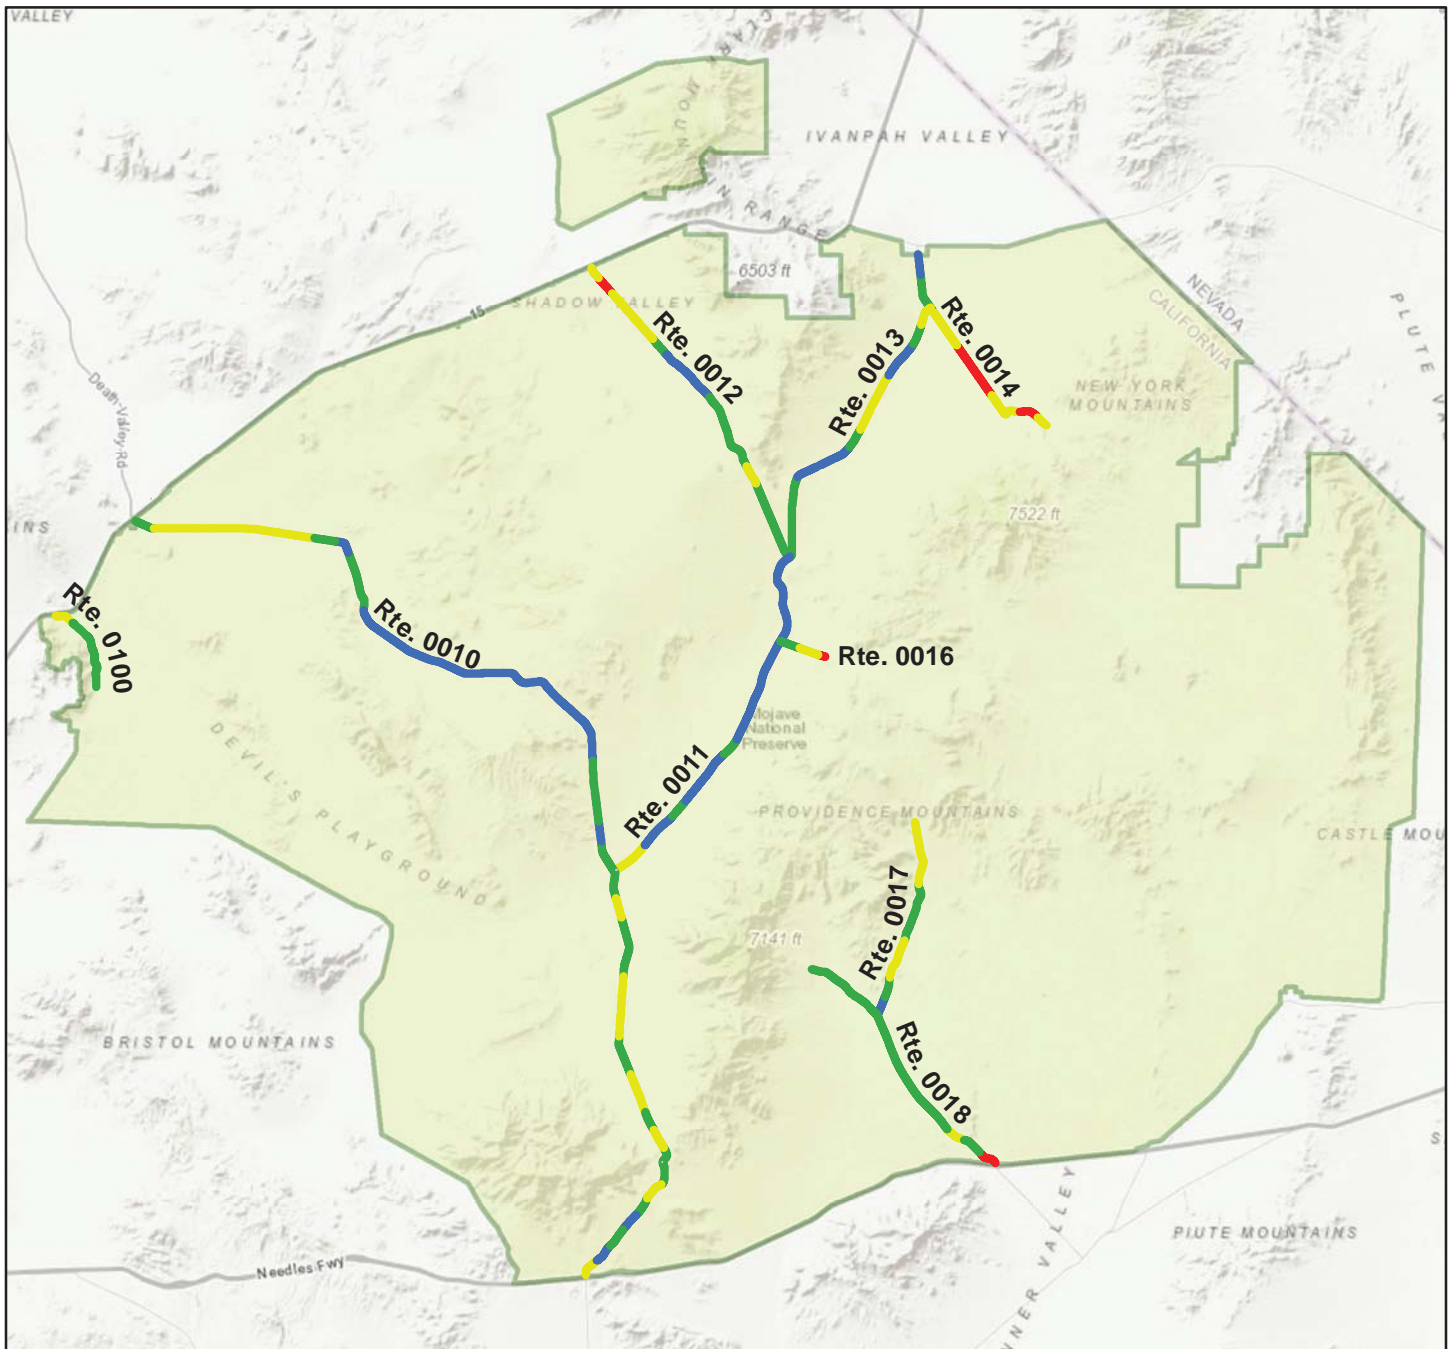
ROUTE CONDITION MAP

Colors on map represent condition scores at 1-mile intervals. See Appendix for definitions and formulas
Only Data Collection Vehicle and Manually Rated Roads are displayed

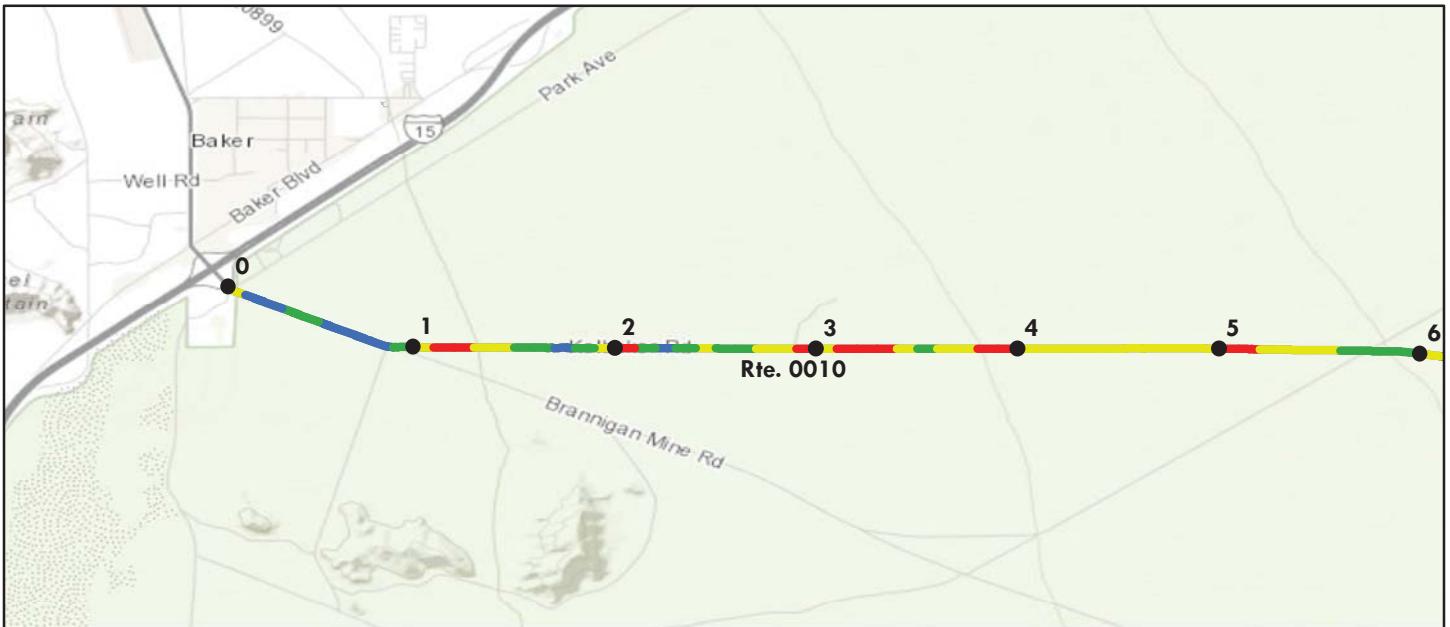
Data Collection Vehicle (DCV) Rating

Colors on map represent condition scores at 0.10-mile intervals. See Appendix for definitions and formulas.

Inspection Date:	4/24/2017	Beginning Section MP	0	1	2	3	4
Paved Length (Miles):	56.98	Section Length (MI)	1	1	1	1	1
Surface Type:	ASPHALT	Route Summary					
Roadway Condition Information							
Pavement Condition Rating (PCR)	91	94	75	81	66	76	
Surface Condition Rating (SCR)	89	90	72	69	45	65	
Roughness Condition Index (RCI)	95	100	80	98	97	93	
Distress Index Values							
Structural Crack Index	93	90	72	75	60	75	
Alligator Crack Index	100	100	100	100	100	100	
Longitudinal Crack Index	93	90	72	75	60	75	
Transverse Cracking Index	89	93	89	69	45	65	
Patching Index	100	100	100	100	100	100	
Rutting Index	95	97	93	95	95	96	
International Roughness Index (IRI)	128	105	168	119	122	132	
Lane & Width Information							
Number of Lanes	2	2	2	2	2	2	
Paved Width (ft)	24.2	26.9	24	22.6	23.4	23.4	
Lane Width (ft)	10.3	10.6	10.3	9.7	9.7	10.1

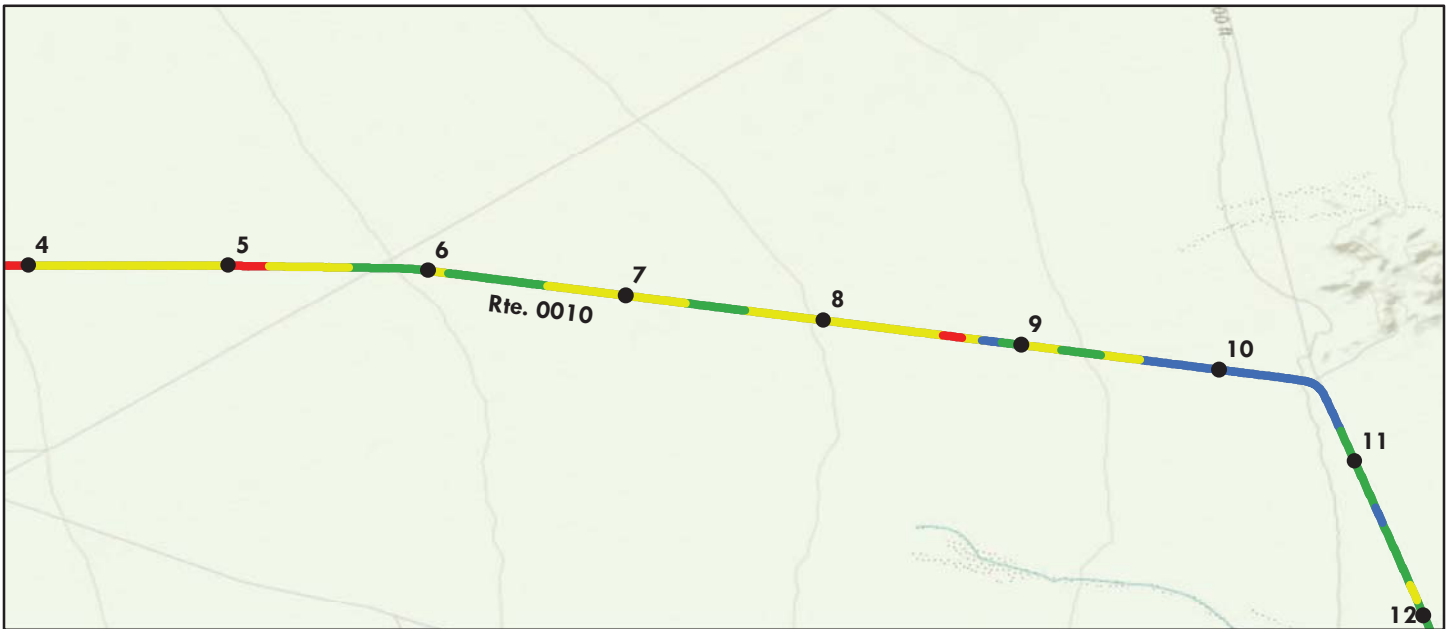
Data Collection Vehicle (DCV) Rating

Route Condition Legend – Pavement Condition Rating (PCR)						
Poor (0 - 60)	Fair (61- 84)	Good (85 - 94)	Excellent (95 - 100)	Not Rated		
Colors on map represent condition scores at 0.10-mile intervals. See Appendix for definitions and formulas.						
Inspection Date: 4/24/2017	Beginning Section MP	5	6	7	8	9
Paved Length (Miles): 56.98	Section Length (MI)	1	1	1	1	1
Surface Type: ASPHALT	Route Summary					
Roadway Condition Information						
Pavement Condition Rating (PCR)	91	77	83	80	72	91
Surface Condition Rating (SCR)	89	77	75	72	59	85
Roughness Condition Index (RCI)	95	77	96	91	92	100
Distress Index Values						
Structural Crack Index	93	84	88	88	79	85
Alligator Crack Index	100	100	100	100	100	100
Longitudinal Crack Index	93	84	88	88	79	85
Transverse Cracking Index	89	77	75	72	59	85
Patching Index	100	100	100	100	100	100
Rutting Index	95	94	96	96	96	95
International Roughness Index (IRI)	128	177	123	137	135	89

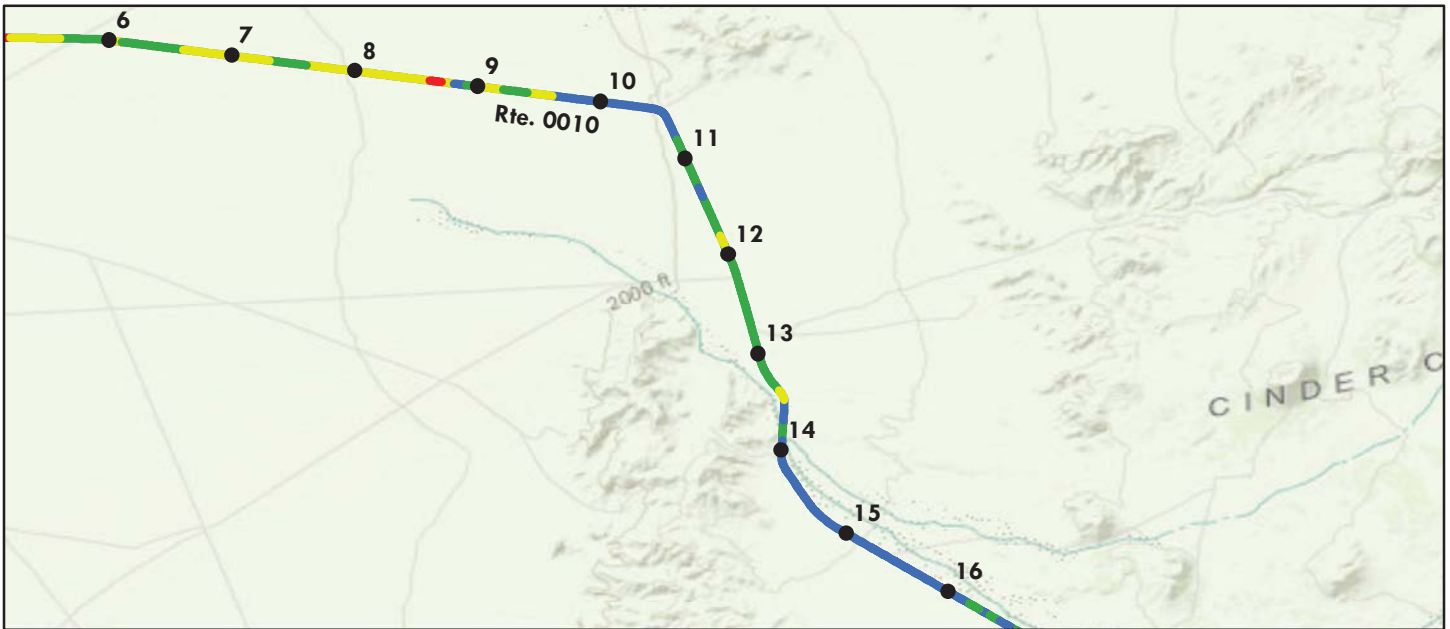
Data Collection Vehicle (DCV) Rating

Colors on map represent condition scores at 0.10-mile intervals. See Appendix for definitions and formulas.

Inspection Date:	4/24/2017	Beginning Section MP	10	11	12	13	14
Paved Length (Miles):	56.98	Section Length (MI)	1	1	1	1	1
Surface Type:	ASPHALT	Route Summary					
Roadway Condition Information							
Pavement Condition Rating (PCR)	91	98	90	91	92	98	
Surface Condition Rating (SCR)	89	96	89	87	92	96	
Roughness Condition Index (RCI)	95	100	91	97	91	100	
Distress Index Values							
Structural Crack Index	93	99	96	93	100	100	
Alligator Crack Index	100	100	100	100	100	100	
Longitudinal Crack Index	93	99	96	93	100	100	
Transverse Cracking Index	89	96	89	87	99	100	
Patching Index	100	100	100	100	100	100	
Rutting Index	95	97	93	96	92	96	
International Roughness Index (IRI)	128	96	137	122	138	98	
Lane & Width Information							
Number of Lanes	2	2	2	2	2	2	
Paved Width (ft)	24.2	25	24.7	25.4	24.7	25.1	
Lane Width (ft)	10.3	10.3	10.7	10.5	10.1	10.1

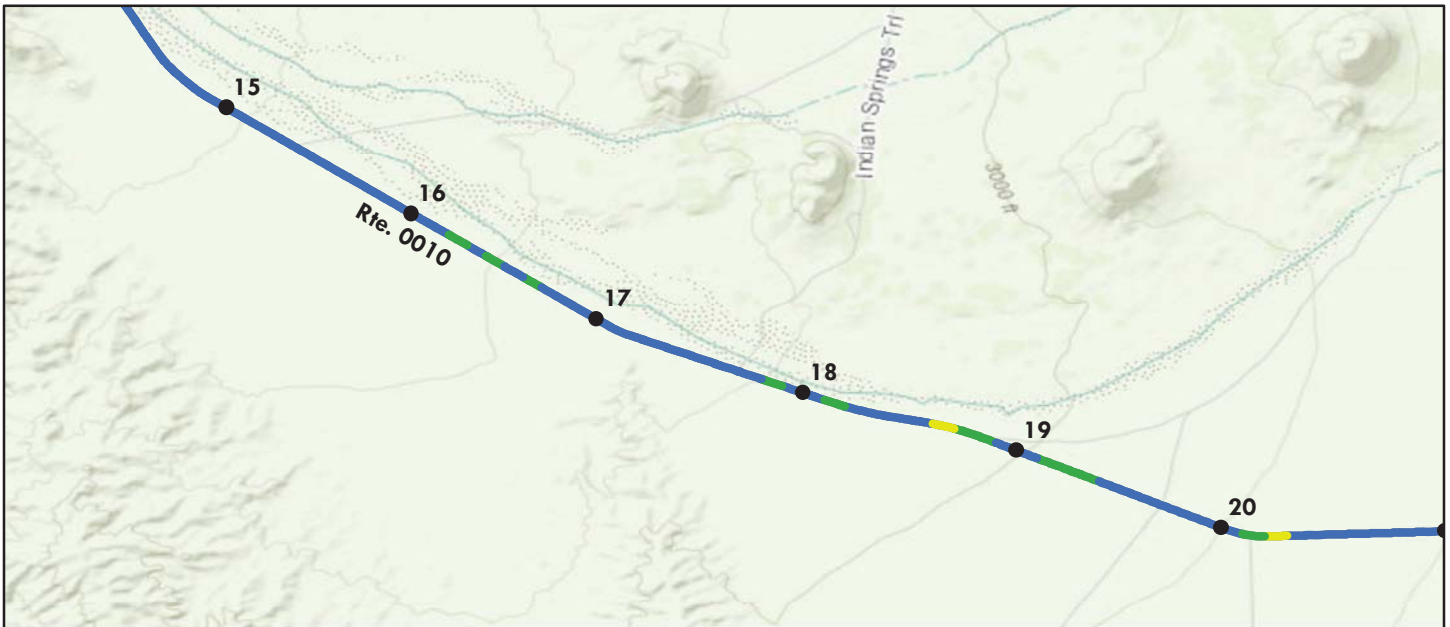
Data Collection Vehicle (DCV) Rating

Colors on map represent condition scores at 0.10-mile intervals. See Appendix for definitions and formulas.

Inspection Date:	4/24/2017	Beginning Section MP	15	16	17	18	19
Paved Length (Miles):	56.98	Section Length (MI)	1	1	1	1	1
Surface Type:	ASPHALT	Route Summary					
Roadway Condition Information							
Pavement Condition Rating (PCR)	91	97	96	98	95	96	
Surface Condition Rating (SCR)	89	95	93	96	93	93	
Roughness Condition Index (RCI)	95	100	100	100	98	100	
Distress Index Values							
Structural Crack Index	93	100	100	100	100	100	
Alligator Crack Index	100	100	100	100	100	100	
Longitudinal Crack Index	93	100	100	100	100	100	
Transverse Cracking Index	89	100	100	100	100	100	
Patching Index	100	100	100	100	100	100	
Rutting Index	95	95	93	96	93	93	
International Roughness Index (IRI)	128	79	100	101	120	107	
Lane & Width Information							
Number of Lanes	2	2	2	2	2	2	
Paved Width (ft)	24.2	25.7	25.4	25.4	24.8	25.4	
Lane Width (ft)	10.3	10.2	10.8	11.1	10.7	10.4

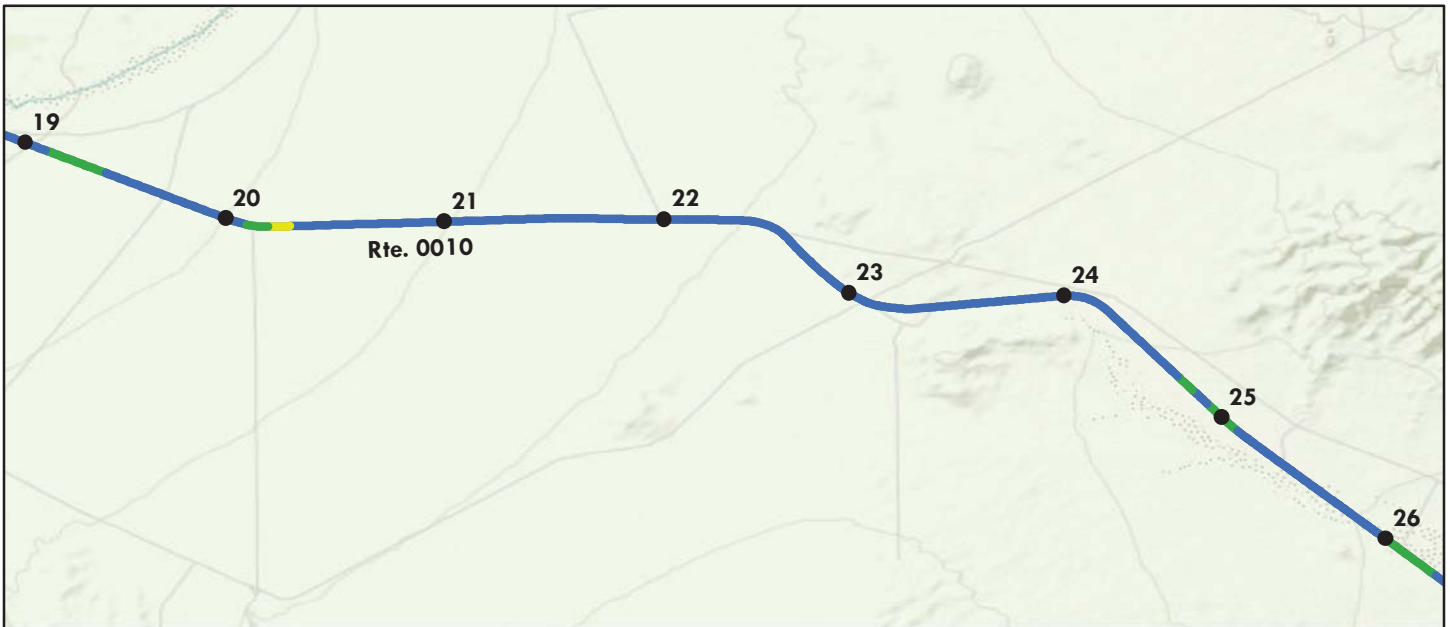
Data Collection Vehicle (DCV) Rating

Colors on map represent condition scores at 0.10-mile intervals. See Appendix for definitions and formulas.

Inspection Date:	4/24/2017	Beginning Section MP	20	21	22	23	24
Paved Length (Miles):	56.98	Section Length (MI)	1	1	1	1	1
Surface Type:	ASPHALT	Route Summary					
Roadway Condition Information							
Pavement Condition Rating (PCR)	91	98	99	99	99	99	98
Surface Condition Rating (SCR)	89	97	99	99	99	99	96
Roughness Condition Index (RCI)	95	100	100	100	100	100	100
Distress Index Values							
Structural Crack Index	93	100	100	100	100	100	99
Alligator Crack Index	100	100	100	100	100	100	100
Longitudinal Crack Index	93	100	100	100	100	100	99
Transverse Cracking Index	89	100	100	100	100	100	100
Patching Index	100	100	100	100	100	100	100
Rutting Index	95	97	99	99	99	99	96
International Roughness Index (IRI)	128	111	93	97	89	112	
Lane & Width Information							
Number of Lanes	2	2	2	2	2	2	2
Paved Width (ft)	24.2	25	22.2	23.6	24.3	24.2	
Lane Width (ft)	10.3	10.1	9.9	10	9.5	10.5

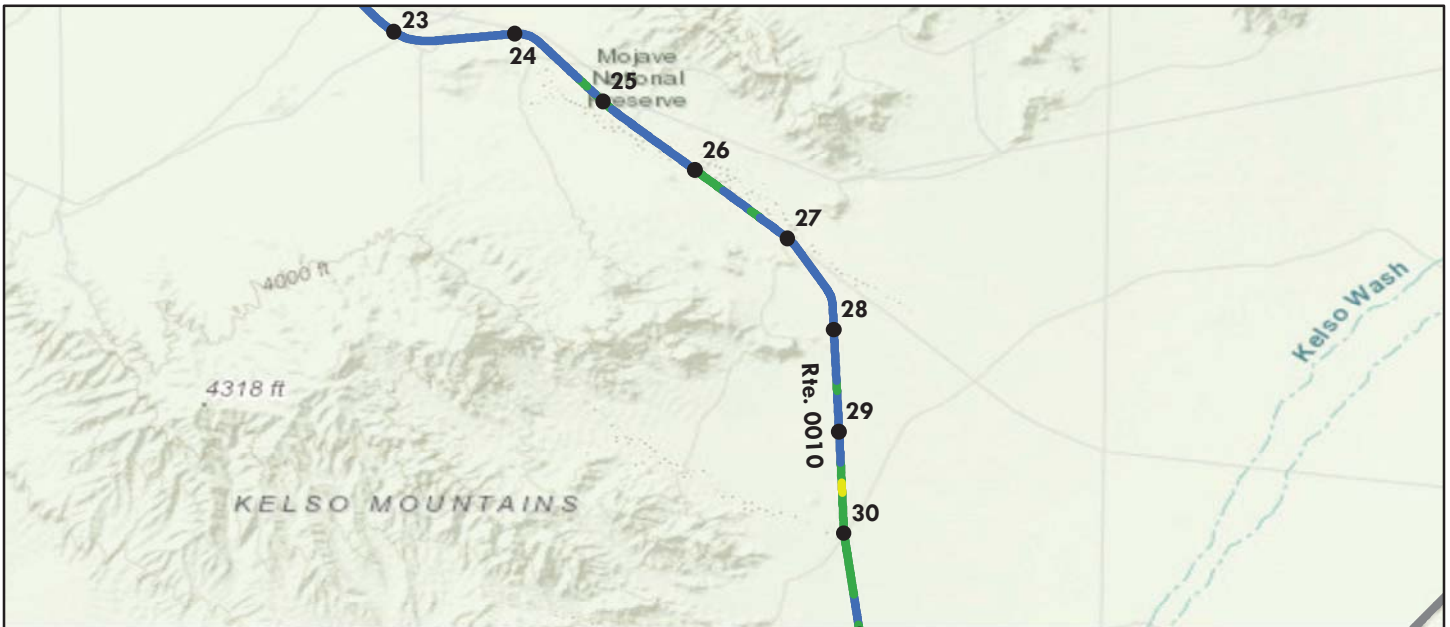
Data Collection Vehicle (DCV) Rating

Colors on map represent condition scores at 0.10-mile intervals. See Appendix for definitions and formulas.

Inspection Date:	4/24/2017	Beginning Section MP	25	26	27	28	29
Paved Length (Miles):	56.98	Section Length (MI)	1	1	1	1	1
Surface Type:	ASPHALT	Route Summary					
Roadway Condition Information							
Pavement Condition Rating (PCR)	91	99	98	99	98	92	
Surface Condition Rating (SCR)	89	98	97	99	97	92	
Roughness Condition Index (RCI)	95	100	100	100	100	93	
Distress Index Values							
Structural Crack Index	93	99	99	100	100	99	
Alligator Crack Index	100	100	100	100	100	100	
Longitudinal Crack Index	93	99	99	100	100	99	
Transverse Cracking Index	89	100	100	100	100	93	
Patching Index	100	100	100	100	100	100	
Rutting Index	95	98	97	99	97	92	
International Roughness Index (IRI)	128	98	99	86	110	131	
Lane & Width Information							
Number of Lanes	2	2	2	2	2	2	
Paved Width (ft)	24.2	23.4	23.3	23.8	23	22.9	
Lane Width (ft)	10.3	10.4	10.2	10.4	10.1	10.3

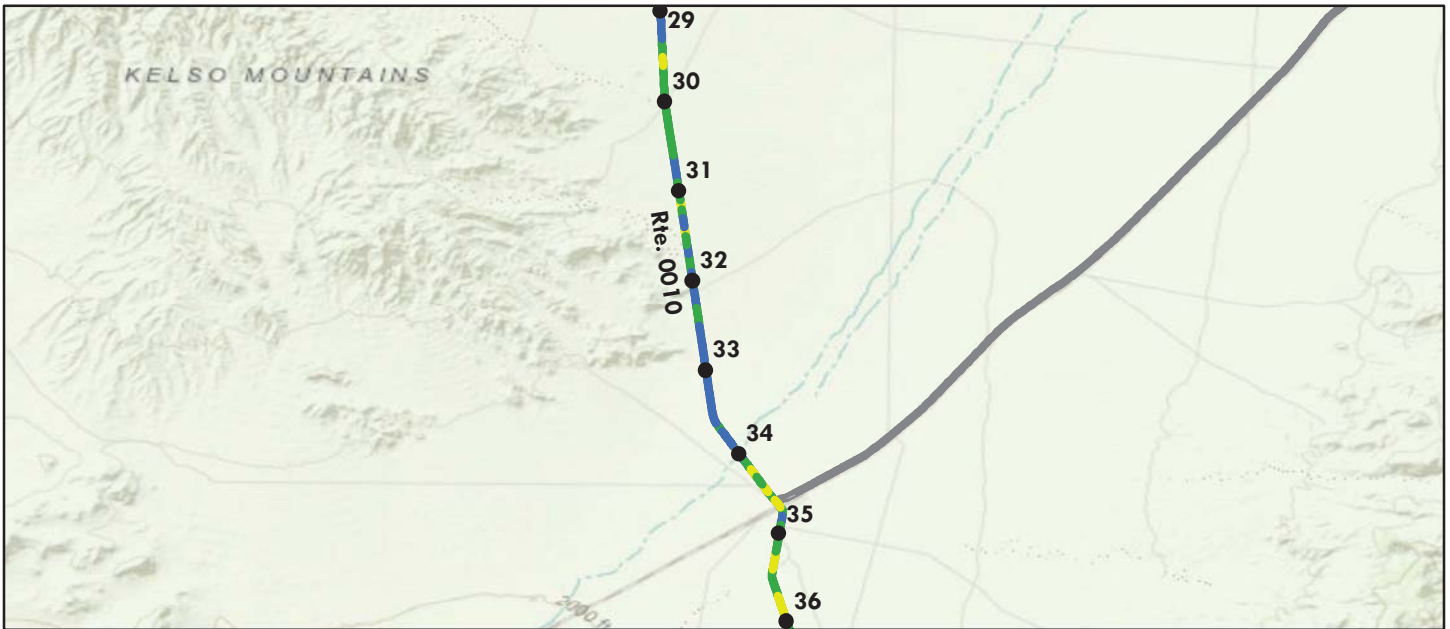
Data Collection Vehicle (DCV) Rating

Route Condition Legend – Pavement Condition Rating (PCR)						
Poor (0 - 60)	Fair (61- 84)	Good (85 - 94)	Excellent (95 - 100)	Not Rated		
Colors on map represent condition scores at 0.10-mile intervals. See Appendix for definitions and formulas.						
Inspection Date: 4/24/2017	Beginning Section MP	30	31	32	33	34
Paved Length (Miles): 56.98	Section Length (MI)	1	1	1	1	1
Surface Type: ASPHALT	Route Summary					
Roadway Condition Information						
Pavement Condition Rating (PCR)	91	93	90	96	94	87
Surface Condition Rating (SCR)	89	93	93	95	96	94
Roughness Condition Index (RCI)	95	94	86	97	91	76
Distress Index Values						
Structural Crack Index	93	99	99	100	99	98
Alligator Crack Index	100	100	100	100	100	100
Longitudinal Crack Index	93	99	99	100	99	98
Transverse Cracking Index	89	97	96	100	100	98
Patching Index	100	100	100	99	99	99
Rutting Index	95	93	93	95	96	94
International Roughness Index (IRI)	128	131	151	122	138	182

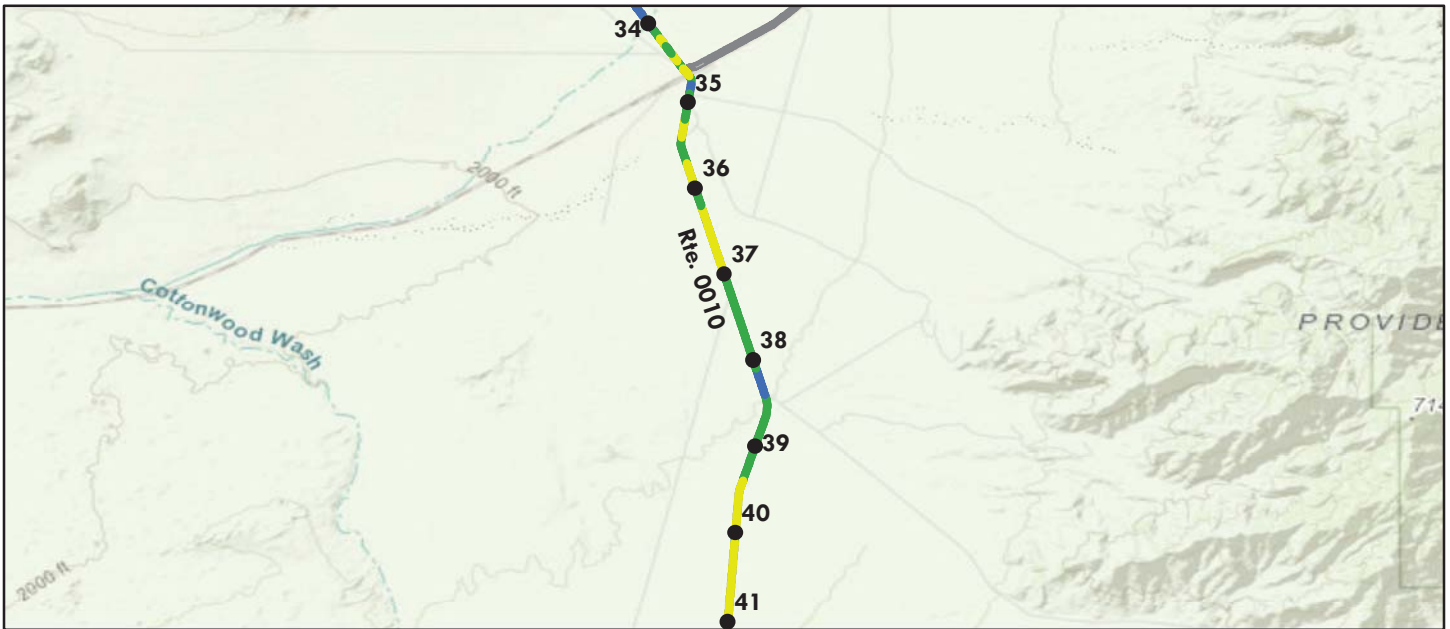
Data Collection Vehicle (DCV) Rating

Route Condition Legend – Pavement Condition Rating (PCR)						
Poor (0 - 60)	Fair (61- 84)	Good (85 - 94)	Excellent (95 - 100)	Not Rated		
Colors on map represent condition scores at 0.10-mile intervals. See Appendix for definitions and formulas.						
Inspection Date: 4/24/2017	Beginning Section MP	35	36	37	38	39
Paved Length (Miles): 56.98	Section Length (MI)	1	1	1	1	1
Surface Type: ASPHALT	Route Summary					
Roadway Condition Information						
Pavement Condition Rating (PCR)	91	89	82	92	94	87
Surface Condition Rating (SCR)	89	81	70	90	92	85
Roughness Condition Index (RCI)	95	100	100	94	96	90
Distress Index Values						
Structural Crack Index	93	81	72	94	98	93
Alligator Crack Index	100	100	100	100	100	100
Longitudinal Crack Index	93	81	72	94	98	93
Transverse Cracking Index	89	82	70	90	98	85
Patching Index	100	100	100	100	100	100
Rutting Index	95	97	96	94	92	96
International Roughness Index (IRI)	128	105	104	131	124	140

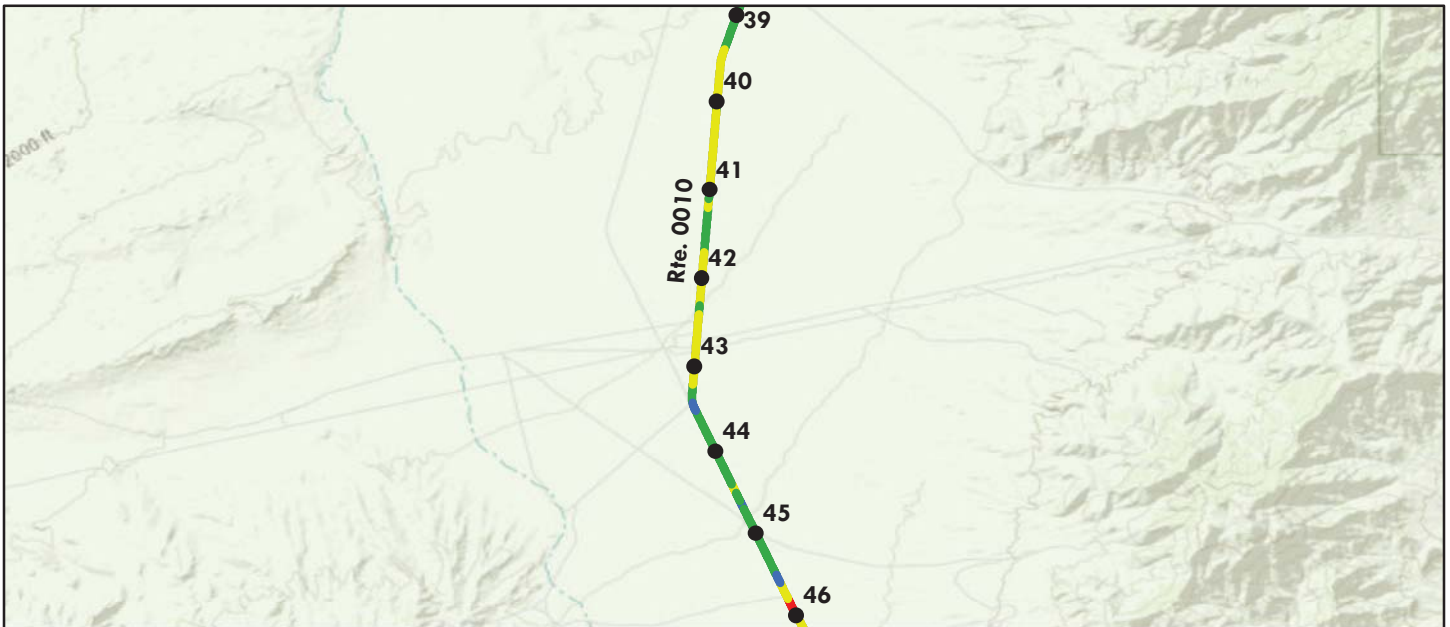
Data Collection Vehicle (DCV) Rating

Route Condition Legend – Pavement Condition Rating (PCR)						
Poor (0 - 60)	Fair (61- 84)	Good (85 - 94)	Excellent (95 - 100)	Not Rated		
Colors on map represent condition scores at 0.10-mile intervals. See Appendix for definitions and formulas.						
Inspection Date: 4/24/2017	Beginning Section MP	40	41	42	43	44
Paved Length (Miles): 56.98	Section Length (MI)	1	1	1	1	1
Surface Type: ASPHALT	Route Summary					
Roadway Condition Information						
Pavement Condition Rating (PCR)	91	76	84	80	89	90
Surface Condition Rating (SCR)	89	70	74	75	86	93
Roughness Condition Index (RCI)	95	86	100	88	93	85
Distress Index Values						
Structural Crack Index	93	89	94	90	96	99
Alligator Crack Index	100	100	100	100	100	100
Longitudinal Crack Index	93	89	94	90	96	99
Transverse Cracking Index	89	70	74	75	86	93
Patching Index	100	100	100	100	100	100
Rutting Index	95	96	95	95	96	94
International Roughness Index (IRI)	128	152	103	145	131	156

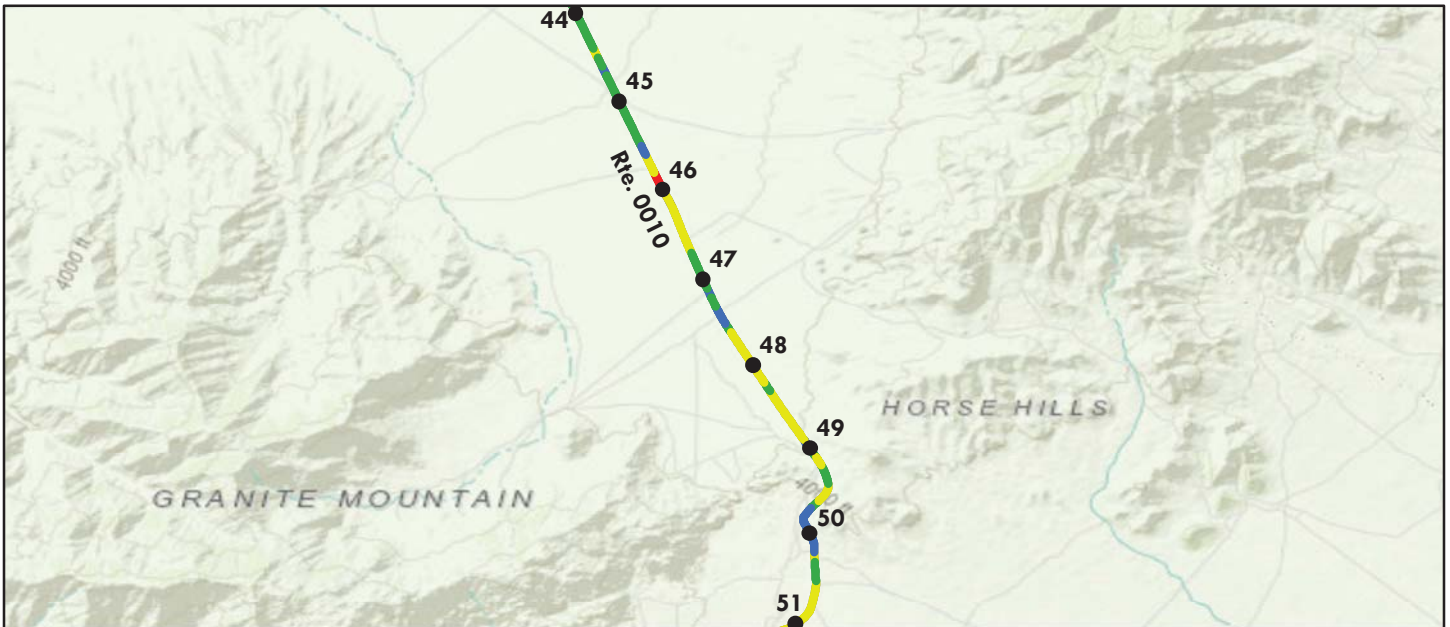
Data Collection Vehicle (DCV) Rating

Colors on map represent condition scores at 0.10-mile intervals. See Appendix for definitions and formulas.

Inspection Date:	4/24/2017	Beginning Section MP	45	46	47	48	49
Paved Length (Miles):	56.98	Section Length (MI)	1	1	1	1	1
Surface Type:	ASPHALT	Route Summary					
Roadway Condition Information							
Pavement Condition Rating (PCR)	91	79	79	92	80	88	
Surface Condition Rating (SCR)	89	77	74	92	88	94	
Roughness Condition Index (RCI)	95	83	86	92	69	79	
Distress Index Values							
Structural Crack Index	93	91	88	92	88	94	
Alligator Crack Index	100	100	100	100	100	100	
Longitudinal Crack Index	93	91	88	92	88	94	
Transverse Cracking Index	89	77	74	93	94	94	
Patching Index	100	100	100	100	98	100	
Rutting Index	95	95	97	95	93	96	
International Roughness Index (IRI)	128	161	151	135	205	171	
Lane & Width Information							
Number of Lanes	2	2	2	2	2	2	
Paved Width (ft)	24.2	23	24.4	25.3	25.7	26.4	
Lane Width (ft)	10.3	9.8	10.7	10.7	10.4	10.8

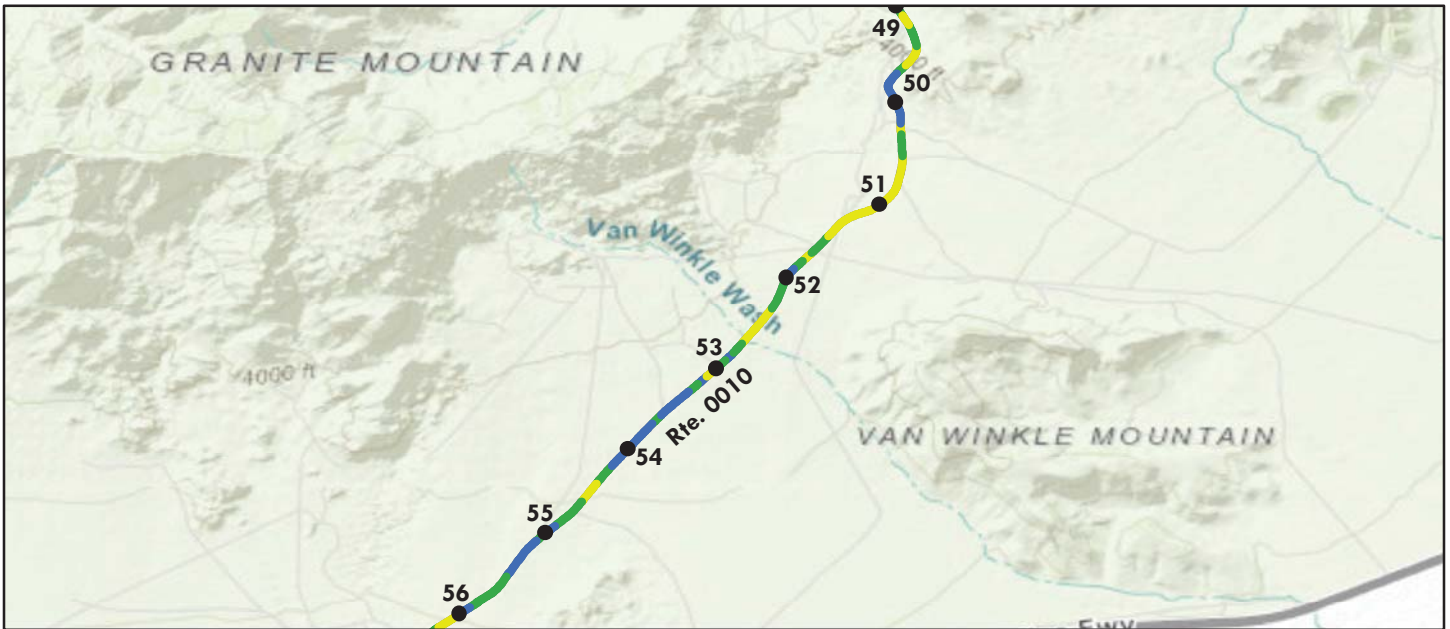
Data Collection Vehicle (DCV) Rating

Colors on map represent condition scores at 0.10-mile intervals. See Appendix for definitions and formulas.

Inspection Date:	4/24/2017	Beginning Section MP	50	51	52	53	54
Paved Length (Miles):	56.98	Section Length (MI)	1	1	1	1	1
Surface Type:	ASPHALT	Route Summary					
Roadway Condition Information							
Pavement Condition Rating (PCR)	91	85	84	86	95	90	
Surface Condition Rating (SCR)	89	83	85	91	93	90	
Roughness Condition Index (RCI)	95	87	82	79	98	91	
Distress Index Values							
Structural Crack Index	93	85	85	96	99	97	
Alligator Crack Index	100	100	100	100	100	100	
Longitudinal Crack Index	93	85	85	96	99	97	
Transverse Cracking Index	89	83	85	95	98	98	
Patching Index	100	99	98	98	99	100	
Rutting Index	95	96	92	91	93	90	
International Roughness Index (IRI)	128	148	164	173	119	137	
Lane & Width Information							
Number of Lanes	2	2	2	2	2	2	
Paved Width (ft)	24.2	26.2	26.1	25.9	25.8	24.9	
Lane Width (ft)	10.3	11	10.7	10.9	11.1	11

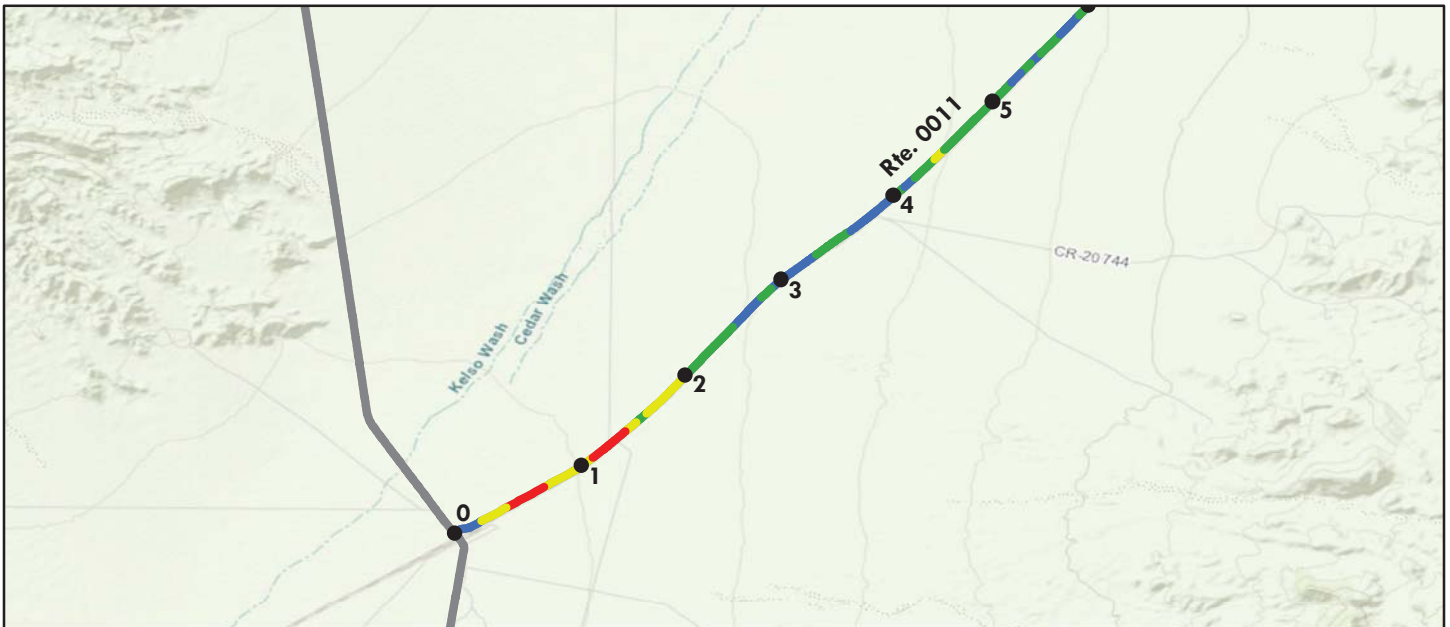
ROUTE 0011: KELSO-CIMA ROAD

Route Condition Legend – Pavement Condition Rating (PCR)						
Poor (0 - 60)	Fair (61- 84)	Good (85 - 94)	Excellent (95 - 100)	Not Rated		
Colors on map represent condition scores at 0.10-mile intervals. See Appendix for definitions and formulas.						
Inspection Date: 4/24/2017	Beginning Section MP	0	1	2	3	4
Paved Length (Miles): 18.96	Section Length (MI)	1	1	1	1	1
Surface Type: ASPHALT	Route Summary					
Roadway Condition Information						
Pavement Condition Rating (PCR)	96	72	66	95	98	91
Surface Condition Rating (SCR)	94	55	43	94	97	92
Roughness Condition Index (RCI)	98	98	100	96	100	90
Distress Index Values						
Structural Crack Index	94	55	43	95	99	93
Alligator Crack Index	100	100	100	100	100	100
Longitudinal Crack Index	94	55	43	95	99	93
Transverse Cracking Index	94	55	59	96	98	93
Patching Index	100	100	100	100	99	100
Rutting Index	97	96	97	94	97	92
International Roughness Index (IRI)	119	120	108	124	115	139

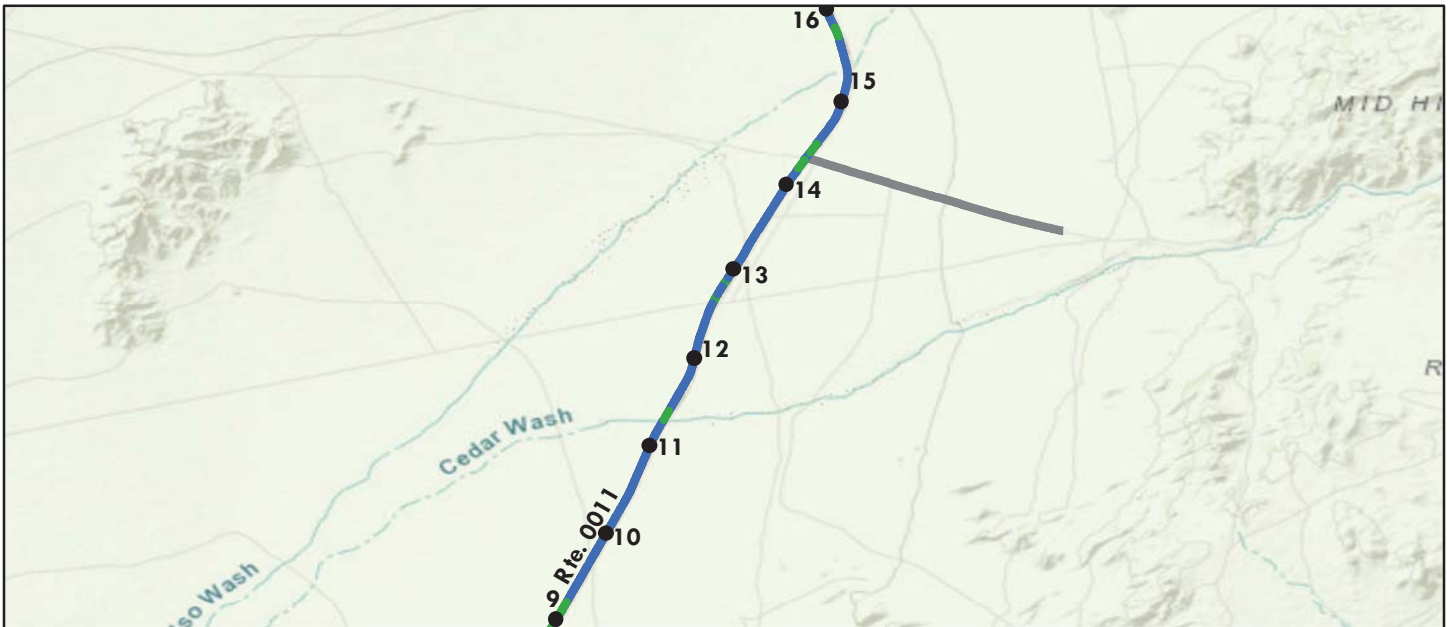
ROUTE 0011: KELSO-CIMA ROAD

Route Condition Legend – Pavement Condition Rating (PCR)						
Poor (0 - 60)	Fair (61- 84)	Good (85 - 94)	Excellent (95 - 100)	Not Rated		
Colors on map represent condition scores at 0.10-mile intervals. See Appendix for definitions and formulas.						
Inspection Date: 4/24/2017	Beginning Section MP	10	11	12	13	14
Paved Length (Miles): 18.96	Section Length (MI)	1	1	1	1	1
Surface Type: ASPHALT	Route Summary					
Roadway Condition Information						
Pavement Condition Rating (PCR)	96	99	99	98	98	97
Surface Condition Rating (SCR)	94	98	98	97	96	97
Roughness Condition Index (RCI)	98	100	100	100	100	96
Distress Index Values						
Structural Crack Index	94	100	100	100	99	100
Alligator Crack Index	100	100	100	100	100	100
Longitudinal Crack Index	94	100	100	100	99	100
Transverse Cracking Index	94	100	100	100	99	100
Patching Index	100	100	100	100	100	100
Rutting Index	97	98	98	97	96	97
International Roughness Index (IRI)	119	93	105	110	107	125

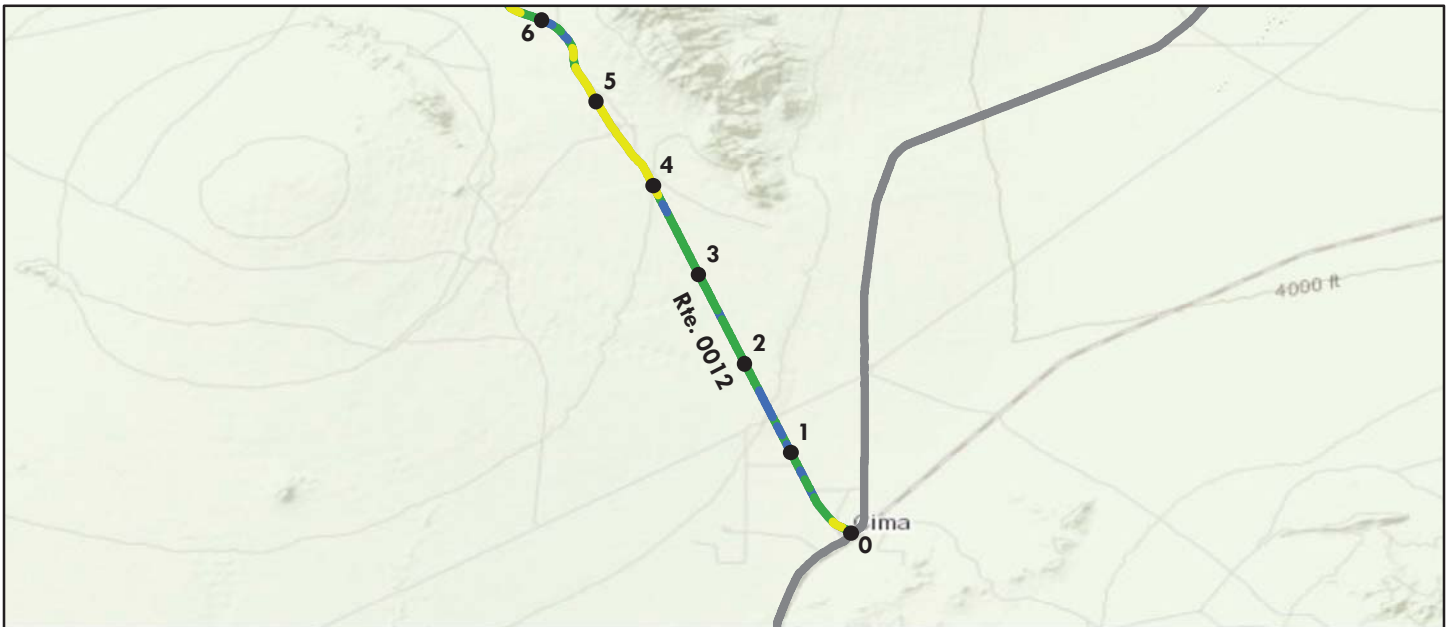
ROUTE 0012: CIMA ROAD

Route Condition Legend – Pavement Condition Rating (PCR)						
Poor (0 - 60)	Fair (61- 84)	Good (85 - 94)	Excellent (95 - 100)	Not Rated		
Colors on map represent condition scores at 0.10-mile intervals. See Appendix for definitions and formulas.						
Inspection Date: 4/25/2017	Beginning Section MP	0	1	2	3	4
Paved Length (Miles): 17.64	Section Length (MI)	1	1	1	1	1
Surface Type: ASPHALT	Route Summary					
Roadway Condition Information						
Pavement Condition Rating (PCR)	86	90	94	91	91	79
Surface Condition Rating (SCR)	84	94	94	91	94	87
Roughness Condition Index (RCI)	89	85	95	92	87	66
Distress Index Values						
Structural Crack Index	93	94	98	98	97	94
Alligator Crack Index	100	100	100	100	100	99
Longitudinal Crack Index	93	94	98	98	97	95
Transverse Cracking Index	84	97	94	91	94	87
Patching Index	99	100	100	99	98	99
Rutting Index	94	96	94	96	95	93
International Roughness Index (IRI)	142	153	127	134	149	217

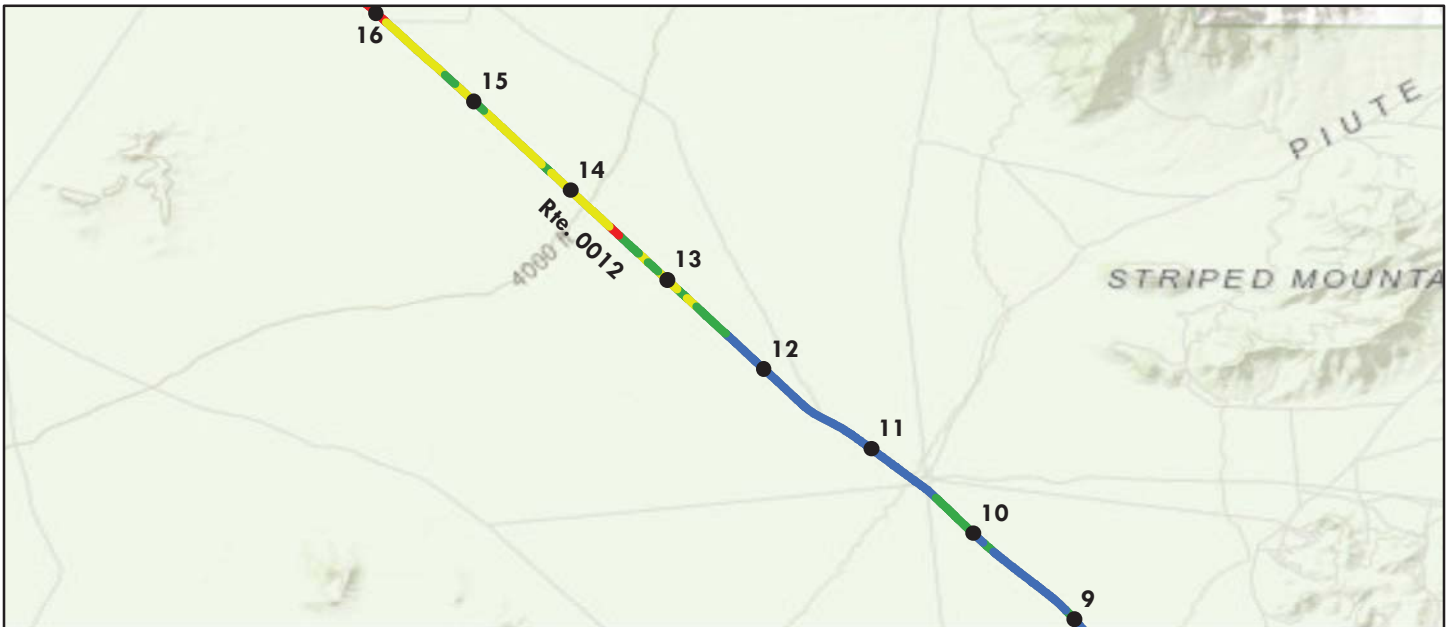
ROUTE 0012: CIMA ROAD

Route Condition Legend – Pavement Condition Rating (PCR)						
Poor (0 - 60)	Fair (61- 84)	Good (85 - 94)	Excellent (95 - 100)	Not Rated		
Colors on map represent condition scores at 0.10-mile intervals. See Appendix for definitions and formulas.						
Inspection Date: 4/25/2017	Beginning Section MP	10	11	12	13	14
Paved Length (Miles): 17.64	Section Length (MI)	1	1	1	1	1
Surface Type: ASPHALT	Route Summary					
Roadway Condition Information						
Pavement Condition Rating (PCR)	86	96	98	91	77	79
Surface Condition Rating (SCR)	84	94	97	91	71	70
Roughness Condition Index (RCI)	89	100	100	90	87	92
Distress Index Values						
Structural Crack Index	93	98	98	96	96	97
Alligator Crack Index	100	100	100	100	100	100
Longitudinal Crack Index	93	98	98	96	96	97
Transverse Cracking Index	84	97	97	92	71	70
Patching Index	99	100	100	99	100	100
Rutting Index	94	94	97	91	95	97
International Roughness Index (IRI)	142	114	94	142	149	134
