MOJA Cycle 6

Road Inventory and Condition Assessment of Paved Routes Mojave National Preserve 2017 Condition Inspection Report

**Federal Lands Highway
Road Inventory Program**

Report Date: September 2018

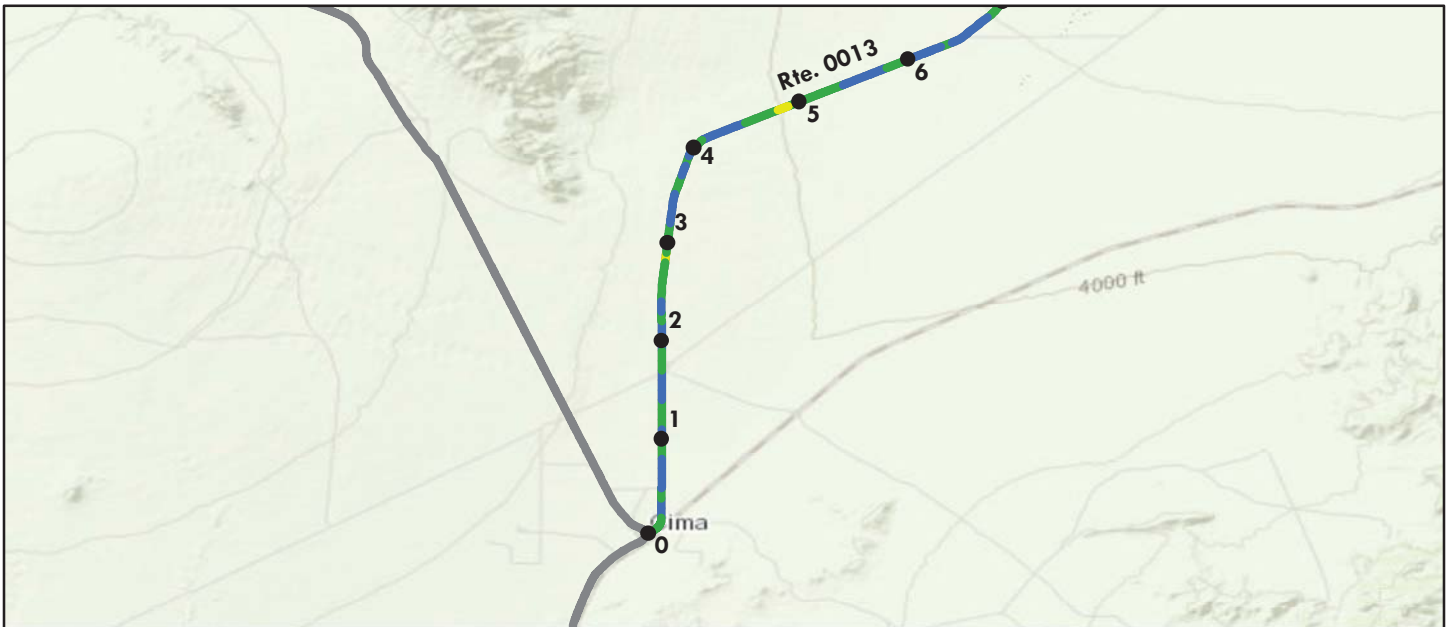
ROUTE 0013: MORNING STAR MINE ROAD

Route Condition Legend – Pavement Condition Rating (PCR)						
Poor (0 - 60)	Fair (61- 84)	Good (85 - 94)	Excellent (95 - 100)	Not Rated		
Colors on map represent condition scores at 0.10-mile intervals. See Appendix for definitions and formulas.						
Inspection Date: 4/25/2017	Beginning Section MP	0	1	2	3	4
Paved Length (Miles): 14.99	Section Length (MI)	1	1	1	1	1
Surface Type: ASPHALT	Route Summary					
Roadway Condition Information						
Pavement Condition Rating (PCR)	92	94	94	89	93	95
Surface Condition Rating (SCR)	86	97	96	97	98	91
Roughness Condition Index (RCI)	100	89	90	78	86	100
Distress Index Values						
Structural Crack Index	92	98	97	100	100	93
Alligator Crack Index	100	100	100	100	100	100
Longitudinal Crack Index	92	98	97	100	100	93
Transverse Cracking Index	86	99	96	100	100	91
Patching Index	100	100	100	100	100	100
Rutting Index	97	97	97	97	98	97
International Roughness Index (IRI)	114	144	141	175	152	103

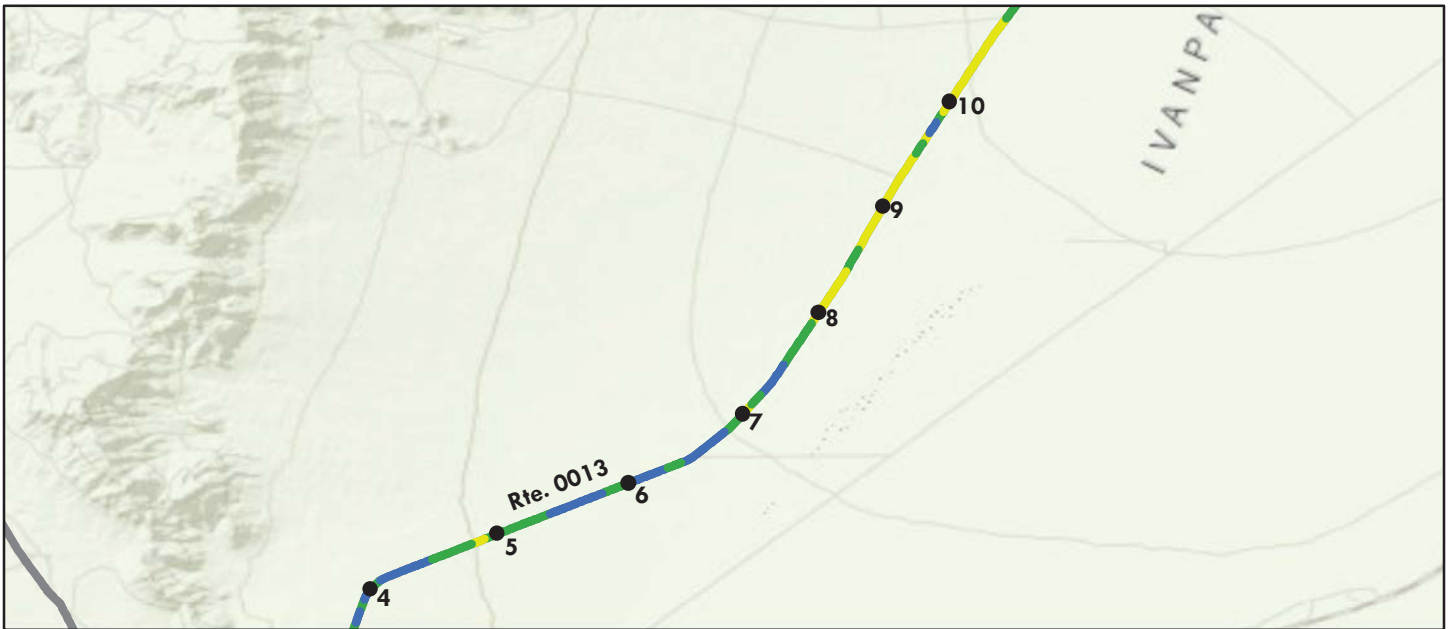
ROUTE 0013: MORNING STAR MINE ROAD

Route Condition Legend – Pavement Condition Rating (PCR)						
Poor (0 - 60)	Fair (61- 84)	Good (85 - 94)	Excellent (95 - 100)	Not Rated		
Colors on map represent condition scores at 0.10-mile intervals. See Appendix for definitions and formulas.						
Inspection Date: 4/25/2017	Beginning Section MP	5	6	7	8	9
Paved Length (Miles): 14.99	Section Length (MI)	1	1	1	1	1
Surface Type: ASPHALT	Route Summary					
Roadway Condition Information						
Pavement Condition Rating (PCR)	92	95	96	93	78	80
Surface Condition Rating (SCR)	86	92	93	88	64	67
Roughness Condition Index (RCI)	100	100	100	100	100	100
Distress Index Values						
Structural Crack Index	92	92	95	89	87	84
Alligator Crack Index	100	100	100	100	100	100
Longitudinal Crack Index	92	92	95	89	87	84
Transverse Cracking Index	86	92	93	88	64	67
Patching Index	100	99	100	100	100	100
Rutting Index	97	98	97	98	97	99
International Roughness Index (IRI)	114	89	80	98	85	113

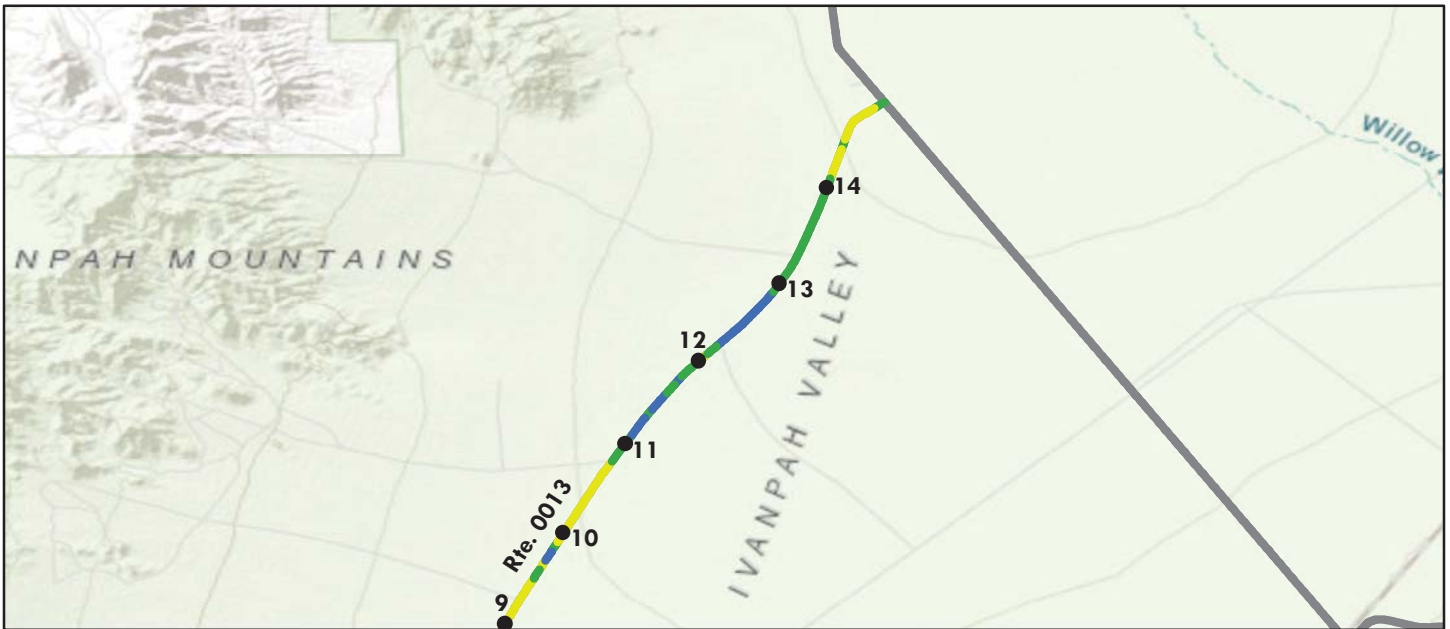
ROUTE 0013: MORNING STAR MINE ROAD

Route Condition Legend – Pavement Condition Rating (PCR)						
Poor (0 - 60)	Fair (61- 84)	Good (85 - 94)	Excellent (95 - 100)	Not Rated		
Colors on map represent condition scores at 0.10-mile intervals. See Appendix for definitions and formulas.						
Inspection Date: 4/25/2017	Beginning Section MP	10	11	12	13	14
Paved Length (Miles): 14.99	Section Length (MI)	1	1	1	1	0.99
Surface Type: ASPHALT	Route Summary					
Roadway Condition Information						
Pavement Condition Rating (PCR)	92	79	95	95	87	82
Surface Condition Rating (SCR)	86	65	92	91	78	74
Roughness Condition Index (RCI)	100	100	100	100	100	95
Distress Index Values						
Structural Crack Index	92	97	98	97	81	74
Alligator Crack Index	100	100	100	100	100	100
Longitudinal Crack Index	92	97	98	97	81	74
Transverse Cracking Index	86	65	92	91	78	77
Patching Index	100	100	100	100	100	100
Rutting Index	97	98	98	97	97	97
International Roughness Index (IRI)	114	100	113	108	90	127

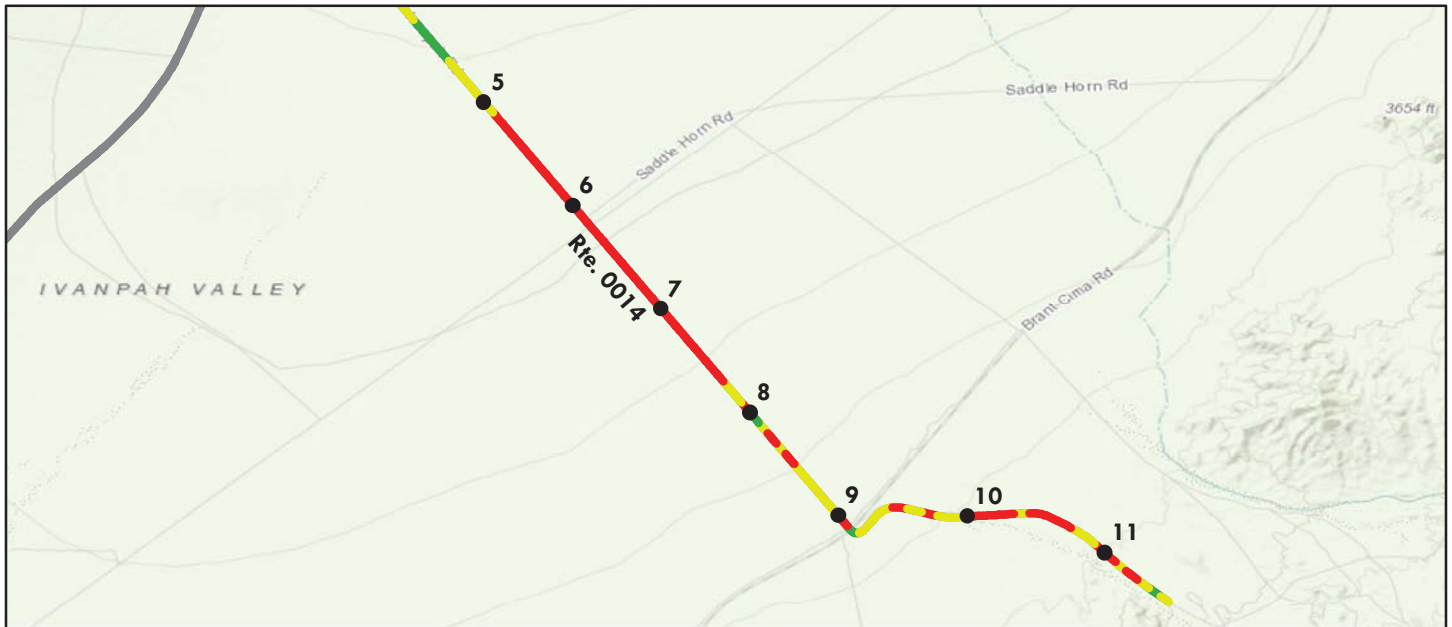
ROUTE 0014: IVANPAH ROAD

Route Condition Legend – Pavement Condition Rating (PCR)						
Poor (0 - 60)	Fair (61- 84)	Good (85 - 94)	Excellent (95 - 100)	Not Rated		
Colors on map represent condition scores at 0.10-mile intervals. See Appendix for definitions and formulas.						
Inspection Date: 4/25/2017	Beginning Section MP	5	6	7	8	9
Paved Length (Miles): 11.57	Section Length (MI)	1	1	1	1	1
Surface Type: ASPHALT	Route Summary					
Roadway Condition Information						
Pavement Condition Rating (PCR)	69	34	24	32	71	62
Surface Condition Rating (SCR)	52	0	0	8	53	54
Roughness Condition Index (RCI)	94	86	59	67	99	74
Distress Index Values						
Structural Crack Index	52	19	0	8	61	71
Alligator Crack Index	94	87	62	81	100	99
Longitudinal Crack Index	58	32	0	27	61	72
Transverse Cracking Index	54	0	0	14	53	54
Patching Index	99	99	93	95	100	99
Rutting Index	96	95	92	93	95	91
International Roughness Index (IRI)	129	152	243	214	116	190
Lane & Width Information

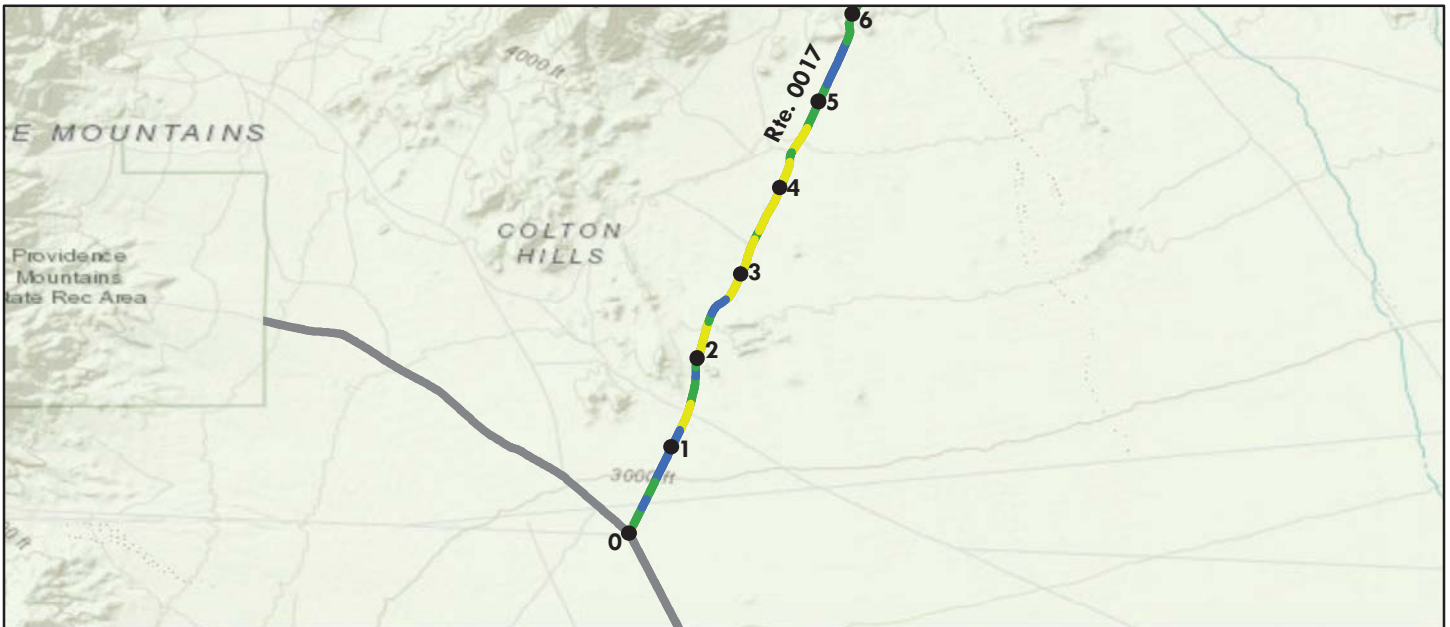
ROUTE 0017: BLACK CANYON ROAD

Route Condition Legend – Pavement Condition Rating (PCR)						
Poor (0 - 60)	Fair (61- 84)	Good (85 - 94)	Excellent (95 - 100)	Not Rated		
Colors on map represent condition scores at 0.10-mile intervals. See Appendix for definitions and formulas.						
Inspection Date: 4/24/2017	Beginning Section MP	0	1	2	3	4
Paved Length (Miles): 10.15	Section Length (MI)	1	1	1	1	1
Surface Type: ASPHALT	Route Summary					
Roadway Condition Information						
Pavement Condition Rating (PCR)	83	95	89	84	80	86
Surface Condition Rating (SCR)	82	96	91	85	82	89
Roughness Condition Index (RCI)	85	94	85	83	78	82
Distress Index Values						
Structural Crack Index	89	100	98	90	82	96
Alligator Crack Index	100	100	100	100	100	100
Longitudinal Crack Index	89	100	98	90	82	96
Transverse Cracking Index	82	99	99	85	82	95
Patching Index	100	100	100	100	100	100
Rutting Index	92	96	91	91	88	89
International Roughness Index (IRI)	154	130	154	161	176	164

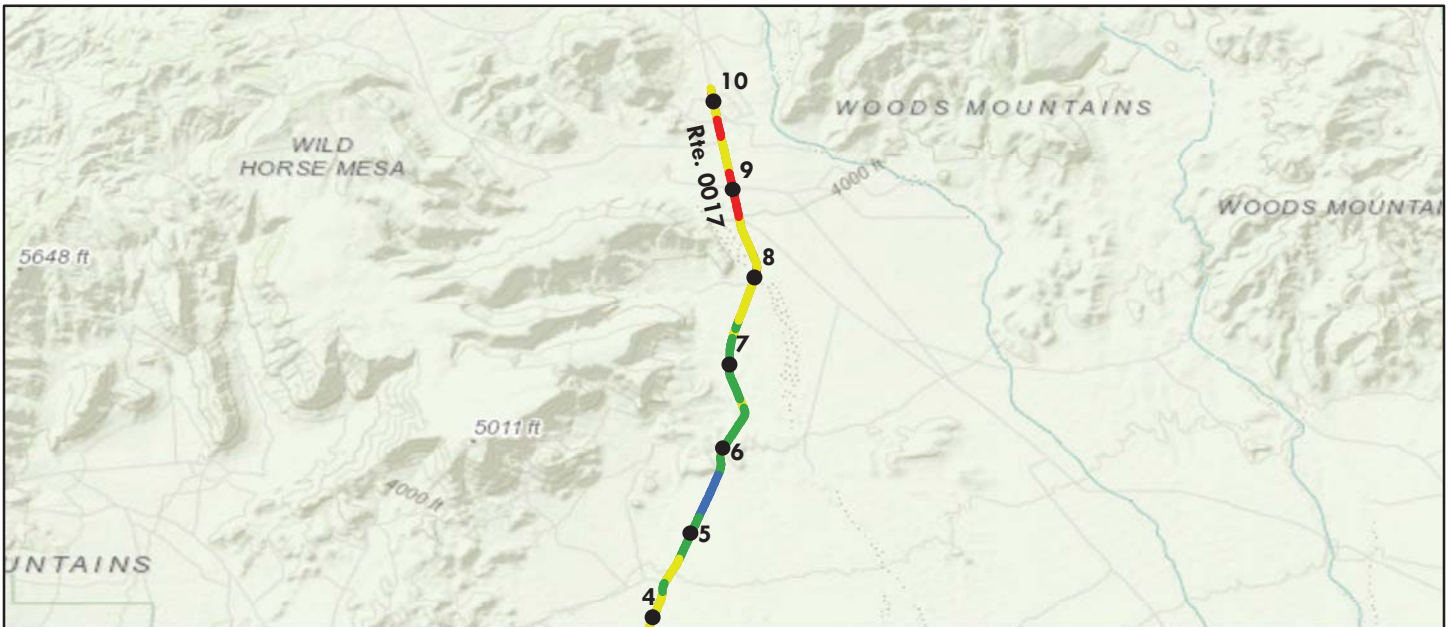
ROUTE 0017: BLACK CANYON ROAD

Route Condition Legend – Pavement Condition Rating (PCR)						
Poor (0 - 60)	Fair (61- 84)	Good (85 - 94)	Excellent (95 - 100)	Not Rated		
Colors on map represent condition scores at 0.10-mile intervals. See Appendix for definitions and formulas.						
Inspection Date: 4/24/2017	Beginning Section MP	5	6	7	8	9
Paved Length (Miles): 10.15	Section Length (MI)	1	1	1	1	1
Surface Type: ASPHALT	Route Summary					
Roadway Condition Information						
Pavement Condition Rating (PCR)	83	93	90	81	65	61
Surface Condition Rating (SCR)	82	93	92	75	47	54
Roughness Condition Index (RCI)	85	93	88	90	92	72
Distress Index Values						
Structural Crack Index	89	94	92	80	76	81
Alligator Crack Index	100	100	100	100	100	100
Longitudinal Crack Index	89	94	92	80	76	81
Transverse Cracking Index	82	93	92	75	47	54
Patching Index	100	100	100	100	100	99
Rutting Index	92	95	94	95	94	89
International Roughness Index (IRI)	154	131	146	140	136	194

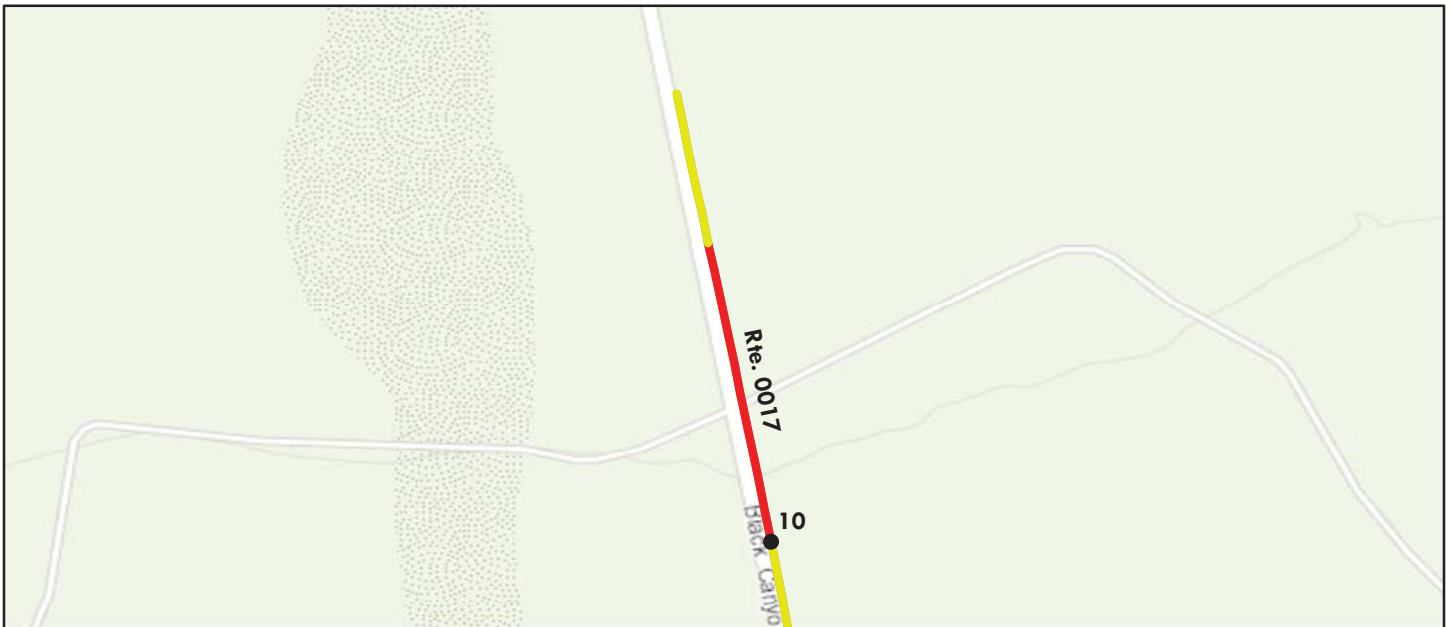
ROUTE 0017: BLACK CANYON ROAD

Inspection Date: 4/24/2017	Beginning Section MP	10				
Paved Length (Miles): 10.15	Section Length (MI)	0.15				
Surface Type: ASPHALT	Route Summary					
Roadway Condition Information						
Pavement Condition Rating (PCR)	83	64				
Surface Condition Rating (SCR)	82	54				
Roughness Condition Index (RCI)	85	80				
Distress Index Values						
Structural Crack Index	89	84				
Alligator Crack Index	100	100				
Longitudinal Crack Index	89	84				
Transverse Cracking Index	82	54				
Patching Index	100	98				
Rutting Index	92	90				
International Roughness Index (IRI)	154	170				
Lane & Width Information						
Number of Lanes	2	2				
Paved Width (ft)	26.9	26				
Lane Width (ft)	10.2	10

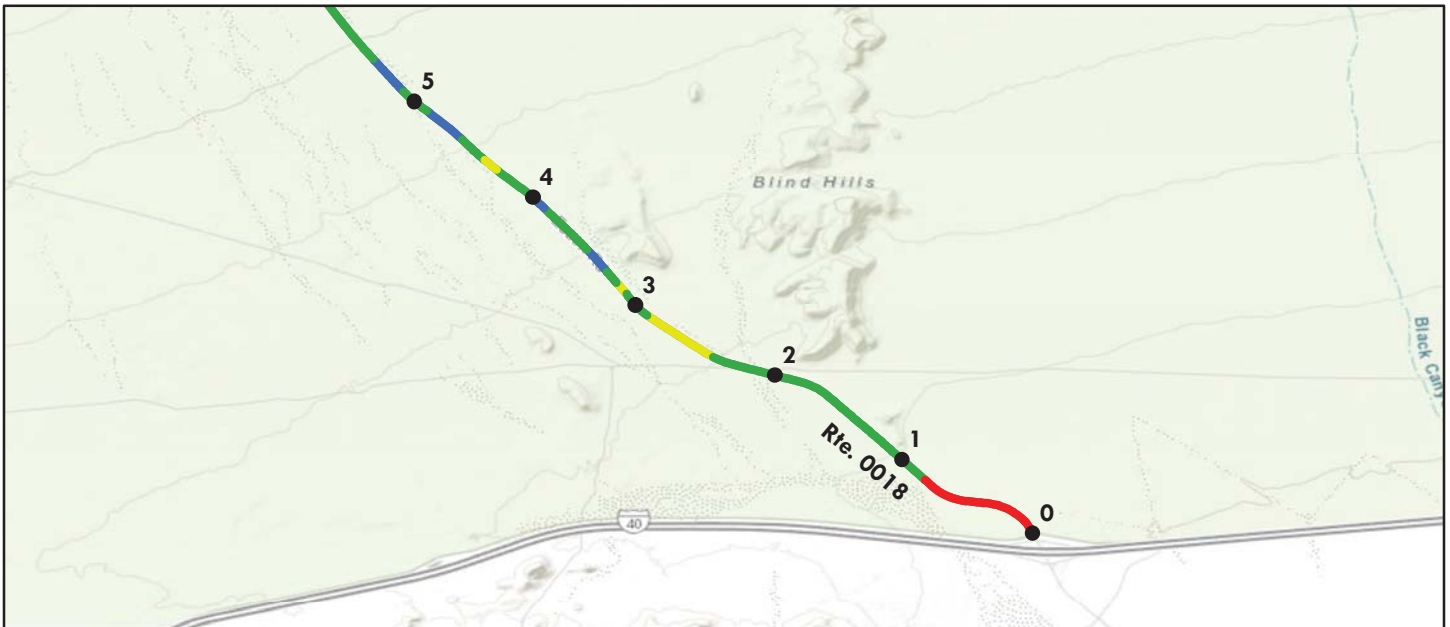
ROUTE 0018: ESSEX ROAD

Route Condition Legend – Pavement Condition Rating (PCR)						
Poor (0 - 60)	Fair (61- 84)	Good (85 - 94)	Excellent (95 - 100)	Not Rated		
Colors on map represent condition scores at 0.10-mile intervals. See Appendix for definitions and formulas.						
Inspection Date: 4/24/2017	Beginning Section MP	0	1	2	3	4
Paved Length (Miles): 13.79	Section Length (MI)	1	1	1	1	1
Surface Type: ASPHALT	Route Summary					
Roadway Condition Information						
Pavement Condition Rating (PCR)	89	52	90	82	91	93
Surface Condition Rating (SCR)	88	26	84	91	94	93
Roughness Condition Index (RCI)	90	92	99	69	87	94
Distress Index Values						
Structural Crack Index	91	32	88	95	99	98
Alligator Crack Index	100	100	100	100	100	100
Longitudinal Crack Index	91	32	88	95	99	98
Transverse Cracking Index	88	26	84	91	95	93
Patching Index	99	98	100	99	99	100
Rutting Index	94	92	95	94	94	96
International Roughness Index (IRI)	141	134	118	205	150	131

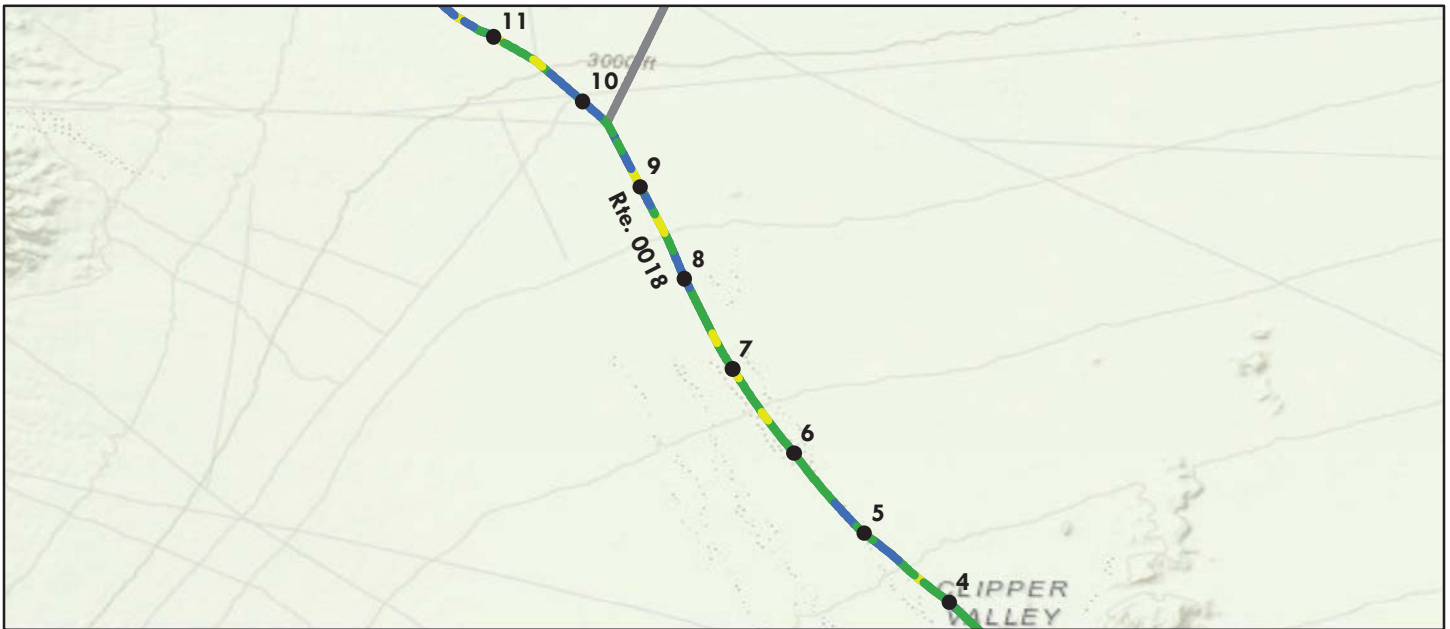
ROUTE 0018: ESSEX ROAD

Inspection Date:	4/24/2017	Beginning Section MP	5	6	7	8	9
	Paved Length (Miles):	13.79	Section Length (MI)	1	1	1	1
Surface Type:	ASPHALT	Route Summary					
Roadway Condition Information							
Pavement Condition Rating (PCR)	89	94	88	93	93	93	
Surface Condition Rating (SCR)	88	90	82	88	91	93	
Roughness Condition Index (RCI)	90	100	98	100	95	93	
Distress Index Values							
Structural Crack Index	91	95	91	94	95	99	
Alligator Crack Index	100	100	100	100	100	100	
Longitudinal Crack Index	91	95	91	94	95	99	
Transverse Cracking Index	88	90	82	88	91	98	
Patching Index	99	100	100	100	100	100	
Rutting Index	94	96	93	93	94	93	
International Roughness Index (IRI)	141	115	120	107	127	132	
Lane & Width Information							
Number of Lanes	2	2	2	2	2	2	
Paved Width (ft)	23.9	24.1	24.3	24.3	22.6	23.7	
Lane Width (ft)	10	10.4	9.9	10	10.1	9.9

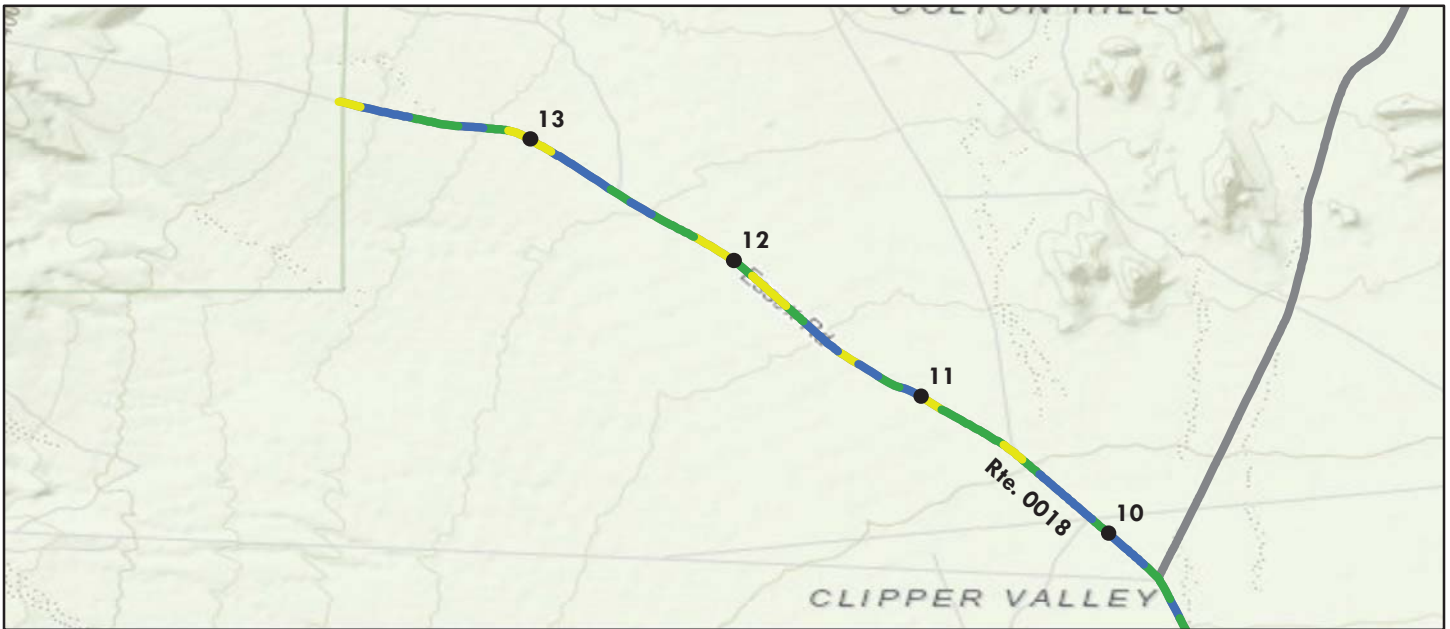
ROUTE 0018: ESSEX ROAD

Route Condition Legend – Pavement Condition Rating (PCR)						
Poor (0 - 60)	Fair (61- 84)	Good (85 - 94)	Excellent (95 - 100)	Not Rated		
Colors on map represent condition scores at 0.10-mile intervals. See Appendix for definitions and formulas.						
Inspection Date: 4/24/2017	Beginning Section MP	10	11	12	13	
Paved Length (Miles): 13.79	Section Length (MI)	1	1	1	0.79	
Surface Type: ASPHALT	Route Summary					
Roadway Condition Information						
Pavement Condition Rating (PCR)	89	90	91	90	89	
Surface Condition Rating (SCR)	88	95	94	94	95	
Roughness Condition Index (RCI)	90	82	86	85	79	
Distress Index Values						
Structural Crack Index	91	99	98	98	97	
Alligator Crack Index	100	100	100	100	100	
Longitudinal Crack Index	91	99	98	98	97	
Transverse Cracking Index	88	99	99	98	97	
Patching Index	99	99	100	100	97	
Rutting Index	94	95	94	94	95	
International Roughness Index (IRI)	141	163	152	154	172	
Lane & Width Information

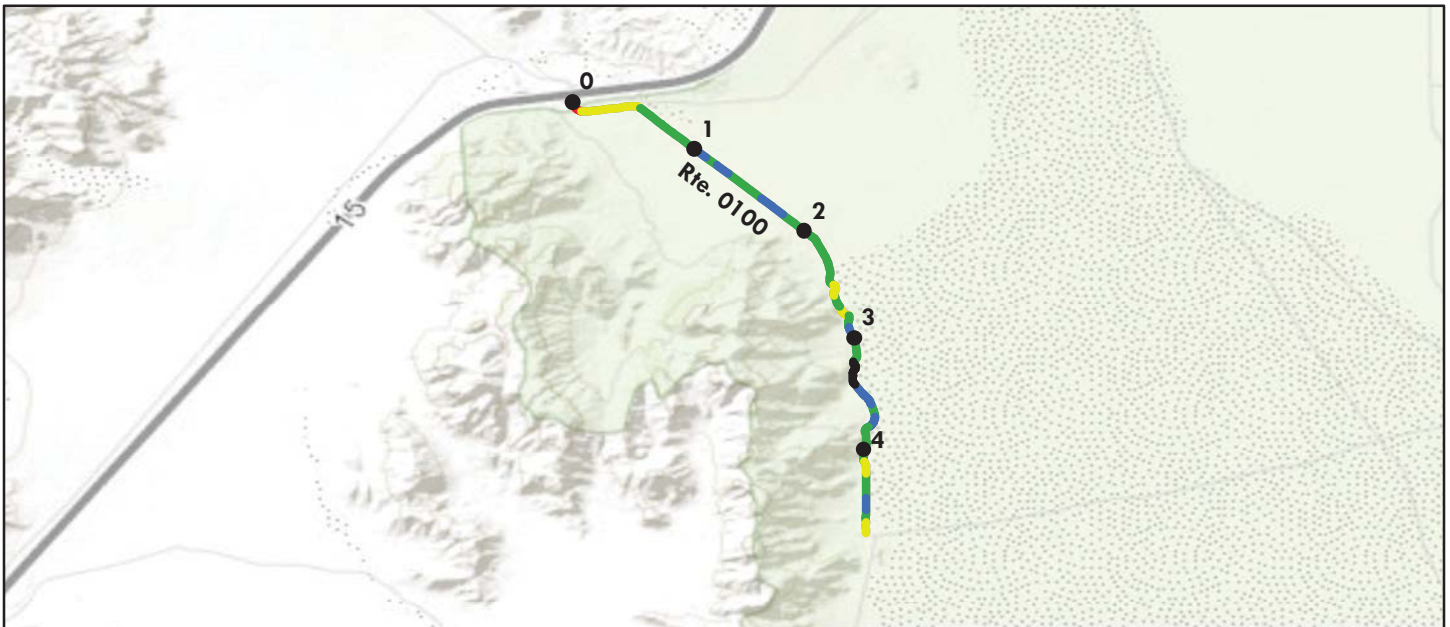
ROUTE 0100: ZZYZX ROAD

Route Condition Legend – Pavement Condition Rating (PCR)						
Poor (0 - 60)	Fair (61- 84)	Good (85 - 94)	Excellent (95 - 100)	Not Rated		
Colors on map represent condition scores at 0.10-mile intervals. See Appendix for definitions and formulas.						
Inspection Date: 4/24/2017	Beginning Section MP	0	1	2	3	4
Paved Length (Miles): 4.47	Section Length (MI)	1	1	1	1	0.69
Surface Type: ASPHALT	Route Summary					
Roadway Condition Information						
Pavement Condition Rating (PCR)	90	78	93	88	92	89
Surface Condition Rating (SCR)	94	80	95	93	94	93
Roughness Condition Index (RCI)	83	75	90	81	90	82
Distress Index Values						
Structural Crack Index	96	81	100	100	100	100
Alligator Crack Index	100	100	100	100	100	100
Longitudinal Crack Index	96	81	100	100	100	100
Transverse Cracking Index	95	80	100	100	100	100
Patching Index	100	100	100	100	100	100
Rutting Index	94	95	95	93	94	93
International Roughness Index (IRI)	160	183	142	167	141	164

Note: Route 0100 has a gravel section of 0.20 miles that was not included in the condition rating.

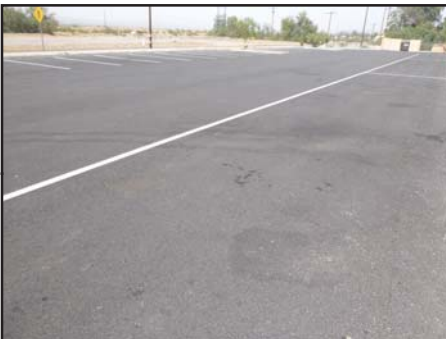
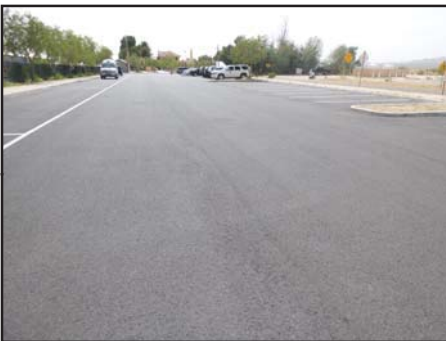
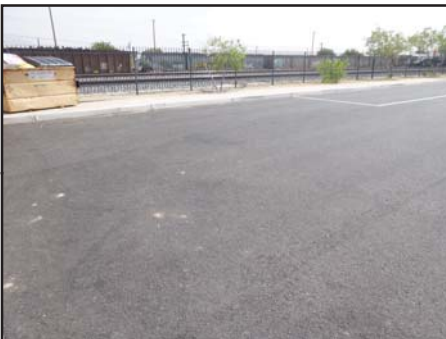
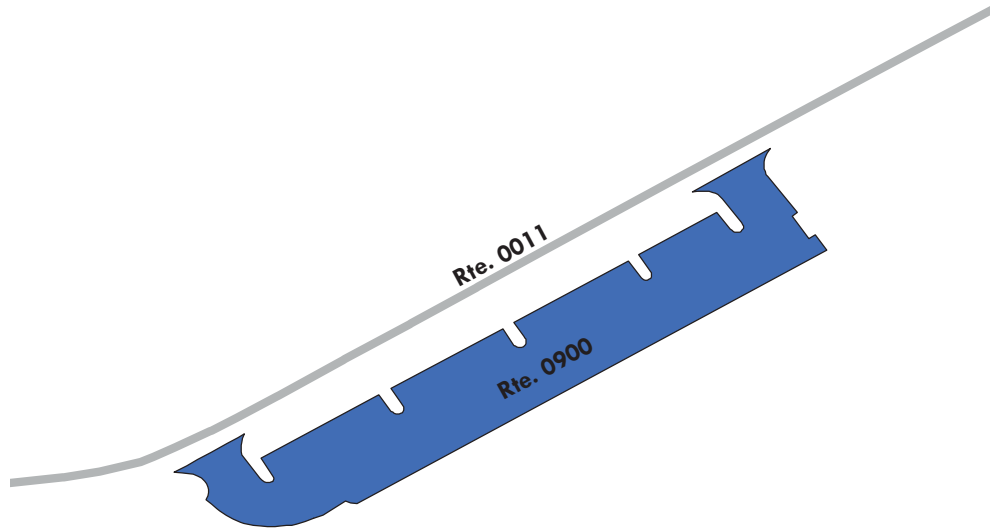
Inspection Date	FMSS Number	User Access	Surface Type
4/24/2017	228803	PUBLIC	ASPHALT
Area (Sq. Ft.)	Lane Miles (11' Widths)	Curb Reveal (Inches)	Curb Recommendation
29,051	0.5	6	DO NOTHING
Curb Type		Curb & Gutter Type	
CONCRETE		NO CURB AND GUTTER	
Pavement Recommendation		Condition Rating / PCR	
DO NOTHING		EXCELLENT / 97

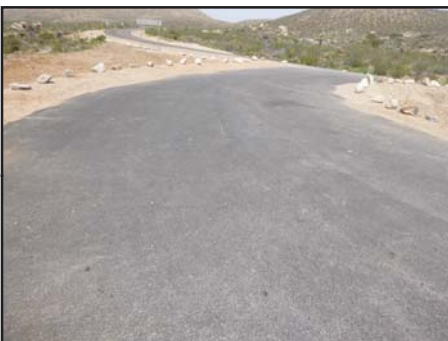
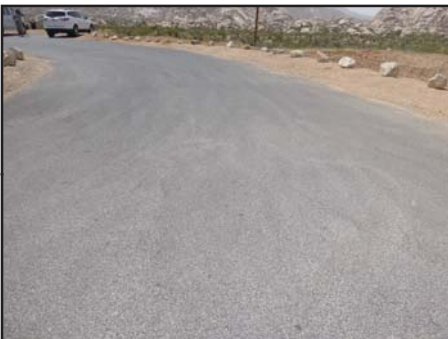
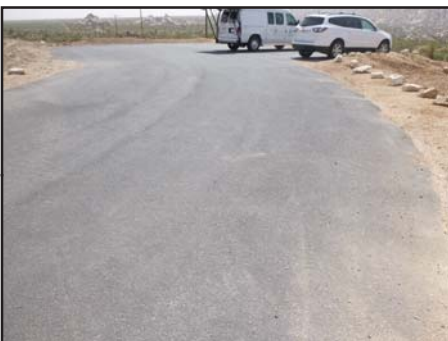
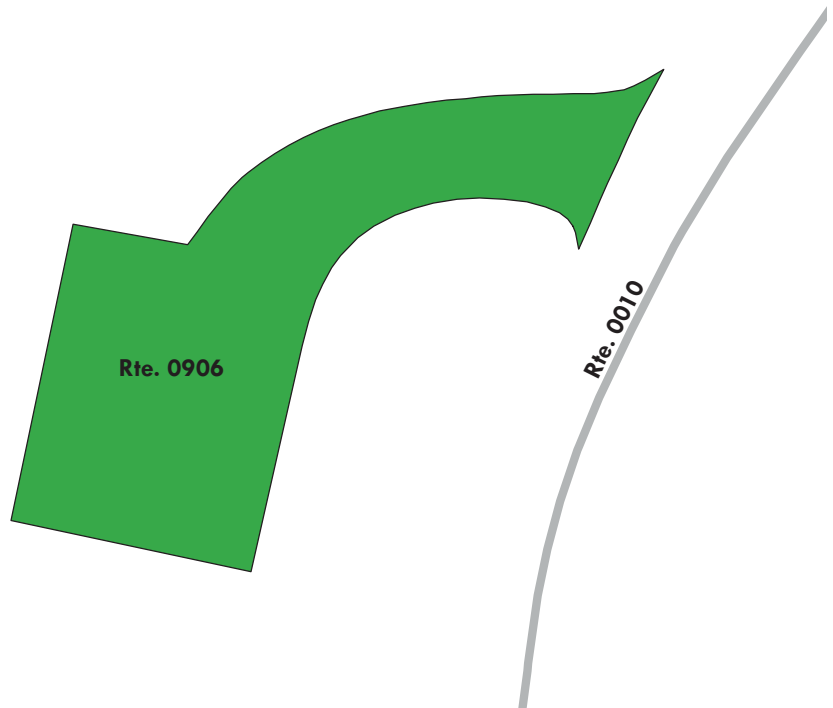
Inspection Date	FMSS Number	User Access	Surface Type
4/24/2017	248766	PUBLIC	ASPHALT
Area (Sq. Ft.)	Lane Miles (11' Widths)	Curb Reveal (Inches)	Curb Recommendation
5,358	0.092	NOT APPLICABLE	NOT APPLICABLE
Curb Type		Curb & Gutter Type	
NO CURB		NO CURB AND GUTTER	
Pavement Recommendation		Condition Rating / PCR	
PREVENTIVE MAINTENANCE		GOOD / 90

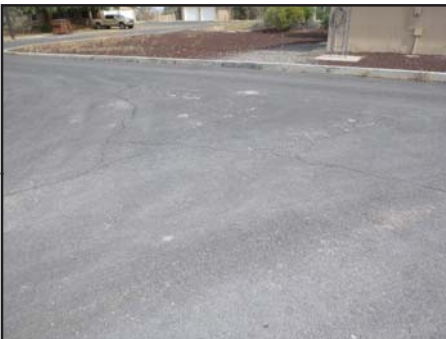
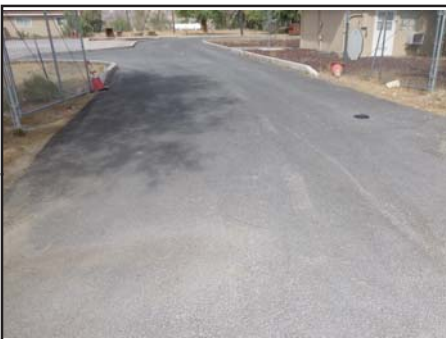
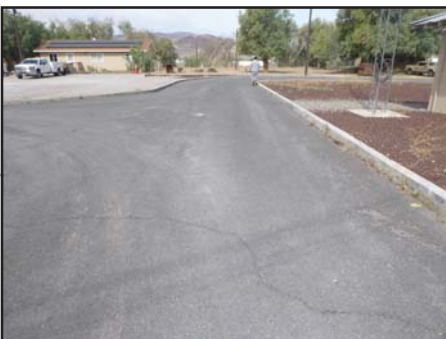
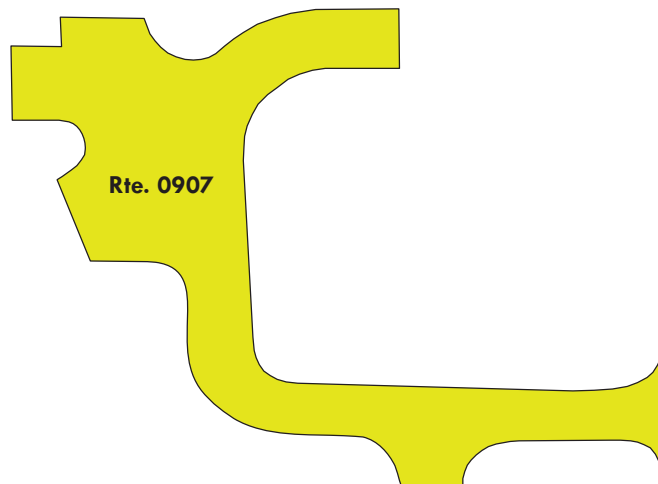
Inspection Date	FMSS Number	User Access	Surface Type
4/24/2017	113329	PUBLIC	ASPHALT
Area (Sq. Ft.)	Lane Miles (11' Widths)	Curb Reveal (Inches)	Curb Recommendation
10,066	0.173	6	LIGHT REPAIR
Curb Type		Curb & Gutter Type	
CONCRETE		NO CURB AND GUTTER	
Pavement Recommendation		Condition Rating / PCR	
LIGHT 3R TREATMENTS		FAIR / 73
