# MONO Cycle 6

## Final Report

### Road Inventory and Condition Assessment of Paved Routes Monocacy National Battlefield

Federal Highway Administration  
Eastern Federal Lands Highway Division  
Road Inventory Program (RIP)

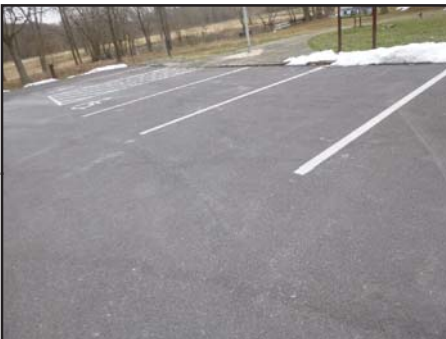
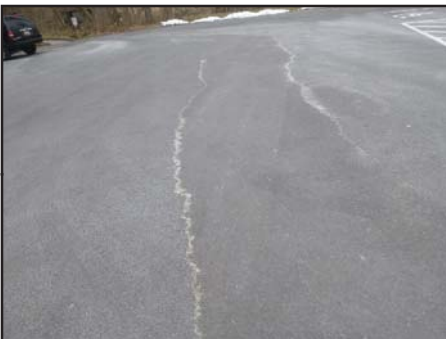
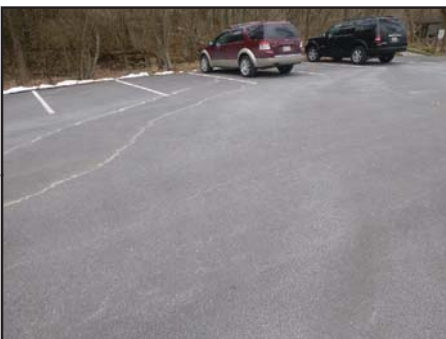
Inspection Date	FMSS Number	User Access	Surface Type
3/27/2018	71001	PUBLIC	ASPHALT
Area (Sq. Ft.)	Lane Miles (11' Widths)	Curb Reveal (Inches)	Curb Recommendation
8,850	0.152	3	MODERATE REPAIR
Curb Type		Curb & Gutter Type	
WOOD		NO CURB AND GUTTER	
Pavement Recommendation		Condition Rating / PCR	
PREVENTIVE MAINTENANCE		GOOD / 90

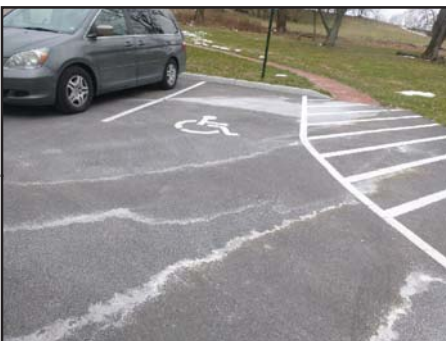
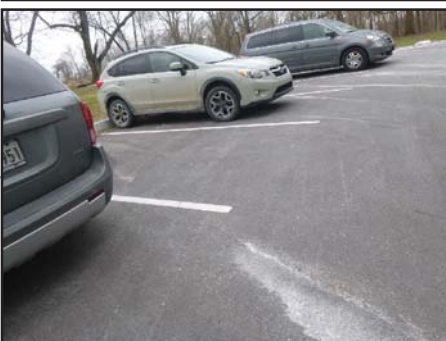
## ROUTE 0903: HPTC PARKING

Inspection Date	FMSS Number	User Access	Surface Type
3/27/2018	71014	NONPUBLIC	ASPHALT
Area (Sq. Ft.)	Lane Miles (11' Widths)	Curb Reveal (Inches)	Curb Recommendation
1,253	0.022	5	DO NOTHING
Curb Type		Curb & Gutter Type	
CONCRETE		NO CURB AND GUTTER	
Pavement Recommendation		Condition Rating / PCR	
PREVENTIVE MAINTENANCE		GOOD / 90

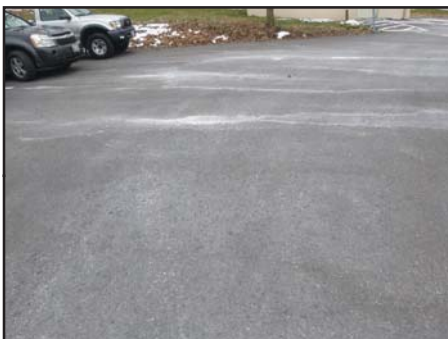
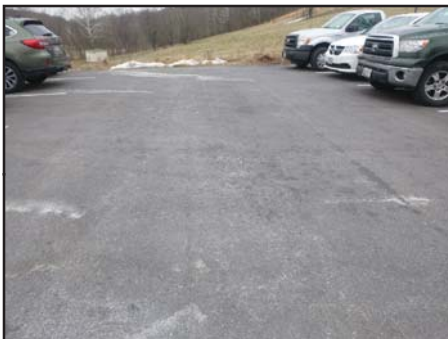
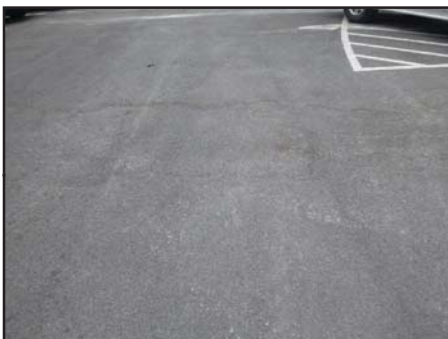
## ROUTE 0904: HPTC FENCED PARKING

Inspection Date	FMSS Number	User Access	Surface Type
3/27/2018	71013	NONPUBLIC	ASPHALT
Area (Sq. Ft.)	Lane Miles (11' Widths)	Curb Reveal (Inches)	Curb Recommendation
7,763	0.134	NOT APPLICABLE	NOT APPLICABLE
Curb Type		Curb & Gutter Type	
NO CURB		NO CURB AND GUTTER	
Pavement Recommendation		Condition Rating / PCR	
PREVENTIVE MAINTENANCE		GOOD / 90

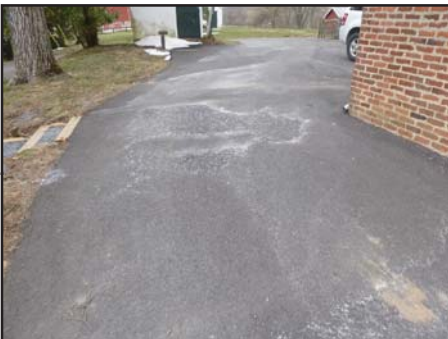
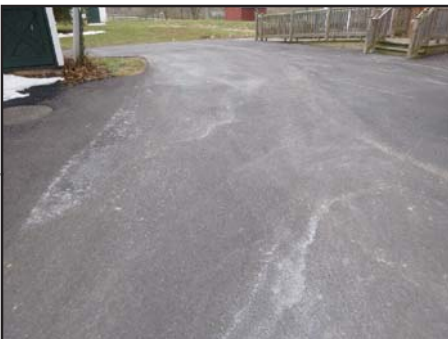
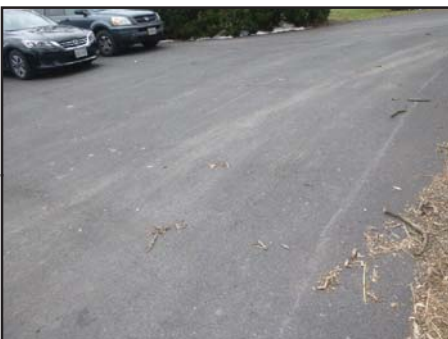
## ROUTE 0905: THOMAS FARM PARKING

Inspection Date	FMSS Number	User Access	Surface Type
3/27/2018	71944	NONPUBLIC	ASPHALT
Area (Sq. Ft.)	Lane Miles (11' Widths)	Curb Reveal (Inches)	Curb Recommendation
6,826	0.118	NOT APPLICABLE	NOT APPLICABLE
Curb Type		Curb & Gutter Type	
NO CURB		NO CURB AND GUTTER	
Pavement Recommendation		Condition Rating / PCR	
PREVENTIVE MAINTENANCE		GOOD / 90

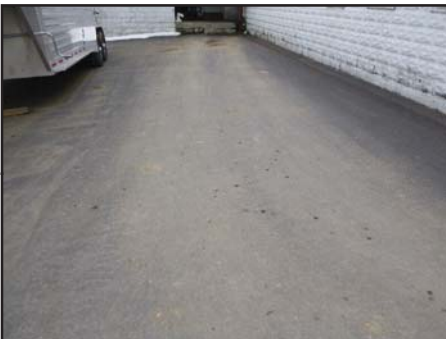
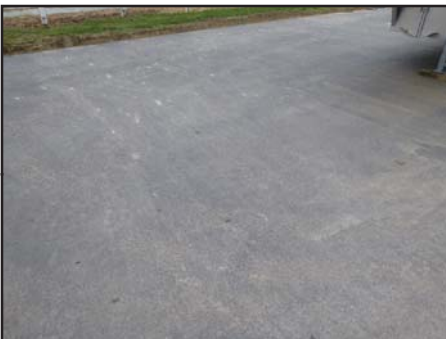
## ROUTE 0907: BAKER FARM PARKING

Inspection Date	FMSS Number	User Access	Surface Type
3/27/2018	104051	NONPUBLIC	ASPHALT
Area (Sq. Ft.)	Lane Miles (11' Widths)	Curb Reveal (Inches)	Curb Recommendation
2,601	0.045	NOT APPLICABLE	NOT APPLICABLE
Curb Type		Curb & Gutter Type	
NO CURB		NO CURB AND GUTTER	
Pavement Recommendation		Condition Rating / PCR	
PREVENTIVE MAINTENANCE		GOOD / 90

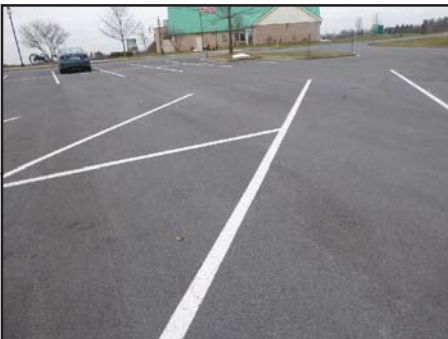
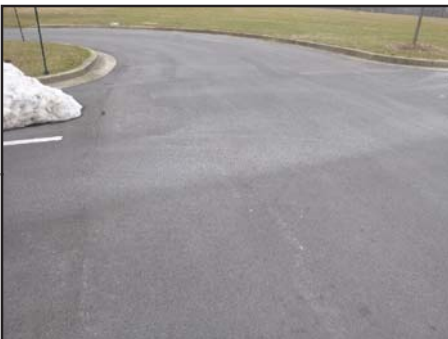
## ROUTE 0908: VISITOR CENTER PARKING

Inspection Date	FMSS Number	User Access	Surface Type
3/27/2018	225258	PUBLIC	ASPHALT
Area (Sq. Ft.)	Lane Miles (11' Widths)	Curb Reveal (Inches)	Curb Recommendation
22,141	0.381	NOT APPLICABLE	DO NOTHING
Curb Type		Curb & Gutter Type	
NO CURB		CONCRETE	
Pavement Recommendation		Condition Rating / PCR	
PREVENTIVE MAINTENANCE		GOOD / 90
