# MORR Cycle 6

## Final Report

### Road Inventory and Condition Assessment of Paved Routes Morristown National Historical Park

**Report Date: September 2021**

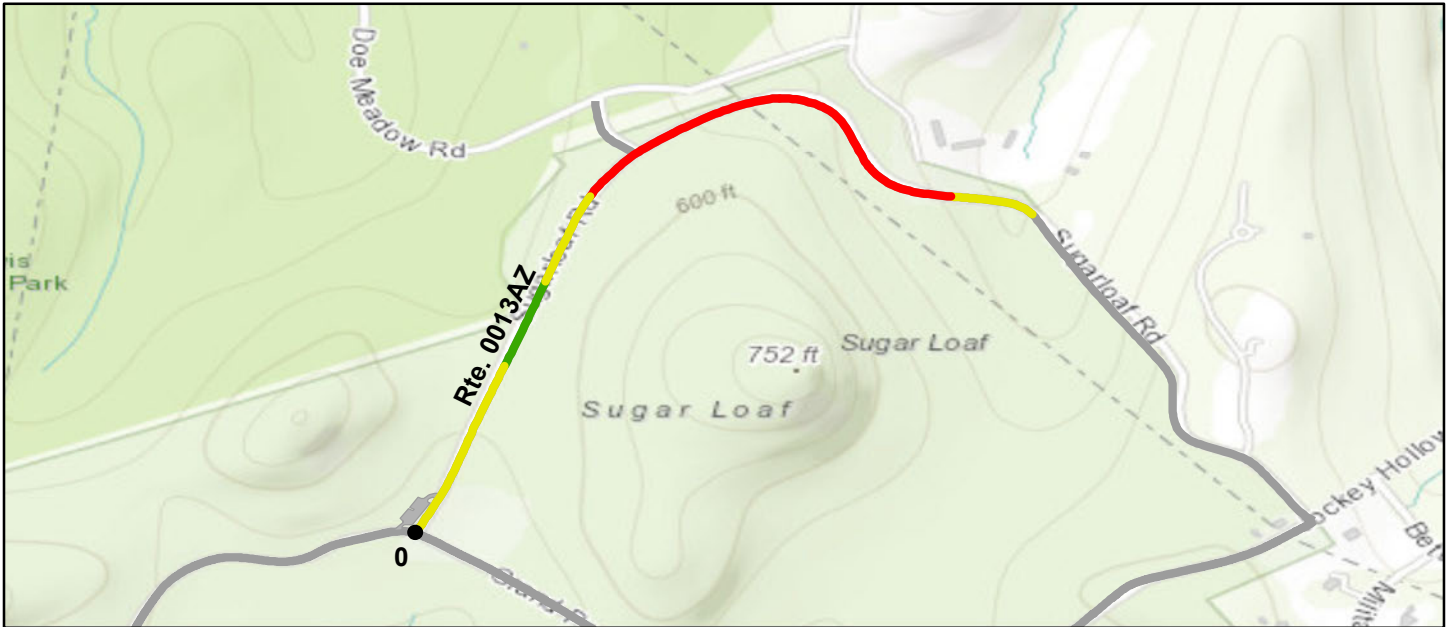
Subcomponent of Route MORR-0013ZZ  
 Data Collection Vehicle (DCV) Rating

<b>Inspection Date:</b>	11/14/2020	<b>Beginning Section MP</b>	0				
<b>Paved Length (Miles):</b>	0.87	<b>Section Length (MI)</b>	0.87				
<b>Surface Type:</b>	ASPHALT	<b>Route Summary</b>					
<b>Roadway Condition Information</b>							
Pavement Condition Rating (PCR)	58	58					
Surface Condition Rating (SCR)	51	51					
Roughness Condition Index (RCI)	69	69					
<b>Distress Index Values</b>							
Structural Crack Index	51	51					
Alligator Crack Index	100	100					
Longitudinal Crack Index	51	51					
Transverse Cracking Index	92	92					
Patching Index	100	100					
Rutting Index	93	93					
International Roughness Index (IRI)	205	204					
<b>Lane &amp; Width Information</b>							
Number of Lanes	2	2					
Paved Width (ft)	18.5	18.5					
Lane Width (ft)	9.1	9.1

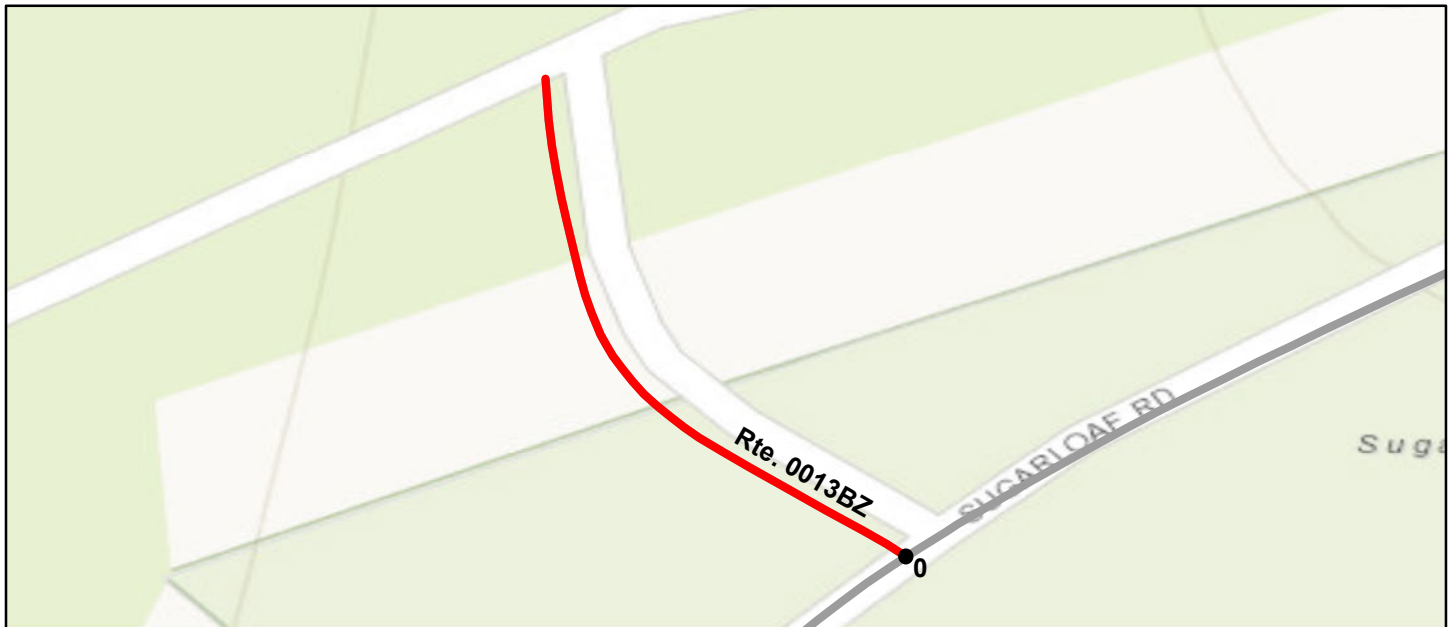
Subcomponent of Route MORR-0013ZZ  
Data Collection Vehicle (DCV) Rating

<b>Route Condition Legend – Pavement Condition Rating (PCR)</b>						
<b>Poor (0 - 60)</b>	<b>Fair (61- 84)</b>	<b>Good (85 - 94)</b>	<b>Excellent (95 - 100)</b>	<b>Not Rated</b>		
Colors on map represent condition scores at 0.10-mile intervals. See Appendix for definitions and formulas.						
<b>Inspection Date:</b>	11/14/2020	<b>Beginning Section MP</b>	0			
<b>Paved Length (Miles):</b>	0.07	<b>Section Length (MI)</b>	0.07			
<b>Surface Type:</b>	ASPHALT	<b>Route Summary</b>				
<b>Roadway Condition Information</b>						
Pavement Condition Rating (PCR)	31	31				
Surface Condition Rating (SCR)	31	31				
Roughness Condition Index (RCI)	N/A	N/A				
<b>Distress Index Values</b>						
Structural Crack Index	31	31				
Alligator Crack Index	100	100				
Longitudinal Crack Index	31	31				
Transverse Cracking Index	67	67				
Patching Index	100	100				
Rutting Index	97	97				
International Roughness Index (IRI)	N/A	N/A

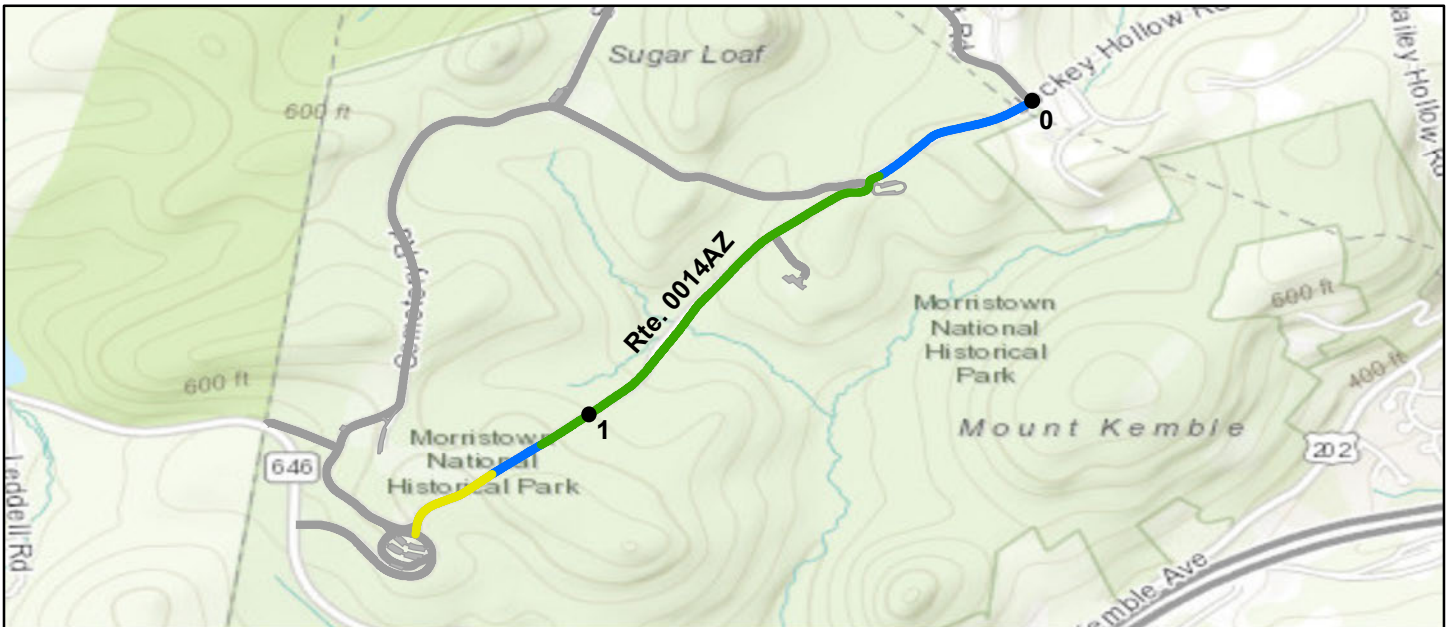
Data Collection Vehicle (DCV) Rating

<b>Inspection Date:</b>	11/14/2020	<b>Beginning Section MP</b>	0	1			
<b>Paved Length (Miles):</b>	1.38	<b>Section Length (MI)</b>	1	0.38			
<b>Surface Type:</b>	ASPHALT	<b>Route Summary</b>					
<b>Roadway Condition Information</b>							
Pavement Condition Rating (PCR)	91	92	83				
Surface Condition Rating (SCR)	91	92	83				
Roughness Condition Index (RCI)	N/A	N/A	N/A				
<b>Distress Index Values</b>							
Structural Crack Index	91	92	86				
Alligator Crack Index	100	100	100				
Longitudinal Crack Index	91	92	86				
Transverse Cracking Index	91	94	83				
Patching Index	100	100	100				
Rutting Index	99	98	99				
International Roughness Index (IRI)	N/A	N/A	N/A				
<b>Lane &amp; Width Information</b>							
Number of Lanes	2	2	2				
Paved Width (ft)	18.2	18.7	16.8				
Lane Width (ft)	9	9.2	8.4

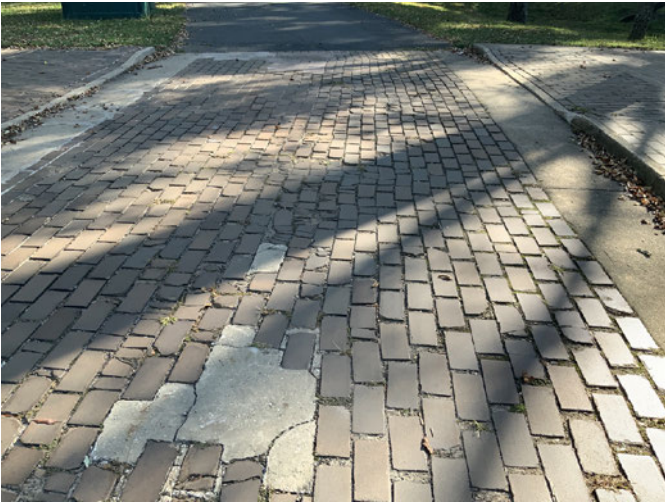
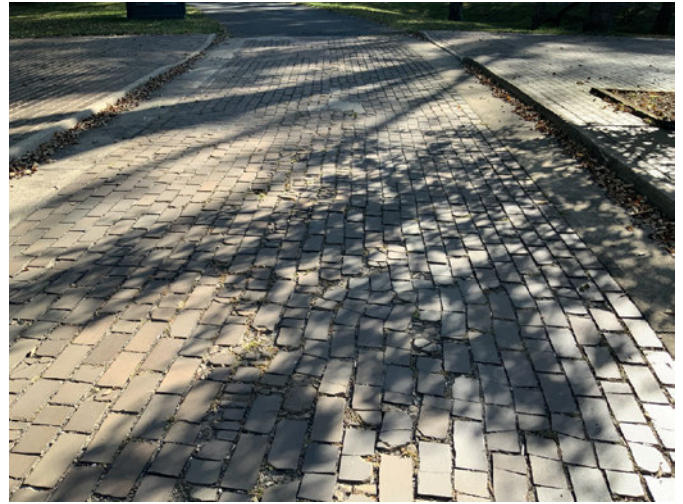
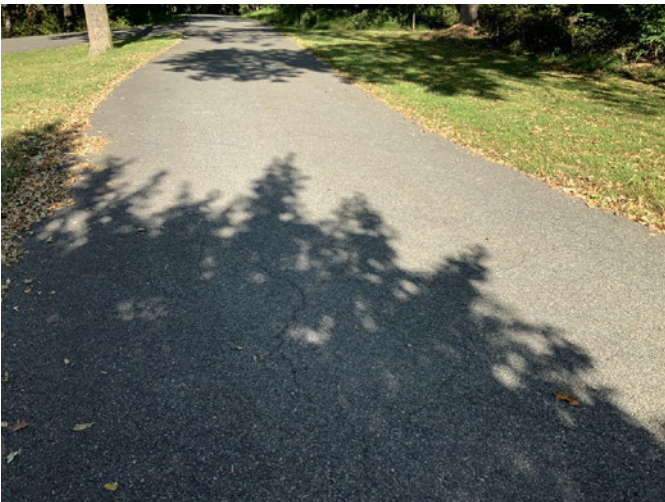
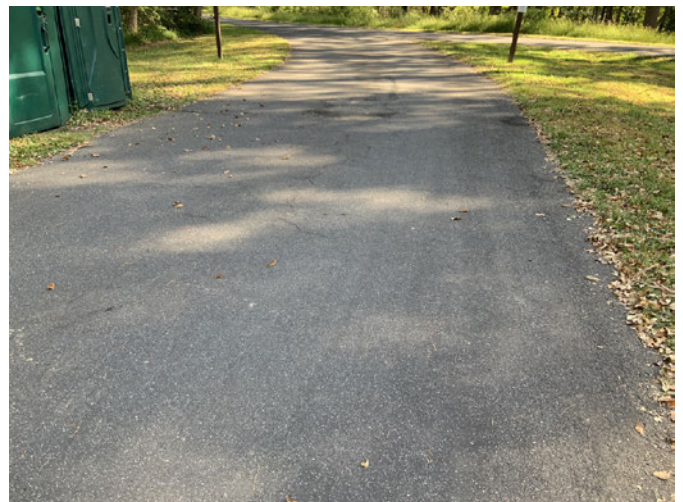
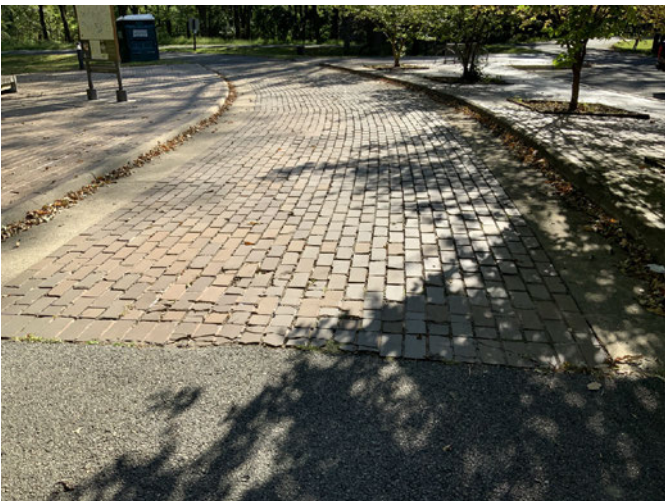
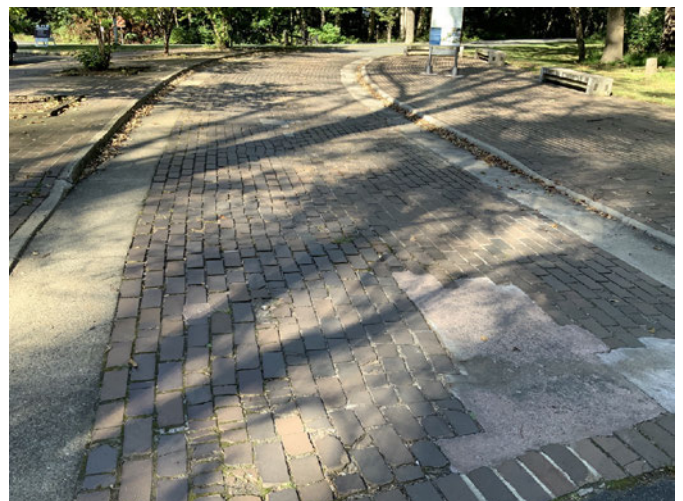
### Condition Photos

Condition photos are shown only for manually rated roads. Use the PathView program to see images of DCV rated roads.

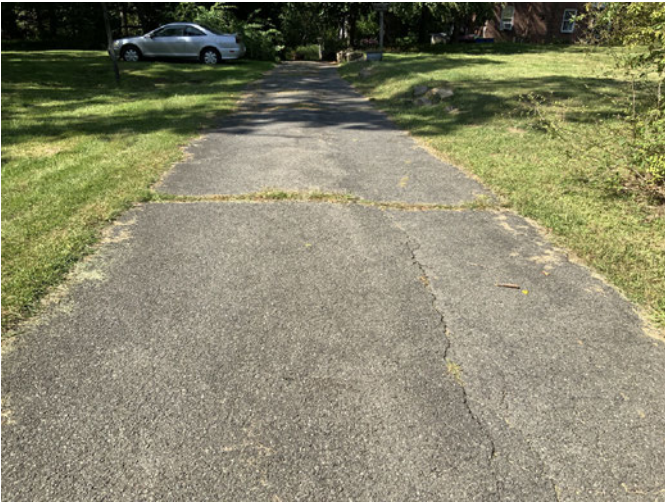
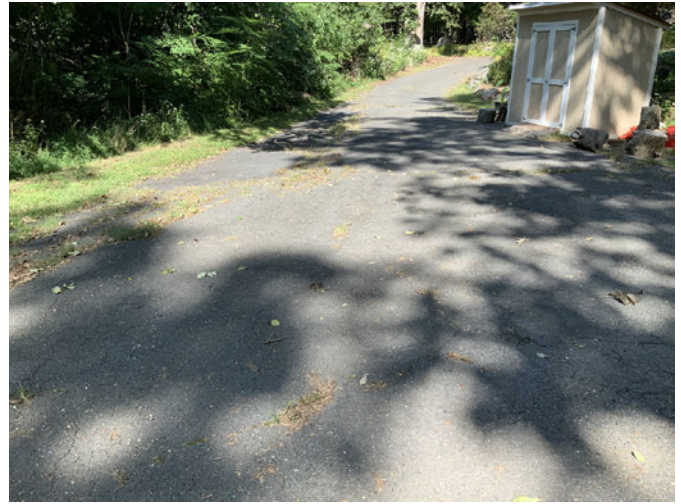
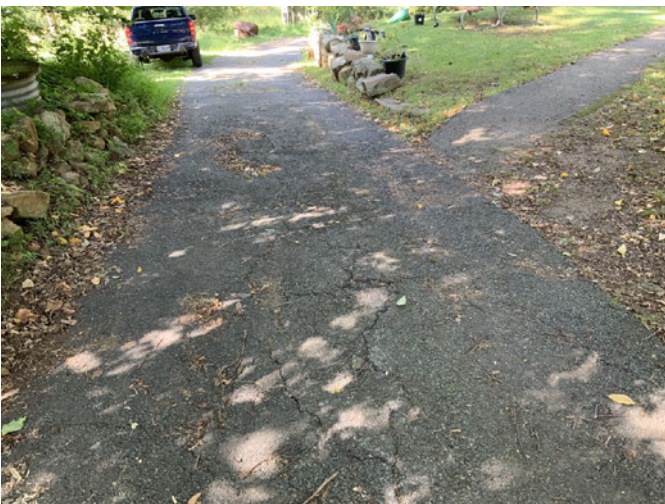
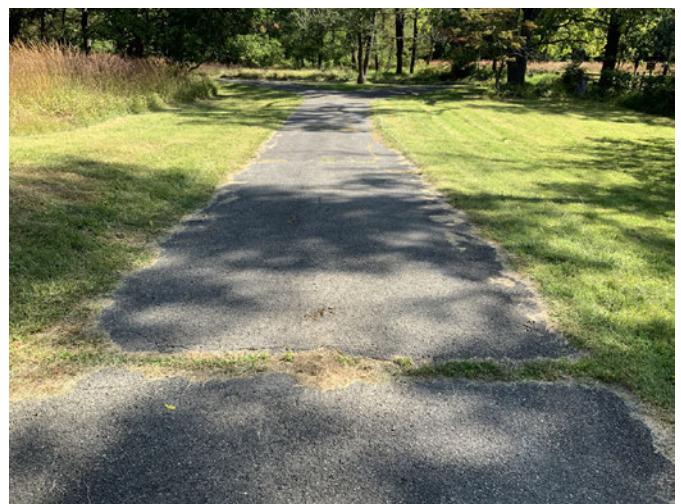
### Condition Photos

Condition photos are shown only for manually rated roads. Use the PathView program to see images of DCV rated roads.
