MORU Cycle 6

Final Report

Road Inventory and Condition Assessment of Paved Routes Mount Rushmore National Memorial

Report Date: April 2018

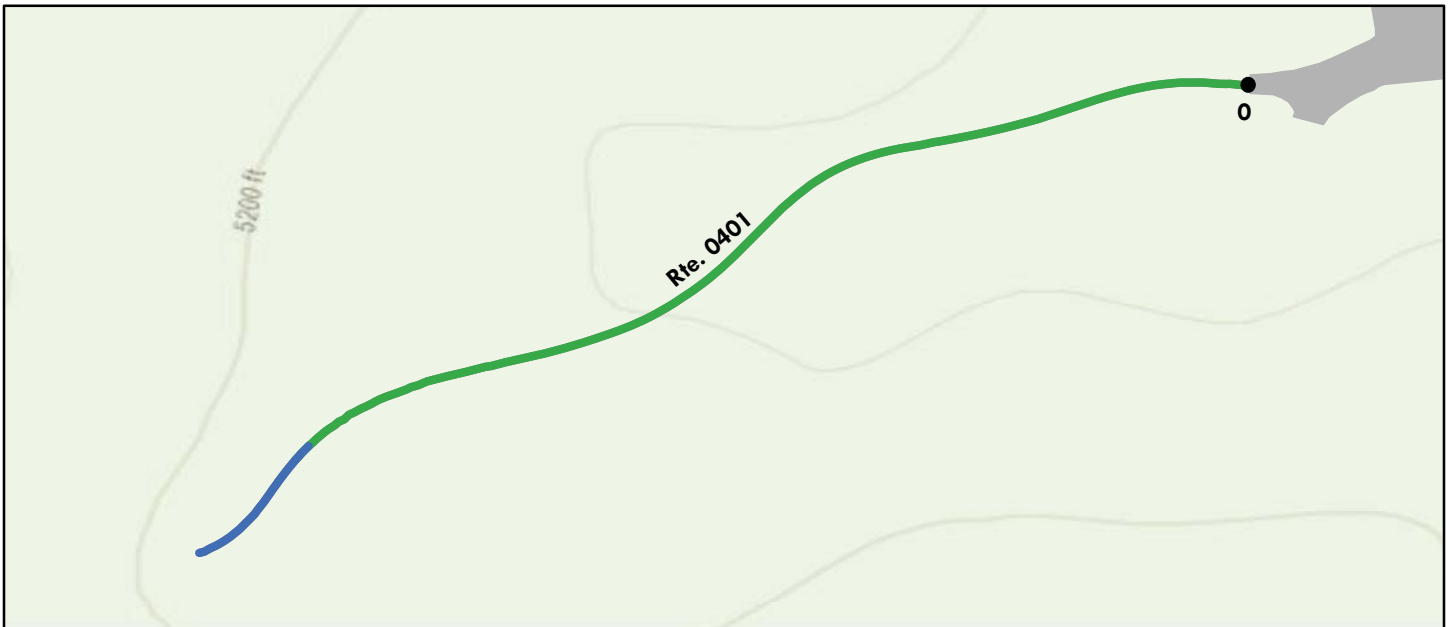
ROUTE 0401: AMPHITHEATER ACCESS ROAD

Colors on map represent condition scores at 0.10-mile intervals. See Appendix for definitions and formulas.

Inspection Date: 7/20/2017	Beginning Section MP	0				
Paved Length (Miles): 0.12	Section Length (MI)	0.12				
Surface Type: ASPHALT	Route Summary					
Roadway Condition Information						
Pavement Condition Rating (PCR)	94	94				
Surface Condition Rating (SCR)	94	94				
Roughness Condition Index (RCI)	N/A	N/A				
Distress Index Values						
Structural Crack Index	100	100				
Alligator Crack Index	100	100				
Longitudinal Crack Index	100	100				
Transverse Cracking Index	100	100				
Patching Index	99	99				
Rutting Index	94	94				
International Roughness Index (IRI)	N/A	N/A				
Lane & Width Information						
Number of Lanes	1	1				
Paved Width (ft)	12	12				
Lane Width (ft)	12	12

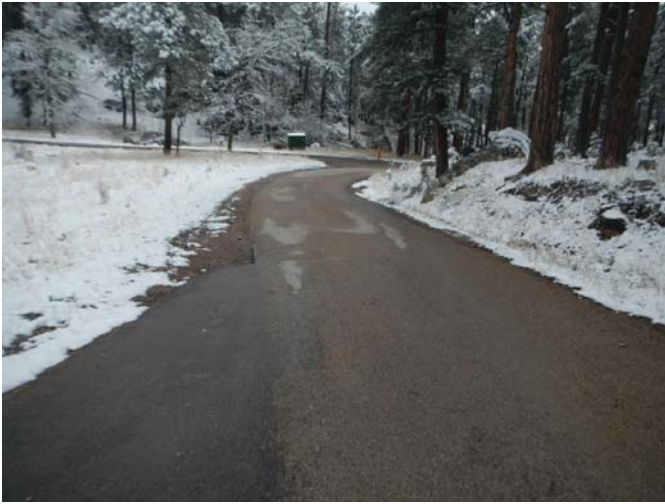
MORU_0403_7683.JPG

Route Condition Legend – Pavement Condition Rating (PCR)						
Poor (0 - 60)	Fair (61- 84)	Good (85 - 94)	Excellent (95 - 100)	Not Rated		
See Appendix for definitions and formulas						
Inspection Date: 4/26/2017	Beginning Section MP	0.00				
Paved Length (Miles): 0.27	Section Length (MI)	0.27				
Surface Type: ASPHALT	Route Summary					
Roadway Condition Information						
Pavement Condition Rating (PCR)	90	90				
Surface Condition Rating (SCR)	90	90				
Roughness Condition Index (RCI)	N/A	N/A				
Distress Index Values						
Structural Crack Index	N/A	N/A				
Alligator Crack Index	90	90				
Longitudinal Crack Index	97	97				
Transverse Cracking Index	90	90				
Patching Index	97	97				
Rutting Index	90	90				
International Roughness Index (IRI)	N/A	N/A				
Lane & Width Information						
Number of Lanes	1	1				
Paved Width (ft)	10.5	10.5				
Lane Width (ft)	10.5	10.5

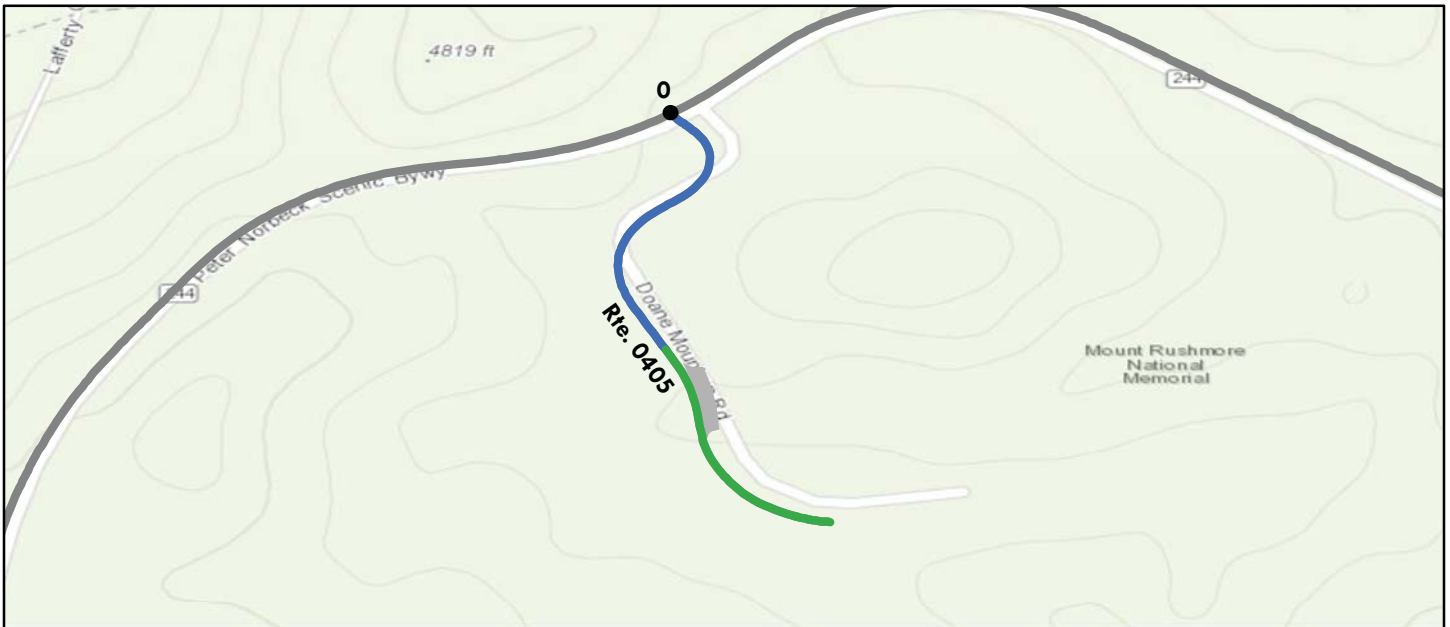
ROUTE 0405: DOANE MOUNTAIN ROAD

Colors on map represent condition scores at 0.10-mile intervals. See Appendix for definitions and formulas.

Inspection Date: 7/20/2017	Beginning Section MP	0				
Paved Length (Miles): 0.19	Section Length (MI)	0.19				
Surface Type: ASPHALT	Route Summary					
Roadway Condition Information						
Pavement Condition Rating (PCR)	93	93				
Surface Condition Rating (SCR)	93	93				
Roughness Condition Index (RCI)	N/A	N/A				
Distress Index Values						
Structural Crack Index	98	98				
Alligator Crack Index	100	100				
Longitudinal Crack Index	98	98				
Transverse Cracking Index	93	93				
Patching Index	99	99				
Rutting Index	97	97				
International Roughness Index (IRI)	N/A	N/A				
Lane & Width Information						
Number of Lanes	2	2				
Paved Width (ft)	17.6	17.6				
Lane Width (ft)	8.8	8.8

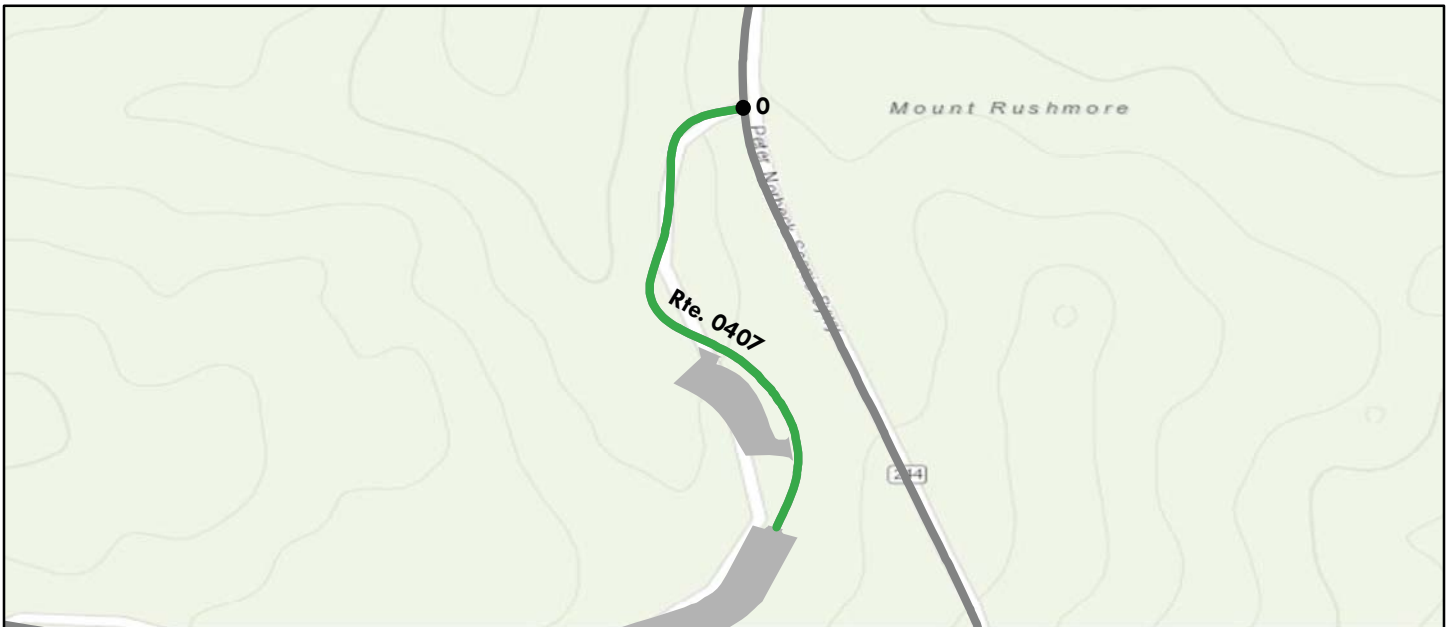
ROUTE 0407: CONCESSION DORMITORY ROAD

Colors on map represent condition scores at 0.10-mile intervals. See Appendix for definitions and formulas.

Inspection Date: 7/20/2017	Beginning Section MP	0				
Paved Length (Miles): 0.19	Section Length (MI)	0.19				
Surface Type: ASPHALT	Route Summary					
Roadway Condition Information						
Pavement Condition Rating (PCR)	95	95				
Surface Condition Rating (SCR)	95	95				
Roughness Condition Index (RCI)	N/A	N/A				
Distress Index Values						
Structural Crack Index	95	95				
Alligator Crack Index	100	100				
Longitudinal Crack Index	95	95				
Transverse Cracking Index	98	98				
Patching Index	95	95				
Rutting Index	97	97				
International Roughness Index (IRI)	N/A	N/A				
Lane & Width Information						
Number of Lanes	2	2				
Paved Width (ft)	20.8	20.8				
Lane Width (ft)	10.4	10.4
