NABR Cycle 6

Final Report

Road Inventory and Condition Assessment of Paved Routes Natural Bridges National Monument

**Federal Highway Administration
Eastern Federal Lands Highway Division
Road Inventory Program (RIP)**

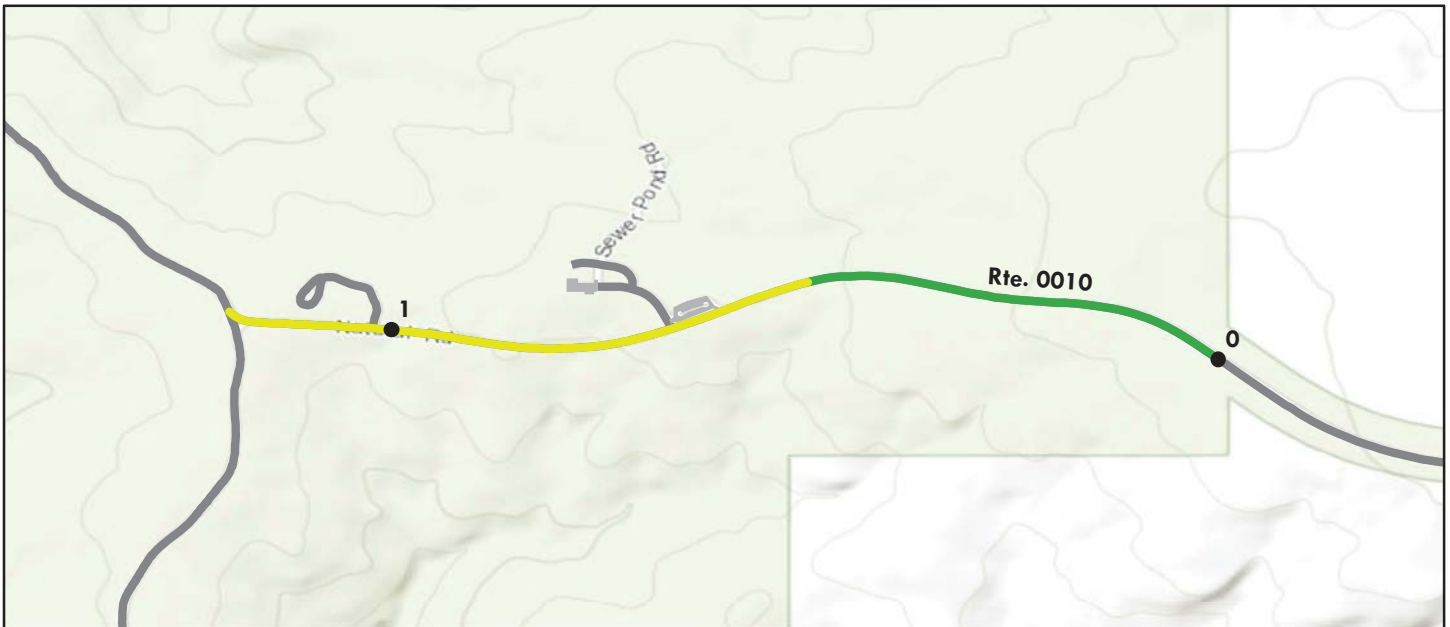
ROUTE 0010: ENTRANCE ROAD

Route Condition Legend – Pavement Condition Rating (PCR)						
Poor (0 - 60)	Fair (61- 84)	Good (85 - 94)	Excellent (95 - 100)	Not Rated		
See Appendix for definitions and formulas						
Inspection Date: 6/4/2017	Beginning Section MP	0	1			
Paved Length (Miles): 1.19	Section Length (MI)	1	0.19			
Surface Type: ASPHALT	Route Summary					
Roadway Condition Information						
Pavement Condition Rating (PCR)	82	83	80			
Surface Condition Rating (SCR)	95	95	97			
Roughness Condition Index (RCI)	63	64	55			
Distress Index Values						
Structural Crack Index	100	100	100			
Alligator Crack Index	100	100	100			
Longitudinal Crack Index	100	100	100			
Transverse Cracking Index	98	98	99			
Patching Index	100	100	100			
Rutting Index	95	95	97			
International Roughness Index (IRI)	229	223	261			
Lane & Width Information						
Number of Lanes	2	2	2			
Paved Width (ft)	23.9	24.4	21.2			
Lane Width (ft)	9.9	10	9.7

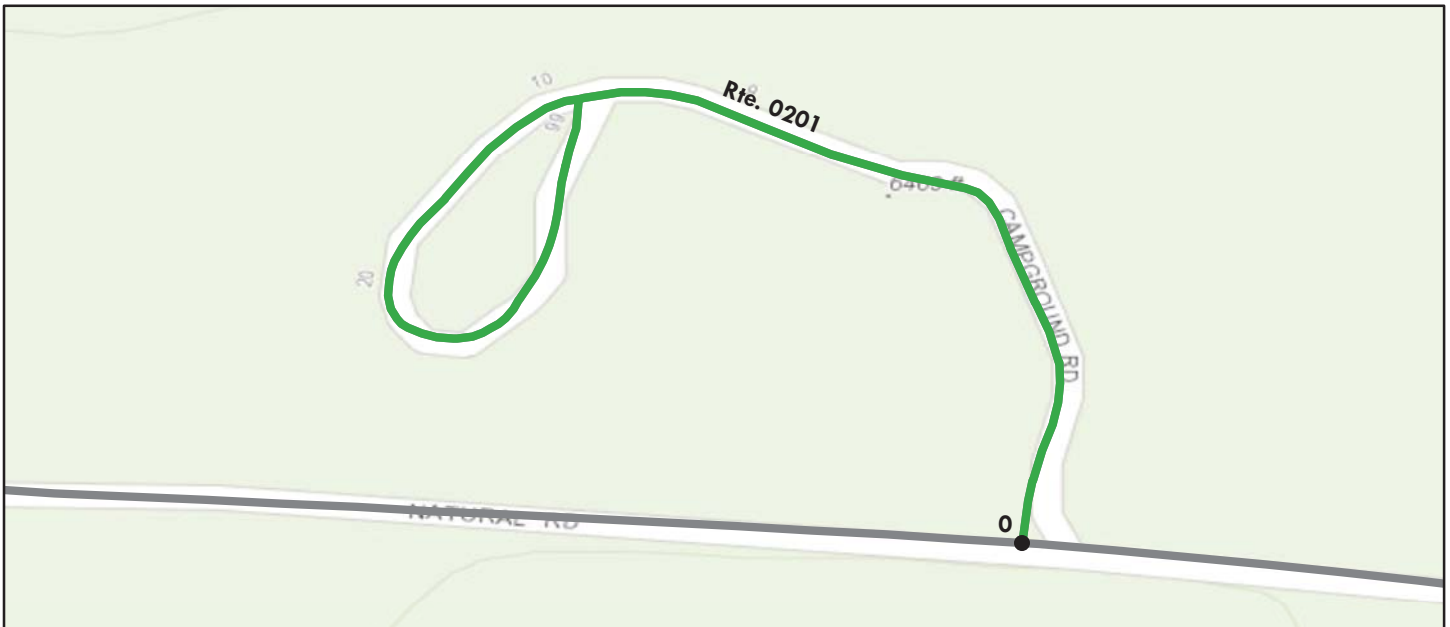
ROUTE 0201: CAMPGROUND LOOP

Route Condition Legend – Pavement Condition Rating (PCR)						
Poor (0 - 60)	Fair (61- 84)	Good (85 - 94)	Excellent (95 - 100)	Not Rated		
See Appendix for definitions and formulas						
Inspection Date: 6/4/2017	Beginning Section MP	0				
Paved Length (Miles): 0.21	Section Length (MI)	0.21				
Surface Type: ASPHALT	Route Summary					
Roadway Condition Information						
Pavement Condition Rating (PCR)	94	94				
Surface Condition Rating (SCR)	94	94				
Roughness Condition Index (RCI)	N/A	N/A				
Distress Index Values						
Structural Crack Index	100	100				
Alligator Crack Index	100	100				
Longitudinal Crack Index	100	100				
Transverse Cracking Index	99	99				
Patching Index	100	100				
Rutting Index	94	94				
International Roughness Index (IRI)	N/A	N/A				
Lane & Width Information						
Number of Lanes	2	2				
Paved Width (ft)	14.1	14.1				
Lane Width (ft)	9.6	9.6

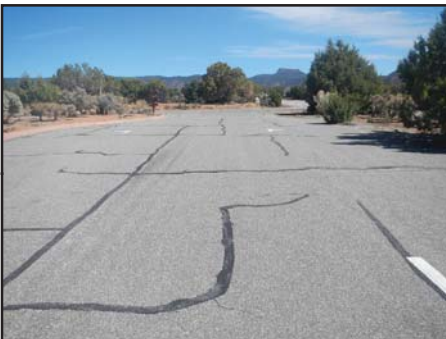
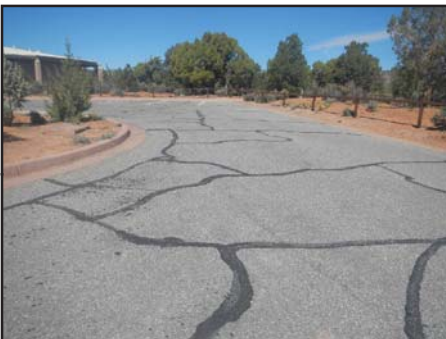
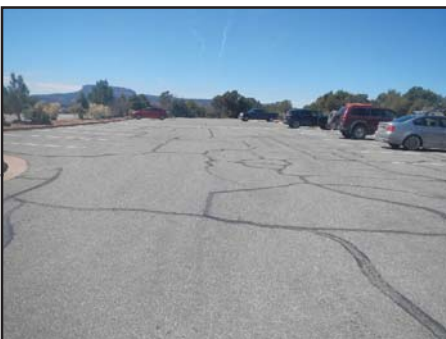
Inspection Date	FMSS Number	User Access	Surface Type
3/20/2016	61273	PUBLIC	ASPHALT
Area (Sq. Ft.)	Lane Miles (11' Widths)	Curb Reveal (Inches)	Curb Recommendation
25,251	0.435	NOT APPLICABLE	DO NOTHING
Curb Type		Curb & Gutter Type	
NO CURB		CONCRETE	
Pavement Recommendation		Condition Rating / PCR	
PREVENTIVE MAINTENANCE		GOOD / 90

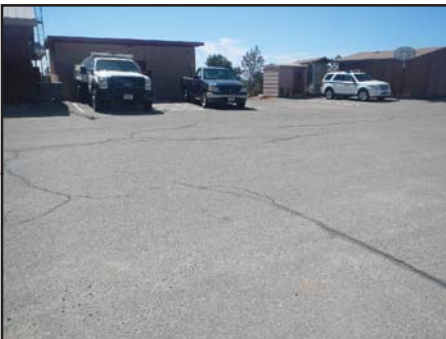
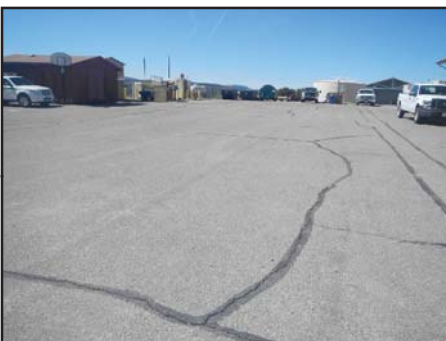
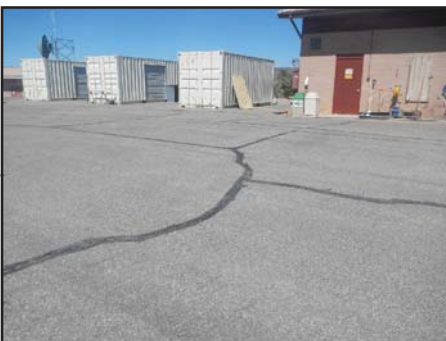
ROUTE 0902: MAINTENANCE AREA

Inspection Date	FMSS Number	User Access	Surface Type
3/20/2016	61237	PUBLIC	ASPHALT
Area (Sq. Ft.)	Lane Miles (11' Widths)	Curb Reveal (Inches)	Curb Recommendation
17,035	0.293	NOT APPLICABLE	NOT APPLICABLE
Curb Type		Curb & Gutter Type	
NO CURB		NO CURB AND GUTTER	
Pavement Recommendation		Condition Rating / PCR	
PREVENTIVE MAINTENANCE		GOOD / 90

Note: Parking area consists of multiple surface types: 1 part Asphalt at 16,583 square feet; 1 part Concrete at 452 square feet.

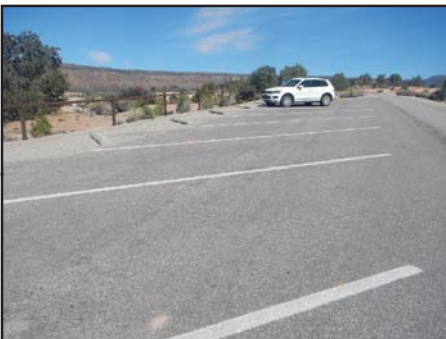
ROUTE 0904: SIPAPU BRIDGE VIEW PARKING

Inspection Date	FMSS Number	User Access	Surface Type
3/20/2016	98114	PUBLIC	ASPHALT
Area (Sq. Ft.)	Lane Miles (11' Widths)	Curb Reveal (Inches)	Curb Recommendation
6,764	0.116	NOT APPLICABLE	NOT APPLICABLE
Curb Type		Curb & Gutter Type	
NO CURB		NO CURB AND GUTTER	
Pavement Recommendation		Condition Rating / PCR	
PREVENTIVE MAINTENANCE		GOOD / 90

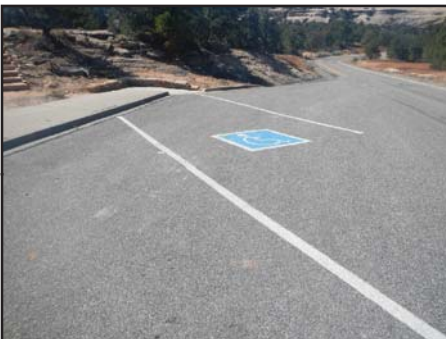
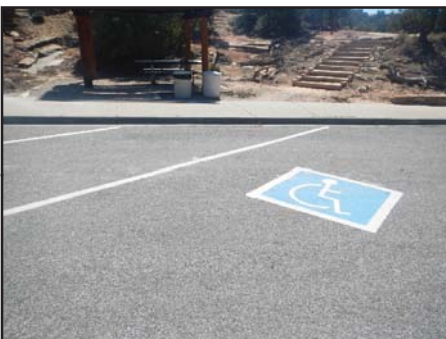
ROUTE 0905: PICNIC AREA PARKING

Inspection Date	FMSS Number	User Access	Surface Type
3/20/2016	98156	PUBLIC	ASPHALT
Area (Sq. Ft.)	Lane Miles (11' Widths)	Curb Reveal (Inches)	Curb Recommendation
3,366	0.058	NOT APPLICABLE	DO NOTHING
Curb Type		Curb & Gutter Type	
NO CURB		CONCRETE	
Pavement Recommendation		Condition Rating / PCR	
PREVENTIVE MAINTENANCE		GOOD / 90

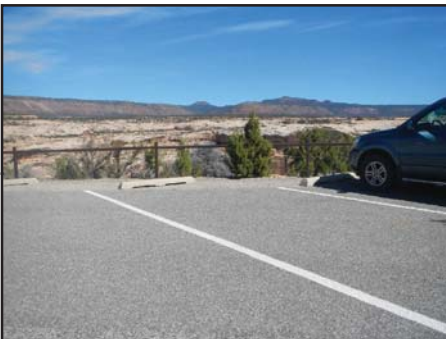
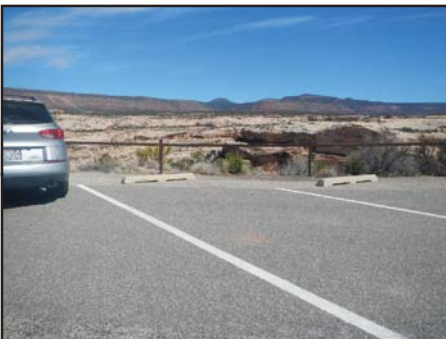
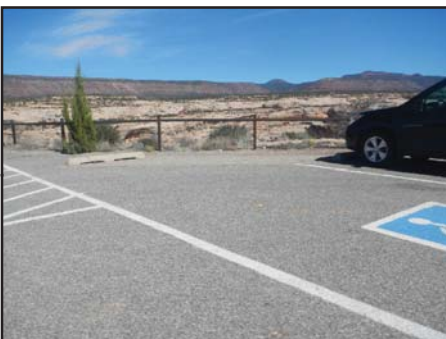
ROUTE 0906: SIPAPU TRAIL PARKING

Inspection Date	FMSS Number	User Access	Surface Type
3/20/2016	98157	PUBLIC	ASPHALT
Area (Sq. Ft.)	Lane Miles (11' Widths)	Curb Reveal (Inches)	Curb Recommendation
10,325	0.178	6	DO NOTHING
Curb Type		Curb & Gutter Type	
ASPHALT		NO CURB AND GUTTER	
Pavement Recommendation		Condition Rating / PCR	
PREVENTIVE MAINTENANCE		GOOD / 90

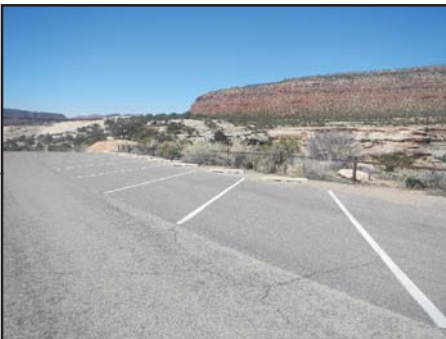
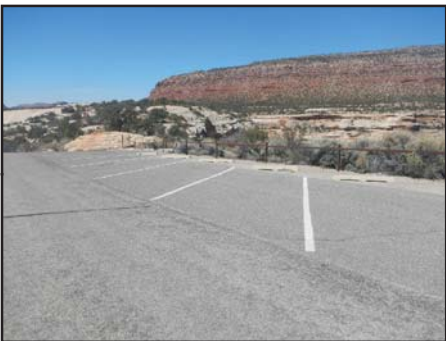
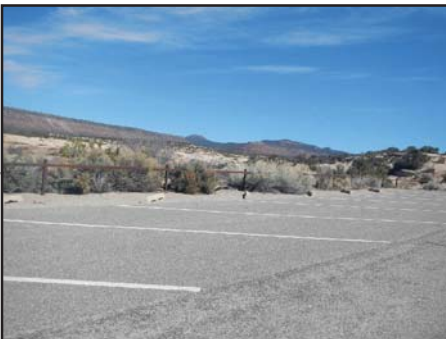
ROUTE 0907: HORSE COLLAR RUIN OVERLOOK PARKING

Inspection Date	FMSS Number	User Access	Surface Type
3/20/2016	98158	PUBLIC	ASPHALT
Area (Sq. Ft.)	Lane Miles (11' Widths)	Curb Reveal (Inches)	Curb Recommendation
8,041	0.138	NOT APPLICABLE	NOT APPLICABLE
Curb Type		Curb & Gutter Type	
NO CURB		NO CURB AND GUTTER	
Pavement Recommendation		Condition Rating / PCR	
PREVENTIVE MAINTENANCE		GOOD / 90

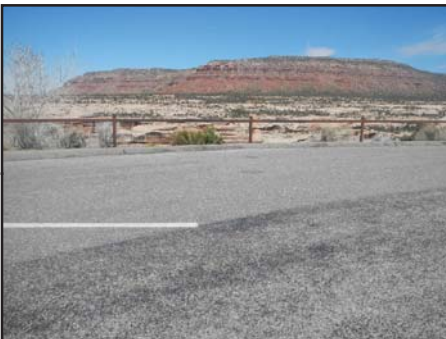
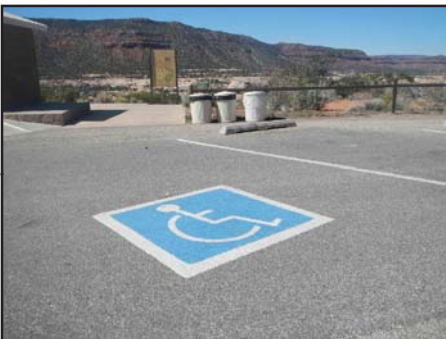
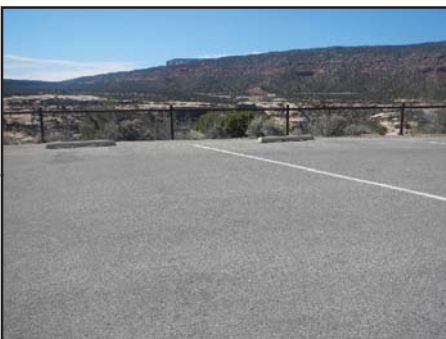
ROUTE 0908: KACHINA BRIDGE PARKING

Inspection Date	FMSS Number	User Access	Surface Type
3/20/2016	98159	PUBLIC	ASPHALT
Area (Sq. Ft.)	Lane Miles (11' Widths)	Curb Reveal (Inches)	Curb Recommendation
12,249	0.211	6	DO NOTHING
Curb Type		Curb & Gutter Type	
ASPHALT		NO CURB AND GUTTER	
Pavement Recommendation		Condition Rating / PCR	
PREVENTIVE MAINTENANCE		GOOD / 90

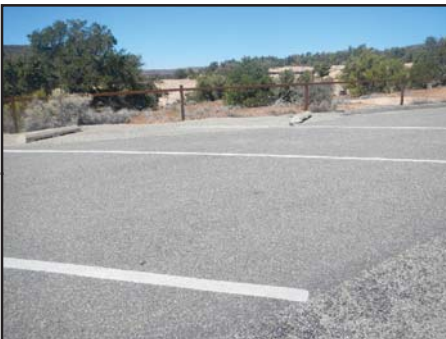
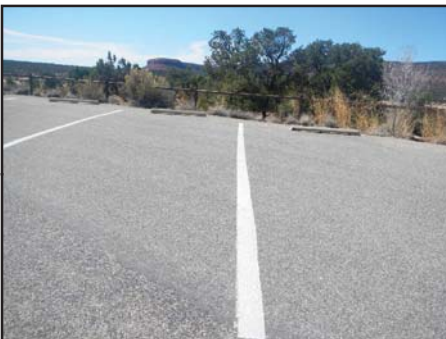
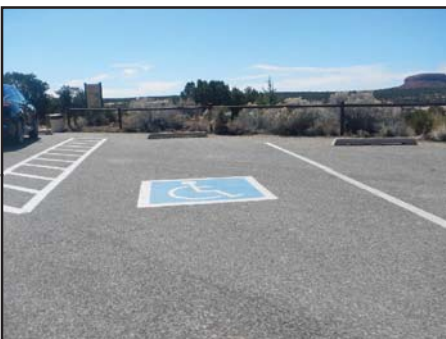
ROUTE 0909: OWACHOMO BRIDGE PARKING

Inspection Date	FMSS Number	User Access	Surface Type
3/20/2016	98160	PUBLIC	ASPHALT
Area (Sq. Ft.)	Lane Miles (11' Widths)	Curb Reveal (Inches)	Curb Recommendation
14,446	0.249	6	DO NOTHING
Curb Type		Curb & Gutter Type	
ASPHALT		NO CURB AND GUTTER	
Pavement Recommendation		Condition Rating / PCR	
PREVENTIVE MAINTENANCE		GOOD / 90

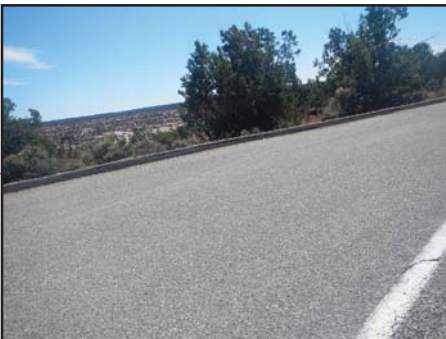
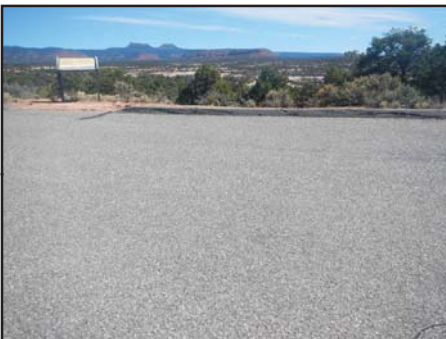
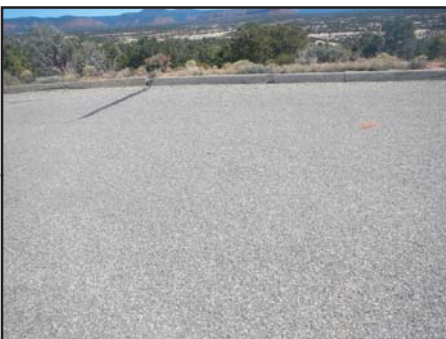
ROUTE 0911: BEARS EARS PARKING

Inspection Date	FMSS Number	User Access	Surface Type
3/20/2016	98162	PUBLIC	ASPHALT
Area (Sq. Ft.)	Lane Miles (11' Widths)	Curb Reveal (Inches)	Curb Recommendation
1,974	0.034	6	DO NOTHING
Curb Type		Curb & Gutter Type	
ASPHALT		NO CURB AND GUTTER	
Pavement Recommendation		Condition Rating / PCR	
PREVENTIVE MAINTENANCE		GOOD / 90
